Hydrogeological Risk Assessment - Upgraded Treated Effluent Discharge to Ground

Llansantffraed Court Hotel, Llanvihangel Gobion, Abergavenny

Snaco UK Limited

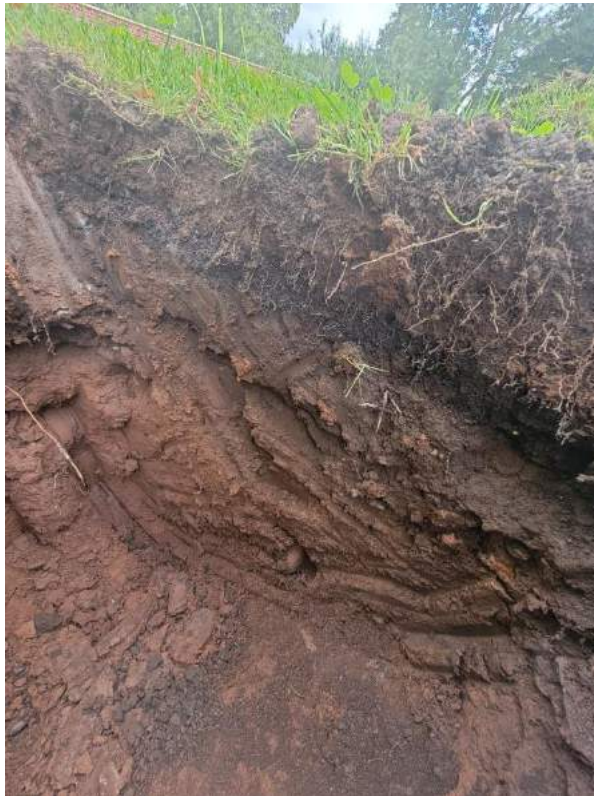
Picture 3 – Test Pit 2 Ground Strata's

The ground was found to be a light red brown clay in line with the BGS superficial soil records of a Till Devensian deposits for a depth of 1m.

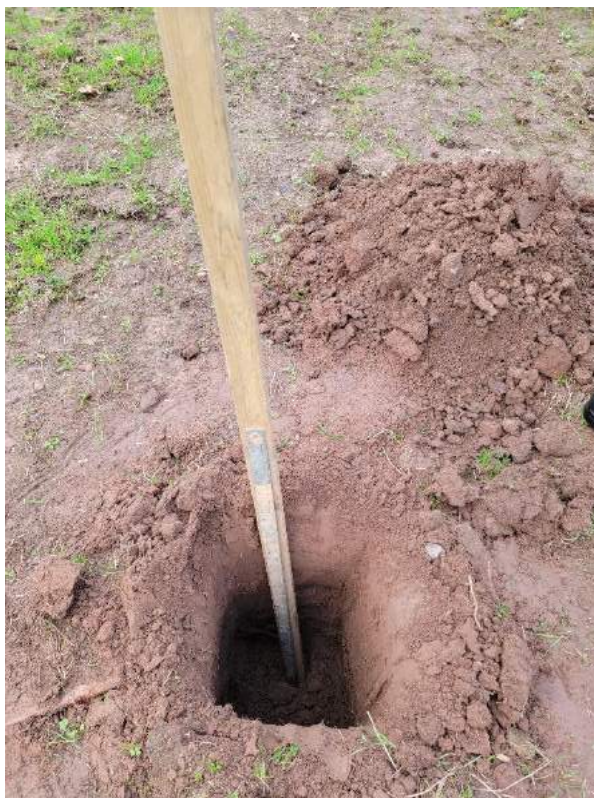
Picture 2 – Test Pit 1 Soil strata

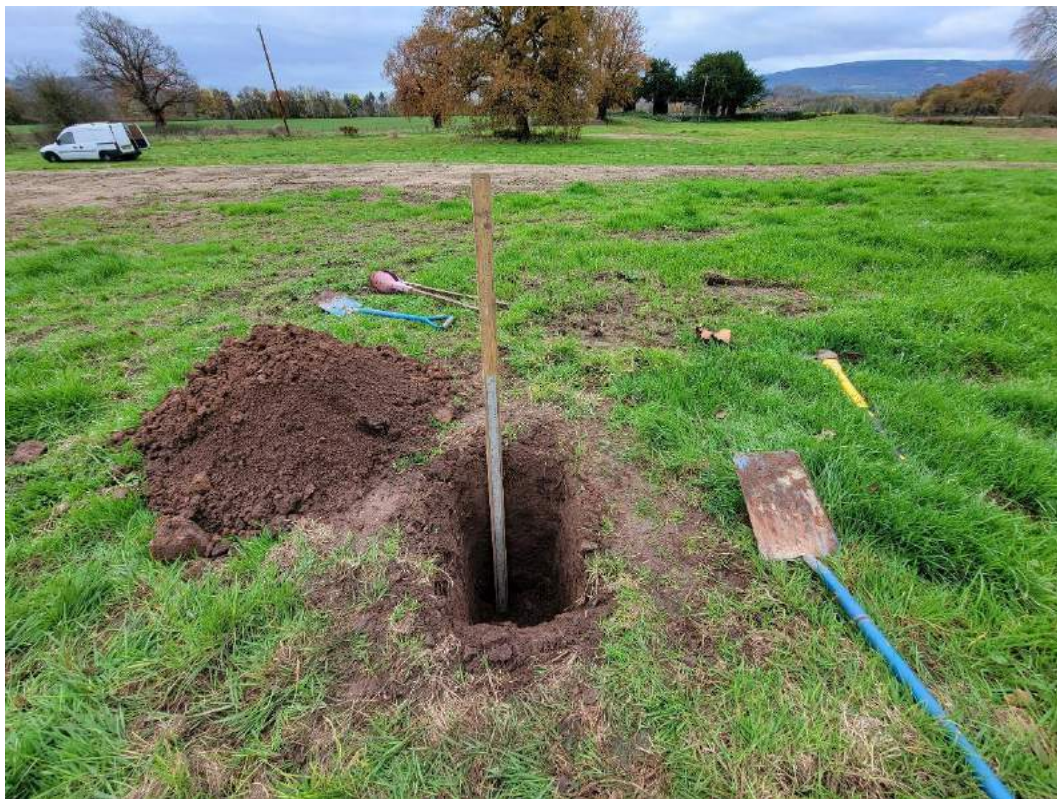
Picture 3 – Test Pit 2 Soil strata

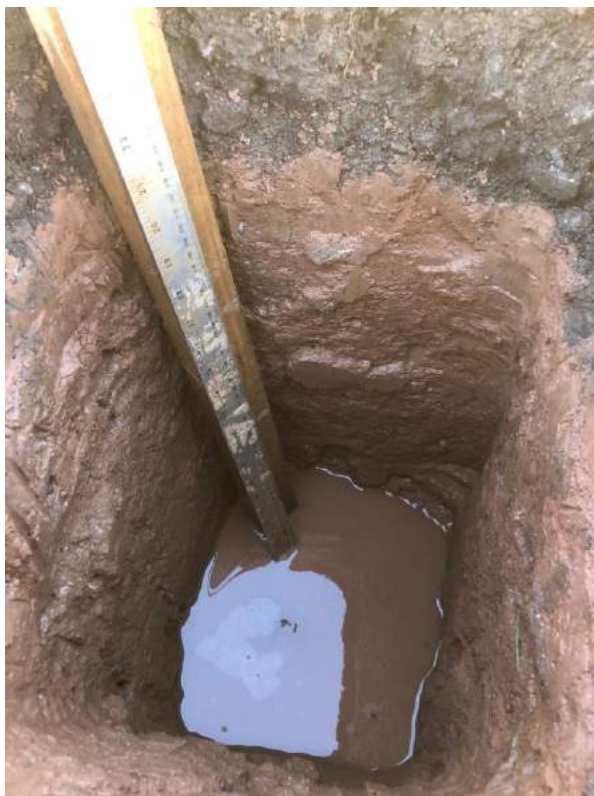
Picture 6 – Test Pit 3 Soil Strata
