## Method Statement for works to the Menai Bridge 2022

**UK Highways**

10 February 2022

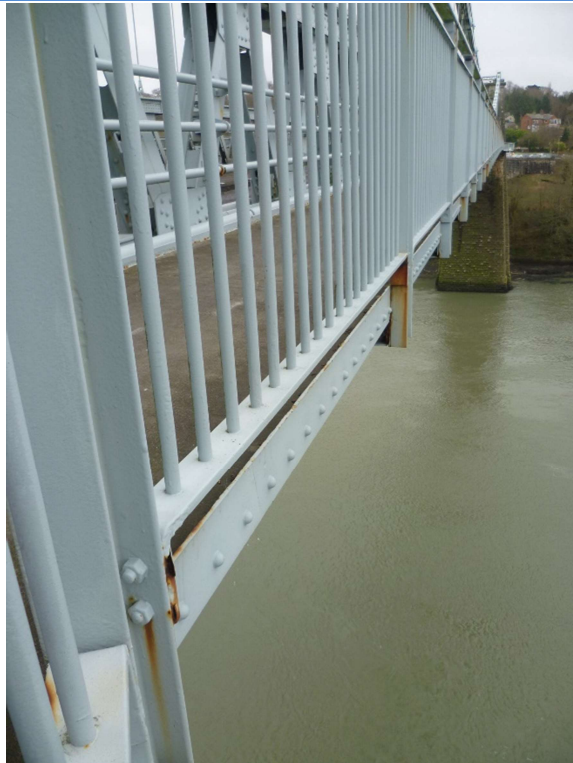
a) Railing support posts bolted onto metal support joist on the parapet.

2.2.2 Essential structural work required to strengthen the existing corbels on the North and South approach viaducts, including the metal posts supporting the guard rail (Figure 2a).

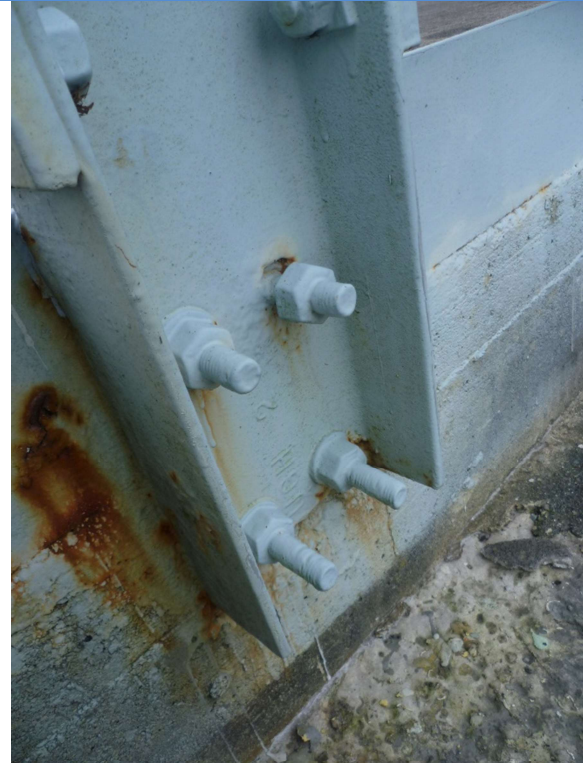
b) Support posts retained by four bolts which may need to be removed.

2.2.3 Additional external reinforcement, including brackets bolted onto the sides of the supporting posts, may be required if the bolts cannot be removed intact. (Figure 2b).

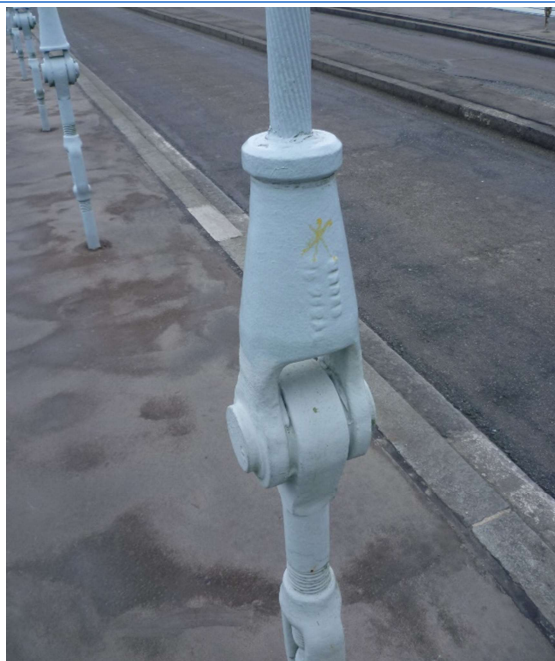
a) Drop-link and turn buckle on the base of the supporting hangers.

2.2.9 The inspection will assess condition of the drop-links and turn buckles (Figure 3a/b) on the bridge hangers. The inspection will follow a 'traffic light' system, where:

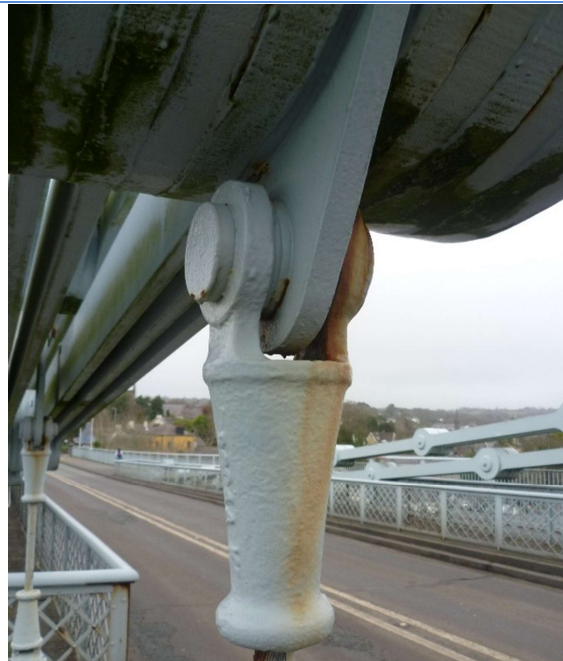
b) Drop-link on the top of the hanger, connecting to the overhead tensioning changes.
