Application for an Environmental Permit

Household, Commercial and Industrial Waste Transfer Station

Additional Information for Application EWS/JG2

Enviroventure Waste Solutions Limited

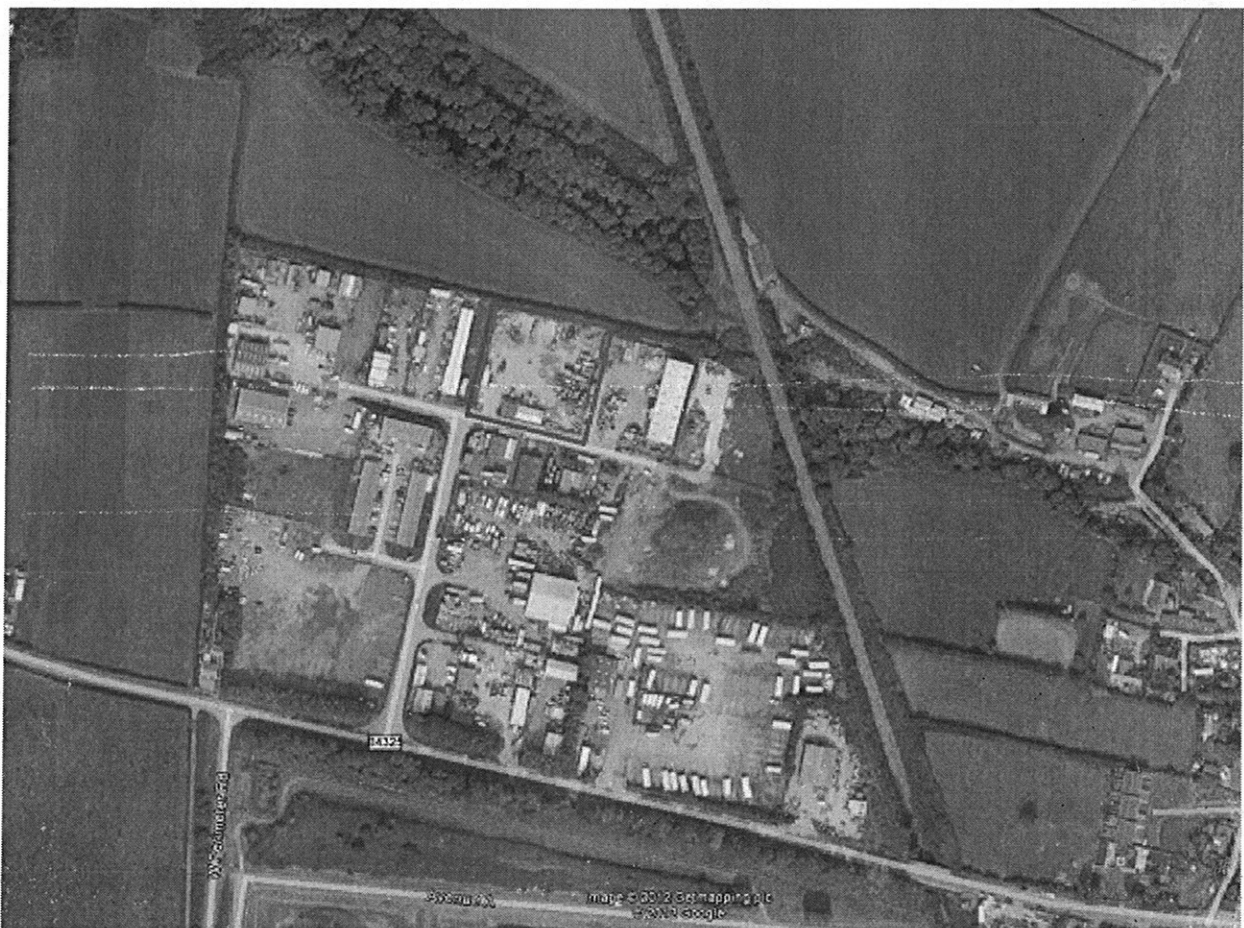
Figure 1 Site Setting

The [**Site**] is located at the northern perimeter of a small industrial estate (NGR SM 93187 06149) which is situated in a predominantly rural area, the site is surrounded on 3 sides (East, South & West) by industrial units/plots and beyond the northern perimeter is agricultural land; see **Figure 1 Site Setting** below:

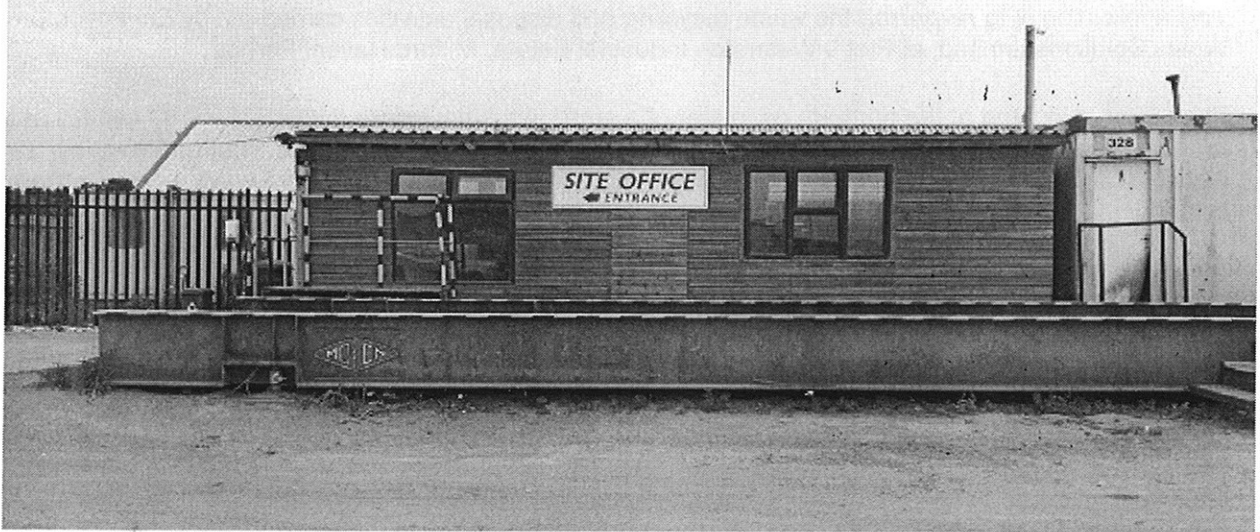
The **site occupies an area** of approximately 65m x 65m and **consists** of an office, toilets and weighbridge which are situated on the left on entering the site. A building which is situated immediately to the right on entering the site, the building is divided into 2 sections (one section used for plant,

equipment and maintenance and the other section used for the **sorting & storage of non-ferrous metals**, this activity is registered (No. EPR/EH0112FS/A001) as exempt under a **T9 Exemption**.

Located at the rear of the site (north western perimeter) is **a concrete pad used for depositing sorting mixed wastes** for segregation and reloading pending despatch to off-site recycling or disposal facilities. The concrete pad drains to a sealed drainage system (sealed underground tank), **This area is to be fitted with roofing** to prevent rainwater ingress and minimise the possibility of generating polluting leachate from wastes undergoing storage on the pad.

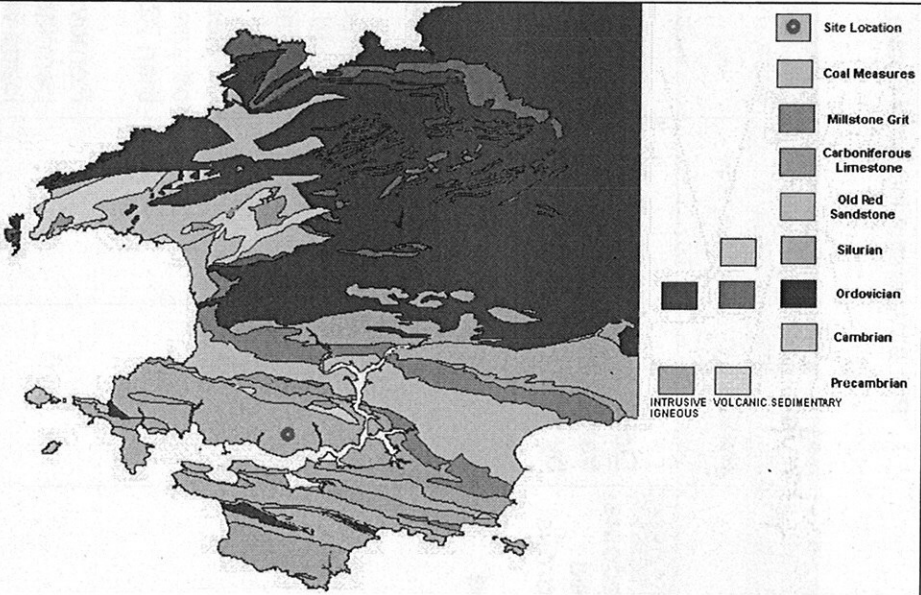
<p>The Geological map above shows the [site] is underlain by strata belonging to the Old Red Sandstone of the Devonian Period.</p>
