# Pembrokeshire County Council Cyngor Sir Penfro

### St. David's Landfill Site Restoration Plan

**St. David's Landfill Site  
Restoration Plan**

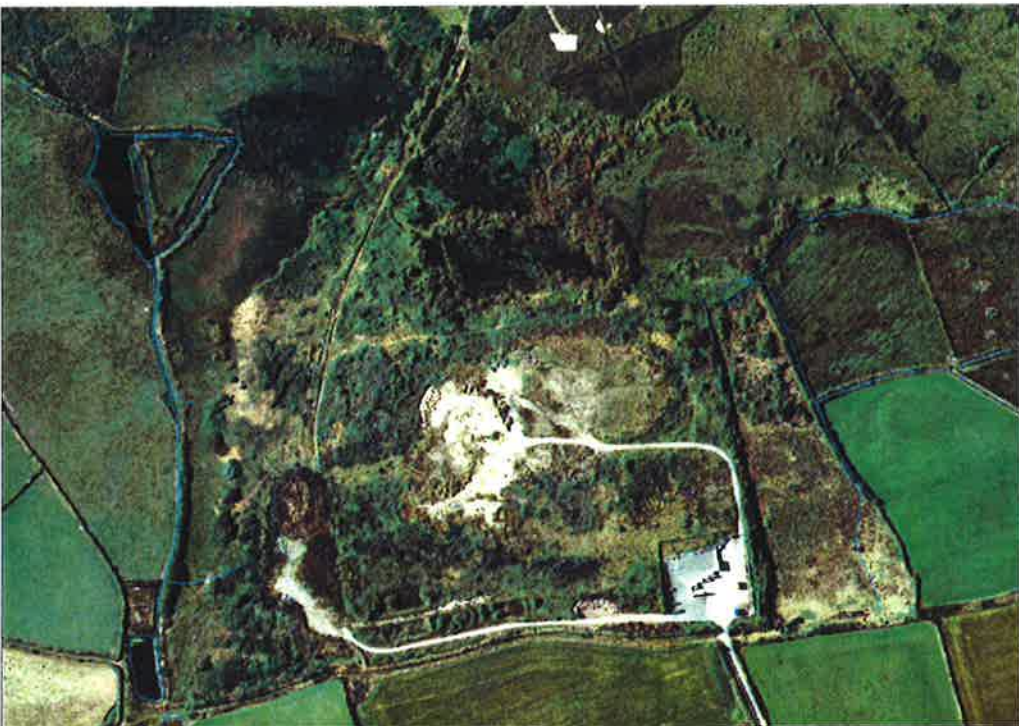
**Fig. 2 St. David's Landfill Site**

This tip was established by Haverfordwest Rural District Council following a planning consent issued by the former Pembrokeshire County Council in February 1961. A Location Plan is shown as Fig. 1. It was to be operated in accordance with rules laid down by the Ministry of Health in 1922 and the access road hardened out to the Public Highway. Fig. 2 illustrates the site and the adjacent S.S.S.I. on the southern boundary.
