Ty Mawr West Quarry

Geotechnical Review of Proposed Development- Eastern Quarries (October 2010)

Report Number: 10-312-R-001

Ty Mawr West Limited

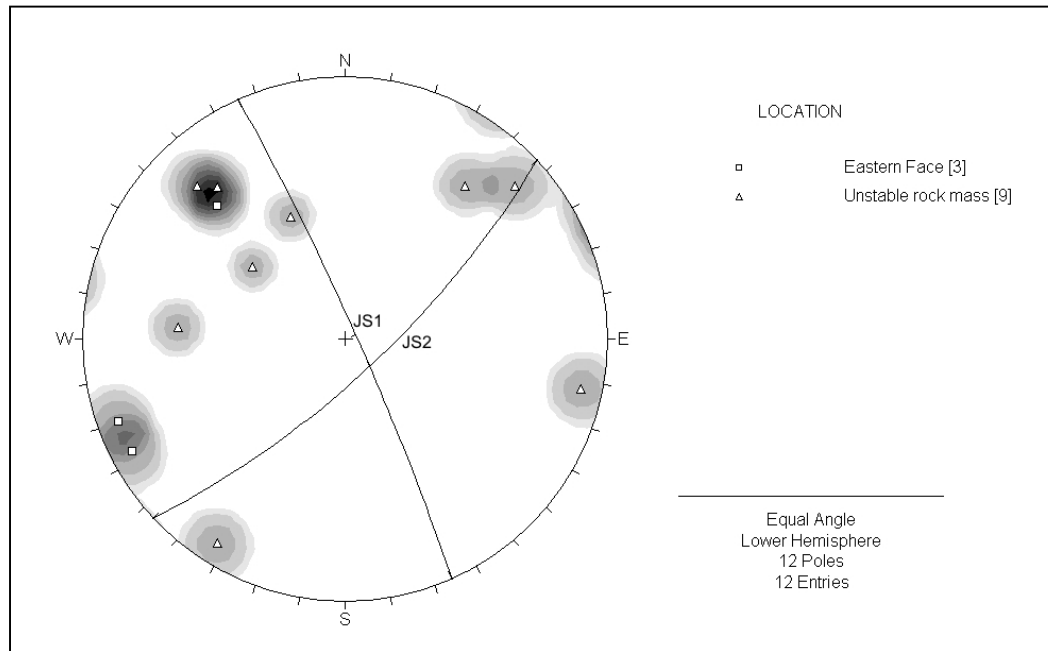
Figure C. Stereoplot summarising principal discontinuity sets at Pant Quarry

Discontinuity Type	Average Dip	Dip Direction
Joint Set 1*	85°	066°
Joint Set 2	74°	137°

* Note: Joint Sets A and B commonly overturned

Recent inspection has, however, identified the presence of two dominant joint sets within the East Blue Quarry, which are steeply inclined to sub-vertical and approximately perpendicular to each other, trending approximately NNW-SSE and SW-NE. The joint sets are locally overturned.

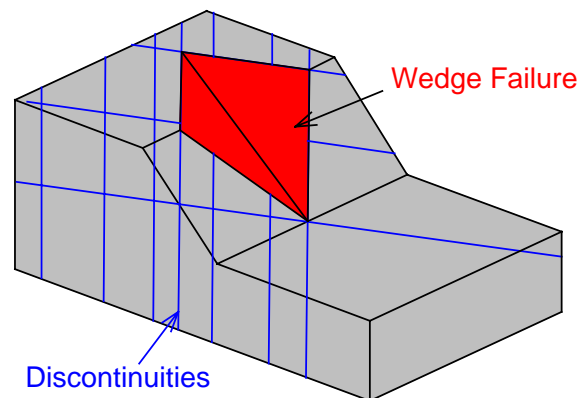
Wedge Failure

Wedge failures occur due to sliding of a block of rock along at least two intersecting discontinuity planes. As with plane failure, it is necessary for the discontinuities to 'daylight' in the slope face and for the dip of the intersection to be greater than the angle of friction.

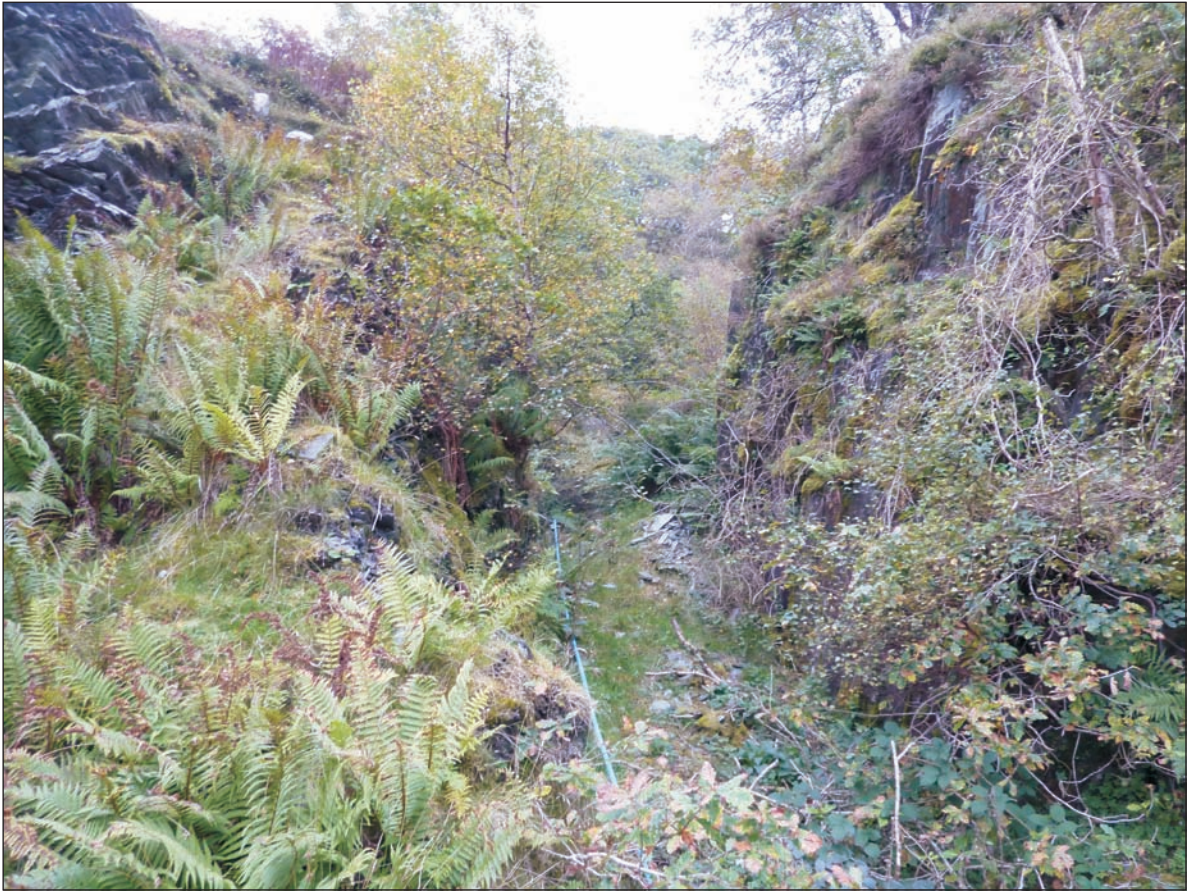
Photo 1. View of narrow cutting leading to East Green Quarry.

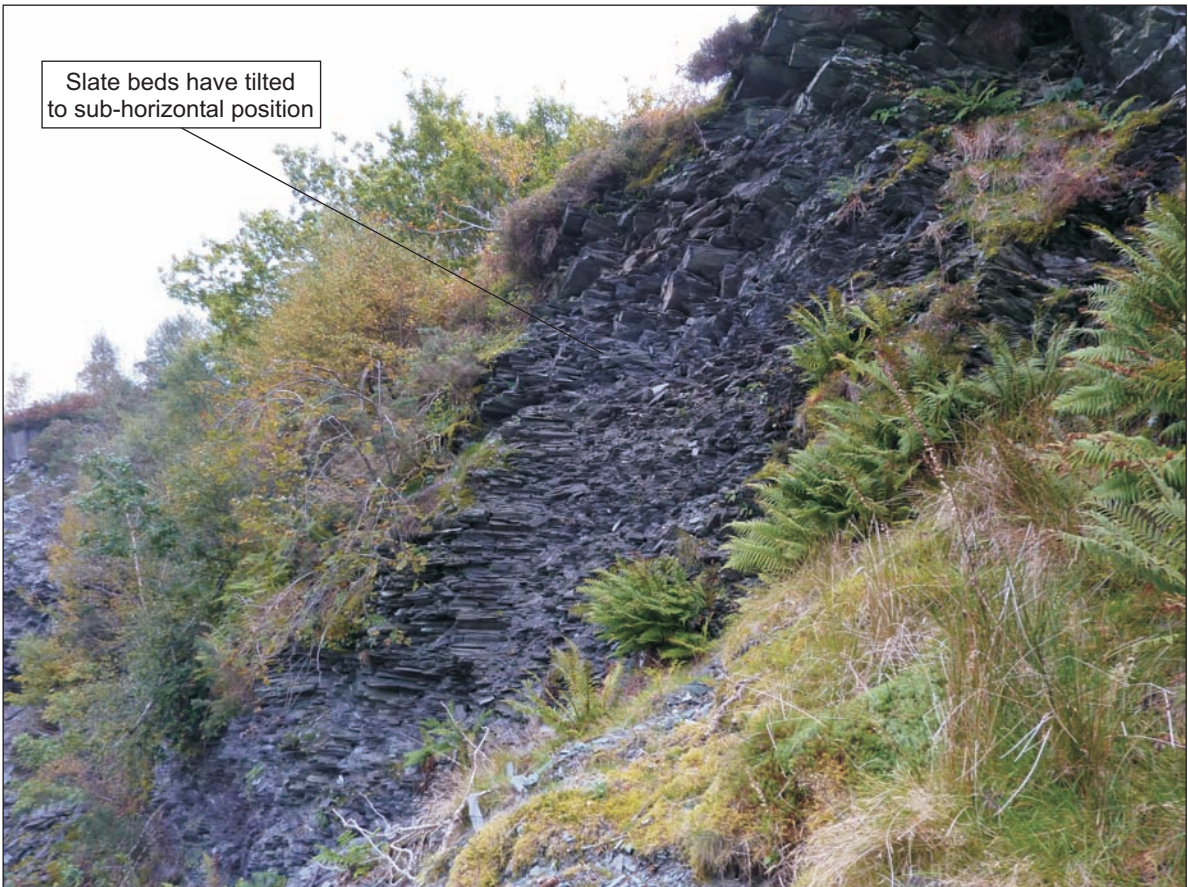
Inspection of the rock mass which separates the two quarries indicates potential for toppling failures and rockfall. This has been exacerbated by the apparent failure/slumping of the rock mass between the two quarries, leading to toppling of the slate beds towards the northwest (Photo 4).

Photo 4. Front of rock mass, East Blue Quarry.

Sub-vertical
slate beds

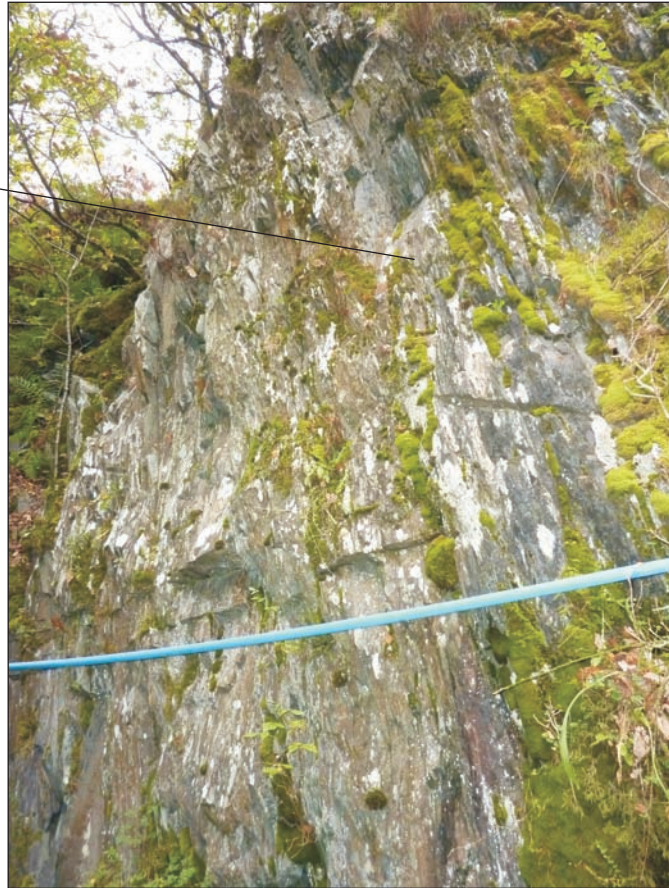
Photo 5. View near to back of rock mass, taken in cutting through to East Green Quarry.

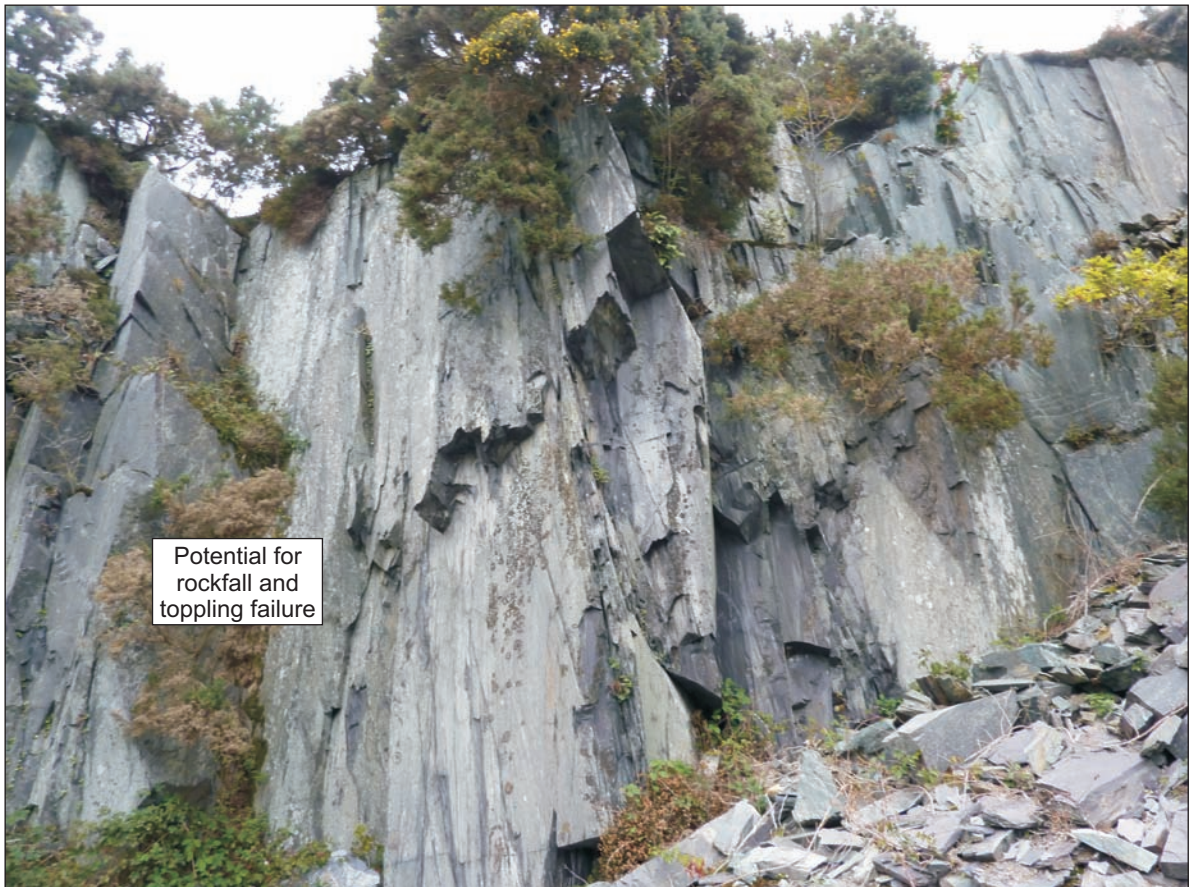
The current condition of the eastern faces is shown in Photo 6.

Photo 6. View of Eastern Faces, East Blue Quarry.

Provided individual faces are limited to a maximum height of 6m, intermediate benches of 3m are maintained between individual faces and faces are inclined at 70° (from horizontal) or shallower, it is considered that the potential failure hazards associated with the intended development will be manageable.

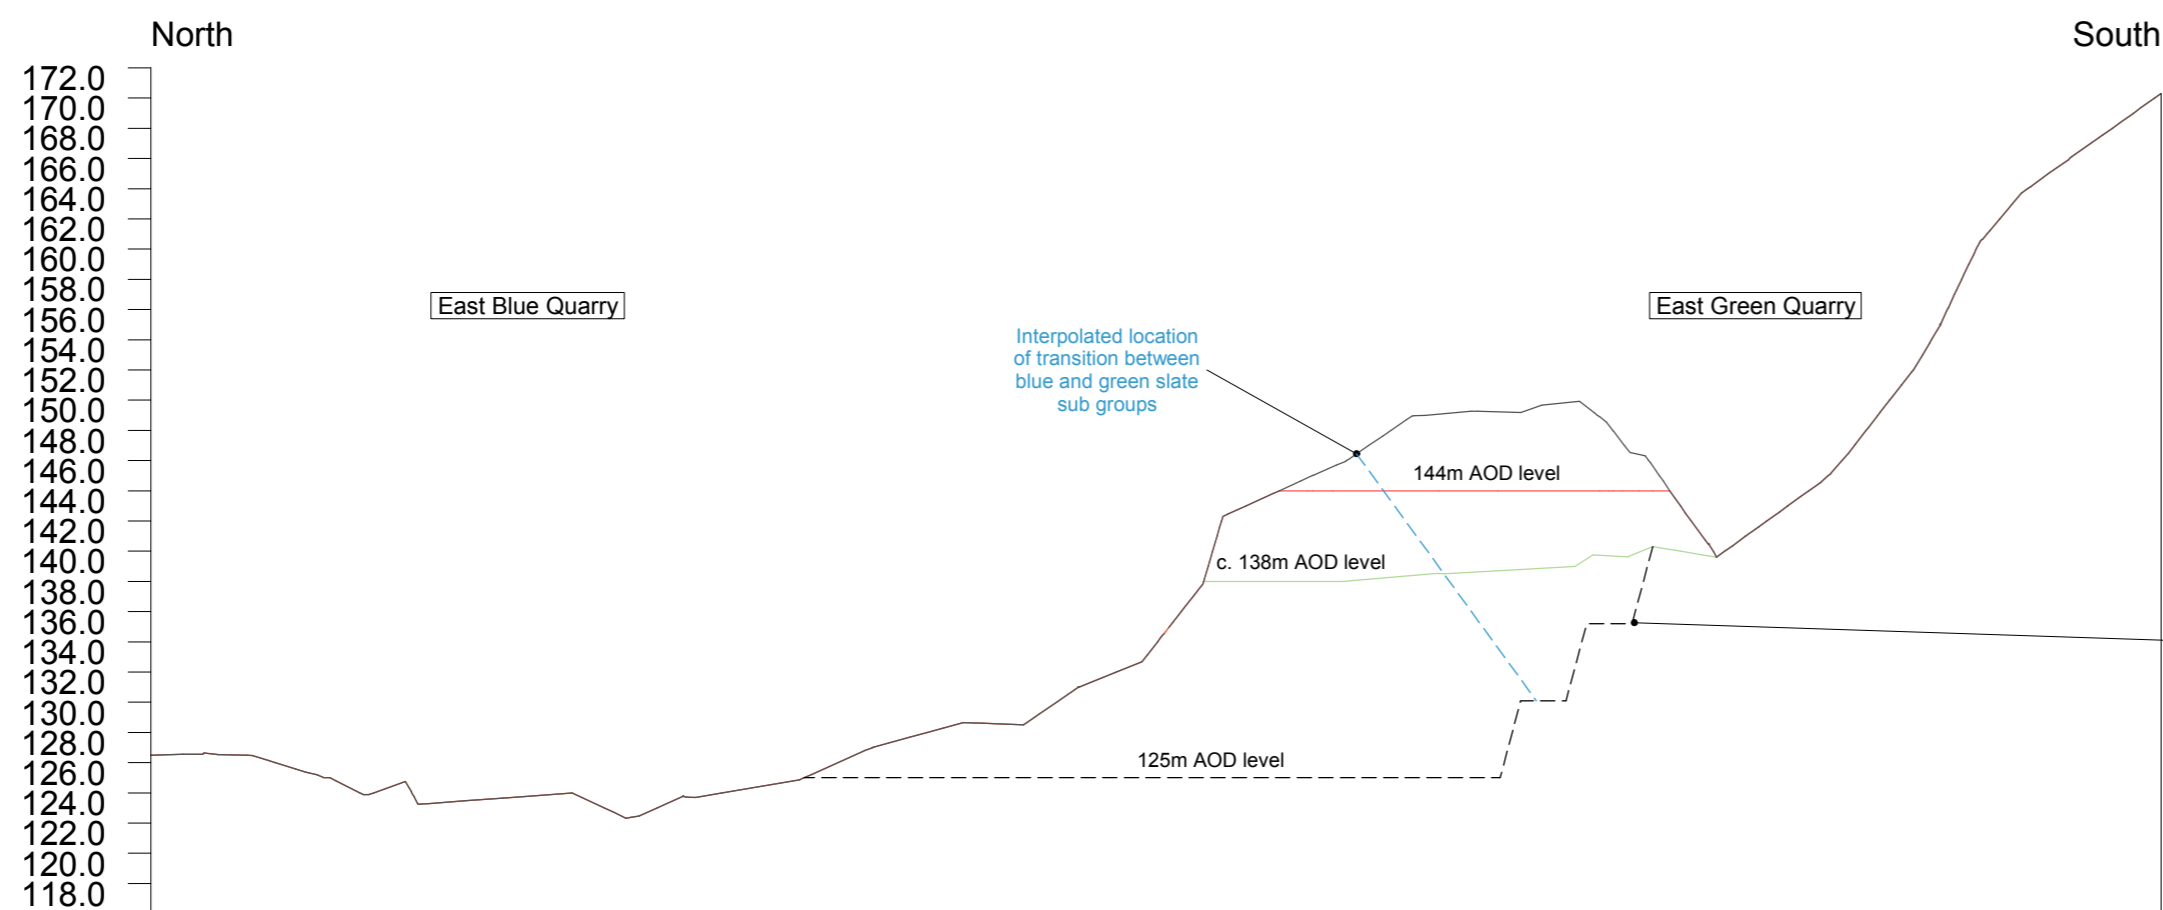
Section B - B'

Longsection Chainage (m)	0.0	10.0	20.0	30.0	40.0	50.0	60.0	70.0	80.0	90.0	100.0	110.0	120.0	130.0	
Topographical Survey (dated May 2008)	126.50	126.55	126.47	125.00	123.87	124.75	123.42	124.00	122.34	123.77	124.37	127.62	128.65	128.50	130.03
Design to 144m AOD level	126.50	126.55	126.47	125.00	123.87	124.75	123.42	124.00	122.34	123.77	124.37	127.62	128.65	128.50	130.03
Design to 138m AOD level	126.50	126.55	126.47	125.00	123.87	124.75	123.42	124.00	122.34	123.77	124.37	127.62	128.65	128.50	130.03
