## Compliance Assessment Report CAR\_NRW0039228

**Permit being assessed:** WB3993HE.

For: Gellia'r-gwellt Uchaf Transfer & Composting Station, held by Bryn Recycling Limited  
At: Gellia'r-gwellt Uchaf Transfer & Composting Station, Hengoed, Caerphilly, CF82 8FY.

**Type of assessment carried out:** Site Inspection, Reason: Routine.

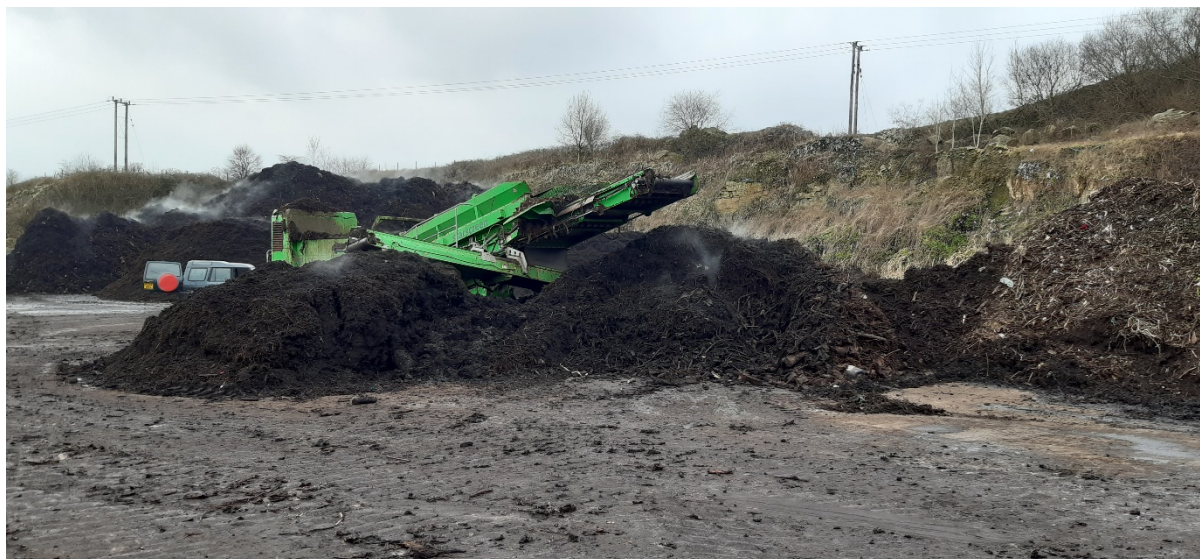
- No treatment of green waste was taking place at the time of the site inspection however recent screening had taken place earlier in the morning (see Photo 1).
- There were incoming loads of green waste being unloaded. Contamination levels within incoming loads were discussed with the operator.
- Windrows of compost undergoing active composting/stored following composting were all being stored appropriately and in accordance with site management documentation.
- There was a remaining stockpile of heavily contaminated compost in the North East corner of this area of the site (see Photo 2). The operator raised intention to further treat this waste to remove non-biodegradable contamination.
- No offensive composting odours were noted by officers in this part of the site.

**Photo 1** – Recent screening in composting station

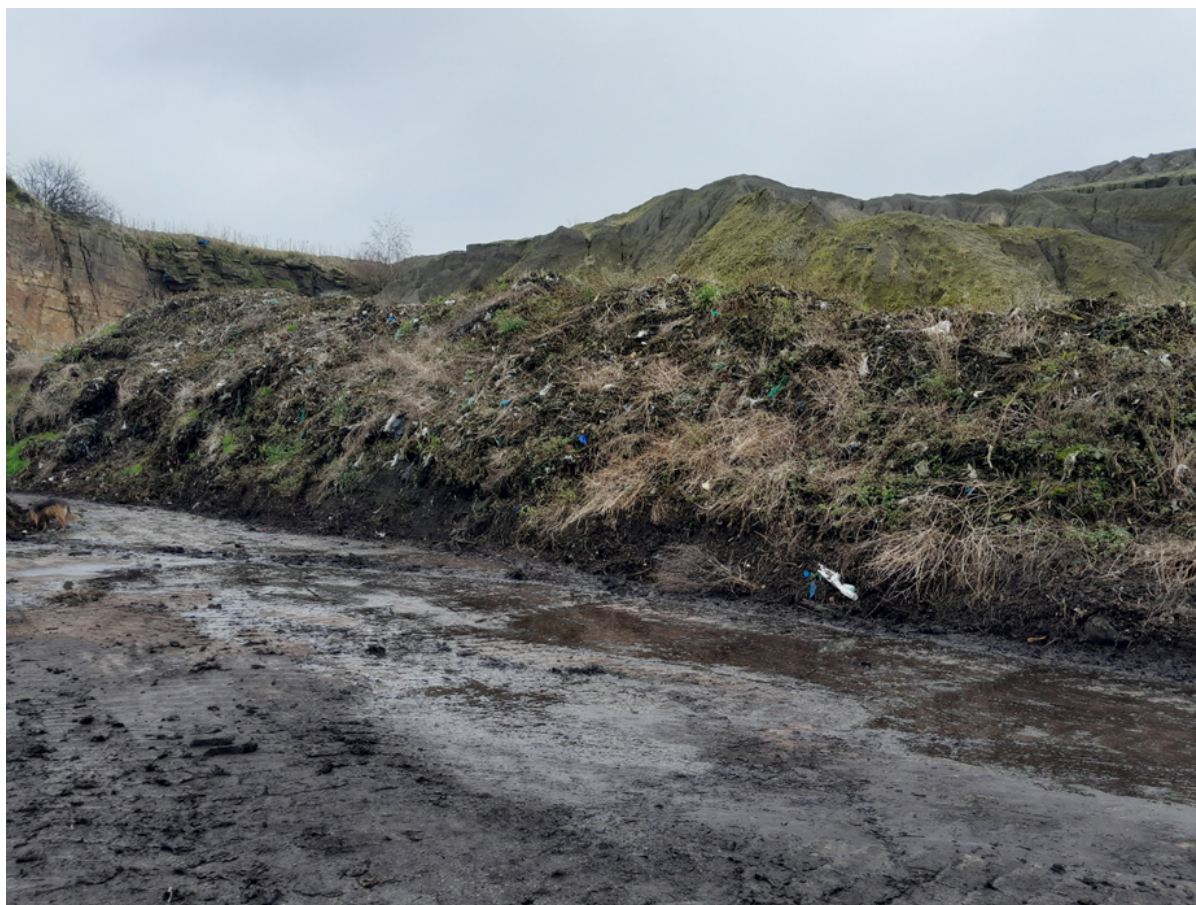
**Photo 2** – Stockpile of compost in North-East corner of composting pad

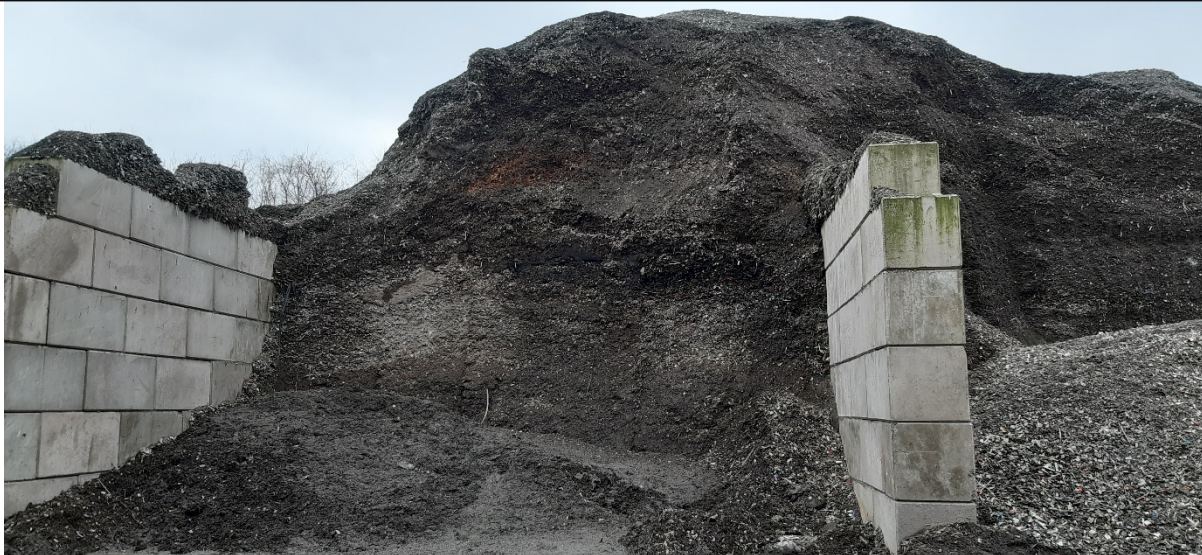
- To the South West of the waste transfer station buildings a large stockpile of waste fines was present. This waste was not being stored in compliance with the guidance. The stockpile of waste was being stored in excess of 4 metres high and was overlapping concrete walled bays (see Photo 3). It was advised to the operator to bring these stockpiles back into compliance with the FPMP guidance and the current site FPMP document. This issue was identified with the operator on a previous site inspection (see *CAR\_NRW0038789*). It was noted that the operator has made efforts to reduce this stockpile since the previous site inspection. However, compliance with the FPMP guidance is critical to reduce the likelihood of a fire and potential impacts if a fire were to occur as well as safe access for firefighting in the event of an incident.

**Photo 3** - Stockpile of waste fines to SW of waste transfer station

- Stockpile of waste fines not being stored in compliance with FPMP guidance.
- Stockpile of waste wood in 'top yard' not being stored in compliance with FPMP guidance.

**Action(s)** – Ensure all waste stockpiles on site are stored in accordance with your FPMP (and EMS) and in compliance with the FPMP guidance. Reduce height and size of stockpile of waste fines as a priority. Create adequate separation between stockpiles of wood on the 'top yard'.

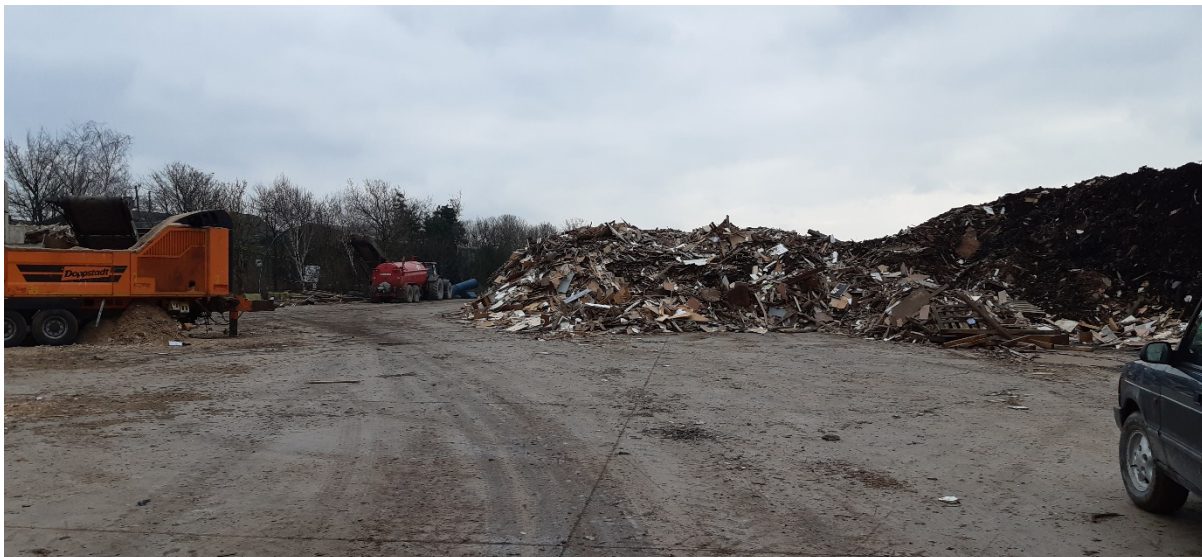
- To the North of the waste transfer station buildings on the 'top yard' stockpiles of wood waste were present with some of this wood benefiting from being stored within concrete bays. However, a stockpile of wood waste/compost-based waste along the South West of the 'top yard' was not being stored in compliance with the Fire Prevention & Mitigation Plan (FPMP) guidance (see Photo 4). It was advised to the operator although the height of the waste wood stockpile was within compliance, the length of this stockpile was not in line with the FPMP guidance. Officers noted the intention to complete construction of further concrete walled bays in 'top yard' and associated buildings, in line with the site FPMP document. Permit condition 2.6.2 referencing Table S1.4 (Pre-operational condition) should be noted in relation to the storage of woodchip in the areas as identified in Areas B and C in Drawing BRL-EPV-2019-003revA. No waste wood was being stored in the 'new' building at the time of the inspection. It should be noted that infrastructure as specified in the current site FPMP document should be completed before any storage of wood is conducted in this area of the site.

**Photo 4** - Stockpile of wood/compost in 'top yard'

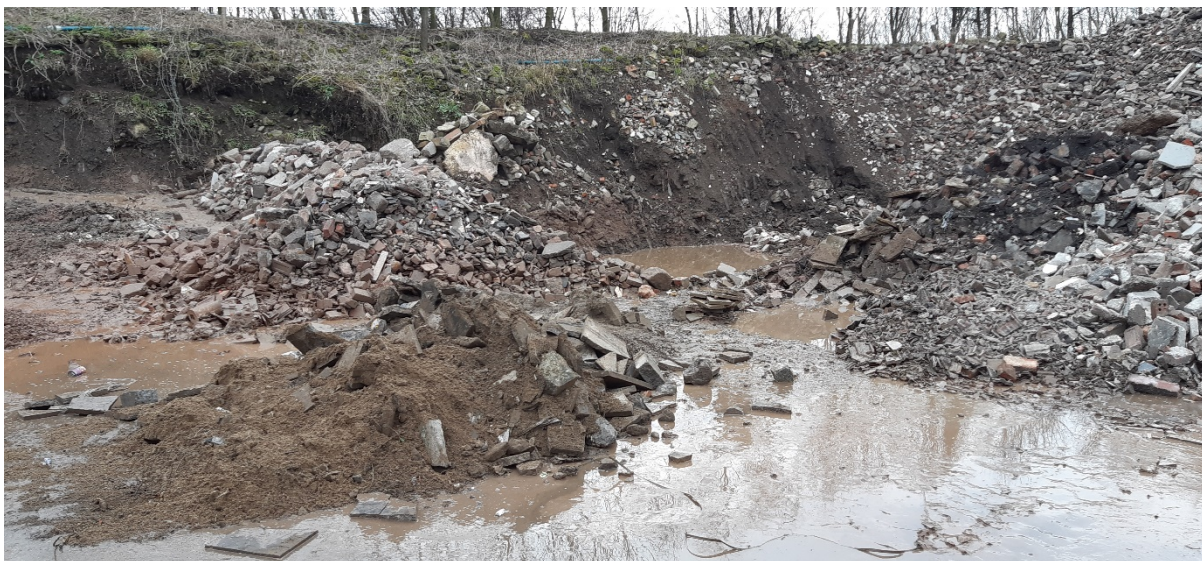
- To the South of the waste transfer station buildings a section of the site surface was in poor condition. This area contained a stockpile of construction & demolition waste (see Photo 5). The poor condition of the surface infrastructure could allow potential pollutants to directly enter the ground and/or surface water. This area of the site was not fully sealed and during periods of rainfall it is likely that site run-off would be able

to bypass the sealed sump and interceptor at the site.

**Photo 5** – Area of compromised drainage infrastructure in ‘lower yard’**Compliance Breaches****CATEGORY 2 BREACH – PERMIT CONDITION 1.1.1 – Root Cause**

- Site surface in area where construction & demolition waste is stored is not fully sealed. Surface run-off is able to bypass the sealed sump and interceptor in the 'lower yard' area of the site.

**Action:** - Ensure suitable repairs to site drainage infrastructure are conducted in area

used for storage of construction/demolition waste, to ensure compliance with permit condition 2.1.1.
