**Remediation Infrastructure Installation Phase II
(Main Production Building) and Baseline Monitoring Report
Grange Road
Cwmbran
Gwent
NP44 3XU
South Wales**

**October 2012
909364102_03**

Meritor Heavy Vehicle Braking Systems (UK) Limited

ARCADIS (UK) Limited

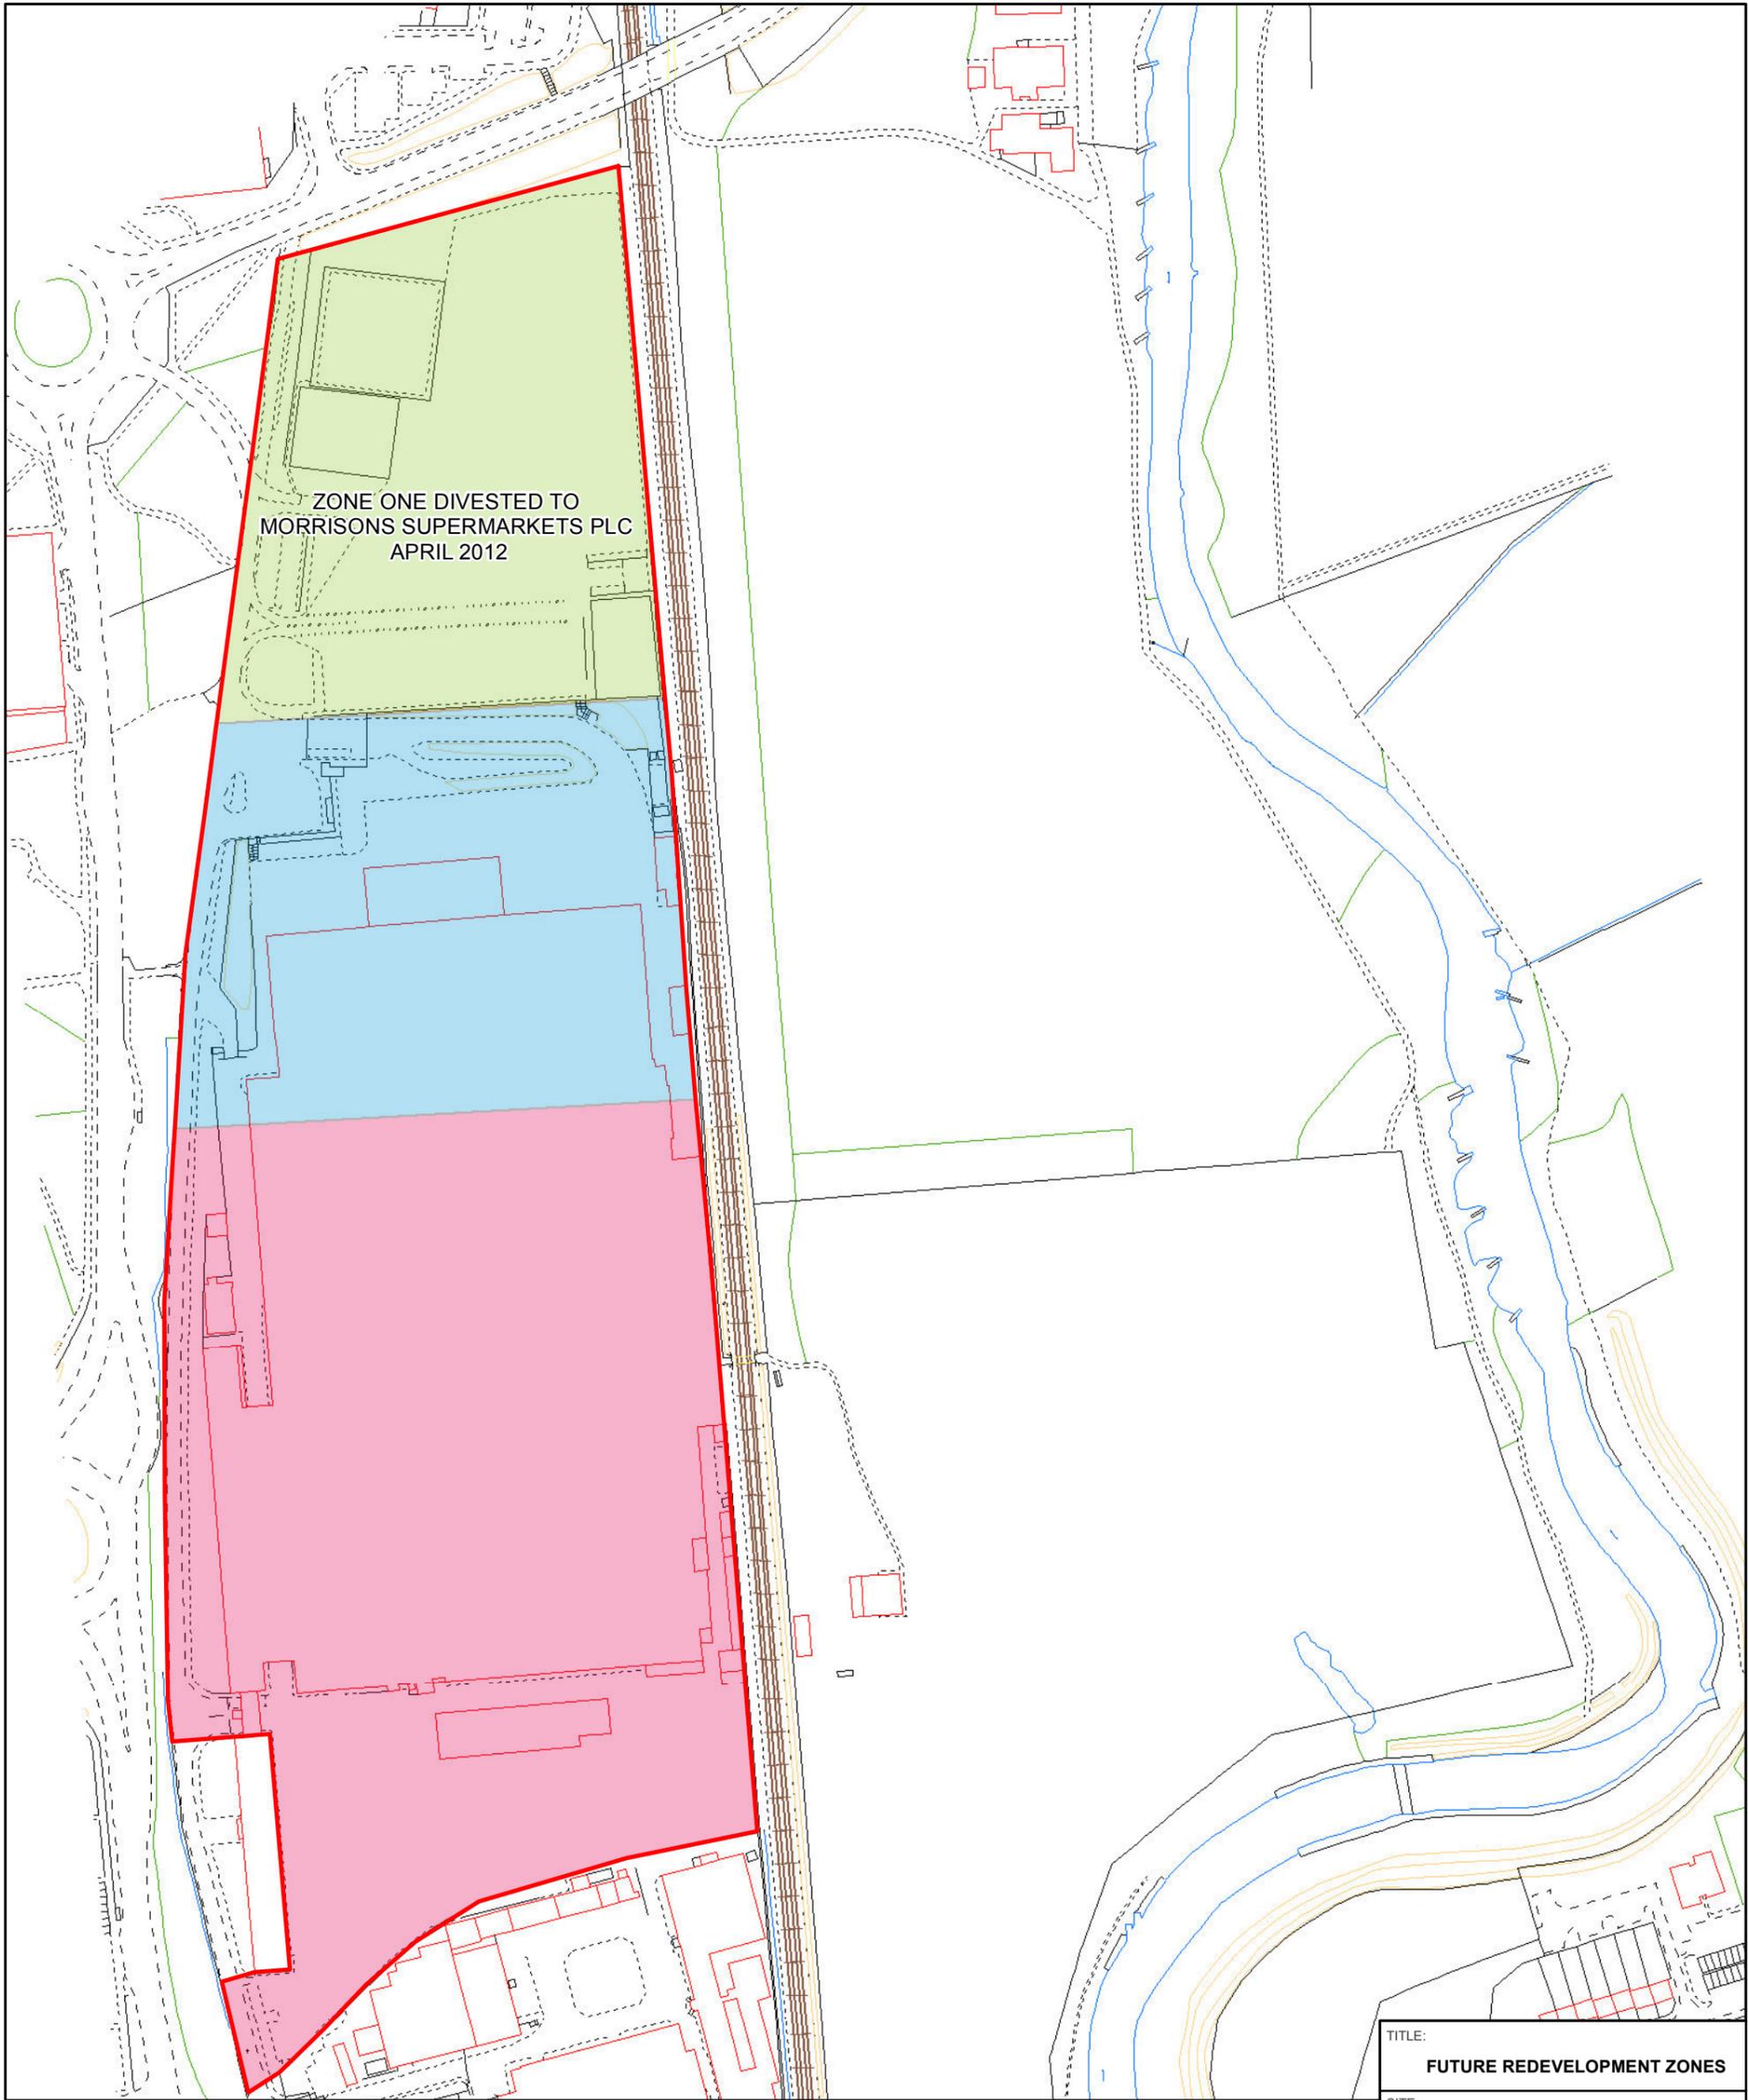
TITLE: FUTURE REDEVELOPMENT ZONES	
SITE: CWMBRAN	
CLIENT: MERITOR HVBS (UK) LIMITED	
PROJECT: 90936.41	FIGURE 3
DATE: 18/10/12	DRAWN BY: RJM
DRG No.: 909364128 GIS	
SCALE: 1 : 2,250	PRINT: A3

ZONE ONE DIVESTED TO
MORRISONS SUPERMARKETS PLC
APRIL 2012

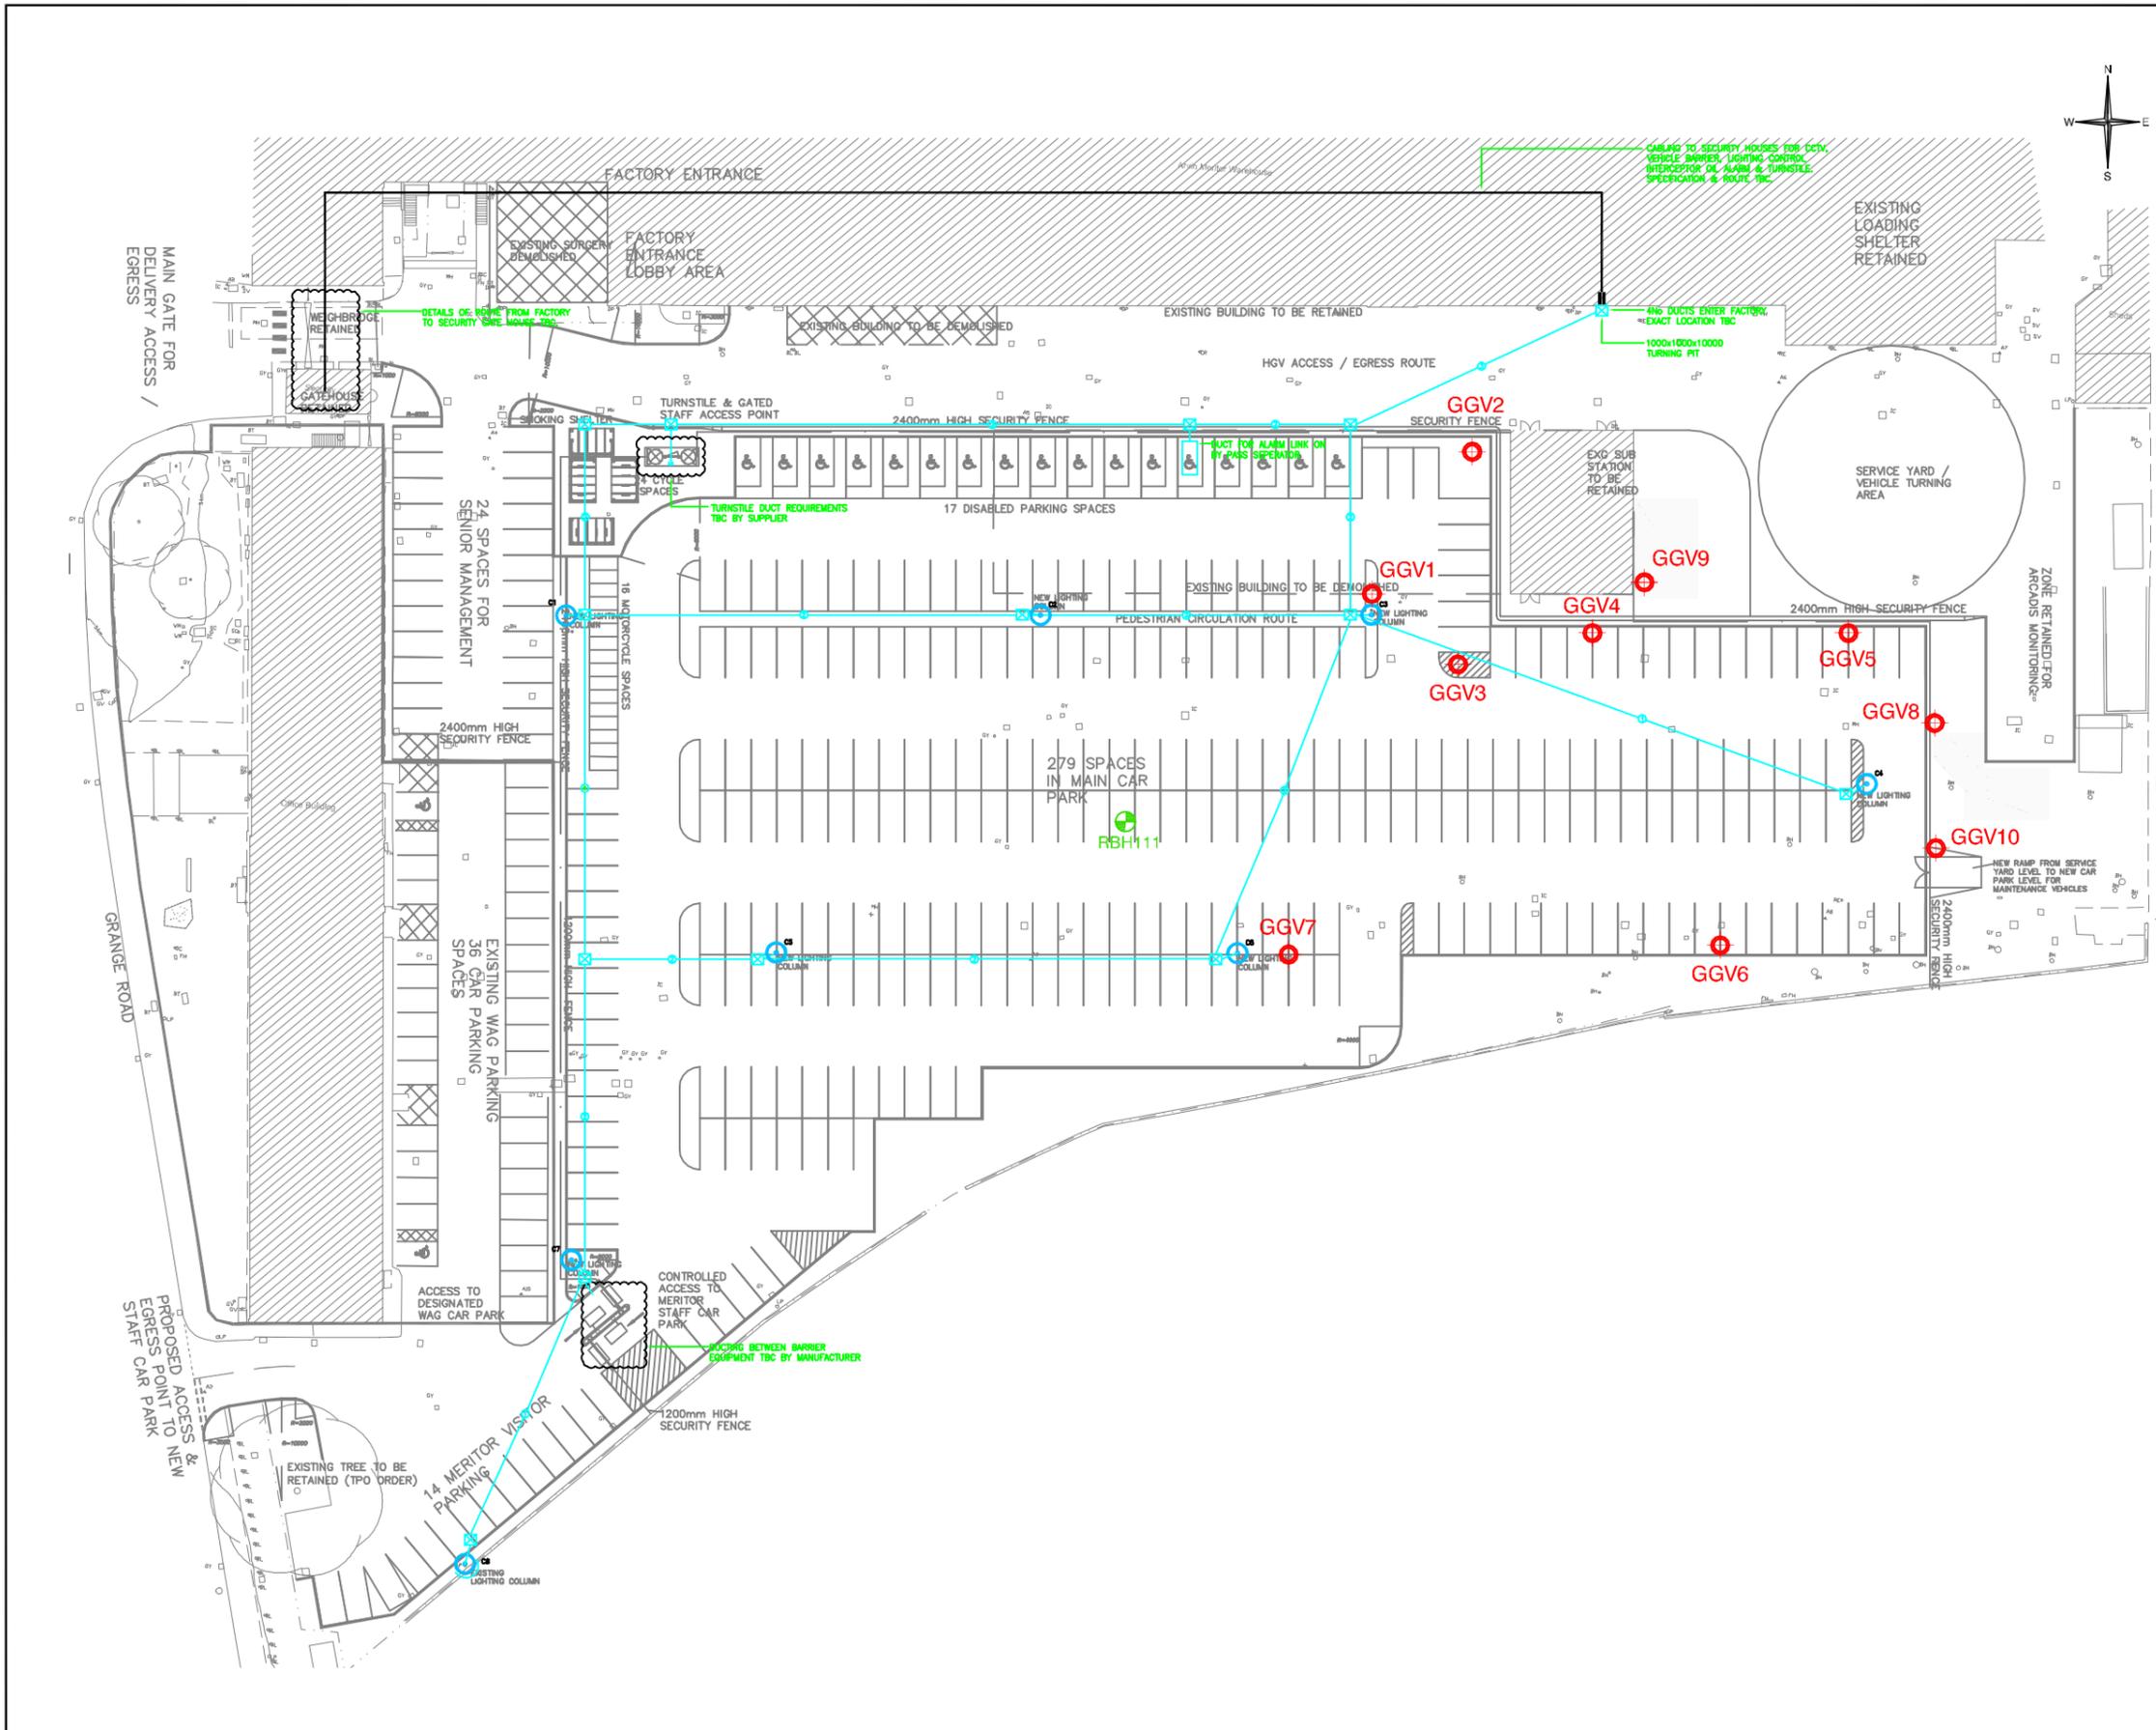
- ⊕ PASSIVE GROUND GAS VENT LOCATION
- ⊕ REPLACEMENT BOREHOLE LOCATION (REPLACEMENT FOR WELL BH111)

ARCADIS undertook the replacement of BH111, named RBH111, concurrently to the installation of the below ground passive ground gas vent infrastructure prior to the opening of the car park for use by site employees, to minimise disruption to site activities and reduce the number of mobilisations to site. Utility clearance and coring activities are described in Sections 9.2.1 and 9.2.2. The replacement location was located as close as practicable to the original location.

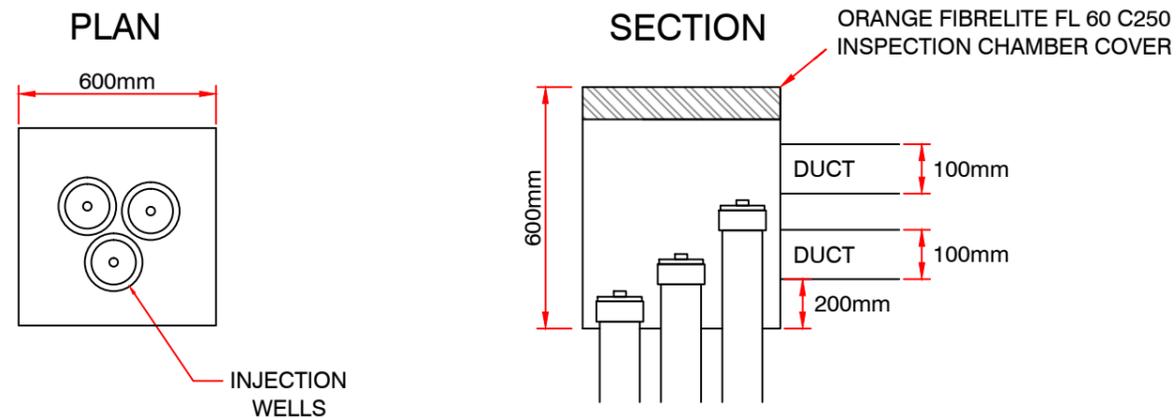
TITLE: INSPECTION CHAMBER AND INJECTION WELL DESIGN

INSPECTION CHAMBER

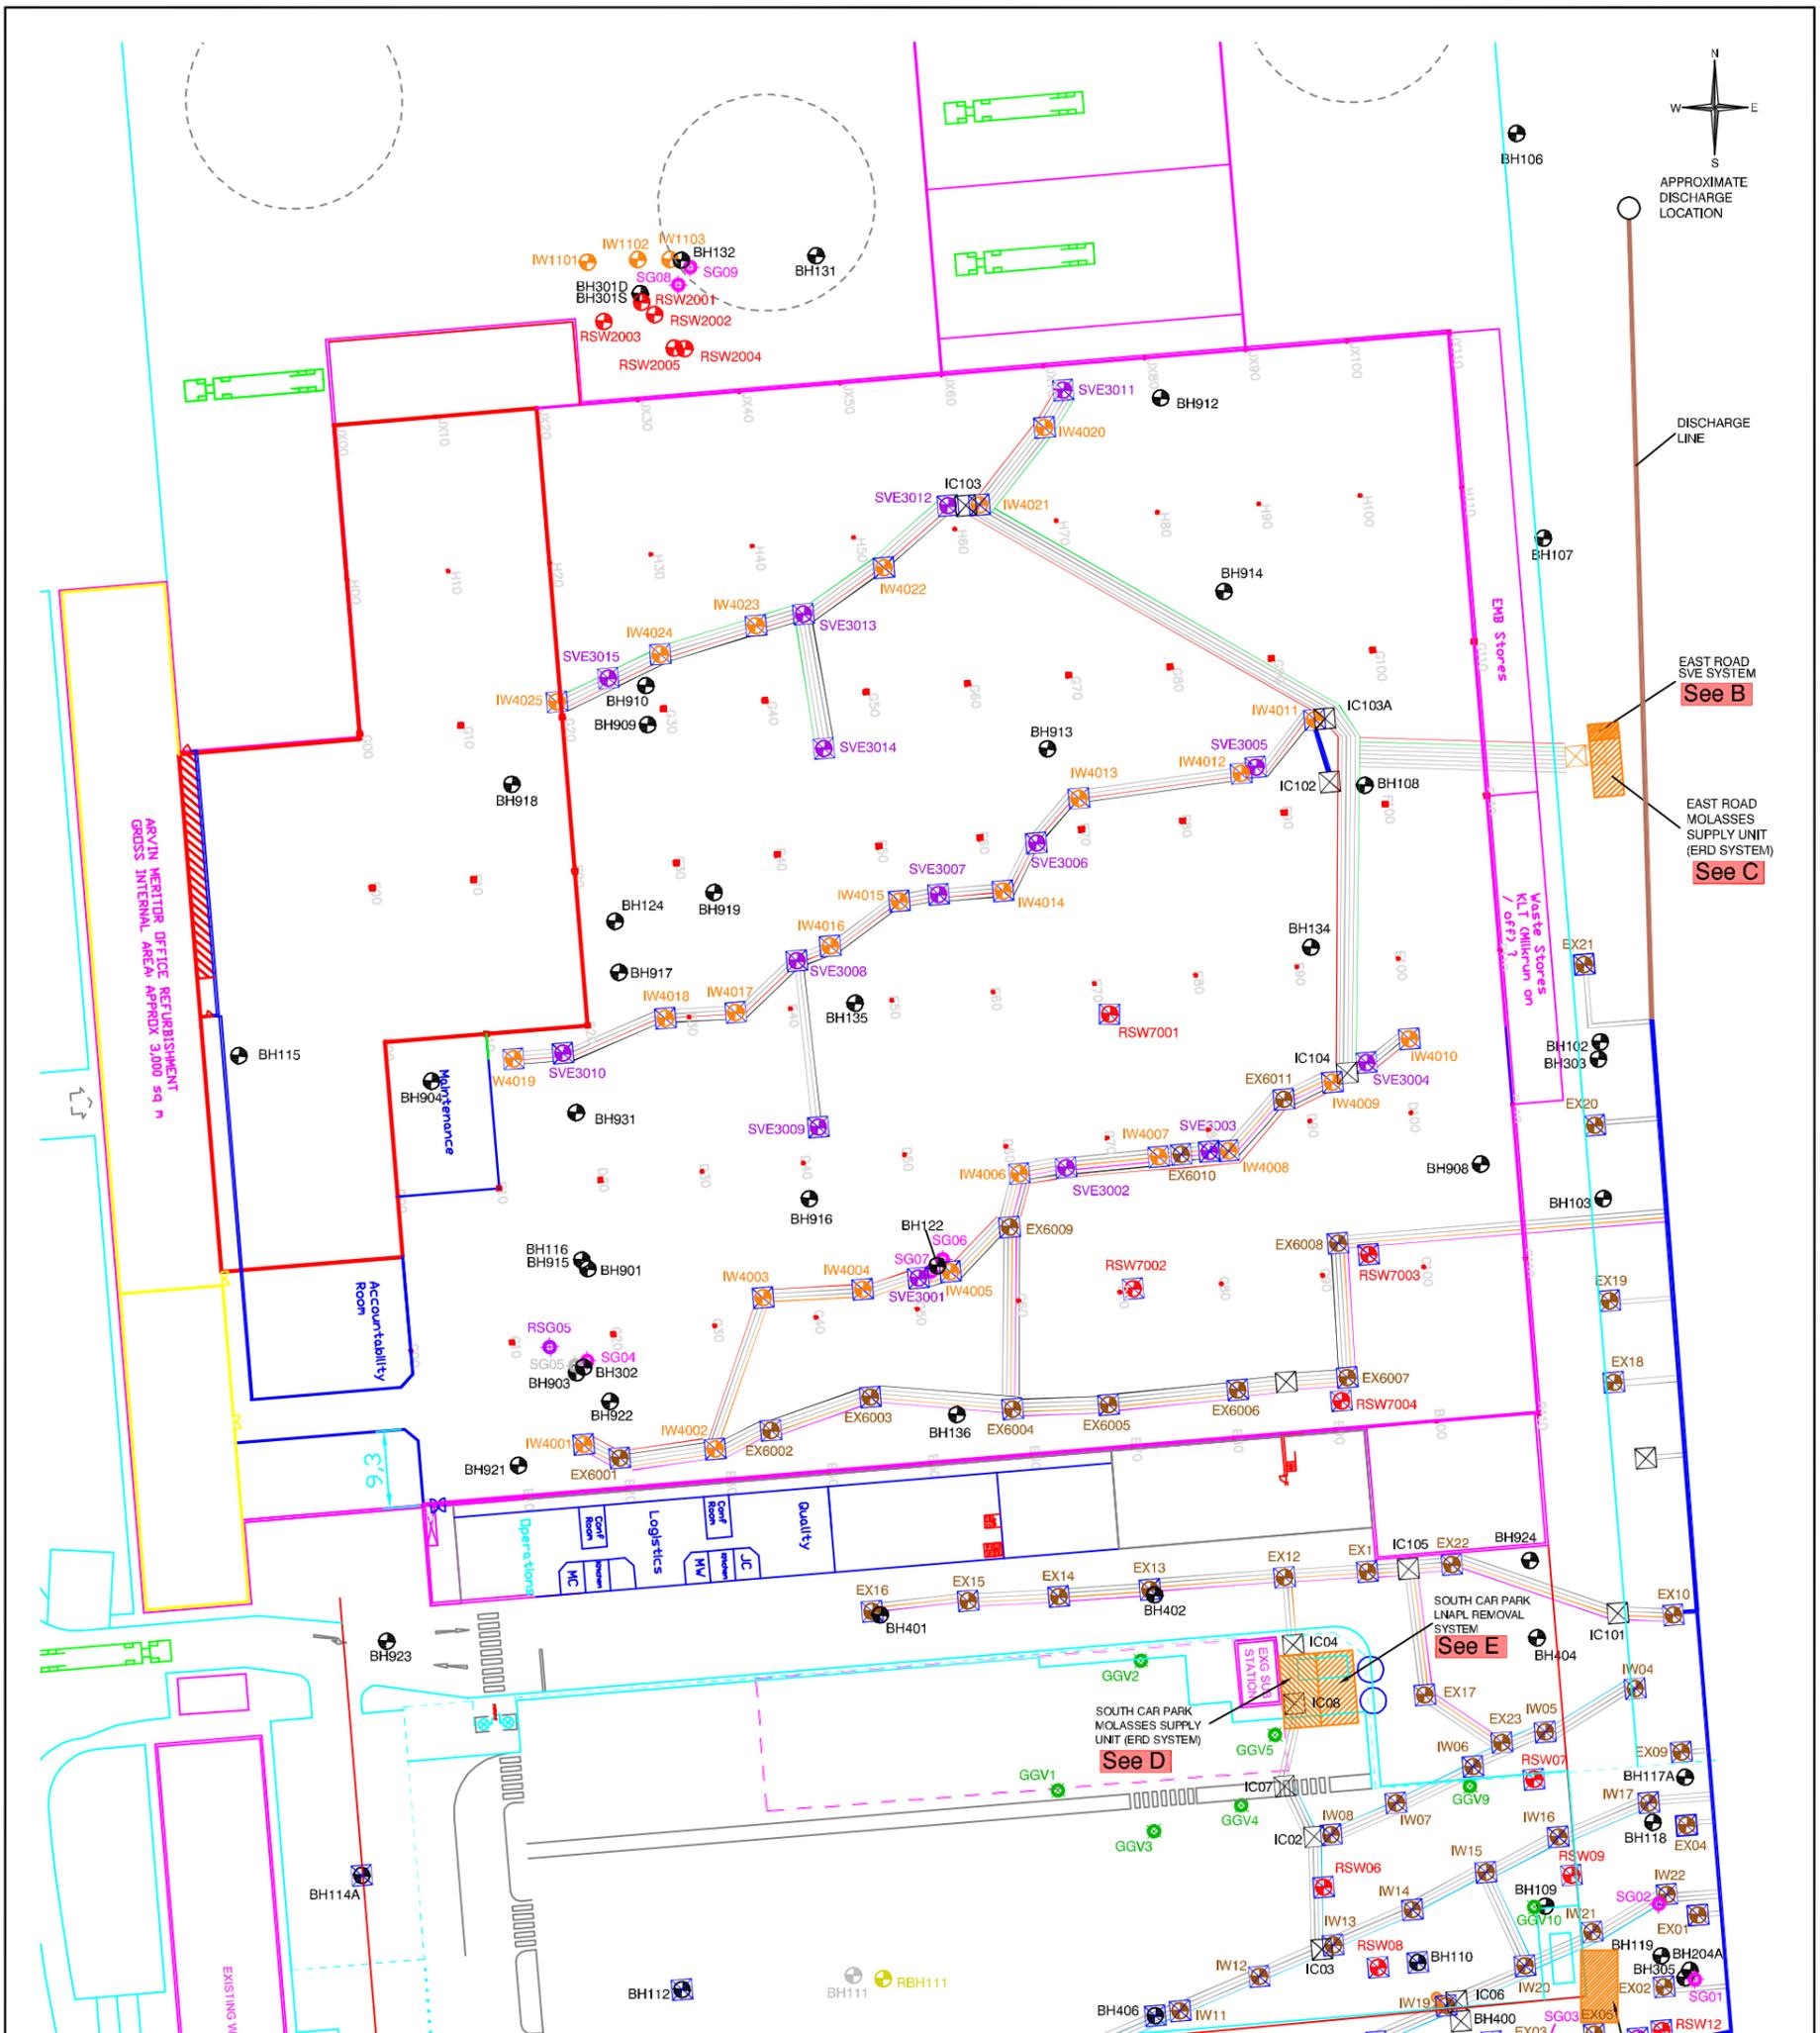
A: South Yard SVE System	Electricity	3 phase 420v 12kW 32A cable, 18.4 amp max current. 4 wire + earth
	Water	None
B: East Road SVE System	Electricity	3 phase 420v 12kW 32A cable, 18.4 amp max current. 4 wire + earth
	Water	None
C: East Road Molasses System	Electricity	3 phase 420v 12kW 40A cable, 18.4 amp max current. 4 wire + earth
	Water	Minimum 3/4inch mains water supply
D: South Yard Molasses	Electricity	3 phase 420v 12kW 40A cable, 18.4 amp max current. 4 wire + earth
	Water	Minimum 3/4inch mains water supply
E: South Yard TFP (LNAPL Removal)	Electricity	3 phase 420v 25kW 50A cable, 38.2 amp max current. 4 wire + earth
	Water	None

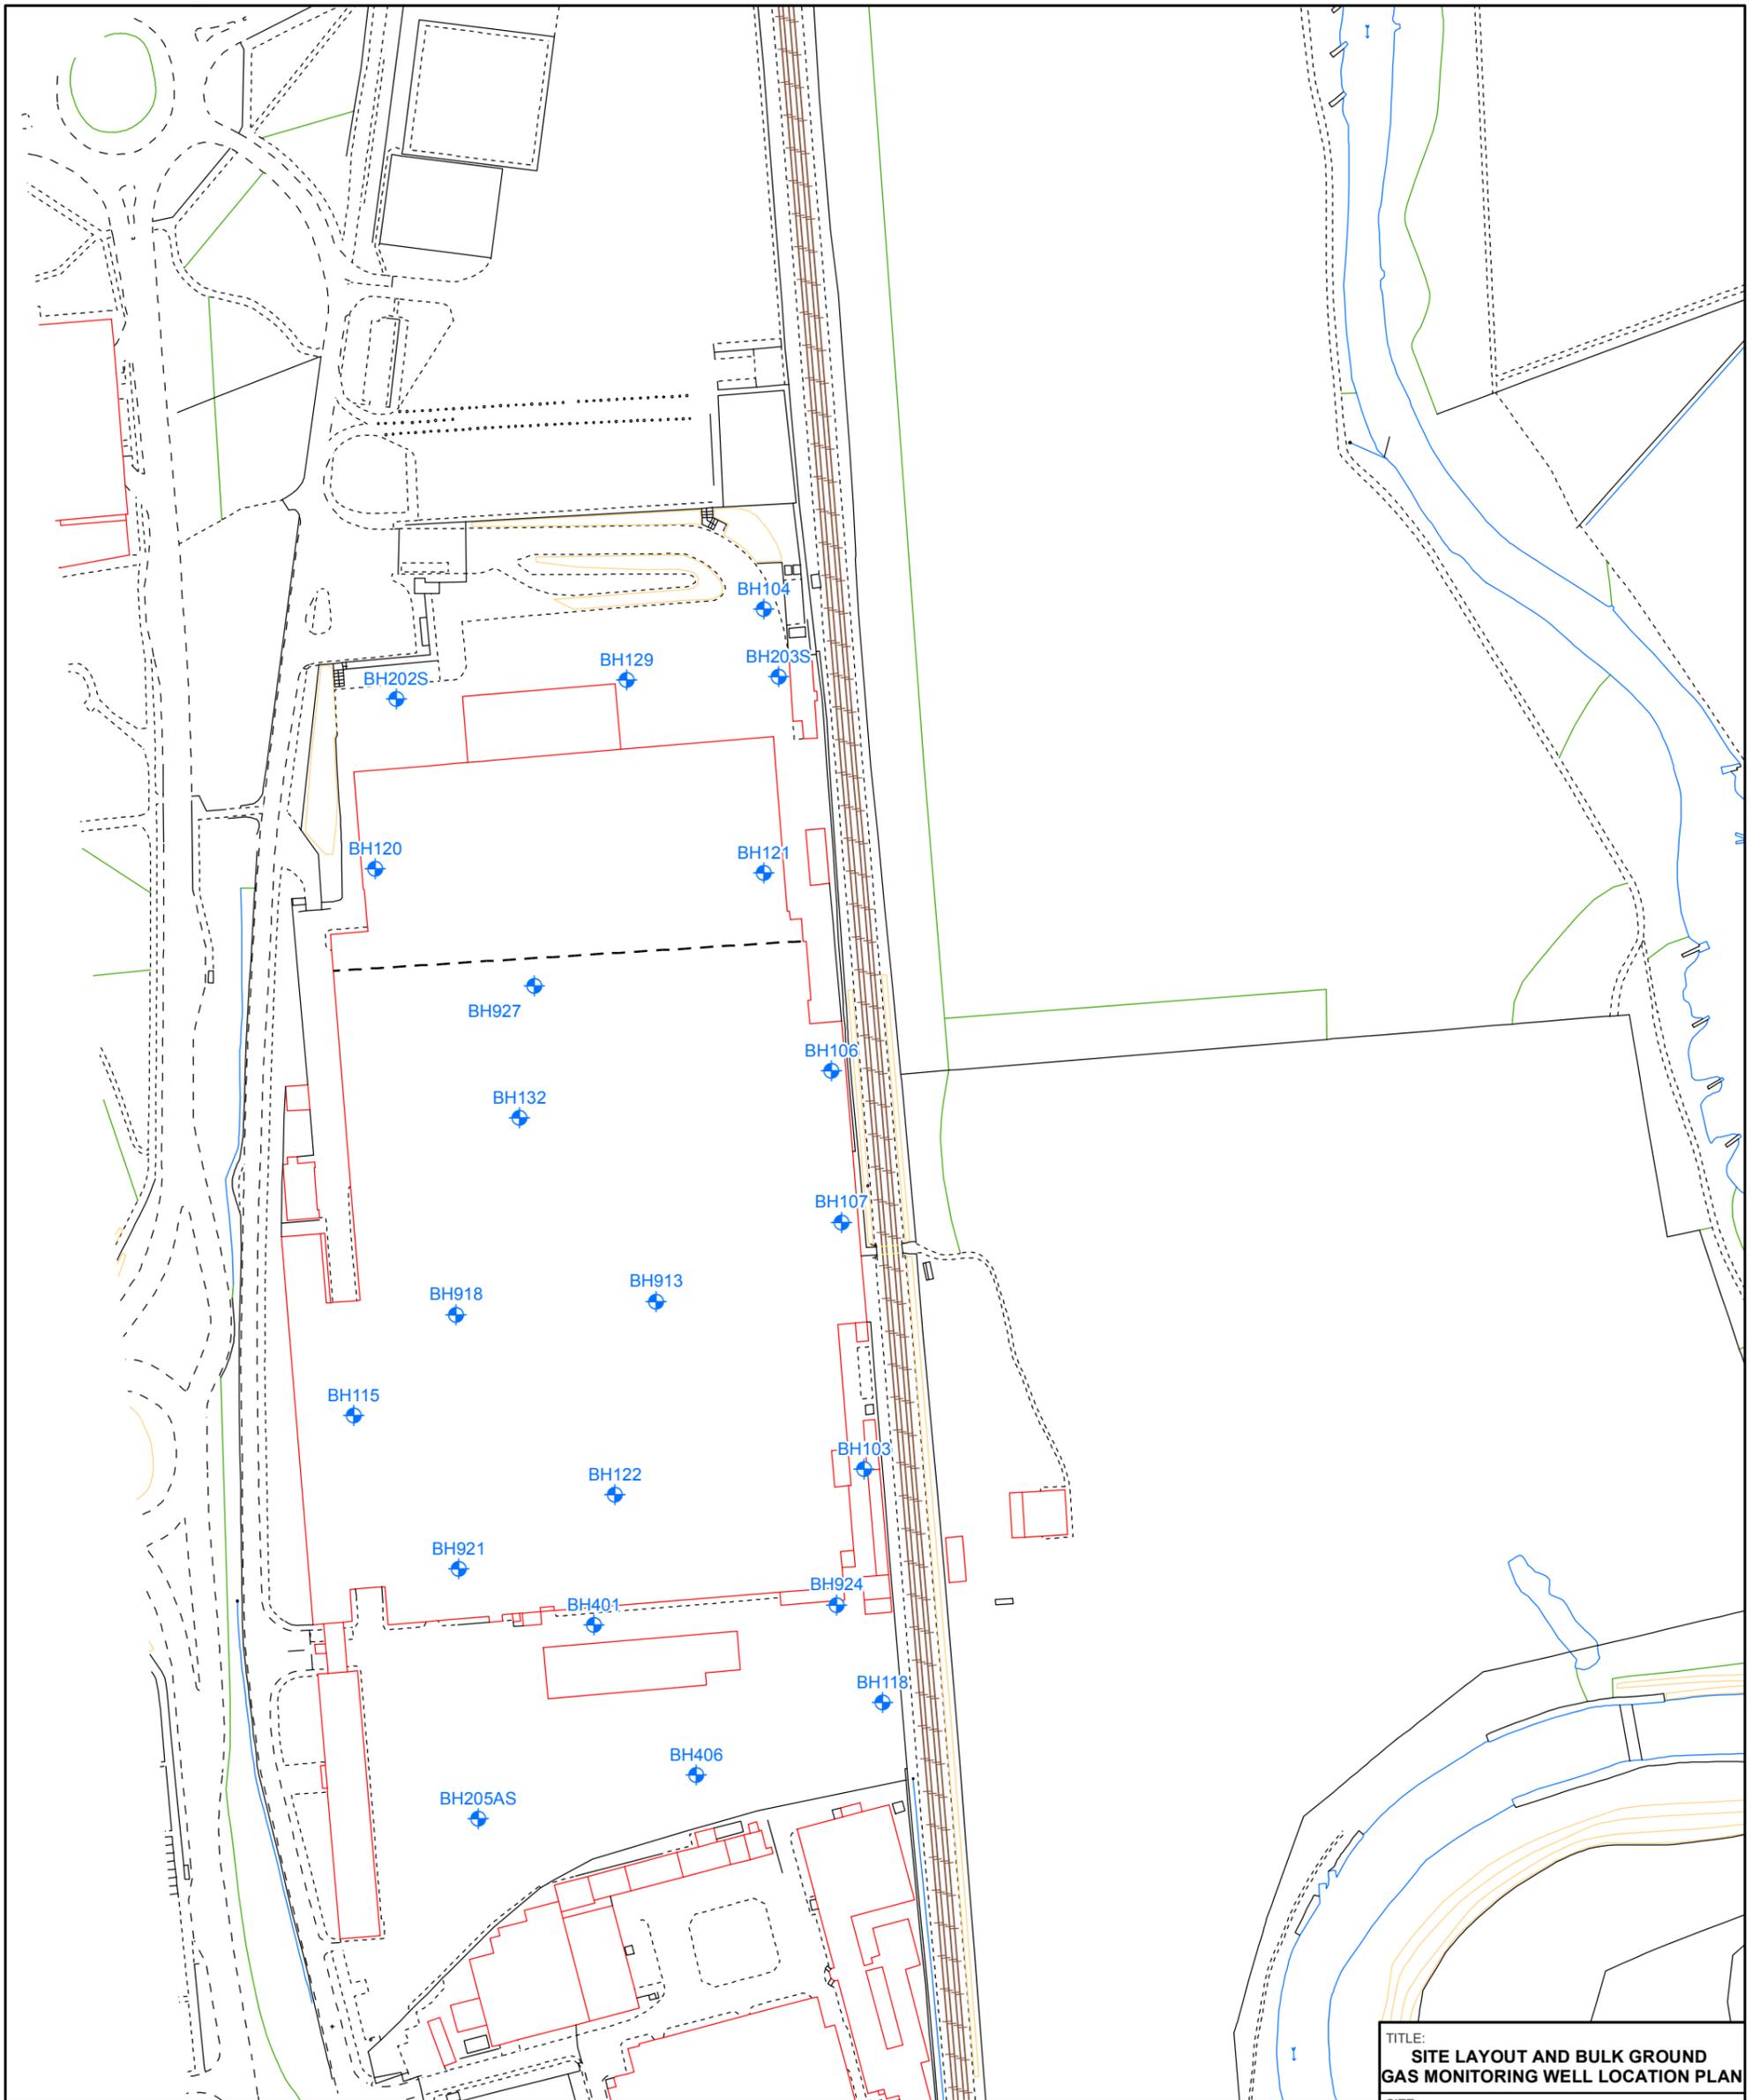
LEGEND	
	GROUND GAS MONITORING WELL LOCATION
	ZONE 2 AND 3 BOUNDARY

As agreed with the Regulators in April 2012 and outlined in the Ground Gas Strategy (ARCADIS reference 909364002_04 dated January 2012) referenced previously in this report an additional near-source soil gas sampling and a baseline bulk ground gas monitoring visit was undertaken to establish ground gas conditions across the Site, prior to proposed remediation works.

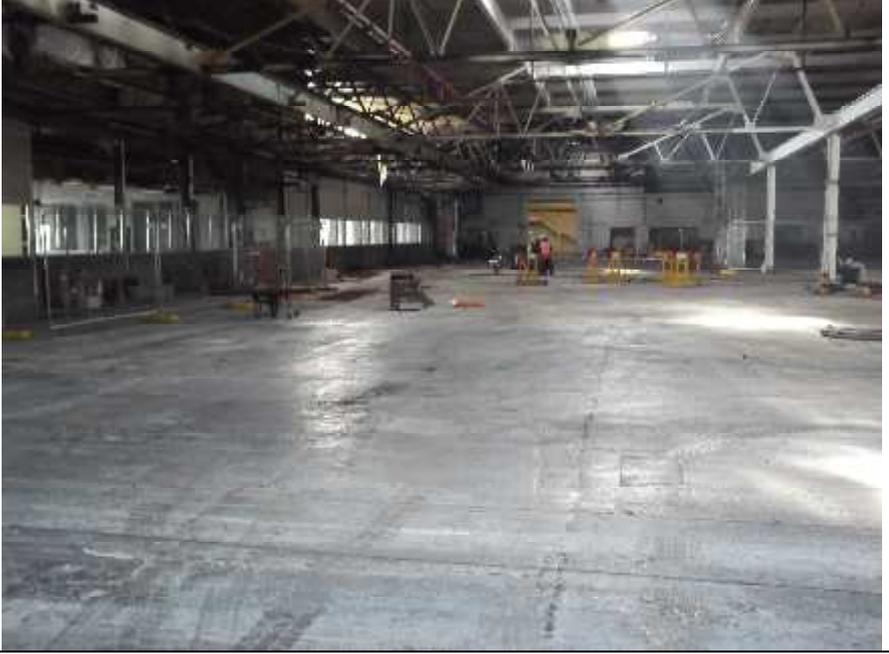
PROJECT NUMBER: 90936.41	
PLATE NUMBER: 1	
DATE: April 2012	
DESCRIPTION: View of the work area within the southern end of the production building. The ARCADIS work area was enclosed using Heras fencing throughout the works to prevent unauthorised access by other site contractors.

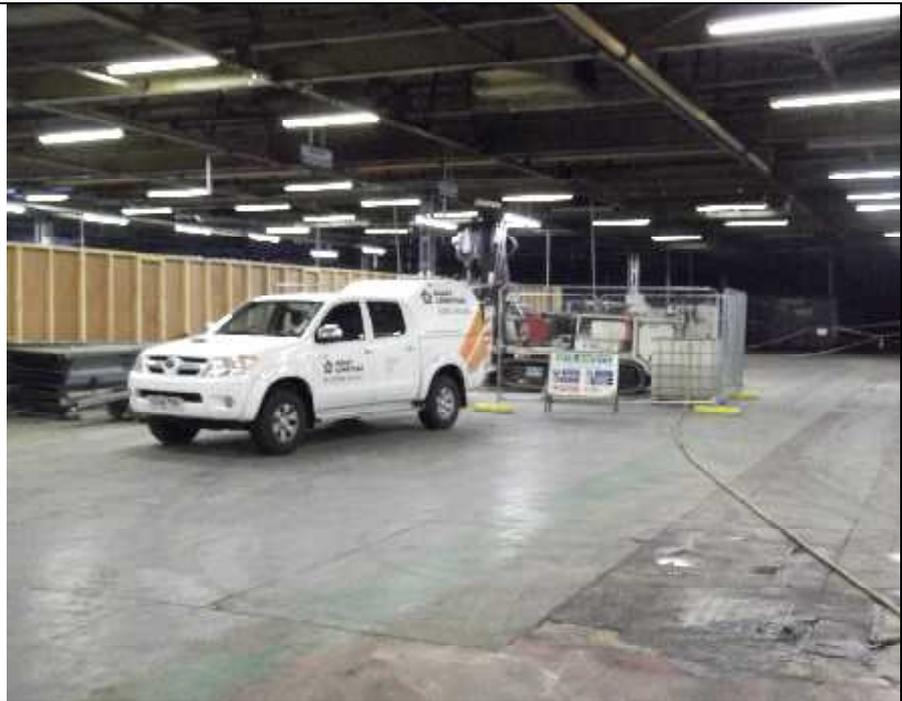
CLIENT: Meritor HVBS (UK) Ltd
PROJECT NUMBER: 90936.41
PLATE NUMBER: 3
DATE: April 2012
DESCRIPTION: Drilling of injection well IW4008 inside the production building. The Rota-Sonic drilling rig was positioned to avoid overhead structures and services, and the work area was enclosed using Heras fencing at all times.

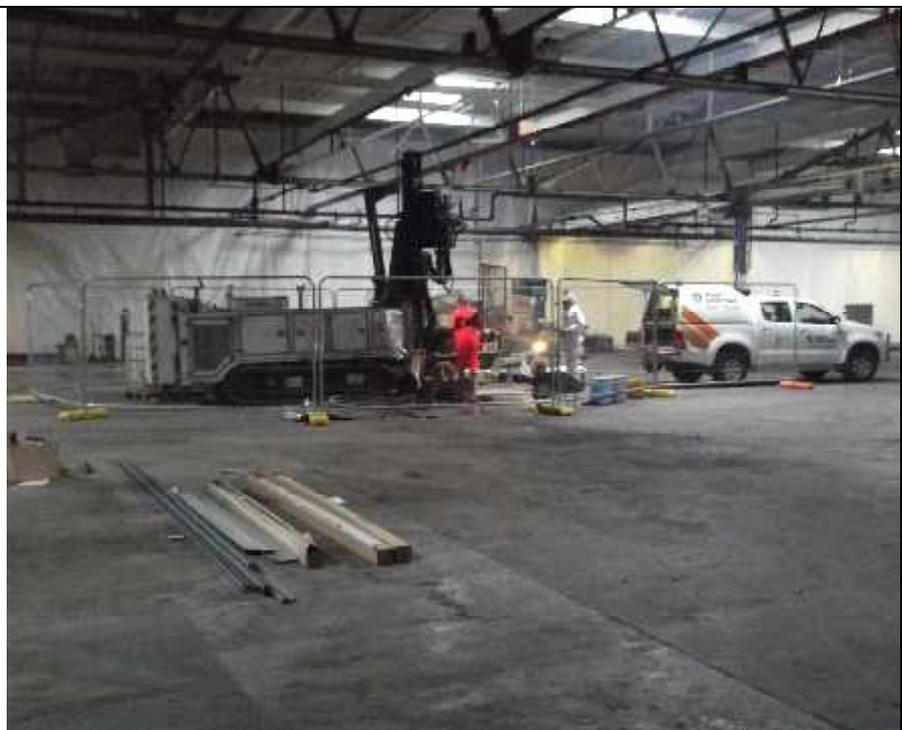
CLIENT: Meritor HVBS (UK) Ltd
PROJECT NUMBER: 90936.41
PLATE NUMBER: 4
DATE: May 2012
DESCRIPTION: Drilling of injection well IW4017. Drilling activities were segregated from other refurbishment and remediation works on going within the building as far as was practicable.

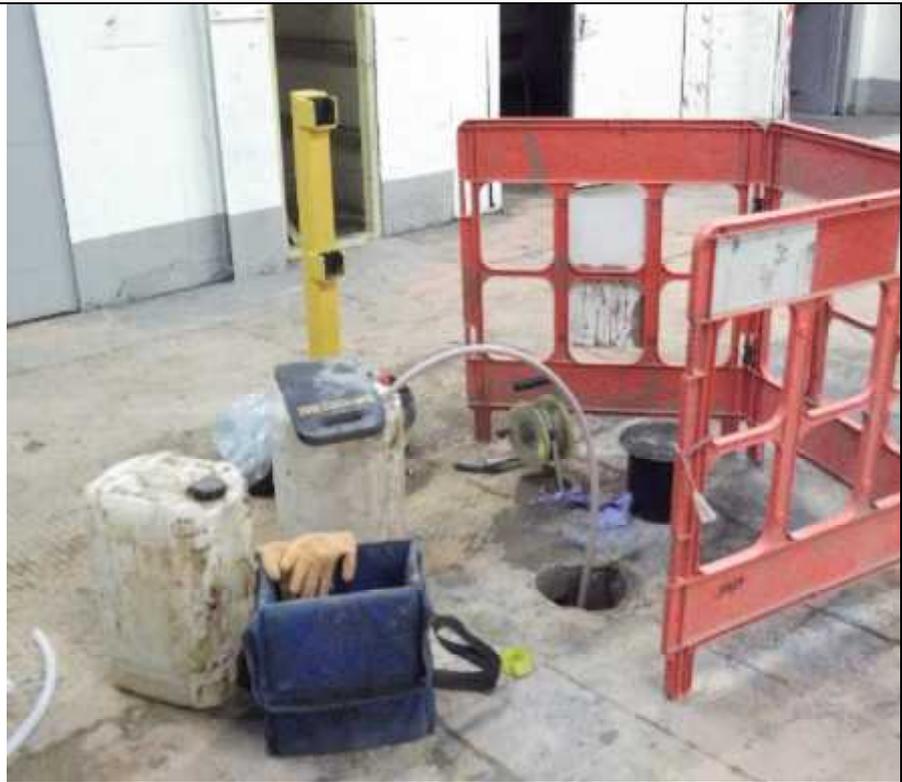
CLIENT: Meritor HVBS (UK) Ltd
PROJECT NUMBER: 90936.41
PLATE NUMBER: 5
DATE: April 2012
DESCRIPTION: Following installation the injection wells, monitoring wells, and LNAPL recovery wells were developed using Waterra pipe and a foot valve to remove 10 times the wetted volume of the well.

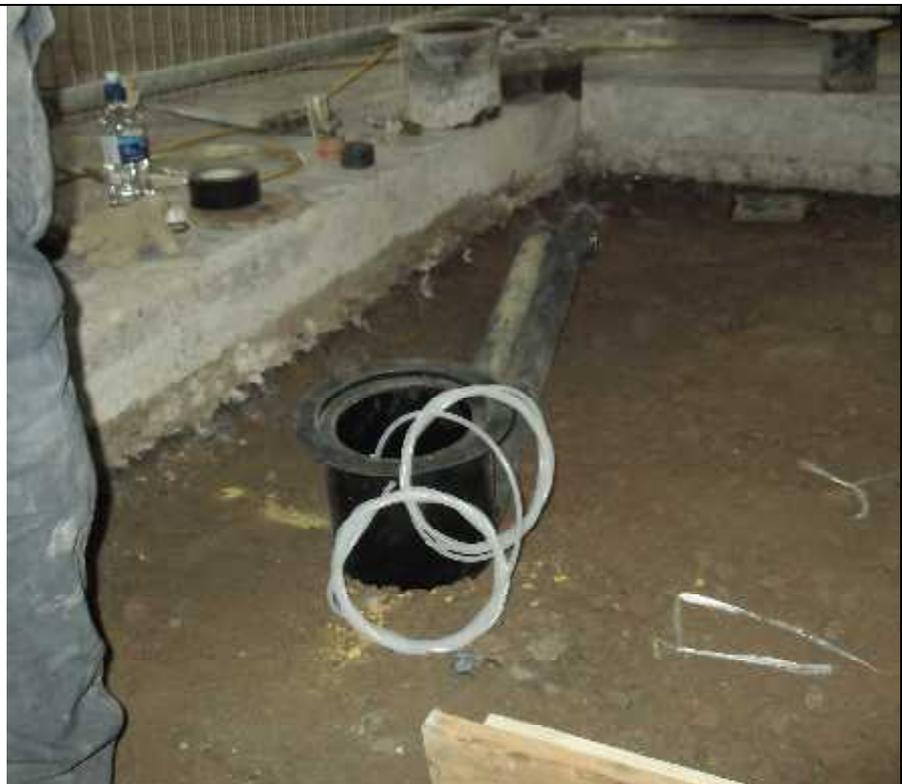
CLIENT: Meritor HVBS (UK) Ltd
PROJECT NUMBER: 90936.41
PLATE NUMBER: 6
DATE: May 2012
DESCRIPTION: The well head for BH302 was relocated to allow access to the well for sampling following the installation of the new Claas line. Low-flow tubing was installed through a relocated well cover and HDPE pipes to the monitoring wells.

As an alternative, it was proposed to relocate the well head to a location that will be accessible following the installation of the new production machines. During the excavation of the Claas line area by Meritor's appointed subcontractor prior to the installation of foundations for the machine bay, an ARCADIS engineer attended Site on 24th May 2012 to relocate the well head.

The original well cover had already been broken out during the excavation works, and was removed. The well pipes were then trimmed down to allow flexible hose to be lowered into each of the monitoring wells with a 90 degree angle tube connector fitted to the top of each well pipe. The flexible hoses were then each run to the new well head location along the excavation base at approximately 0.2 mbgl, through a length of HDPE pipe to prevent damage to the flexible hoses once the excavation was reinstated. A length of HDPE tubing was run through the flexible hose and into each of the wells below the groundwater resting level, to allow the collection of groundwater samples from the wells via the newly installed well head. Photographs of the works are presented in Appendix B.

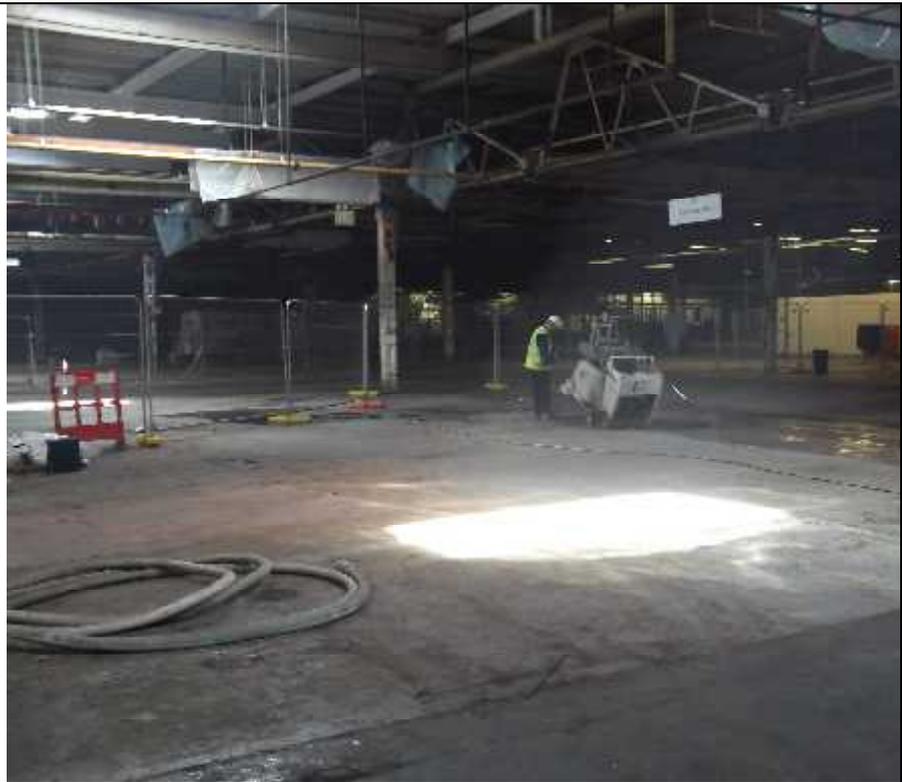
CLIENT: Meritor HVBS (UK) Ltd
PROJECT NUMBER: 90936.41
PLATE NUMBER: 7
DATE: April 2012
DESCRIPTION: Floor sawing along the marked up trench lines connecting EX6004 to EX6009.

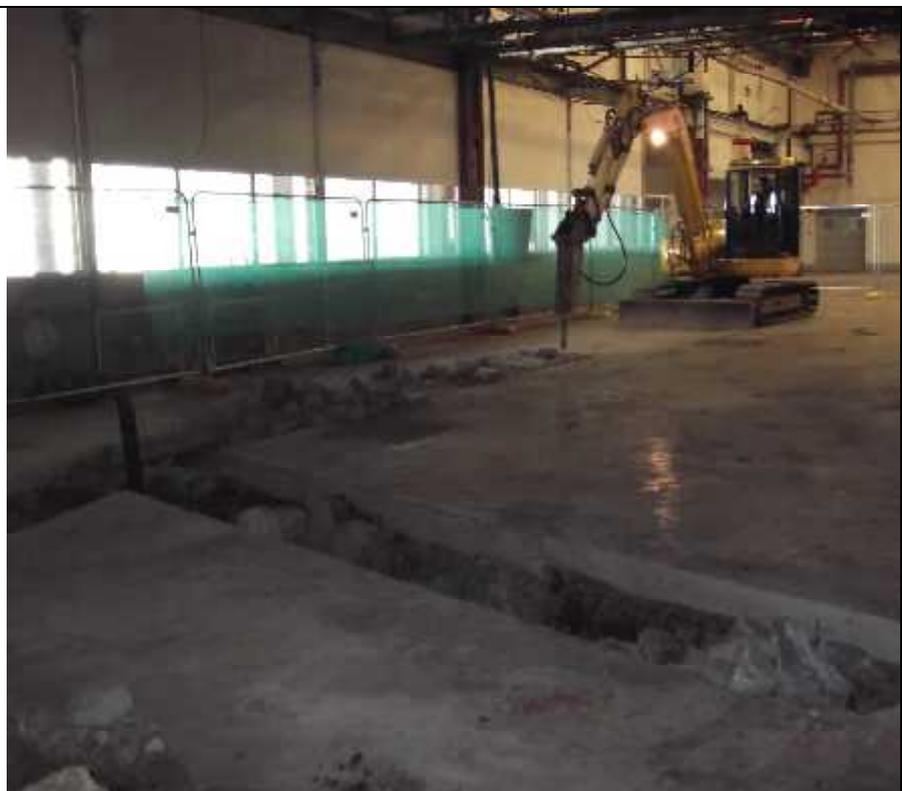
CLIENT: Meritor HVBS (UK) Ltd
PROJECT NUMBER: 90936.41
PLATE NUMBER: 8
DATE: April 2012
DESCRIPTION: Breaking out of the concrete along the trench lines. Debris netting was used over the Heras fencing to prevent flying debris from causing injury or damage.

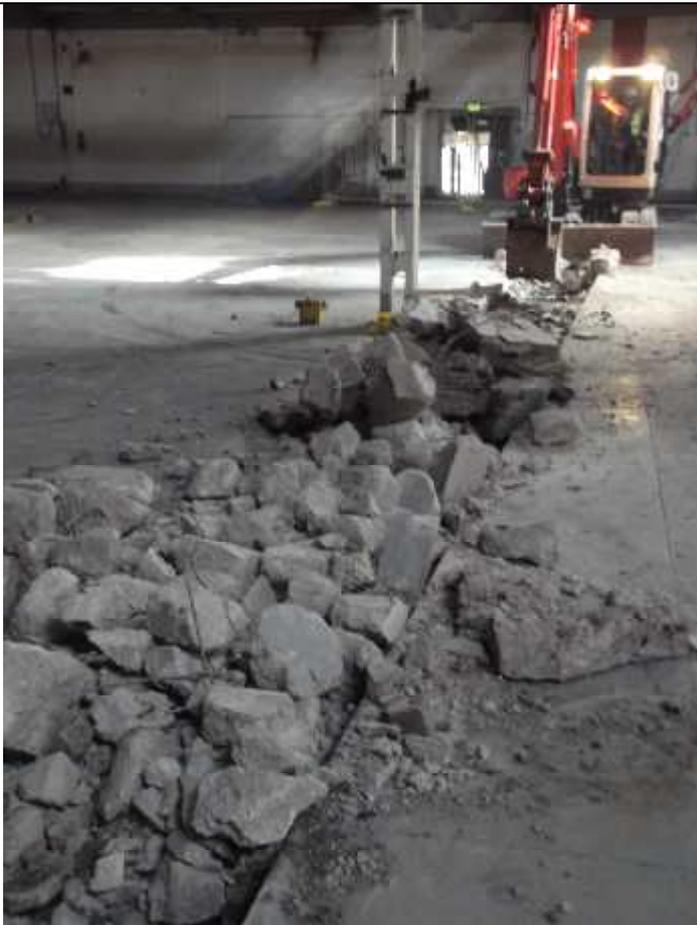
PROJECT NUMBER: 90936.41	
PLATE NUMBER: 9	
DATE: April 2012	
DESCRIPTION: Removal of broken out concrete and soils with a mechanical excavator between EX6004 and EX6009.

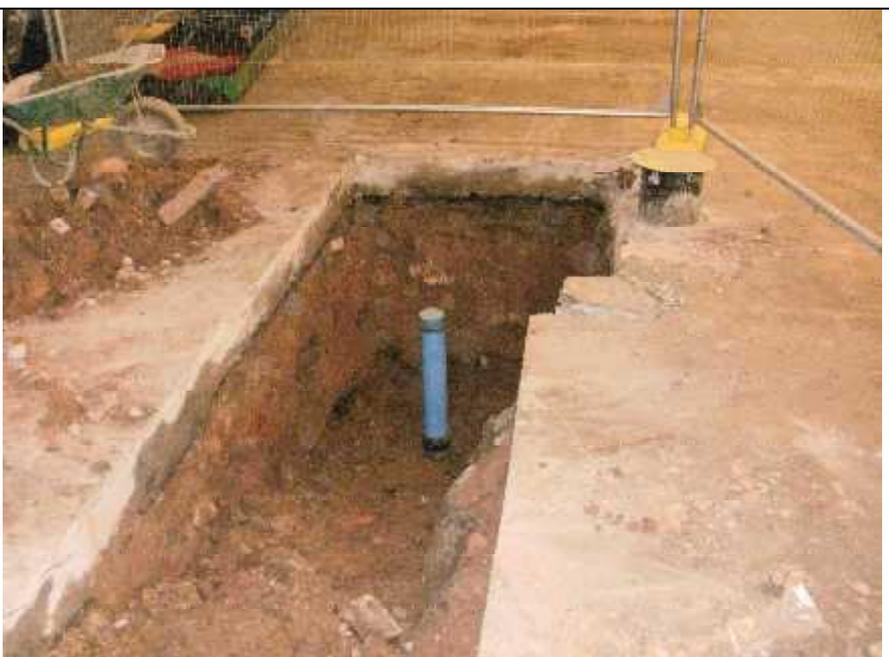
PROJECT NUMBER: 90936.41	
PLATE NUMBER: 10	
DATE: April 2012	
DESCRIPTION: Material excavated around EX6008 prior to the installation of the manhole chamber around the well.
