**Remediation Infrastructure Installation Phase II
(Main Production Building) and Baseline Monitoring Report
Grange Road
Cwmbran
Gwent
NP44 3XU
South Wales**

**October 2012
909364102_03**

Meritor Heavy Vehicle Braking Systems (UK) Limited

ARCADIS (UK) Limited

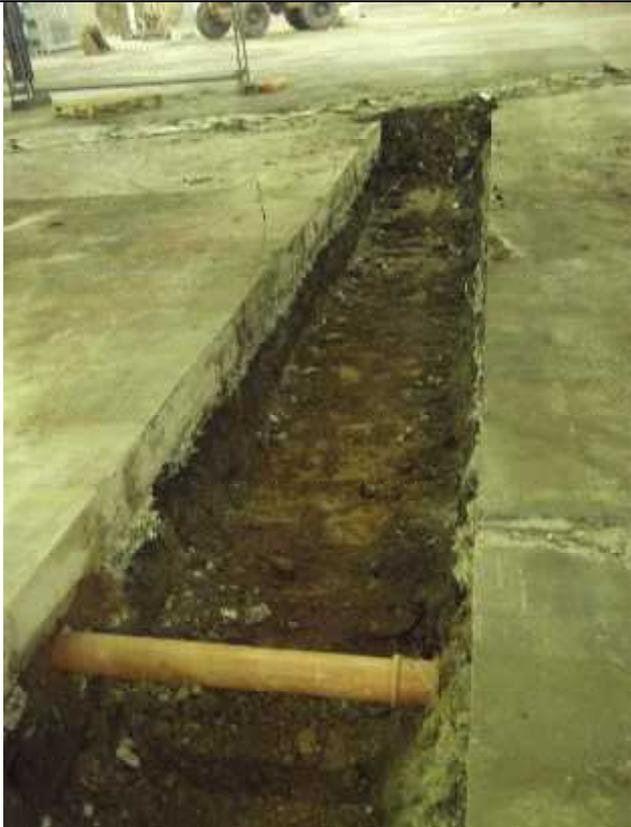
PROJECT NUMBER: 90936.41	
PLATE NUMBER: 11	
DATE: May 2012	
DESCRIPTION: Example of a redundant drainage utility encountered during the excavation works.

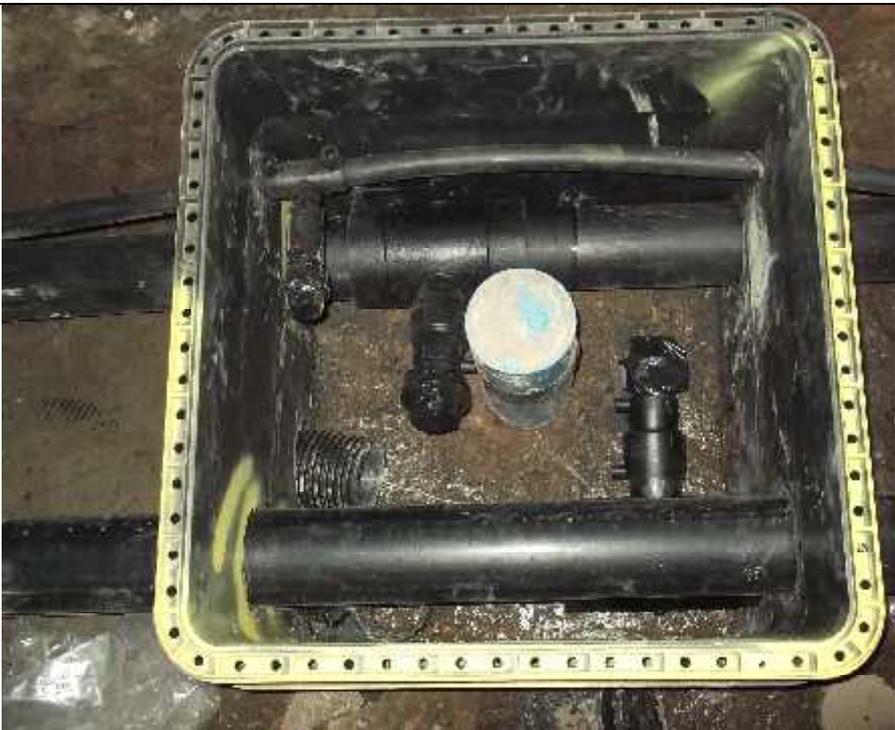
PROJECT NUMBER: 90936.41	
PLATE NUMBER: 12	
DATE: May 2012	
DESCRIPTION: View of the pipework and well head in an LNAPL extraction manhole chamber.

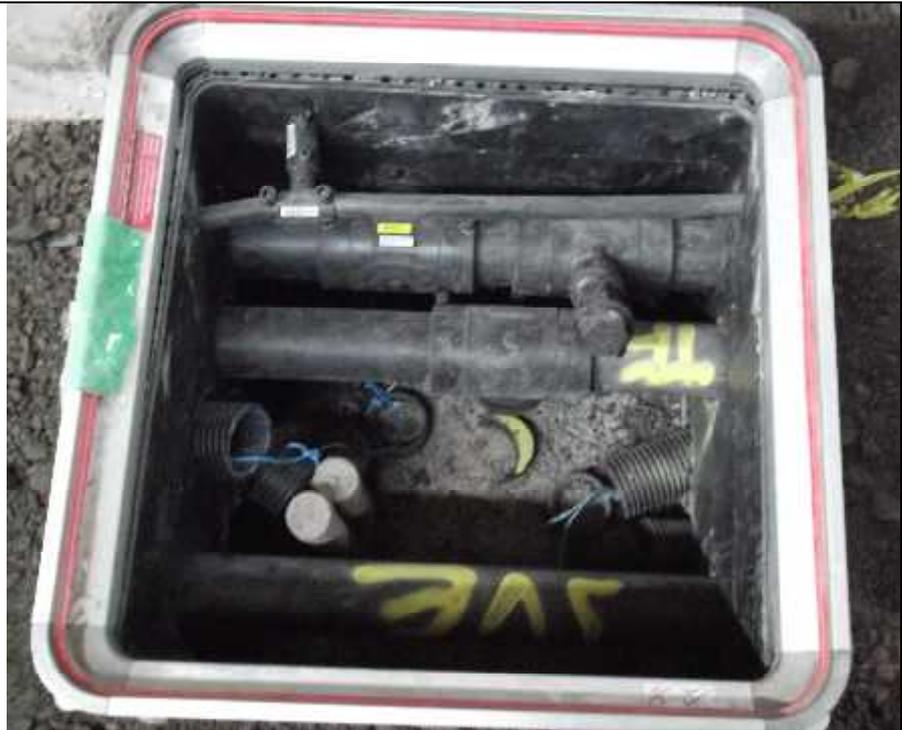
CLIENT: Meritor HVBS (UK) Ltd
PROJECT NUMBER: 90936.41
PLATE NUMBER: 13
DATE: May 2012
DESCRIPTION: View of the pipework and well head in an injection manhole chamber.

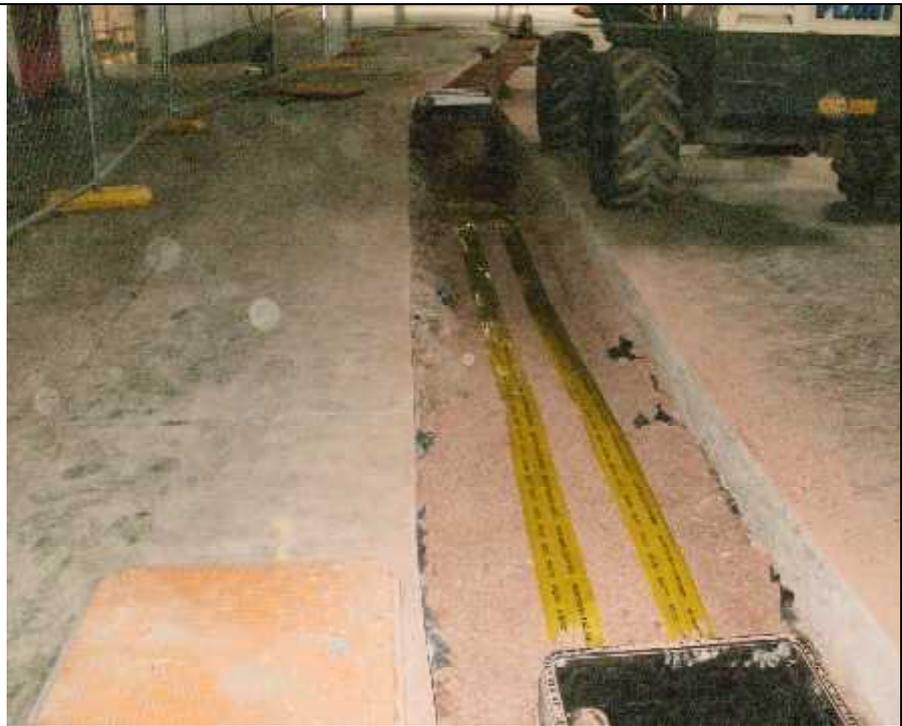
CLIENT: Meritor HVBS (UK) Ltd
PROJECT NUMBER: 90936.41
PLATE NUMBER: 14
DATE: April 2012
DESCRIPTION: Marking tape was laid in the trenches prior to the concreting.

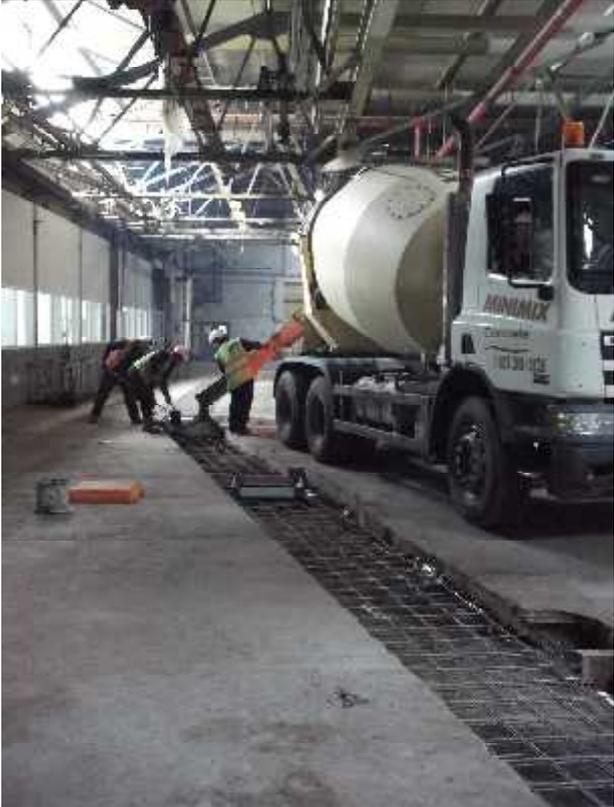
PROJECT NUMBER: 90936.41	
PLATE NUMBER: 15	
DATE: April 2012	
DESCRIPTION: Concrete pouring in the southern remediation line.

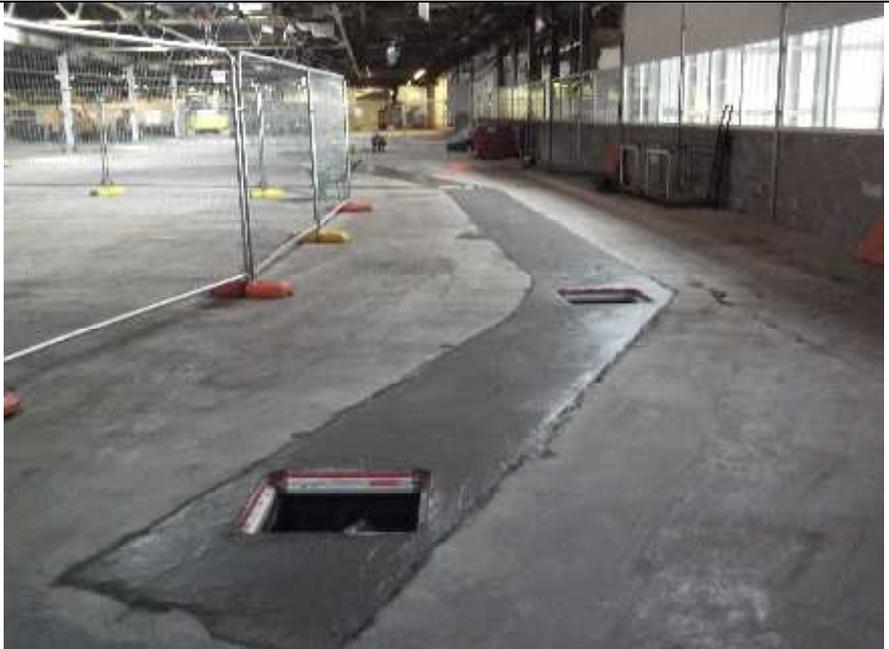
PROJECT NUMBER: 90936.41	
PLATE NUMBER: 16	
DATE: April 2012	
DESCRIPTION: Hand smoothed concrete finish across the remediation line.

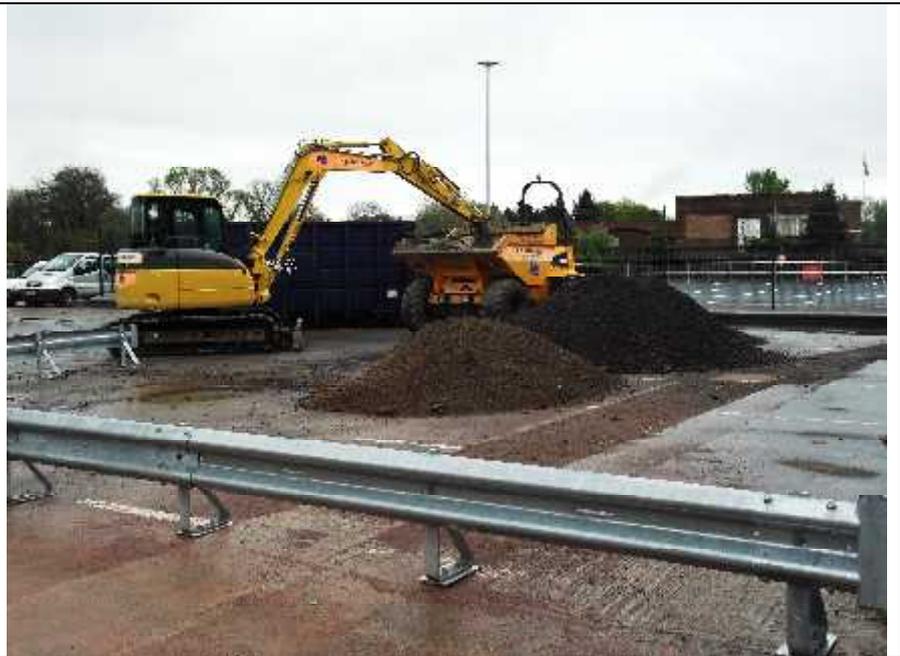
CLIENT: Meritor HVBS (UK) Ltd
PROJECT NUMBER: 90936.41
PLATE NUMBER: 17
DATE: June 2012
DESCRIPTION: Clean material for backfilling stored externally in the south yard.

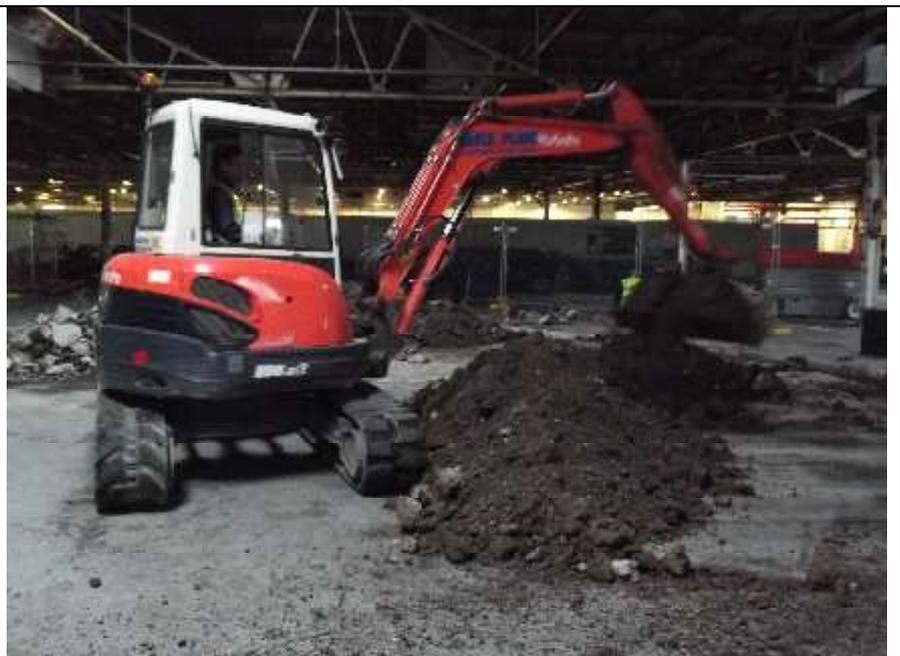
CLIENT: Meritor HVBS (UK) Ltd
PROJECT NUMBER: 90936.41
PLATE NUMBER: 18
DATE: June 2012
DESCRIPTION: Excavated material from the trenches was stored internally with the fenced off ARCADIS work area.

During the course of the trenching works, broken out concrete was stored externally in the south yard. Soil arising were stored internally, and samples were collected and sent for laboratory analysis for waste classification purposes. Results indicated the material excavated from the site was non-hazardous. The concrete and soils were removed separately by ARCADIS' appointed subcontractor under duty of care documentation.

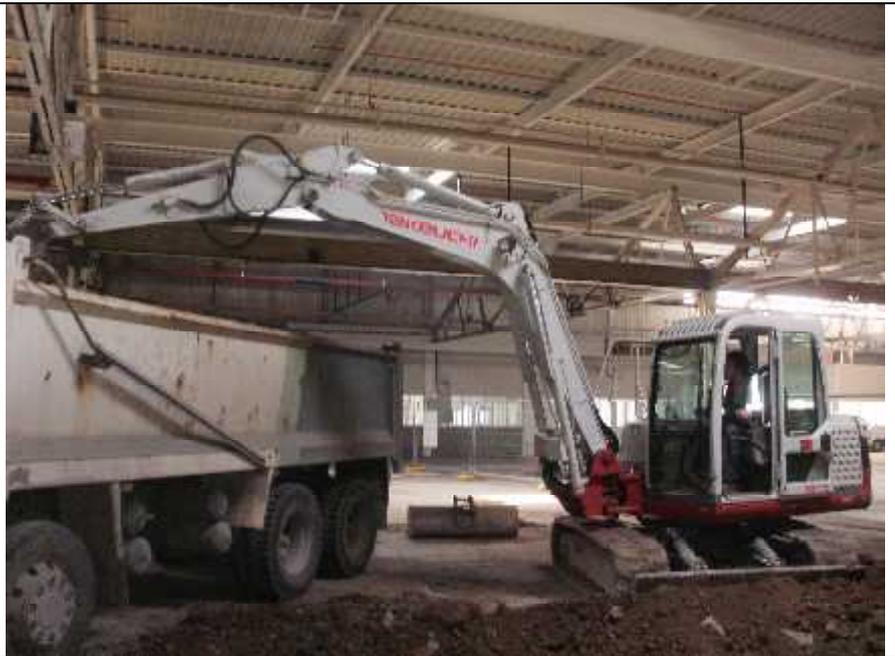
CLIENT: Meritor HVBS (UK) Ltd
PROJECT NUMBER: 90936.41
PLATE NUMBER: 19
DATE: June 2012
DESCRIPTION: Excavated material was removed off site and appropriately disposed of on a needs basis.

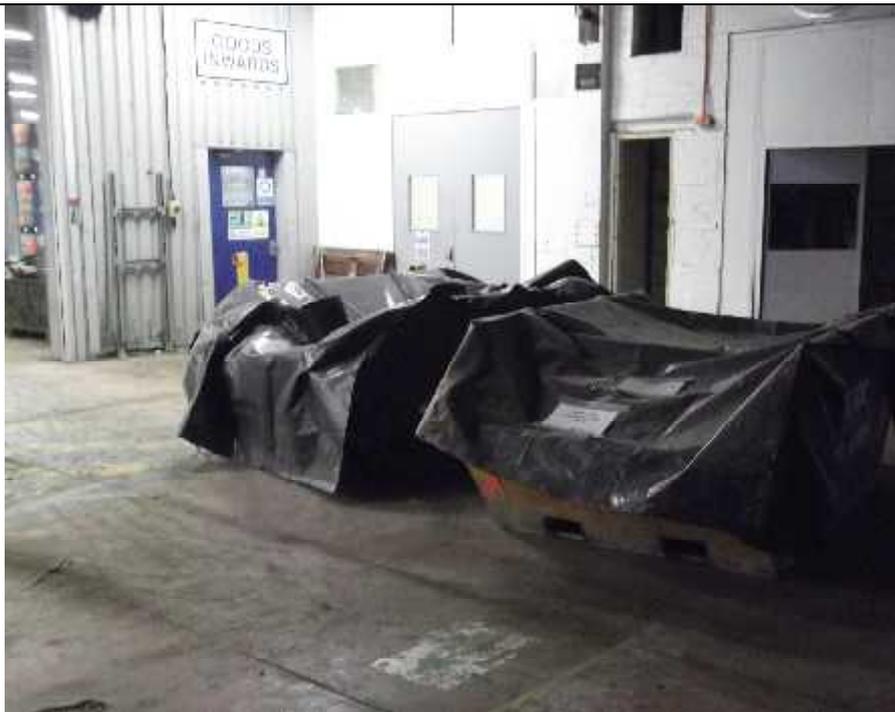
CLIENT: Meritor HVBS (UK) Ltd
PROJECT NUMBER: 90936.41
PLATE NUMBER: 20
DATE: May 2012
DESCRIPTION: Dedicated labelled skips were used in the ARCADIS working area for segregating and storing drilling arisings and general waste. The skips were lined with a plastic membrane to prevent releases, and covered to help prevent unauthorised use.

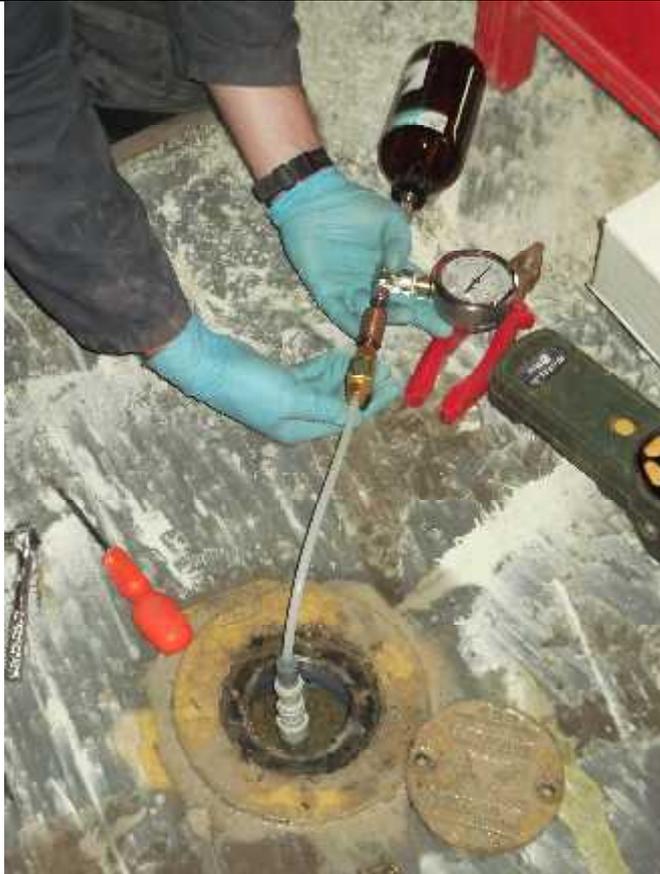
CLIENT: Meritor HVBS (UK) Ltd
PROJECT NUMBER: 90936.41
PLATE NUMBER: 21
DATE: May 2012
DESCRIPTION: Soil gas sampling from SG05 using a vacuum canister.

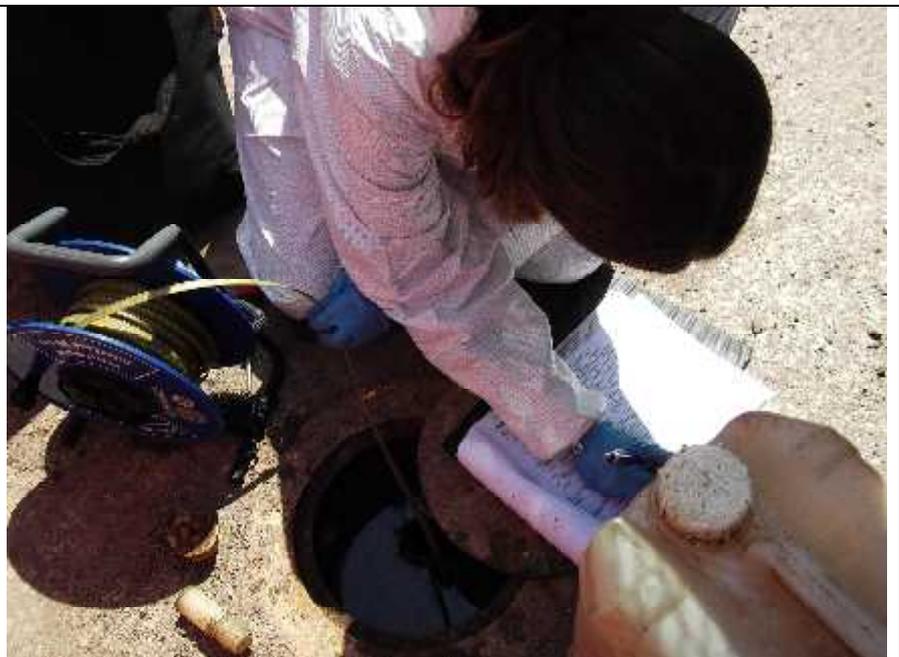
CLIENT: Meritor HVBS (UK) Ltd
PROJECT NUMBER: 90936.41
PLATE NUMBER: 22
DATE: July 2012
DESCRIPTION: Groundwater monitoring of EX10.
