February 2016  
Report No 2651-R01-01 SRA

## **STANDARD ROAD LANDFILL SITE STABILITY RISK ASSESSMENT**

**Date: 12<sup>th</sup> February 2016**

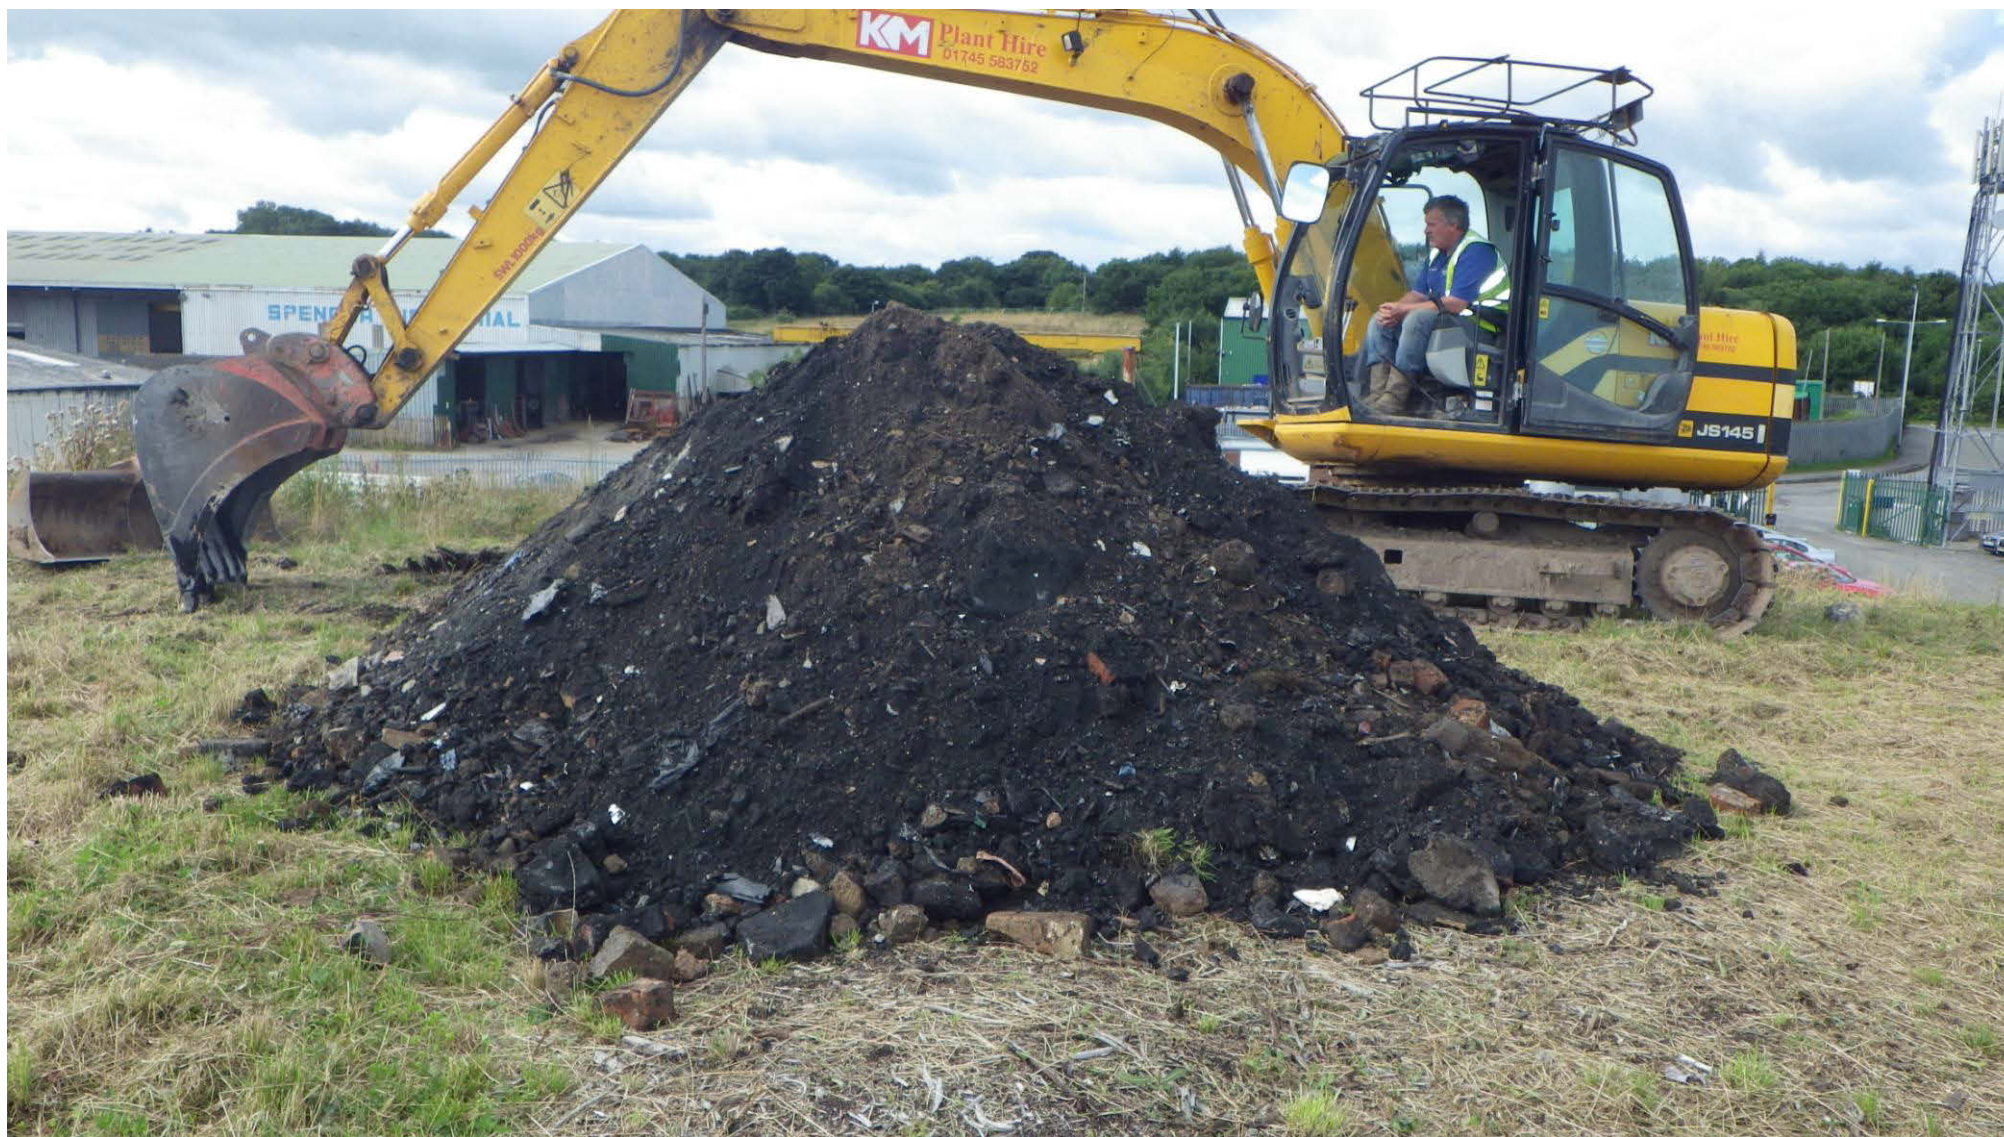
Taken on WPR stockpile on edge of Standard Landfill site, shows burnt waste from trial pit 10.

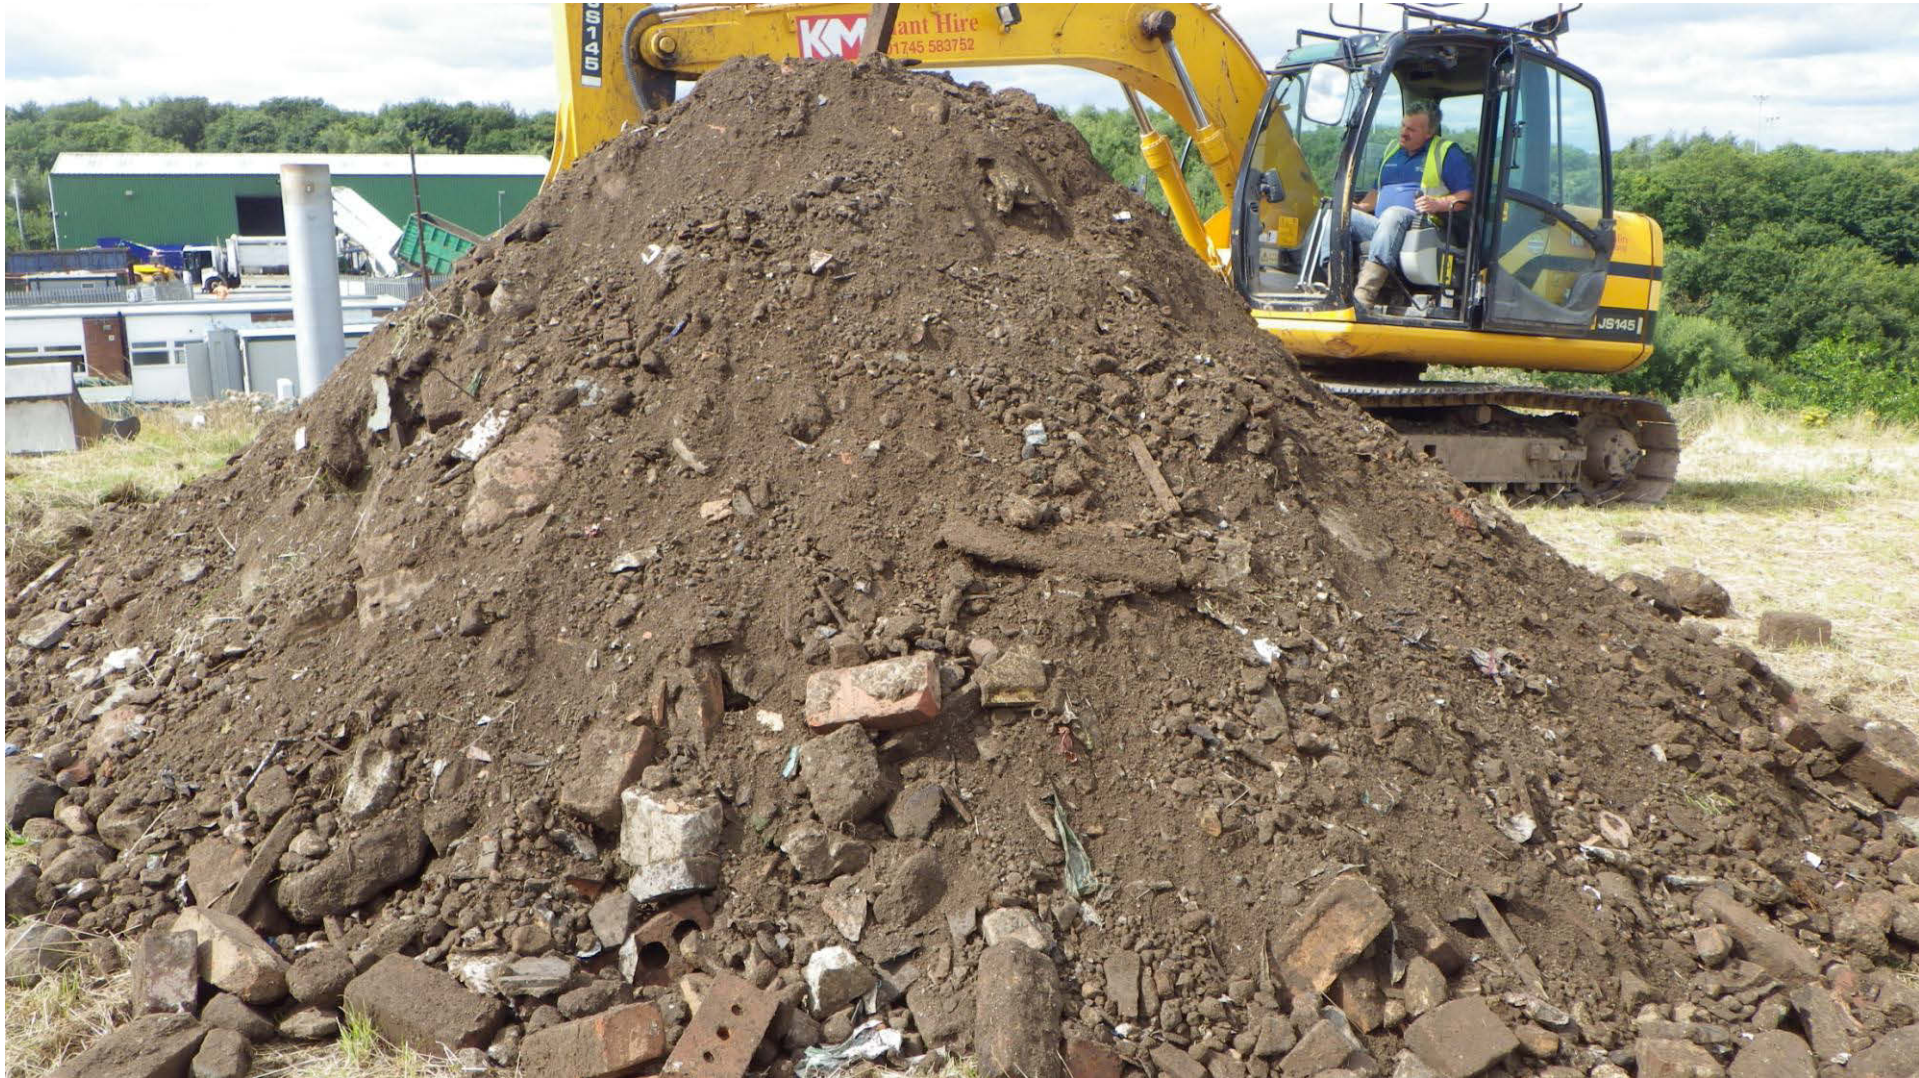
Taken on WPR stockpile on edge of Standard Landfill site, waste from trial pit 9 at 2m deep.

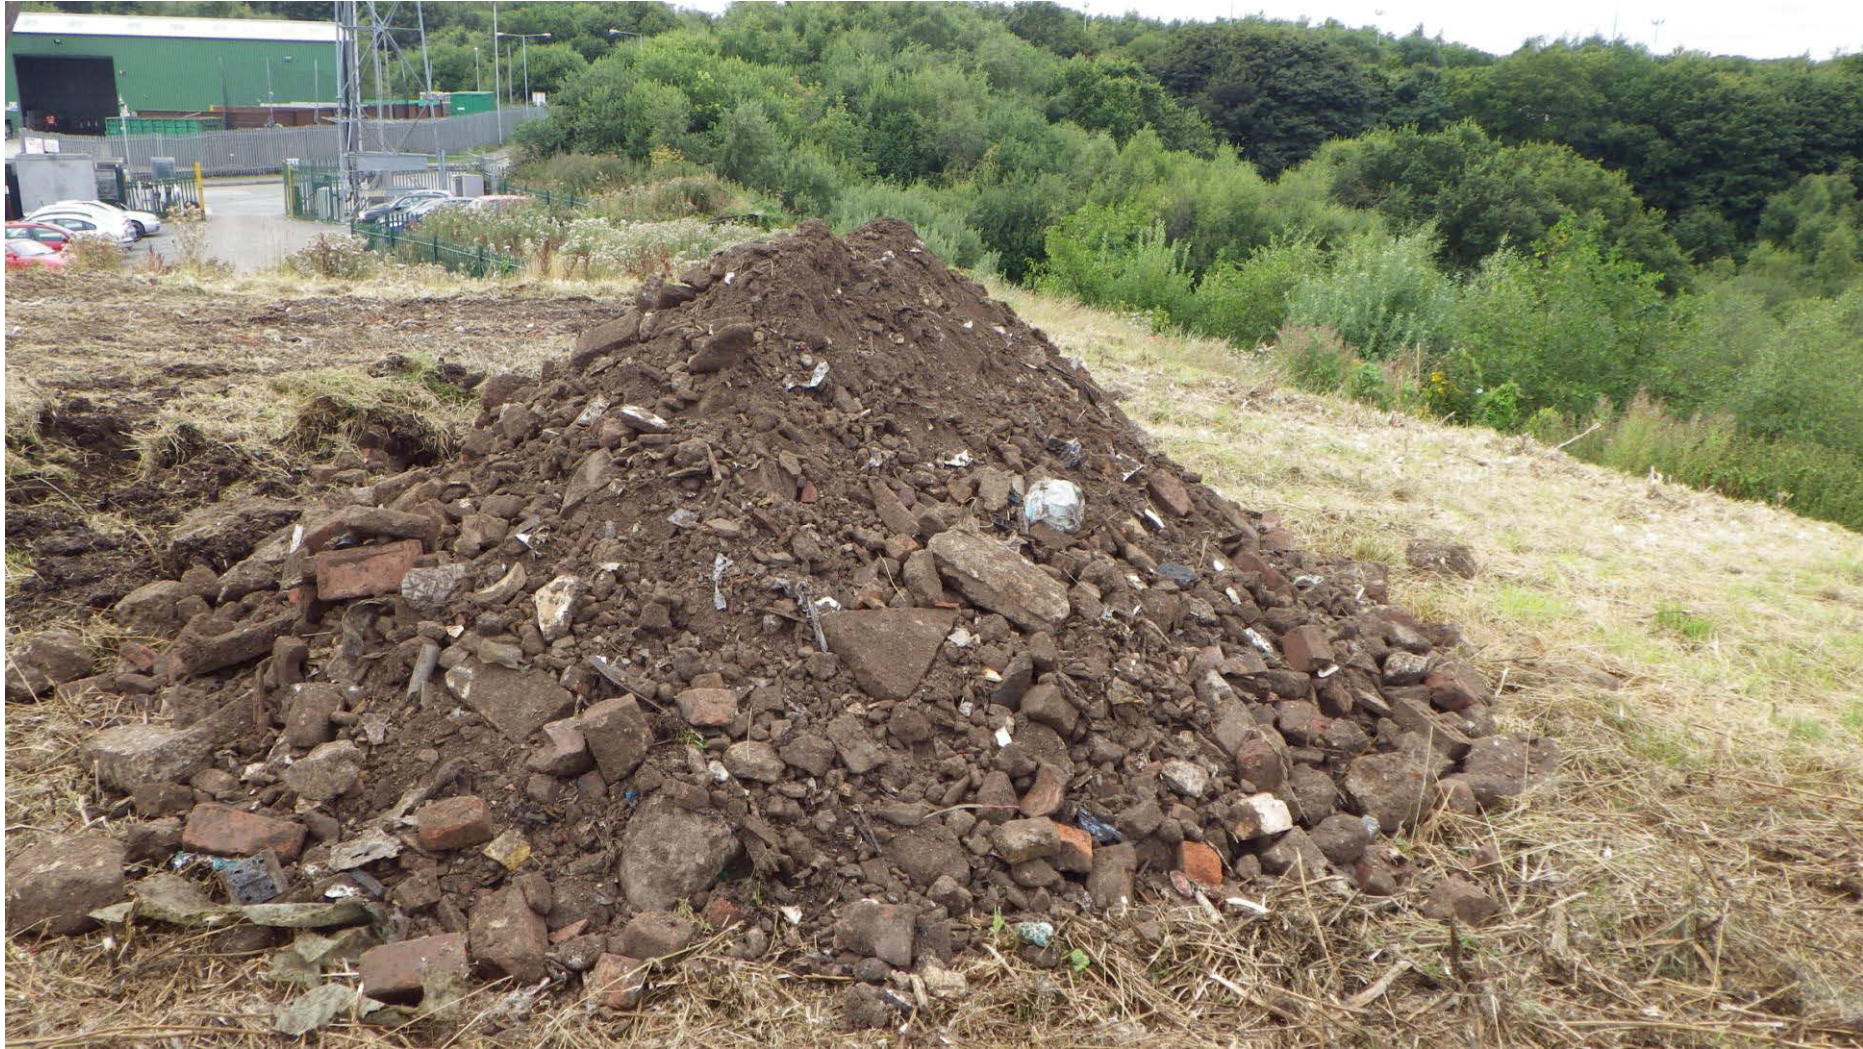
Waste from trial pit 4 at 2m deep

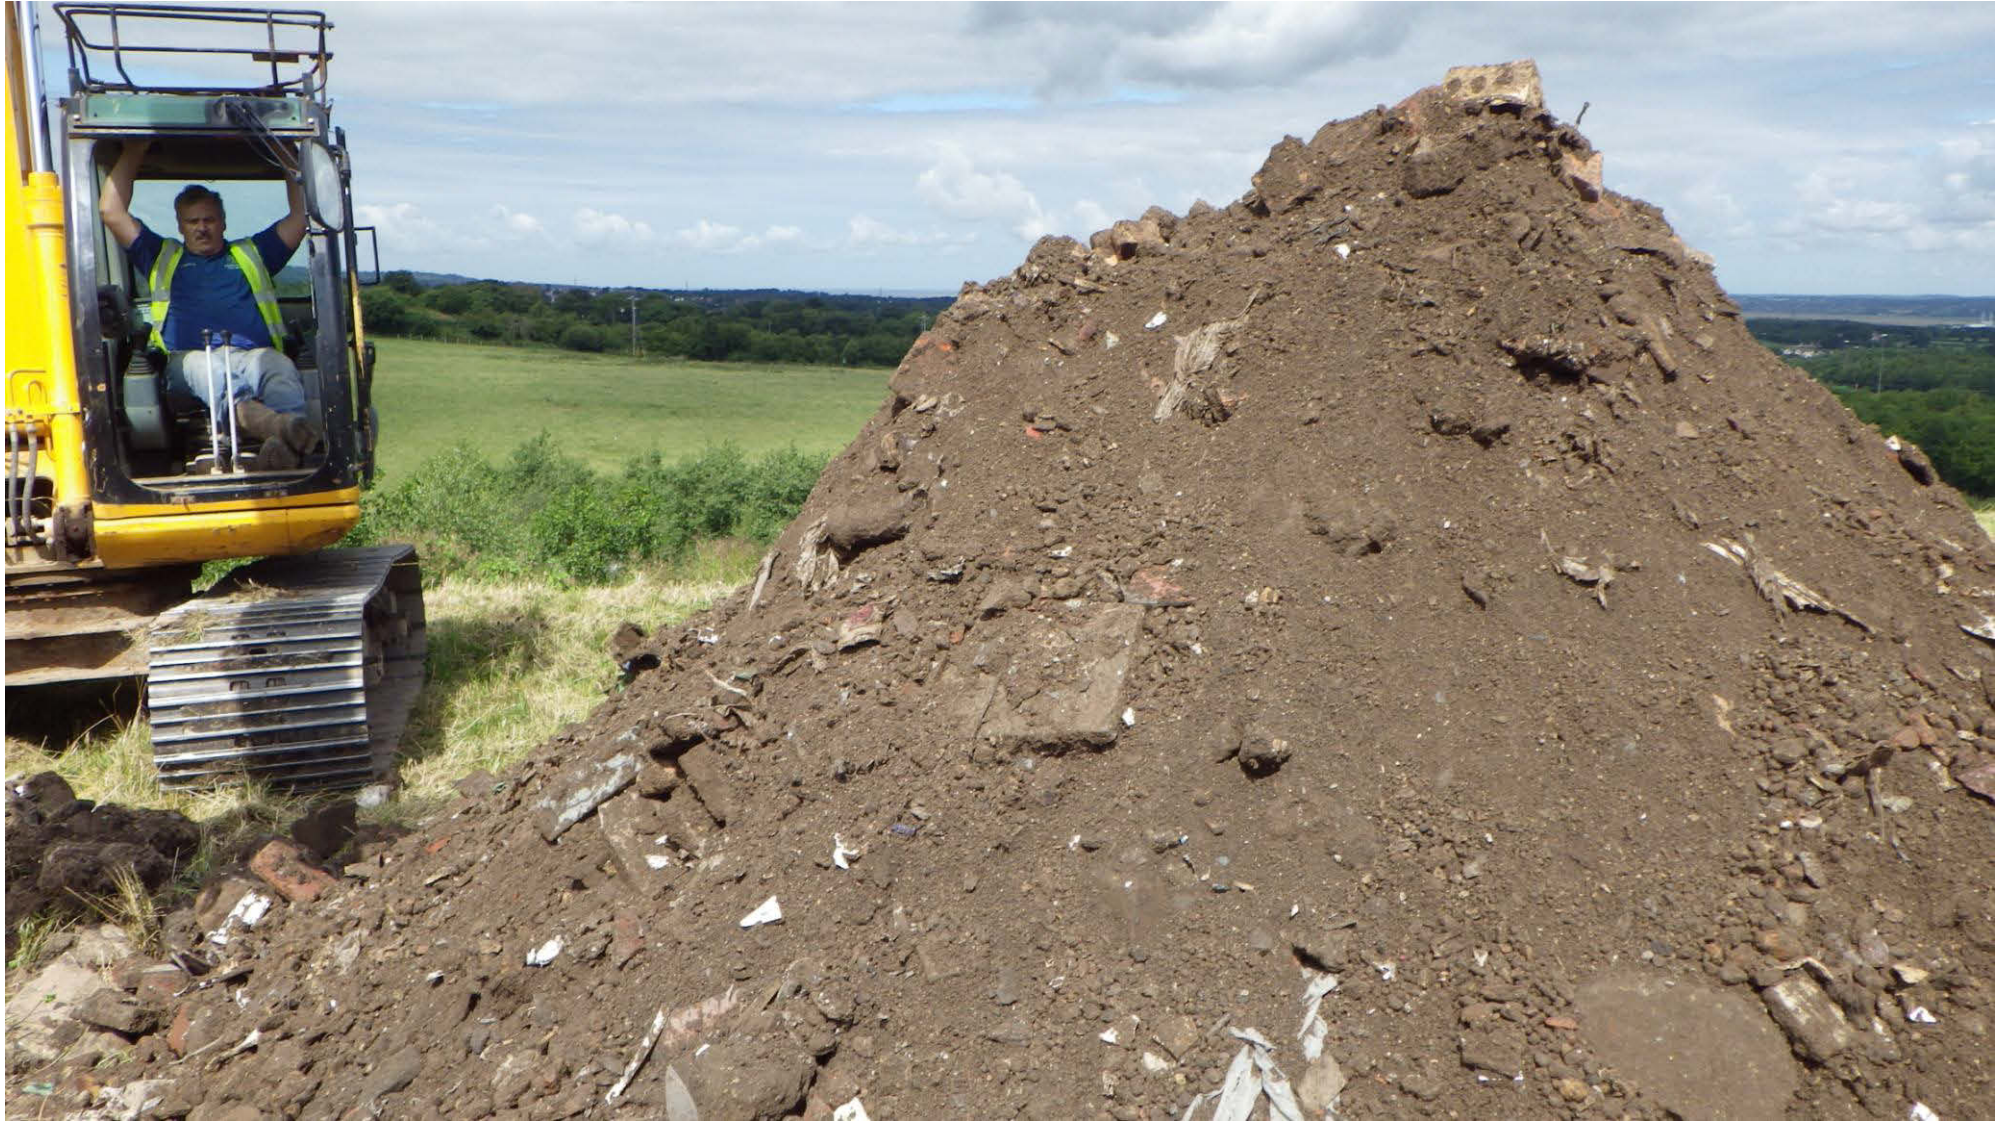
Waste from Trial pit 4 at 4m deep

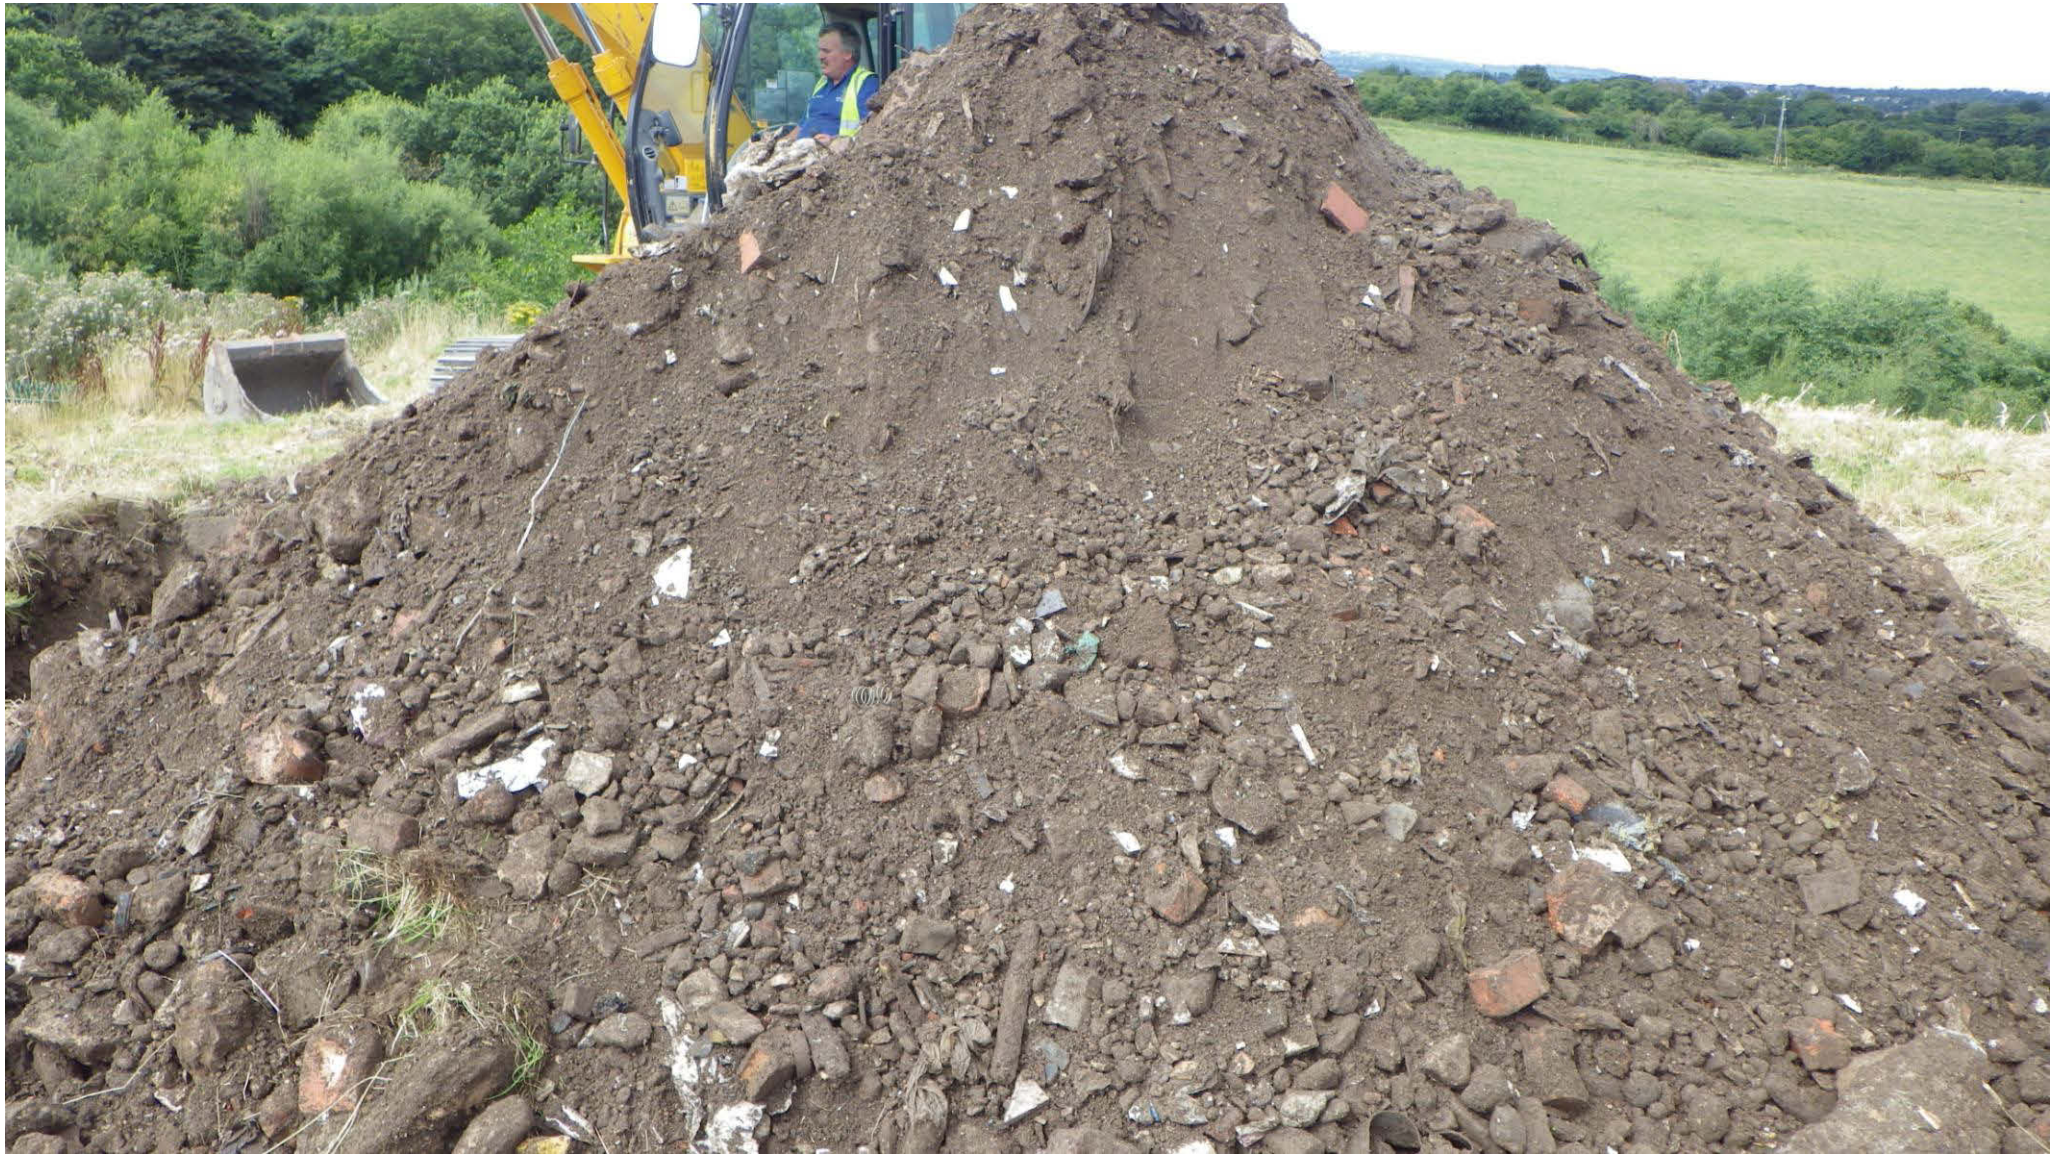
Waste from Trial pit 4 at 6m deep

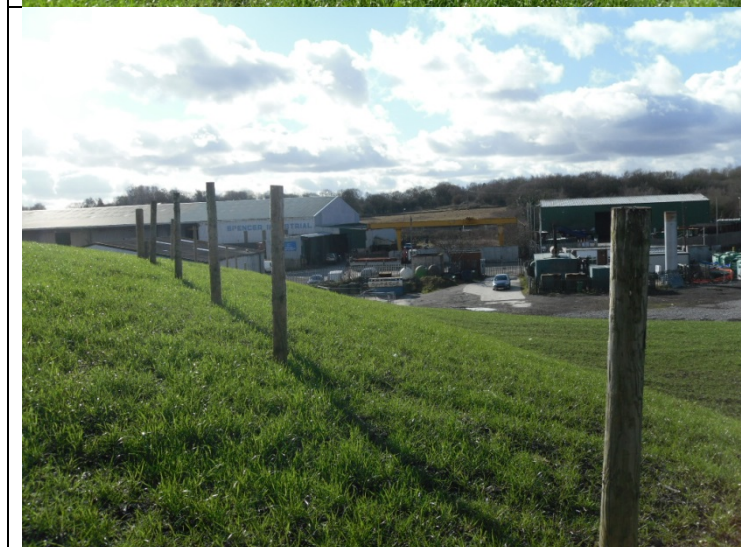
Similar to above view but further round  
showing more of the slope
