## Compliance Assessment Report

**Report ID:**  
**CAR\_NRW0031448**

Site	The Old Transport Yard	Permit Ref	XP3694FN			
Operator/Permit holder	Mr M R Jackson					
Regime	Waste Operations					
Date of assessment	16/02/2017	Time in	11:10	Out	12:10	
Assessment type	Site Inspection					
Parts of the permit assessed	Management system and operating procedures; Storage, handling, labelling and segregation					
Lead officer's name	White, Steven					
Accompanied by	Haider, Mefty					
Recipient's name/position	Mike & Steve Jackson/ Directors	Date issued	18/05/2017

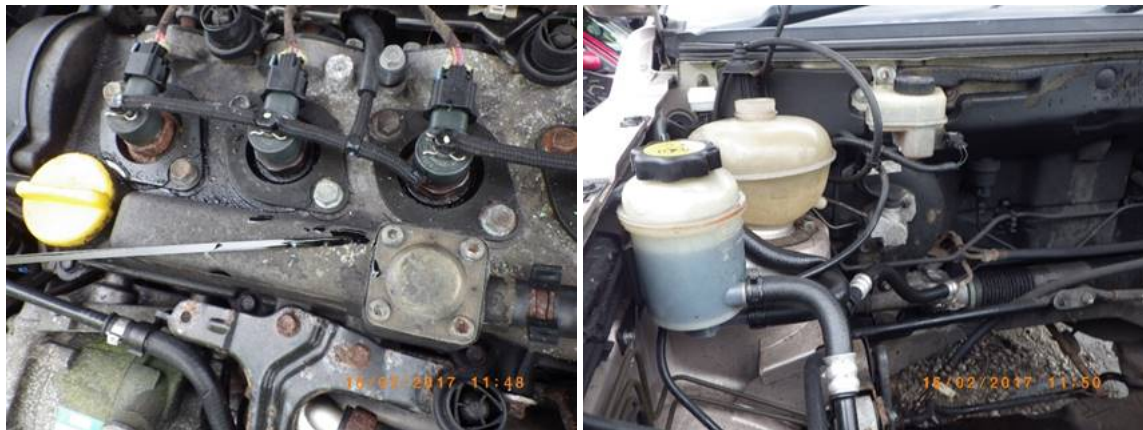
The ELV storage area was inspected during the visit, this area of site does not benefit from an impermeable surface with sealed drainage therefore all ELV's stored here need to be fully depolluted. Approx. 20 ELVs stored on permeable ground were inspected at random and most were found to be not fully depolluted containing fluid including; engine oil, coolant, hydraulic oil, and screen-wash. Some vehicles checked also still contained their batteries.

Engine oil and fluids observed in (separate) vehicles

- Working Plan condition 4.2 states that 'engines shall be carefully drained of residual oil'; there were a number of vehicles checked that still had oil observed in the engine (see above photo)  
Working Plan condition 4.3 states that 'vehicle batteries shall be carefully removed and stored in a skip'; a number of vehicles checked had not had the batteries removed (see above photo)

**Action:** Ensure that all ELVs stored on permeable ground are fully de-polluted. Any ELV's still containing hazardous material should be stored on an impermeable surface with sealed drainage. **Action by: 30th June 2017**

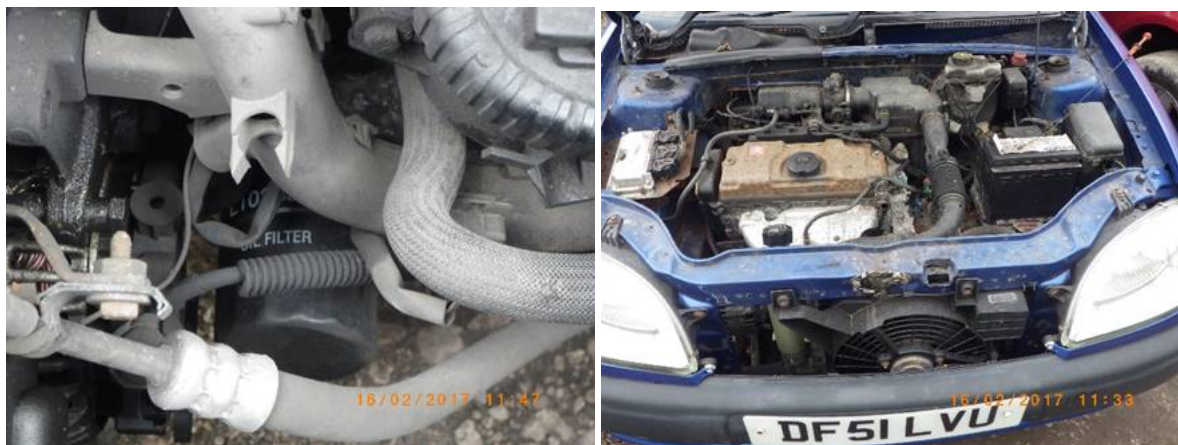
Oil filter and battery observed in (separate) vehicles

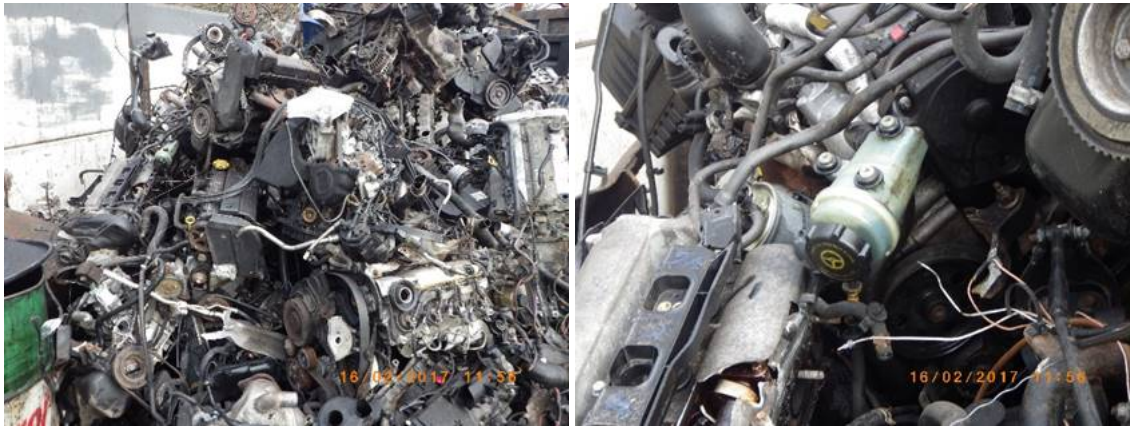
The vehicle breaking area is the only area, other than the indoor depollution area, within the permitted site that benefits from an impermeable surface with sealed drainage system. During the inspection of this area it was observed that vehicles ready to be broken by the new equipment on site had not been fully depolluted and still contained fluids. An engine was observed that had been removed but still had power-steering fluid visible in the

engine (see photos below).

Removed engine in vehicle breaking area with power steering fluid still in

**Action:** Ensure that all ELVs stored on permeable ground are fully de-polluted. Any ELV's still containing hazardous material should be stored on an impermeable surface with sealed drainage. **Action by: 30th June 2017**

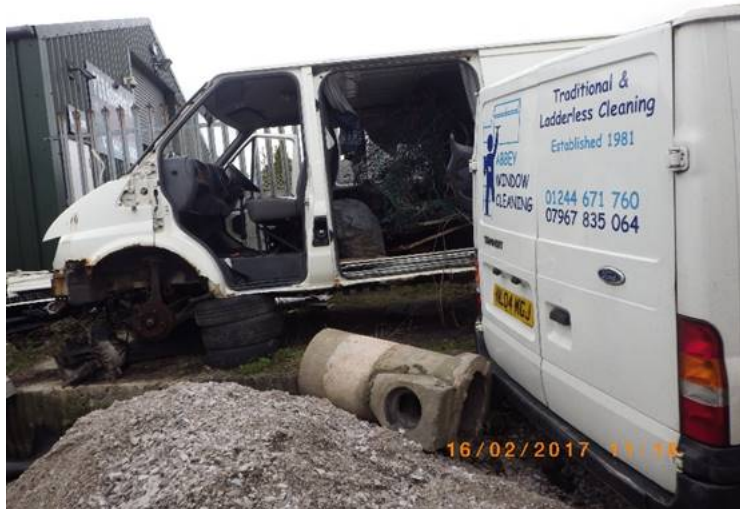
There were a number of vehicles stored outside the permitted boundary (4x large vans, 3x small vans, 3x cars) one of the larger vans (pictured below) was obviously an ELV as there were no doors, wheels and it was in such a state of disrepair that it could not be considered as anything other than a waste vehicle.

Waste vehicle stored outside permitted boundary

Condition 2.2.1 of the site permit states 'The activities shall not extend beyond the site, being the land shown edged in green on the site plan at schedule 7 to this permit.

As the vehicle was stored outside the site boundary a CCS score of C3 has been applied for this breach.

**Action:** You must ensure that all ELV's are stored within the permitted boundary; all undepolluted waste vehicles must be relocated into the permitted site boundary. **Action by: 30th June 2017**

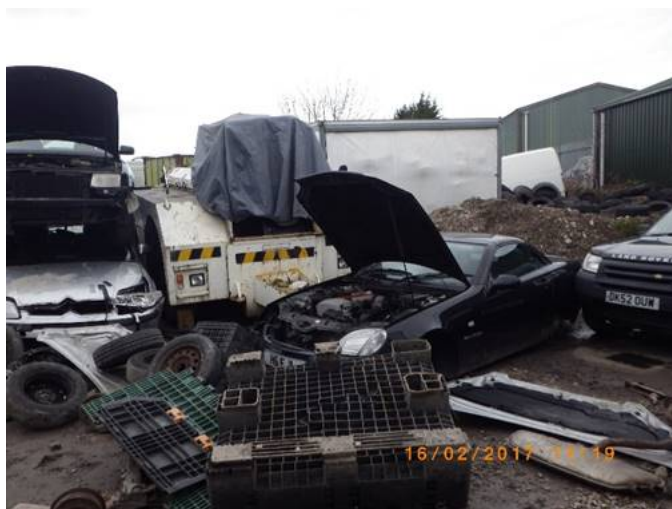
The sites oil interceptor is located adjacent to the entrance gate, at the time of the visit two vehicles (a black Mercedes and a Land Rover Freelander) were observed on top of the interceptor (see photo below). This would make it very difficult for the interceptor to be regularly checked and maintained, and emptied if required.

Cars stored on the site oil interceptor

Please ensure that the interceptor is easily accessible at all times, any vehicles stored on top are removed and that records of checks and maintenance are retained for inspection by regulatory officers and recorded in the site diary.
