## Compliance Assessment Report

**Report ID:**  
**CAR\_NRW0035468**

| Site | Atlantic Recycling Limited | Permit Ref | PP3993VS | | |
| Assessment type | Site Inspection | | | | |

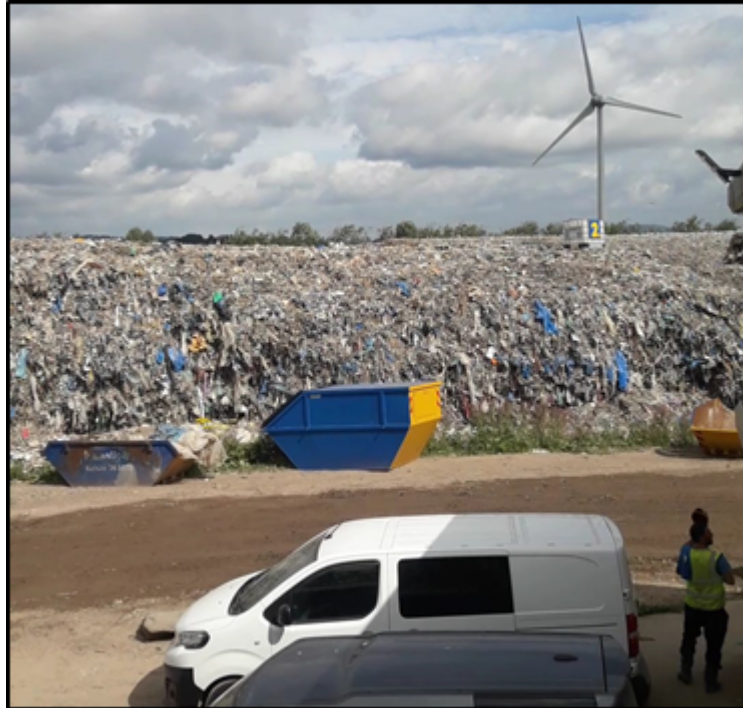
Photograph 1 | taken on 10/07/19 – showing the height of Stockpile 2 (loose RDF material) stored on Field 1

On Wednesday 10 July 2019, it was evident that the loose RDF Stockpile 2 on Field 1 was very long in length consisting of a large volume of waste. This was easily viewed from the office unit and car parking area. The entire stockpile was estimated to be exceeding the four-metre height restriction along with other loose RDF Stockpiles on Field 1; Phil and John agreed on this point with the Officer.

**Table 3** of ARL's FPMP states that waste within all stockpiles shall be stored at a height of 4 metres. During the inspection, waste was being stored within stockpiles in excess of 4 metres and as a result, is not being stored in accordance with ARL's FPMP. Exceeding stockpile heights goes against fire mitigation and has contributed to the breach of condition **3.7.1** as a result. The storage of waste in excess of 4 metres is a direct consequence of storing too much waste on site and having to stack waste high in order to try and maintain compliant separation distances between piles.

- **Comply with Section 3.3.3 - Storage pile sizes and Separation Distances of your FPMP – Table 3.**
  - i) Reduce the heights of all Stockpiles exceeding 4 metres.
  - ii) Establish compliant separation distances between Stockpiles.
- **Comply with Section 4.3 Quarantine Area of your FPMP**
  - i) Create a suitable Quarantine Area to hold 50% of the largest stockpile

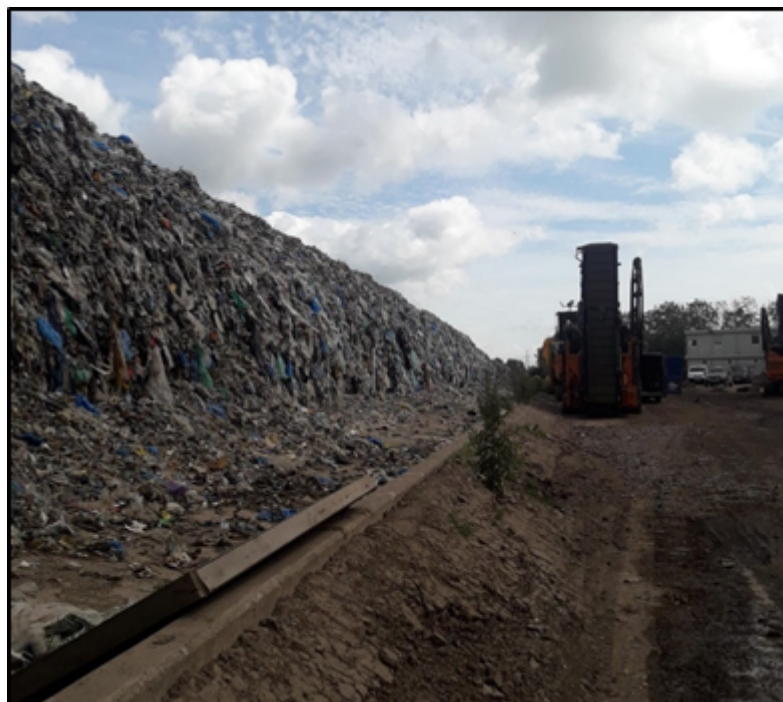
Photograph 2 | taken on 10/07/19 – Stockpile 2, showing the height and length of material stored on Field 1 close to the slab boundary

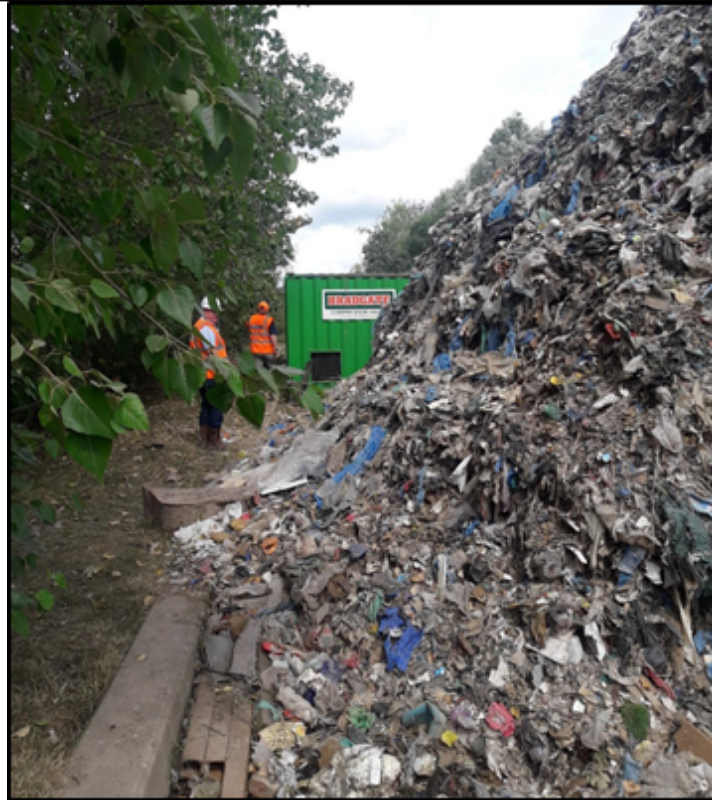
**Photograph 3 | taken on 10/07/19 - showing Stockpile 2 material spilling onto Field 1 boundary**

The FRS expressed concern at the lack of access to Stockpile 2, to enable emergency vehicles to get to the whole waste pile in the event of an incident. Material was also placed very close to the slab boundary, to the extent where residual waste was spilling onto the curbing at one end of the stockpile; as per Photograph 3. Additionally, the MRF fines material in Transfer Station area were stored up against the mesh fencing due to the large volume.

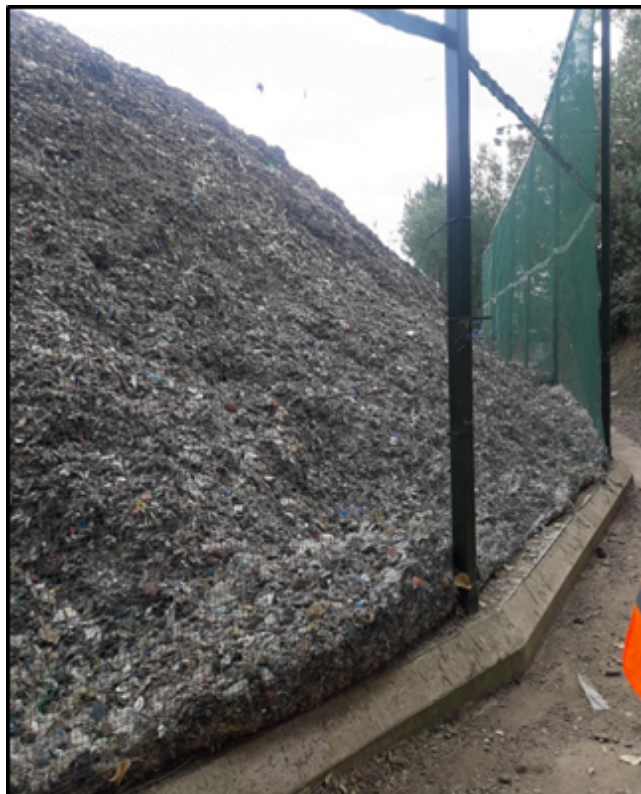
**Photograph 4 | taken on 10/07/19 - showing material stored in the Transfer Station pushed against the mesh fencing**

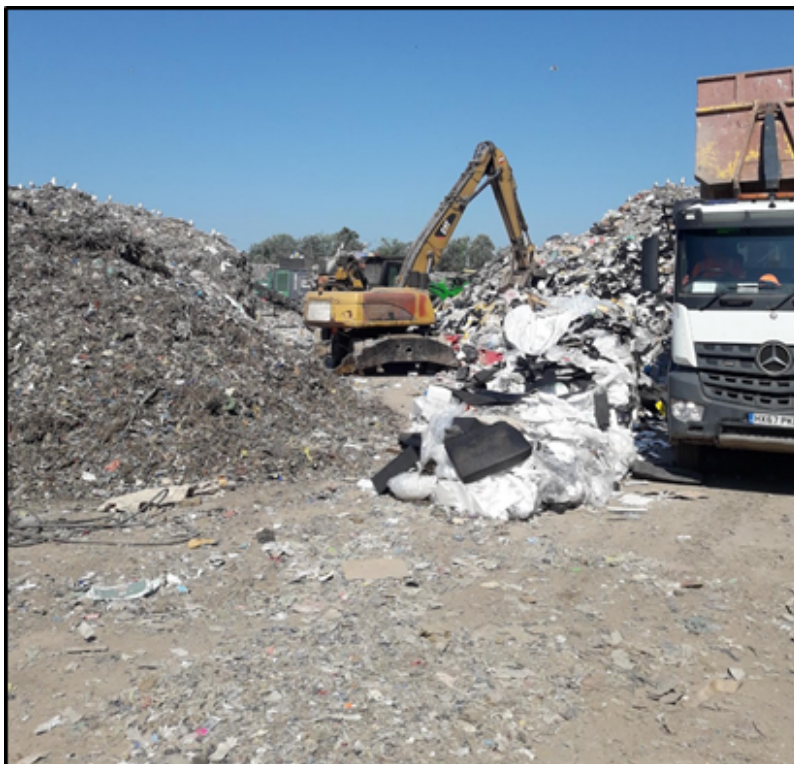
Due to the lack of room available on-site and the treatment activities occurring in the fire break areas, the separation distances did not seem to reflect an adequate 12metre gap. This demonstrates that your FPMP procedures are not being followed to ensure fire breaks are established at all times.

Photograph 5 | taken on 15/07/19 - showing mixed waste deposited on Field 1 within the fire breaks between RDF stockpiles

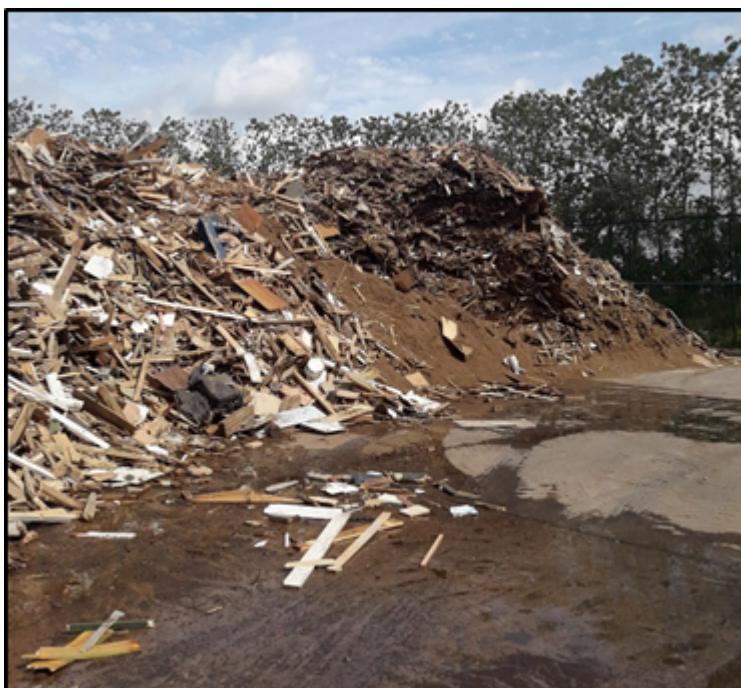
On the 10/07/19 and 15/07/19, wood waste within the Waste Transfer Area far exceeded the dimensions of the guidance. There was no clear fire break in place between the wood chip piles and processed waste and the height of the largest wood waste pile was above the 5-metre mesh fencing; as per Photograph 8. The site again claimed this is a knock-on effect from the limited space available.

**Photograph 8 | taken 10/07/19 – showing wood waste material stored in the Transfer Station higher the mesh fencing line**

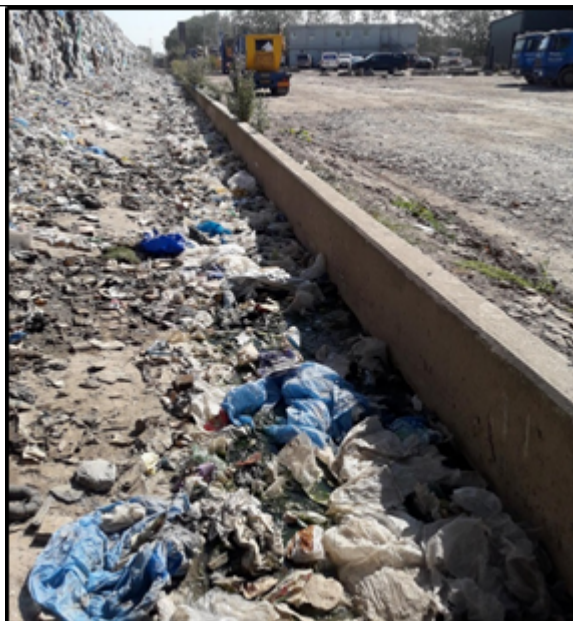
The drainage channel next to Stockpile 2 within the Field 1 slab was filled with residual material from the pile; as per Photograph 9. This could hinder the flow of surface water from reaching the drainage system efficiently and could cause issues. Please see that this material is cleared from the channel. No issues noted with the drainage system noted in the Transfer Station area.

Photograph 9 | taken on 15/07/19 - showing residual waste material in the Field 1 drainage channel

| Criteria Ref. | CCS Category | Action required/advised | Due Date |
|---|---|---|---|
| F3 | X | Remove any residual RDF material that has collected in the Field 1 slab drainage channel. | 06/08/2019 |
