**TROSTRE FORMER LANDFILL, LLANELLI**

**SURRENDER REPORT**

**AUGUST 2015**

**Carmarthenshire County Council**

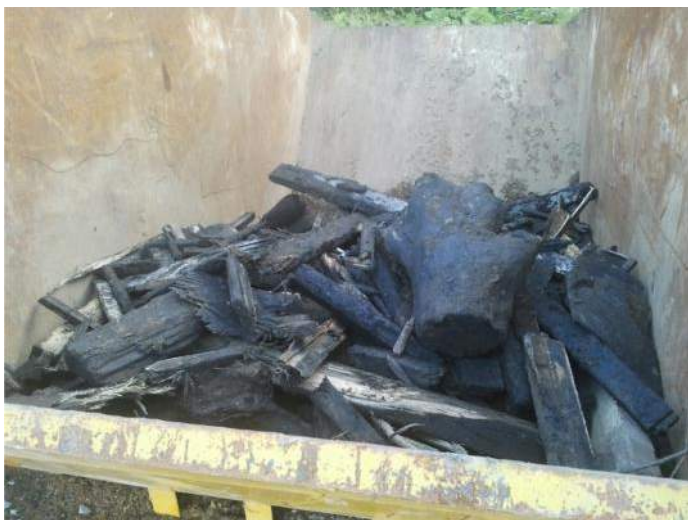
**Figure 1 – Blackened organic material**

Identified organic matter was blackened which is typical of the effects of anaerobic biodegradation, a by-product of which is methane gas.

The waste examined from this area had a strong odour, typical of organic materials biodegrading under anaerobic conditions.

Figure 1 below shows excavated organic material which had been blackened due to anaerobic biodegradation.

As material was segregated, the remaining inert material was compacted back into the initially excavated area.

This cycle was repeated until no further organic matter was encountered in the areas of interest.

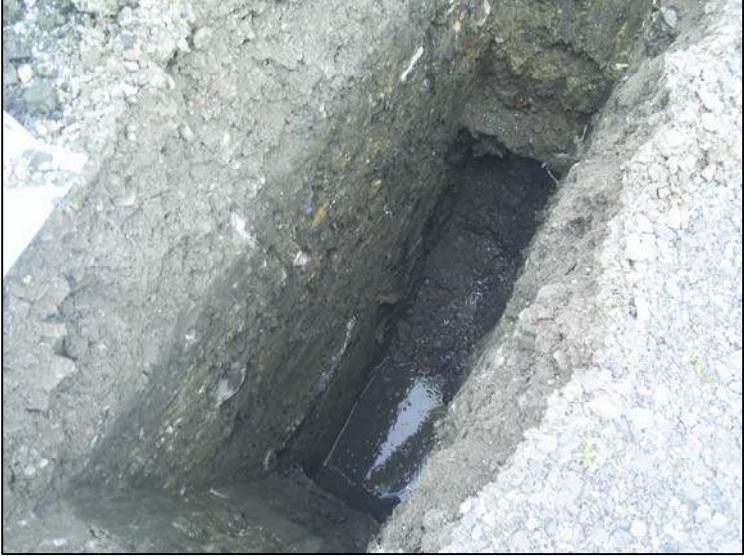
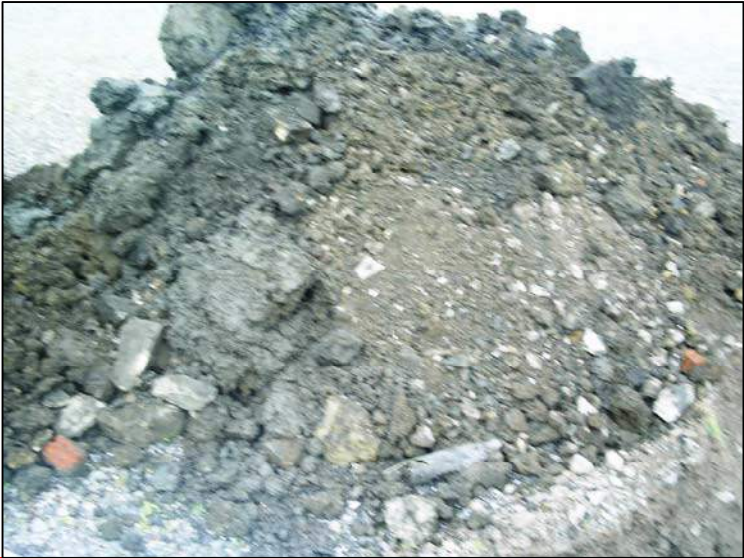
1	0.50  (2.50)	MADE GROUND: Black silty very sandy gravelly clay with cobbles, made ground and cobbles are of brick, concrete, siltstone and mudstone.

4	3.50	Excavation ended at 3.5 Meters		3.50		
5						
6						
7						
8						
9

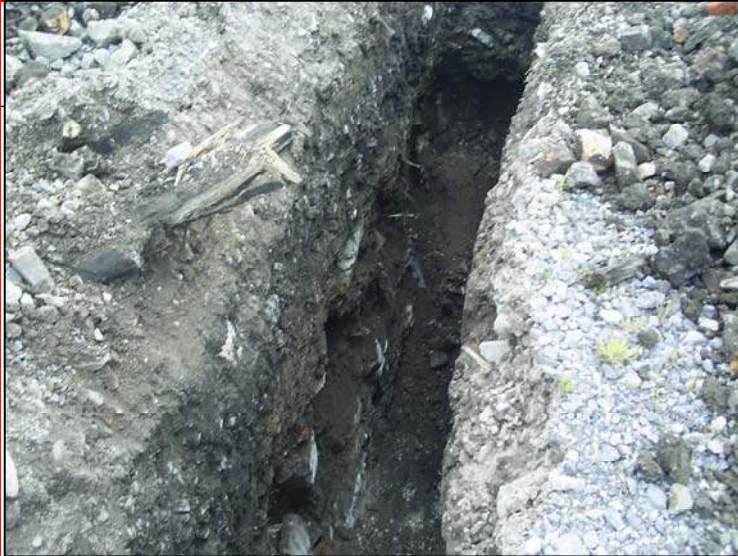
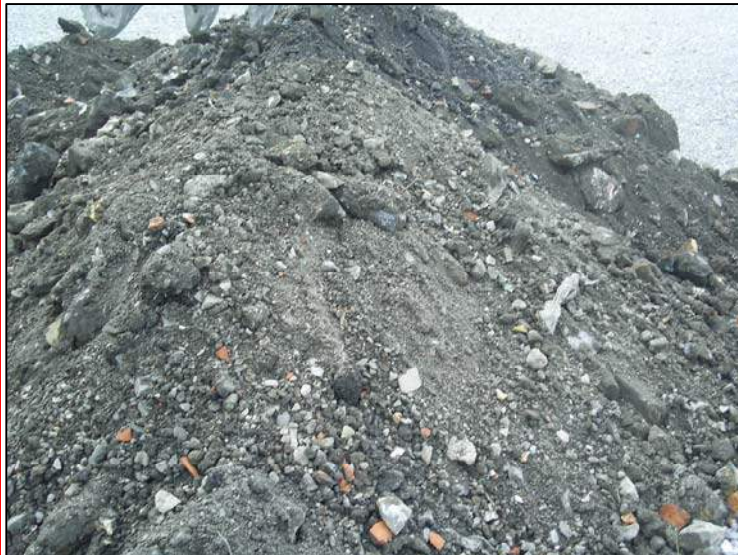
STRATA					
	Depth (Thick- ness)	Description	Legend	Depth (Thick- ness)	Water
	0.00 (0.30) 0.30	MADE GROUND: Loose light grey gravel to cobble of limestone aggregate surface cover over grey slightly silty very gravelly sand with angular to subangular pebbles and cobbles of limestone		0.00 (0.30) 0.30

1          2	(2.70)	MADE GROUND: Black silty very sandy gravelly clay with cobbles, made ground and cobbles are of brick, concrete, siltstone and mudstone.		(2.70)	
3	3.00 (0.50)	Brown silty CLAY with cobbles of siltstone and mudstone		3.00 (0.50)	
4           5           6           7           8           9	3.50	Excavation ended at 3,5 Meters		3.50

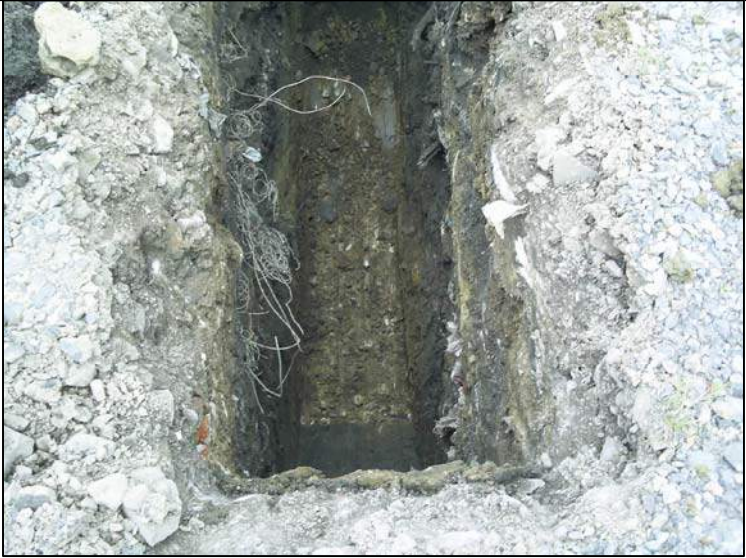
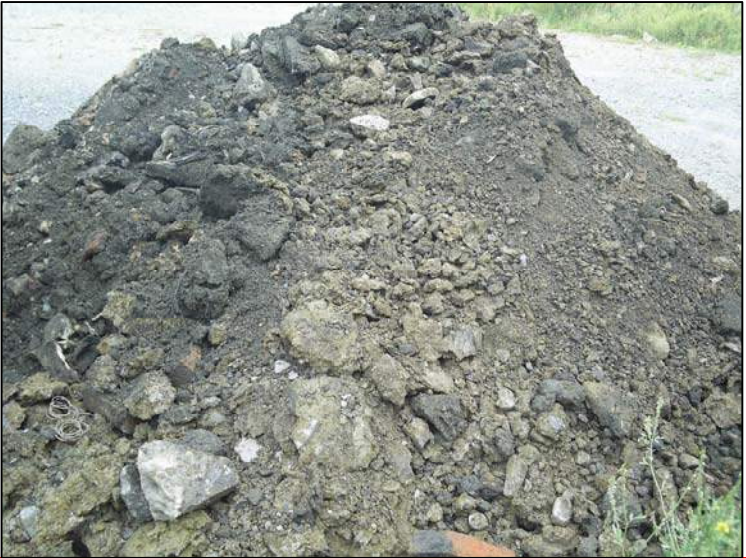
Contract: Trostre Landfill		Trial Pit No. TP5	
Client: Carmarthenshire County Council			
Dates: 11/8/2010	Job Number: 45-05-01	Ground Level:	
Location: Car Park B Trostre	Engineer: R Holmes	Coordinates:

STRATA					PHOTOGRAPHS	
	Depth (Thick- ness)	Description	Legend	Depth (Thick- ness)	Water	
	0.00 (0.30)	MADE GROUND: Loose light grey gravel to cobble of limestone aggregate surface cover over grey slightly silty very gravelly sand with angular to subangular pebbles and cobbles of limestone		0.00 (0.30)

1	0.30       (1.70)	MADE GROUND: Black silty very sandy gravelly clay with cobbles, made ground and cobbles are of brick, concrete, siltstone and mudstone.		0.30       (1.70)		
2	2.00 (0.50)	Firm brown silty CLAY		2.00 (0.50)		
3	2.50 (1.00)	Brown silty CLAY with cobbles of siltstone and mudstone		2.50 (1.00)

4	3.50	Excavation ended at 3.5 Meters		3.50		
5						
6						
7						
8						
9
