| Site | Atlantic Recycling Limited | Permit Ref | PP3993VS | | |
| Assessment type | Site Inspection | | | | |

Regulation Officers Alex BOWDER, Laoni TYE and Richard PALMER attended Atlantic Recycling Ltd (ARL) at Atlantic Eco Park, Newton Road, Cardiff on Thursday 14<sup>th</sup> March 2019 at 10:30 to conduct the Quarter 4 inspection of the permit **EPR-PP3993VS** for 2018/19.

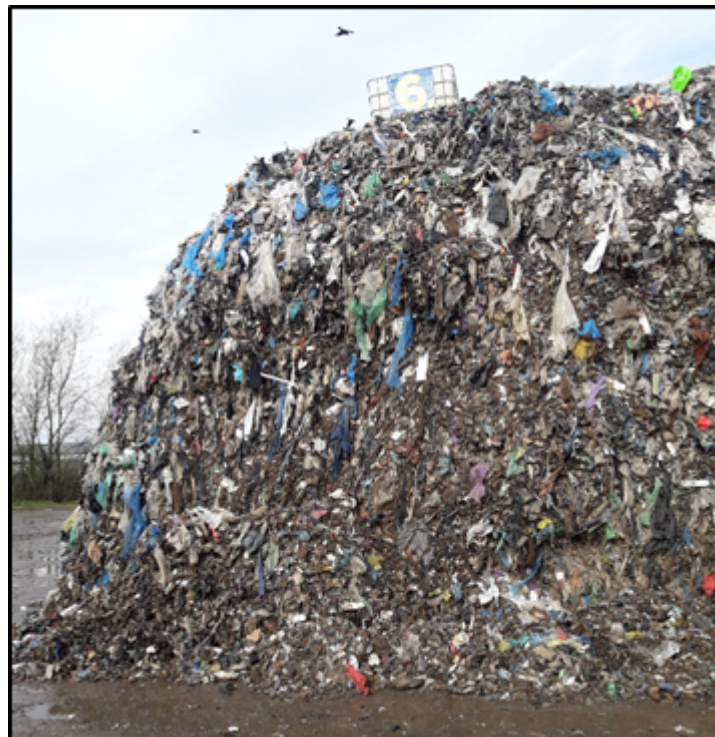
At the time of inspection, it was evident that numerous Stockpiles were exceeding **four metres** in height and that some separation distances between neighbouring stacks were not adequate. These measurements have been highlighted in **red** below; please reference Graph 1 of the FPMP for further details.

| <b>STOCKPILE 1</b><br>Height - <b>5.3 m</b><br>Width - <b>18.4m</b><br>Length - <b>54.6m</b> | <b>STOCKPILE 4</b><br>Height - <b>5.9m</b> | <b>STOCKPILE 6</b><br>Height - <b>5.5m</b> |

*Picture 1 – showing the storage and height of stack 6 material in Field 1, taken on 14/03/19*

- Bring down the heights of all Stockpiles exceeding 4 metres.
- Increase separation distances so that they comply with Graph 1 of the FPMP guidance.

**Deadline:** 12 April 2019

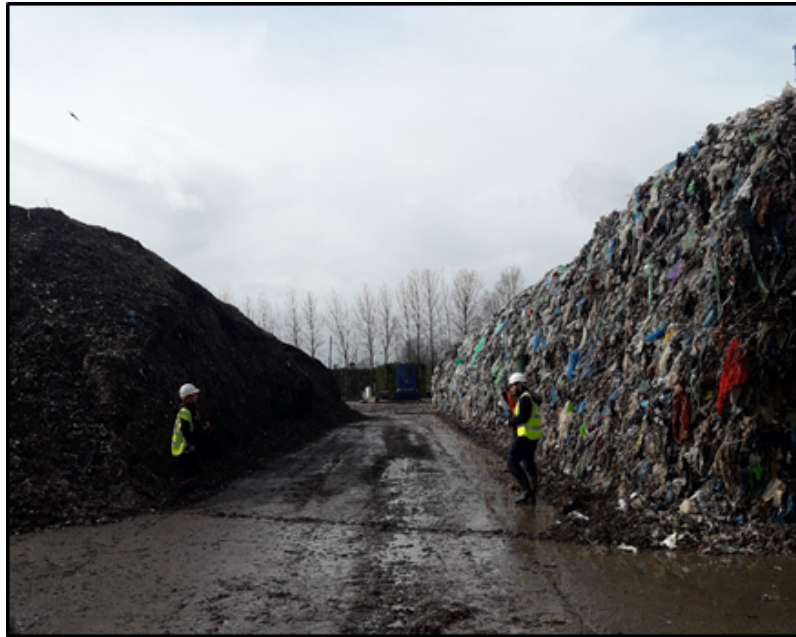
Although it was stated that the finer material (labelled Stockpile 12) was being temporarily stored and worked on, this still compromised the storage requirements.

- Between Stockpiles 1 and 2 - **10.8 m**
- Between Stockpile 2 and 12 (finer material) - **5.9m**
- Between Stockpiles 1 and 6 - **10.4m**
- Between Stockpiles 6 and 7 - **12.2m**
- Between Stockpiles 4 and 5 - **6m**

*Picture 2 – showing an inadequate separation distance between Stockpile 2 and 12, taken on 14/03/19*

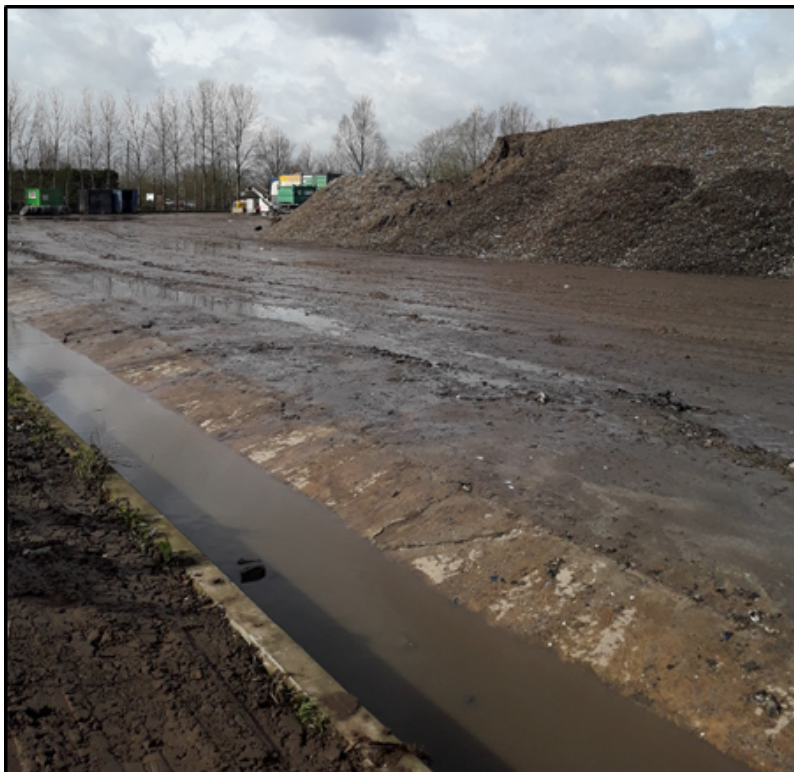
It was noted that there was more material present on Field 1 than previous visits in 2018. This was said to be because there were no RDF stockpiles stored in the Transfer Station area. Officers questioned whether the allocated Quarantine area would be able to comply with the FPMP separation distances.

As previously stated to the business, the designated Quarantine area must have the capacity to store 50% of the volume of the largest waste pile, to allow ability to manoeuvre and pull away sections for isolation. Although the quarantine area can be dynamic due to stacks not being permanent fixtures, the area should be clearly labelled on the site plan in the office. This is so that all staff are clearly aware of the use of the area and can react quickly in the event of an incident.

*Picture 3 – showing the designated quarantine area in Field 1, taken on 14/03/19*

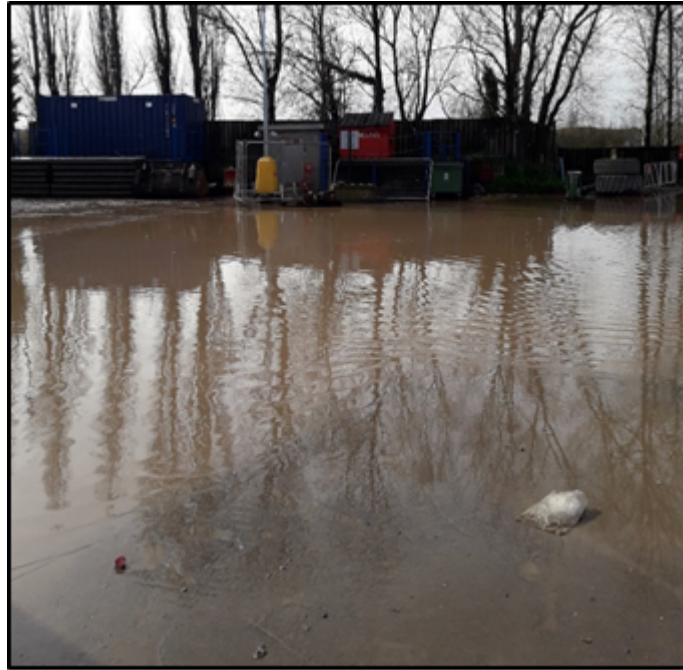
Due to periods of heavy rainfall prior to the visit, there was large amounts of water pooling in the Transfer Station area and parts of Field 1 between waste stacks. Officers were told that there are regular clean outs of the channels and pathways that connect the drainage system. This is vital to ensure that that the system is functioning efficiently to be able to handle large volumes of water. It was stated that the

interceptor was last maintained in July 2018.

*Picture 4 – showing pooling water in the Transfer Station, taken on 14/03/19*

Wear and tear of the infrastructure flooring is expected with the heavy operations on site, however it is important to recognise when the surface is in need of repair. This is to ensure the surface is constantly fully impermeable and that everything is captured by the sealed drainage system. Please endeavour to restore any weakened surface to its impermeable status when damaged.
