# TIR JOHN (PHASE 2) LANDFILL

Annual Monitoring Review January - December 2021

Report No. 14-K6065-ENV-R009

March 2022

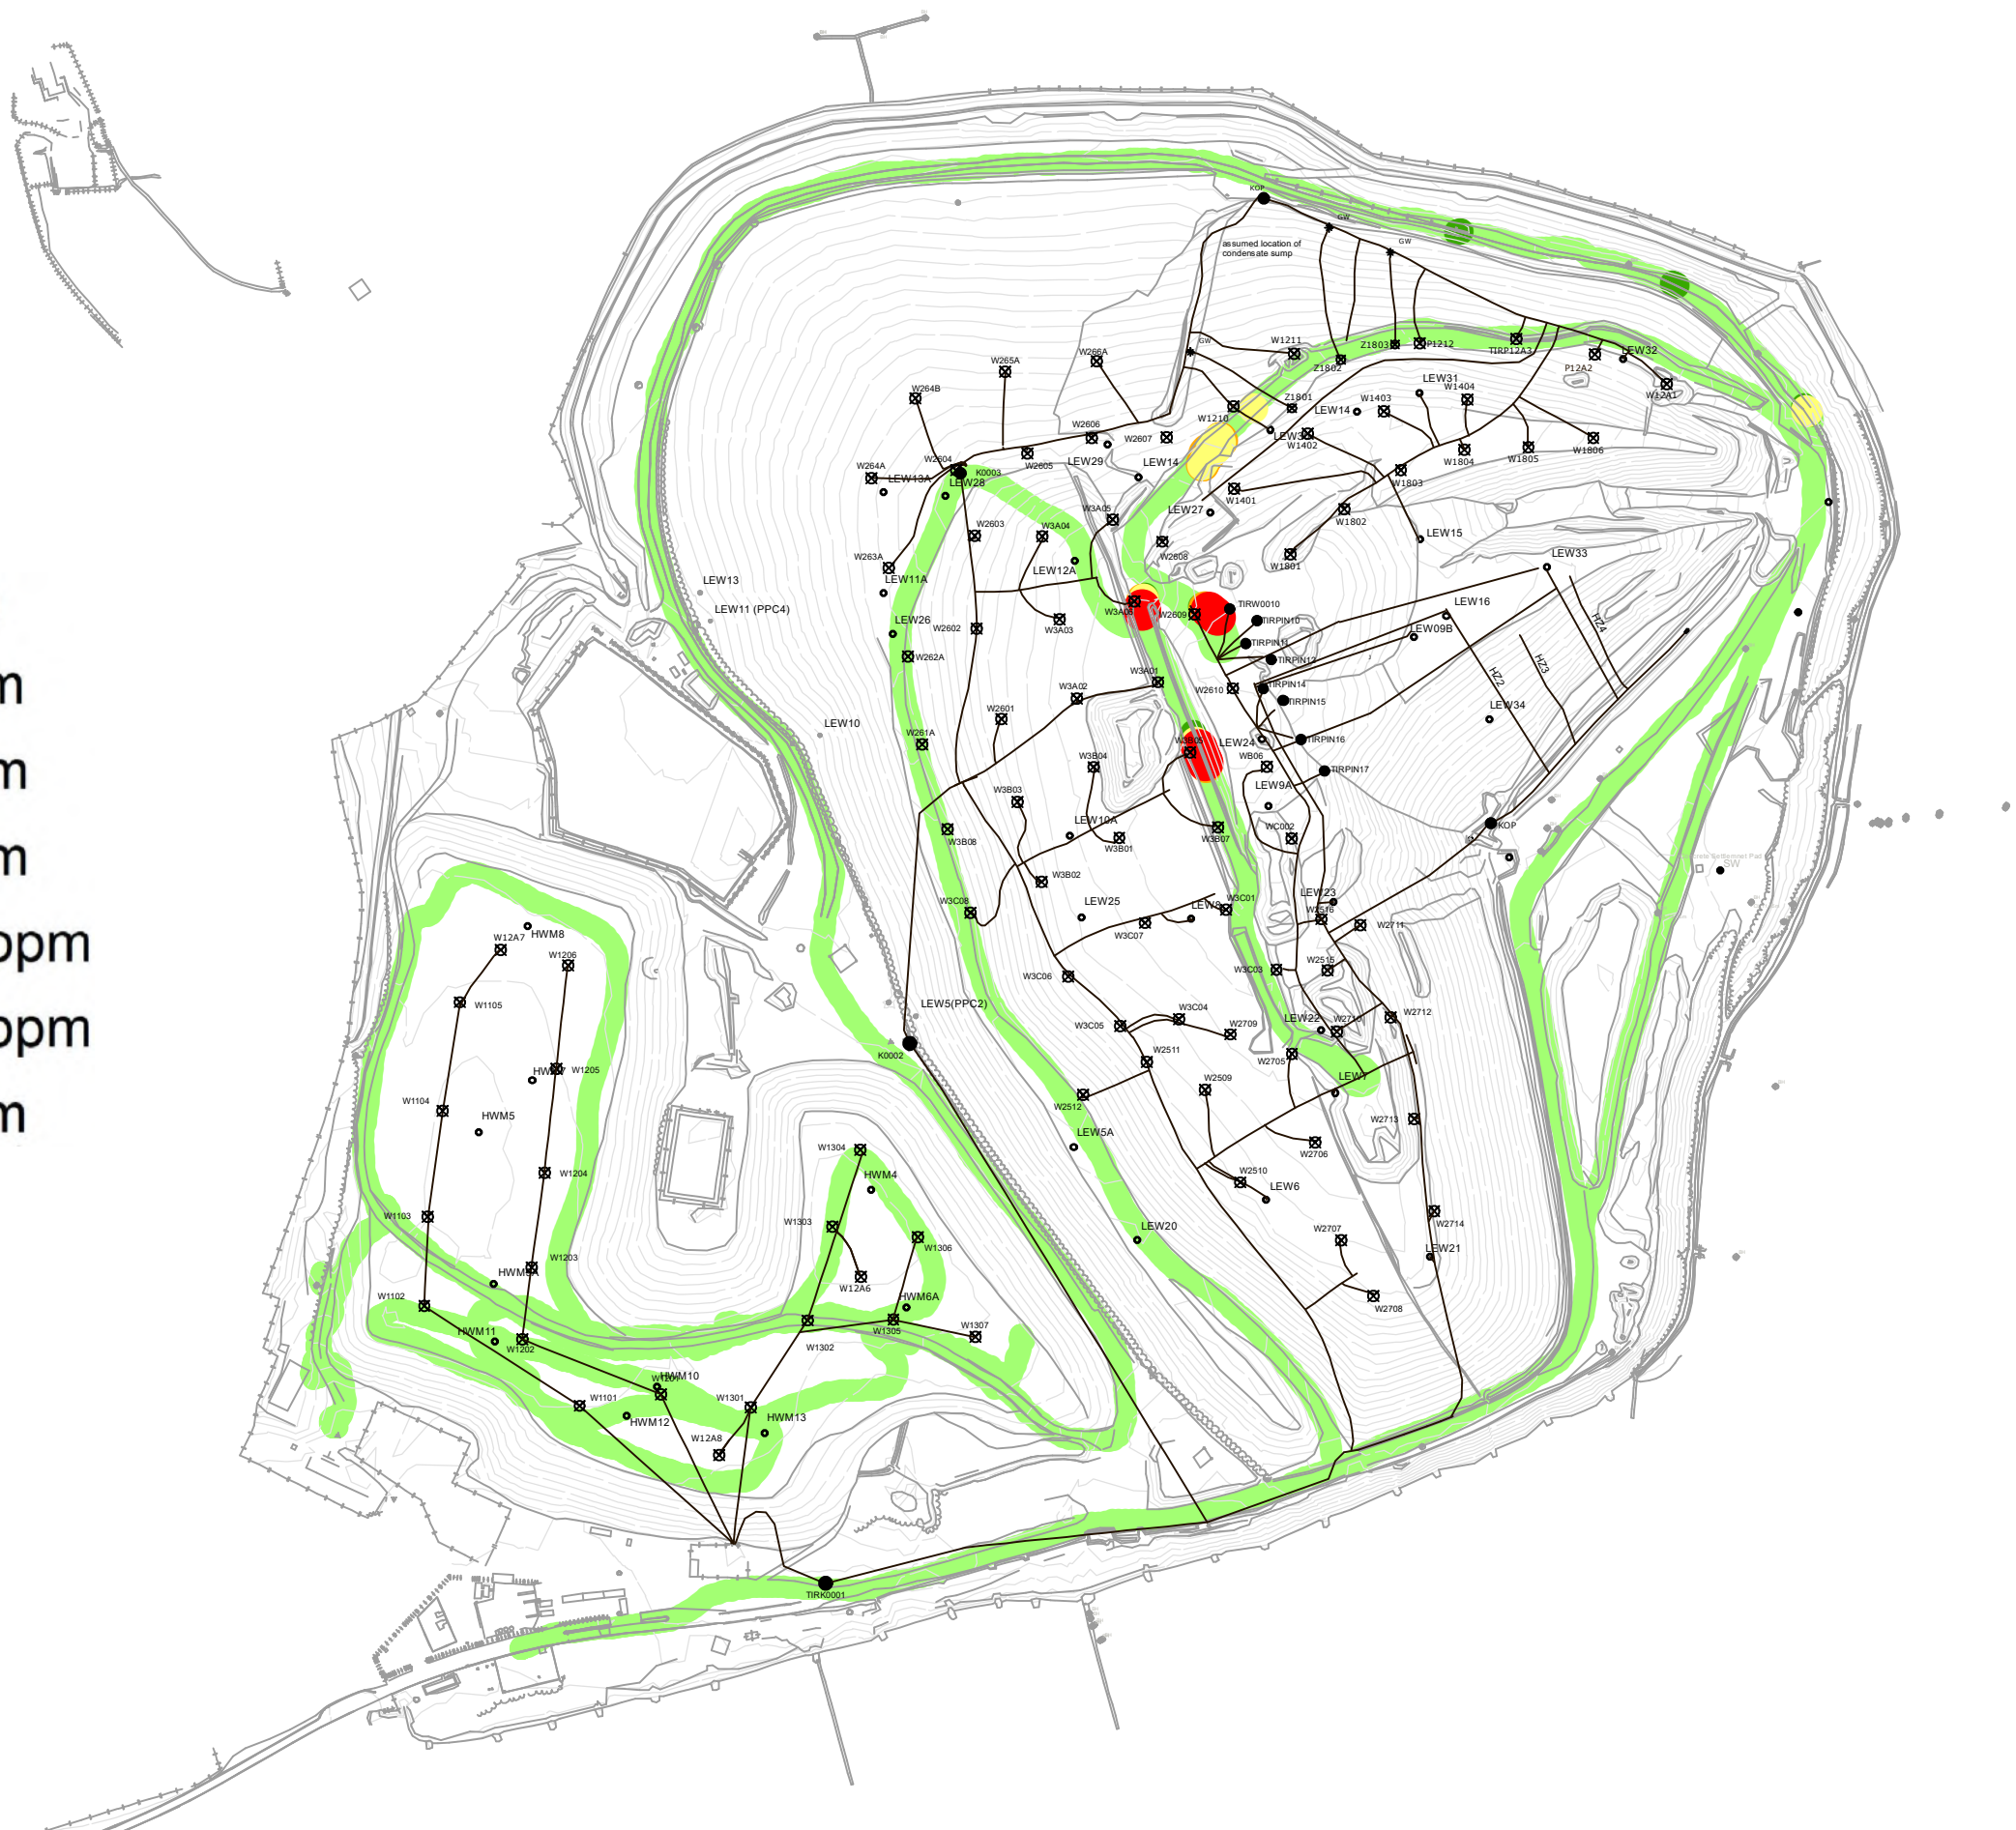
| TIR JOHN | | |
|---|---|---|
| Drawing number:<br><b>TJ66</b> | | |

- Key**
- Permit Boundary
  - Settlement Calculation Location
  - 5m contour line
  - 1m contour line
