SEIONT BRICKWORKS AND QUARRY

Waste Recovery Plan

JONES BROS RUTHIN CO LTD

Rev.2 MAY 2018

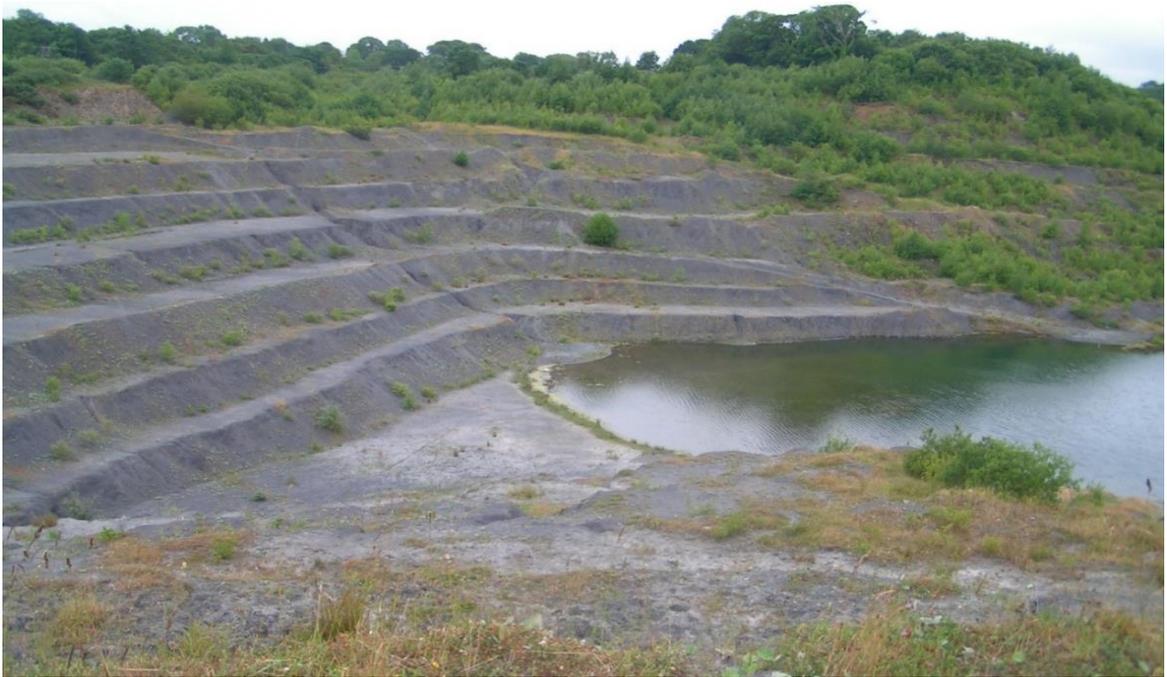
Figure 4.1: 10-year-old benches in the south face of the quarry. The foreground vegetation is a mix of annual and perennial herbaceous plants growing on bare, weathered overburden, while growth on the benches (left) only occurs in accumulated wash-off from the steep slopes. The background slopes to the right have been formed without benches and are developing woodland cover on very old weathered clay and overburden. The trees on the upper quarry slopes are on overburdens that have been exposed to weathering for in excess of 16 years.

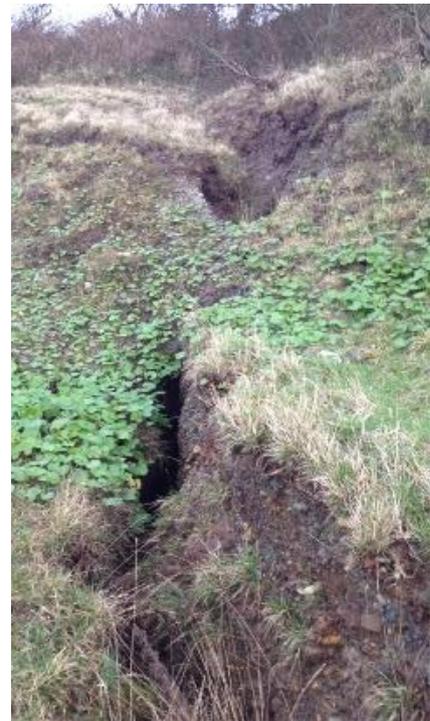
Figure 4.2: Tension crack on the eastern slopes of the quarry

Taken in February 2016, this photograph illustrates the tension cracking which results from movement of unstable material. These cracks are now serving as cut-off drains collecting surface water. This water is able to percolate deeper into the slope.

4.3.1 Evidence of instability today is visible on the surface across the east and north east side of the quarry (see Figure 4.2). Anecdotal evidence is available that the instability was recognised and reported to the mineral planning authority as part of the 2000 ‘Review of Old Planning Permissions’ (ROMP) submission for the site³. The geological study of the quarry (carried out by Geoplan Ltd), also raised concerns about groundwater and ground conditions on the same slopes. Dr Ken Addison⁴, a geologist with the RIGS Group, has reported being on site and observing a landslip occur. He explained that these events seemed to occur when quarrying exposed lenses of liquefying clay in the excavated face which become more mobile in wet conditions, this process is known as liquefaction.

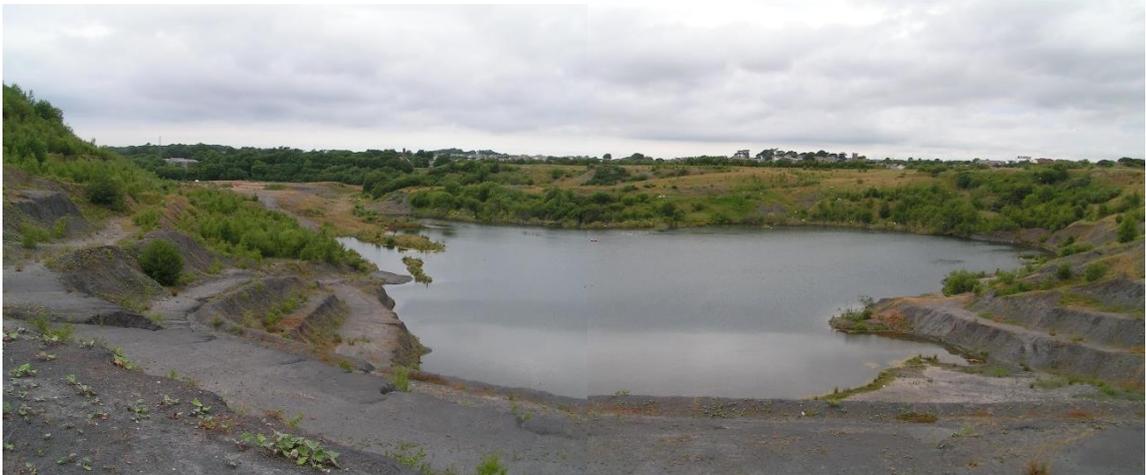
Figure 4.4: the flooded sump around 12 metres deep with steeply-shelving sides

4.4.1 The quarry is deep void in the side of Pen y bryn Hill with sides that drop steeply into the flooded sump, which is now a pool of deep water with steeply shelving margins which presents a hazard to people who venture into the cold water or fall in accidentally. The 2.12-hectare body of water is over 12 metres deep with steeply shelving banks formed by the flooded benches. The waterbody has formed since pumping ceased around 2008. While there is no formal public access to the quarry, it is clear that the members of the
