## Compliance Assessment Report

Report ID:  
CAR\_NRW0026832

| Site | Clwyd Breakers Ltd | Permit Ref | NP3290VM | | | |
| Assessment type | Site Inspection | | | | | |

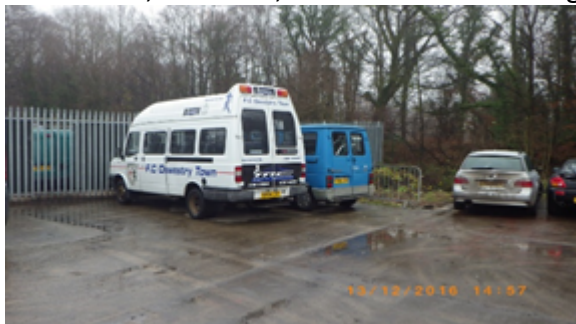
Photo 1

The first vehicle was a blue van (see Photo 1). This was observed in the same location during the last site inspection on the 7<sup>th</sup> November 2016. The blue van was observed, on both occasions, to be full of car parts. During the inspection on the 7<sup>th</sup> November 2016 we were informed that this van was not waste and was due to be sold as a van. During this site inspection we were informed that the blue van belonged to an employee who was currently on holiday but that it would be moved when they returned.

**All effort now needs to be taken to ensure that all waste outside the permitted area is removed and that no more waste is ever found outside the permitted area again. Ensuring this should be regarded as a priority. Enforcement action is already being considered for previous permit breaches of this nature and we will now have to consider if any further action may be required.**

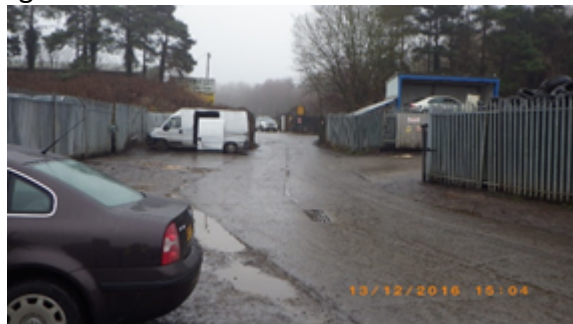
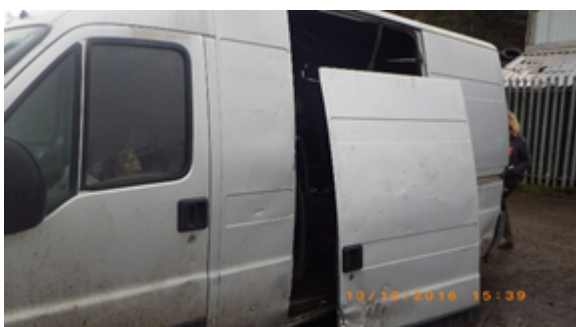
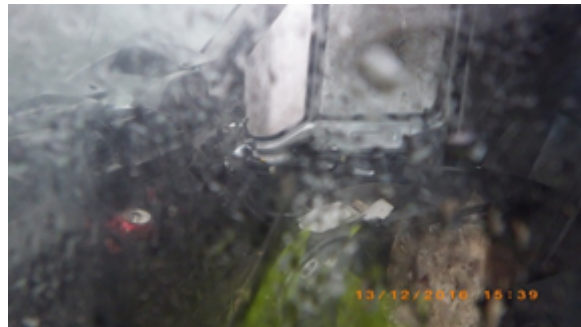
Photo 2

Photos 2, 3 and 4 show a grey van parked opposite the gate to area B. We were informed that this van belonged to Clwyd Breakers and had been SORNed but was not regarded as waste. It was waiting to be repaired. However, we believe it to be waste due to its condition and the manner in which it was being stored/used. It was observed that the side door was not attached, headlights had been removed from the vehicle and when we looked inside the cab of the van the steering wheel had been removed. We also saw that the van had been filled with vehicle parts both in the rear section and some in the cab of the van. As a result this van is regarded as waste and as an undepolluted ELV it should be stored within the permitted area on an impermeable surface with sealed drainage.

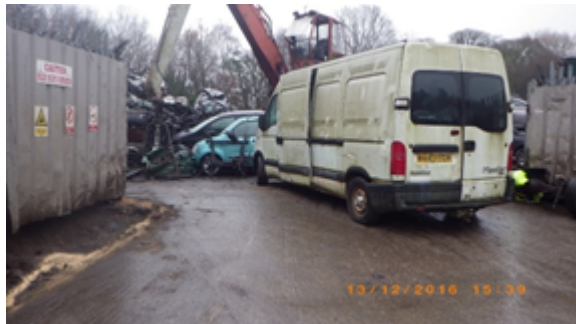
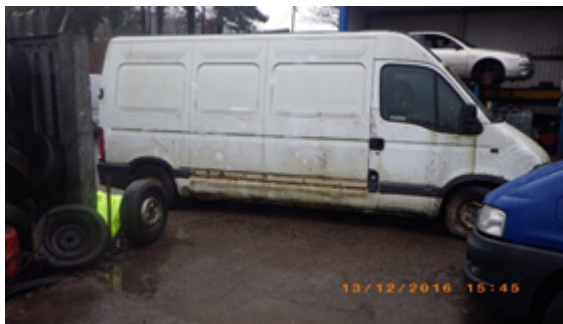
Photo 4

Photos 5 and 6 show another van that had been left half in and half out of area B of the permitted area. This van was also full of car parts. We were informed that this van had only recently been received at the site and that the car parts had been inside the van when it was received. All waste ELVs and waste accepted by the site needs to be stored completely within the permitted area. The van was also stored in an area that is of some concern to us as the gradient of that part of the site suggests that any surface water would drain off site to a surface water drain. This means we would not consider this part of area B to have sealed drainage.

Despite no undepolluted ELVs being found within area A, it should be pointed out that the white van shown in photos 5 and 6 above was not being stored in an area with sealed drainage. This could therefore be regarded as a breach. As the inappropriate storage of this ELV has been scored under criteria A1 no further breach will be applied for this on this occasion. However, in future you will need to carefully ensure that all undepolluted ELVs are stored in a location which is both impermeable and has sealed

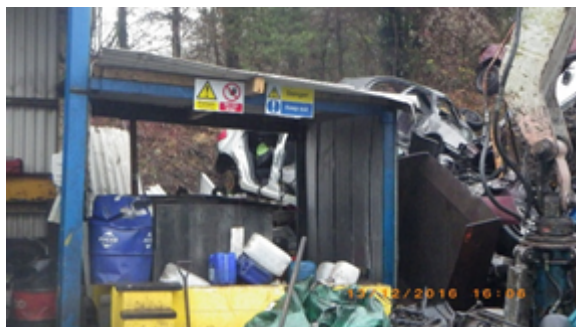
Photo 7 shows what seems to be ELVs overflowing out of the site and onto the large earth bund that runs along the northern boundary of area B, behind the bunded area. We were informed that these ELVs should have been fully depolluted. This earth bund is outside the permitted area. Photo 8 also shows what appears to be waste tyres behind the depollution building also on the earth bund outside the permitted area. No waste accepted by Clwyd Breakers Ltd should be stored outside the permitted area.

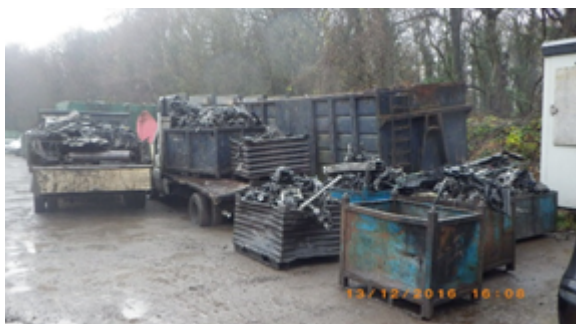
#### Photo 9

Photo 9 shows a number of containers stored on the car park to the north of Clwyd Breakers boundary and alongside Haywards. All these containers contained oily car parts which had come from Clwyd Breakers Ltd. We were informed that these oily parts had been transferred to Jeremy Wells. Mr Wells was apparently sorting through the oily parts before taking them to Haywards. During a conversation with Mr Wells we were told that these metal parts were being stored in this location until he could take them to Haywards. There did not seem to be any record of waste transfer notes to show that this waste had changed hands. If there are any waste transfer notes these would need to be completed at the time the waste changed hands. As we cannot be certain the waste has changed ownership we must consider it to still belong to Clwyd Breakers and that it is being stored outside the permitted area. If this is not the case we will need to see some evidence, i.e. valid waste transfer notes for all waste sent to Mr Wells.

Following a search of our public register we have not been able to find any record of a waste carrier registration under the name of Jeremy Wells. In order for Mr Wells to transfer waste from one permitted site to another he should be a registered waste carrier. He would also need to have an environmental permit to store and treat car parts, especially if they have been contaminated with oil. You need to ensure that any waste that leaves your site goes via a registered waste carrier or is sent to suitable permitted waste site. Failure to carry out these basic duty of care checks can be regarded as an offence.

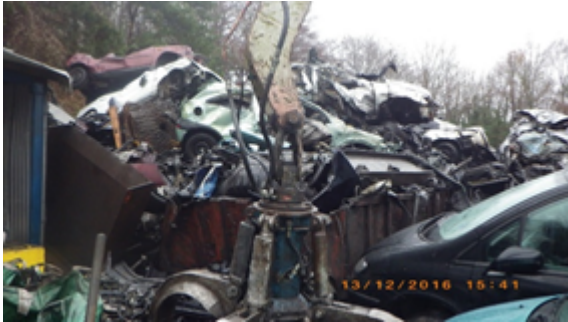
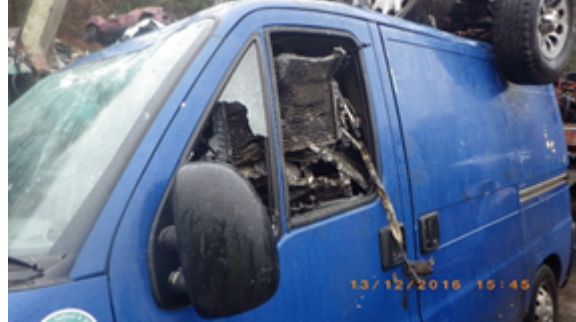
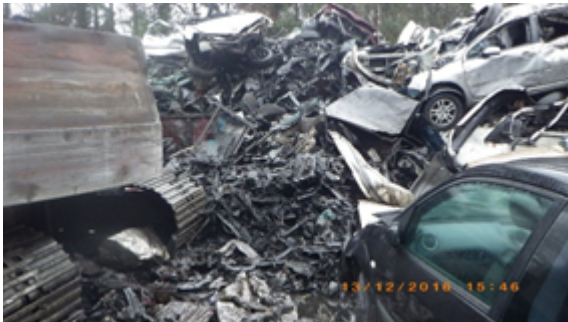
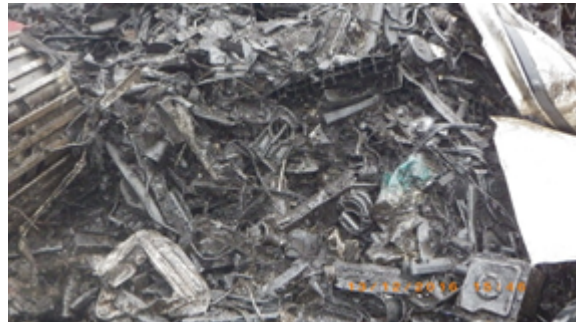
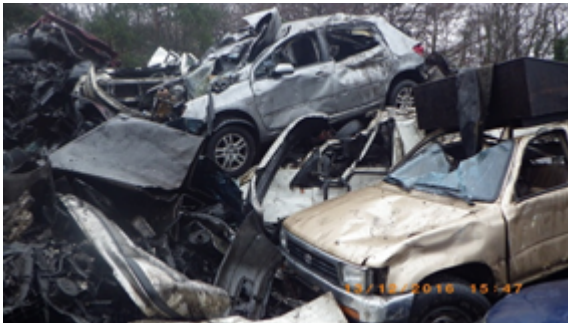
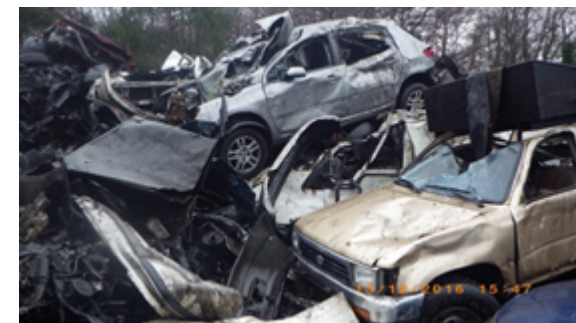
The Environment Management System (Version 2, dated 22<sup>nd</sup> September 2016) in section 4.6(d) states “salvaged engines and other parts will be stored on the racking or in designated containers”. This breach has been observed and scored as a Cat 3 on the last two inspections (19/08/2016 and 07/11/2016). On both those and this occasion it was observed that many car parts (and cars) were both scattered over area B and piled up in a large mound where the old baler used to be located. It was also observed that car parts were being stored inside waste vehicles. See Photos 10 to 15.

The mound of waste car parts did look to have decreased in height since the last inspection and we were informed on site that effort had been made in the last couple of weeks to try and reduce the amount of waste. We were informed that staff had been working very hard sorting through the waste pile to try and reduce the quantities. The task, however, has taken longer than expected. As a result there was still a large amount of waste on the site. We were told that the waste car parts etc were being sent to I Haywards Ltd. Haywards need to be wary of the level of oil contamination on these car parts. If the oil contamination is too high, as I would consider likely from my observations, then these car parts should be regarded as hazardous waste. This would mean that you would need to ensure that they are sent to a suitably permitted site (i.e. one that can accept oil contaminated parts) and that the waste is accompanied

As the parts are still not being stored on racking or in designated containers and oily parts were still lying on the ground or in a mound a CCS Cat 3 breach has been applied.

How long it would take to clean up all these parts was discussed on site. Taking into account this conversation and the Christmas period between the inspection and the report form being issued **I would expect to see all car parts etc being stored appropriately by 28<sup>th</sup> February 2017**. Failure to have completed the clean up in this timeframe is likely to lead to further enforcement action. Waste transfer notes or hazardous waste consignment notes for all the waste sent off site need to be kept.

| Criteria Ref. | CCS Category | Action required/advised | Due Date |
|---|---|---|---|
| B4 | C3 | Parts must be stored on racking or in designated containers and oily parts should be stored in areas with sealed drainage and undercover | 28/02/2017 |

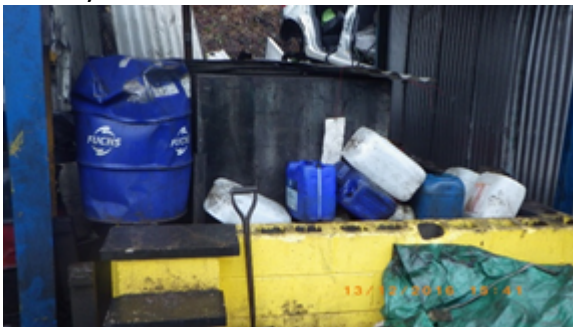
During the site inspection on the 19<sup>th</sup> August 2016 the bunded area was observed to have not been fully sealed. On the 7<sup>th</sup> November it was observed that work had been started to seal the bunded area and that around half of it had been done. We were informed at the time that the rest of the bund would be sealed either later that day or the following day and as the work had been started and was due to be completed imminently it was decided that we would not regard this as a breach on this occasion. However, during this site inspection we observed that no further work had been done to the bund since the last inspection, i.e. only half of it had been sealed.

We also observed liquid containers and an oil drum to be stored haphazardly within the bund. The oil drum had been placed on the wall of the bund and was not completely within it (see Photo 16 above). As the bund had not been sealed and liquid containers and a drum were being inappropriately stored a CCS Cat 3 breach has been applied. **We would expect to see the bund completely sealed and all potentially polluting liquids stored appropriately by the 28<sup>th</sup> February 2016.**

| Criteria Ref. | CCS Category | Action required/advised | Due Date |
|---|---|---|---|
| B4 | C3 | Bund wall needs to be sealed and all potentially polluting liquids need to be stored within secondary containment. | 28/02/2017 |

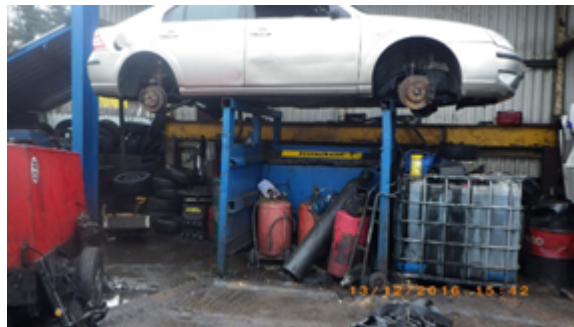
We were informed on site that all ELVs are depolluted within the depollution building (see Photo 17 above). We were told that any newly accepted ELV will be depolluted within the building following arrival at the site. The ELV is then stored either on area A or B and then once it is deemed to have no further value for parts etc and before the ELV is sent off site to I Haywards Ltd the ELV is returned to the depollution building to have the shock absorbers drained (if they haven't been removed) and to ensure the airbags have been deployed or removed. I was told that no ELVs are depolluted outside the depollution building.

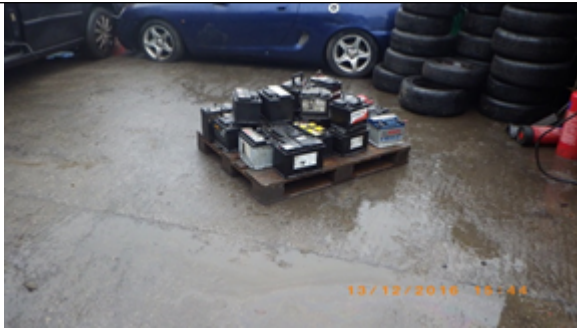
Photo 18

Storing car batteries on a pallet on the ground on area B is not considered to be appropriate (see Photo 18). These batteries should be stored within a sealed battery box with a lid on it. The oil interceptor that area B drains into is not capable of dealing with battery acids. As a result of not complying with the above condition a CCS Cat 3 breach has been applied. **You must ensure that any car batteries on site are stored according to the permit as soon as possible and certainly no later than by the 28<sup>th</sup> February 2016.**

| Criteria Ref. | CCS Category | Action required/advised | Due Date |
|---|---|---|---|
| C4 | C3 | Ensure batteries are stored in a sealed battery box and that the box remains covered. | 28/02/2017 |
