## Compliance Assessment Report

**Report ID:**  
**CAR\_NRW0026631**

| Site | Clwyd Breakers Ltd | Permit Ref | NP3290VM | | | |
| Assessment type | Site Inspection | | | | | |

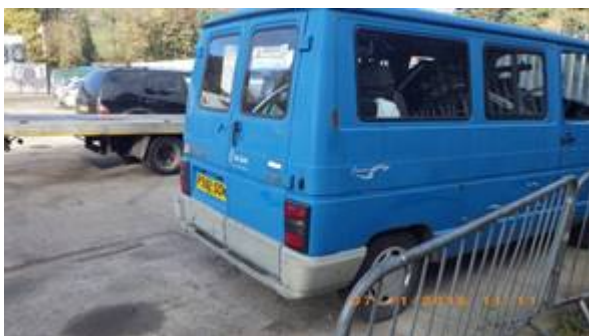
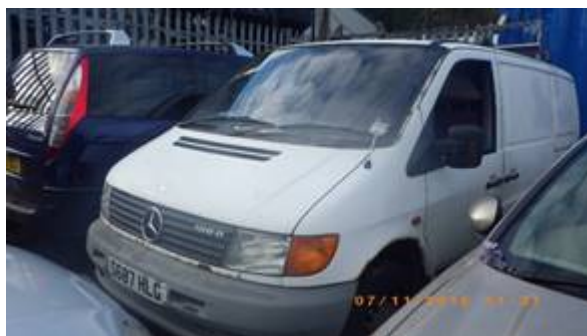
A couple of vans were observed outside the permitted area that we suspected may be waste vehicles (see photos 1 and 2). However, when we asked it was explained that these vans were not waste and had been sold as vans. In order to make the distinction clear I would recommend that vehicles that have been sold are either stored in a designated area or labelled in some manner. You should also try to ensure you have any relevant paperwork available (i.e. who the vans have been sold to and receipts etc) so that it can be checked if needed. None of the other vehicles parked outside the permitted area had the appearance of a waste vehicle.

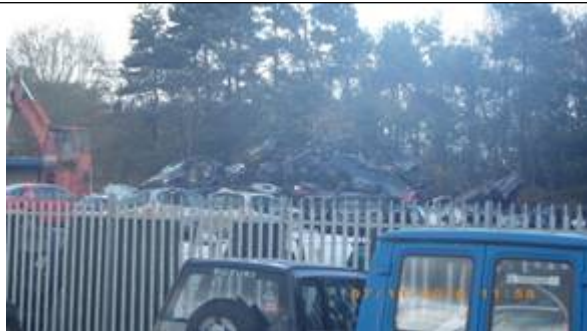
Some concerns were raised due the lack of space in area B for receiving any new ELVs onto site. Space within area B was very limited and it was observed that ELVs had been stacked on top of each other and on top of the large pile of scrap metal (see photo 3) just to make what space there was. When I asked if the site was still accepting new ELVs onto site I was informed that they had stopped until some order had been re-established. However, as we left we did observe a truck delivering a new ELV to site. This ELV was being offloaded outside the permitted area along the boundary fence. How ELVs are brought onto and left on site needs to be reviewed to ensure they are not left outside the permitted area. The lack of space was discussed on site and we were told that the plan is to remove much of the waste on area B and create some dedicated fenced off space to store incoming waste ELVs.

4.6 (d) states that “Salvaged engines and other parts will be stored on the racking or in designated containers”. Like during the last inspection in August 2016 it was observed that there were many car parts (and cars) either scattered all over area B or piled up in a large mound where the old baler used to be located (see Photo 3 above).

**All parts should be stored either on racking or in designated containers.** Leaving oily parts lying on the ground or in a large mound will lead to oily runoff and has probably contributed to much of the oily residue on the concrete ground. It is also regarded as untidy and bad practice. **All parts must be stored**

**appropriately by the next site inspection on the 13<sup>th</sup> December 2016.**

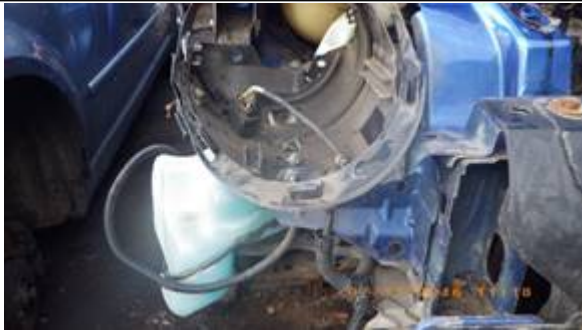
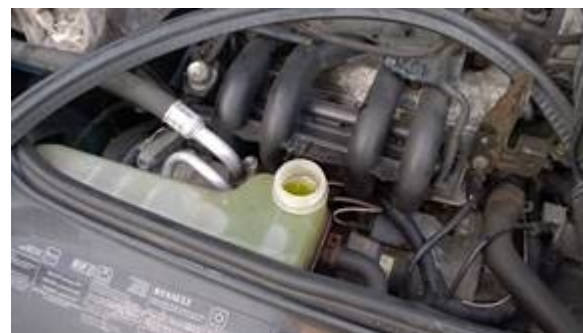
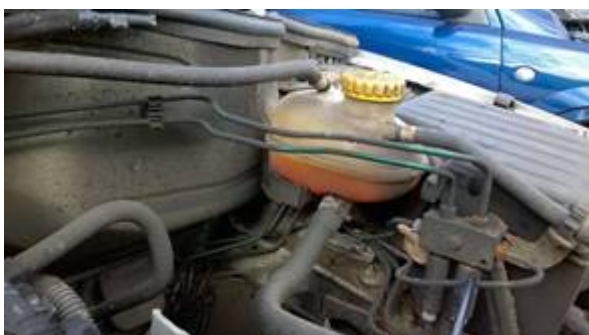
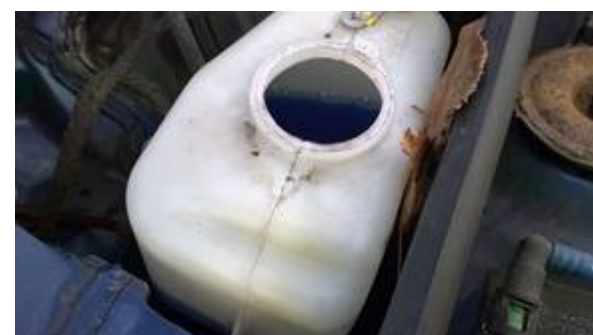
Photos 4, 9, 10 and 11 show reservoirs that still contain potentially polluting liquids such as screenwash, coolant and gearbox oil/power steering fluid. Photo 8 shows a dipstick that is covered in oil. This demonstrated that the car the dipstick was taken from still contained engine oil. Finally photos 5, 6 and 7 show that oil filters still present in the waste cars.

Whilst an attempt has been made to depollute the ELVs it is still a concern that such a significant number of cars within area A have not been fully depolluted and for this reason the breach is deemed a CCS Cat 2. **I would expect all ELVs within area A to be fully depolluted at the time of my next inspection on the 13<sup>th</sup> December 2016.**

The issues were highlighted on site and we were informed that the ELVs in area A would be checked again to ensure they have all been depolluted. It is advised that all staff that depollute ELVs read the relevant guidance to ensure they are aware of everything that needs to be done to ensure ELVs are fully depolluted.

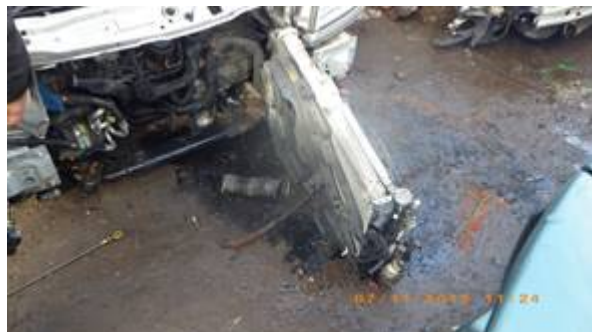
Photo 12

During the inspection the oil spill shown in photo 12 below was observed. The location of this incident was on area A which is not an impermeable surface with sealed drainage and as a consequence the oil spill will have soaked into the ground. The spill suggests that the engine oil came from the part dismantled ELV. It also suggests that this ELV may not have been fully depolluted. At the time of the inspection no action had been taken to clean up this spill. The spill was highlighted to a member of staff as Neil and Joanne Bennett had not accompanied us on that part of the inspection. Due to the quantity of oil that has been spilt it is likely that this area of ground will need to be dug up and the oil contaminated soil disposed of to an appropriately permitted site. This breach has been deemed a CCS Cat 3 on this occasion.

**It is very important that all appropriate action is taken to both prevent further emissions and to tidy up any spills that have occurred. This action should be taken immediately. If customers are unaccompanied on site then staff need to undertake regular site inspections to ensure that incidents of this nature are dealt with as soon as possible.**

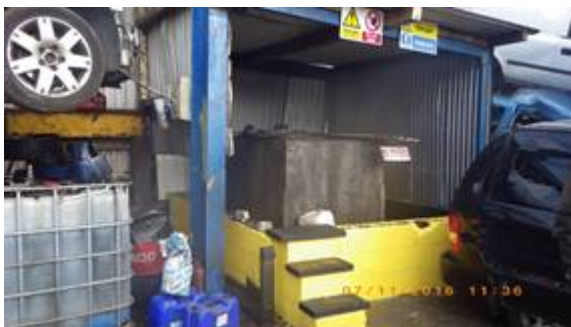
Photo 13

Since the last inspection the bunded area has been fixed (see Photo 13). The roof has been re-erected and the brickwork has been painted. A closer inspection of the bunded area showed that only half of the internal wall had been sealed. The work had temporarily stopped to allow time for part of the bund to dry out before the final part of the sealing works was completed. I was informed that the remaining half was due to be sealed either later in the day or the following day. Whilst this work was being carried out some of the liquid containers were being stored outside the bunded area on the impermeable surface. Care was being taken to ensure these did not leak or spill.

- Complete the continuing competency test by 31<sup>st</sup> December 2016 or arrange cover by a suitably qualified person.
- Ensure that the bunded area has been fully sealed by the 13<sup>th</sup> December 2016.
