**GEOTECHNICAL &
GEO- ENVIRONMENTAL REPORT
PROPOSED ANAEROBIC DIGESTER
CRUGMORE FARM
PENPARC
CARDIGAN**

**Prepared for:
Syrus Energy Limited**

July 2013

Job No: 12226B

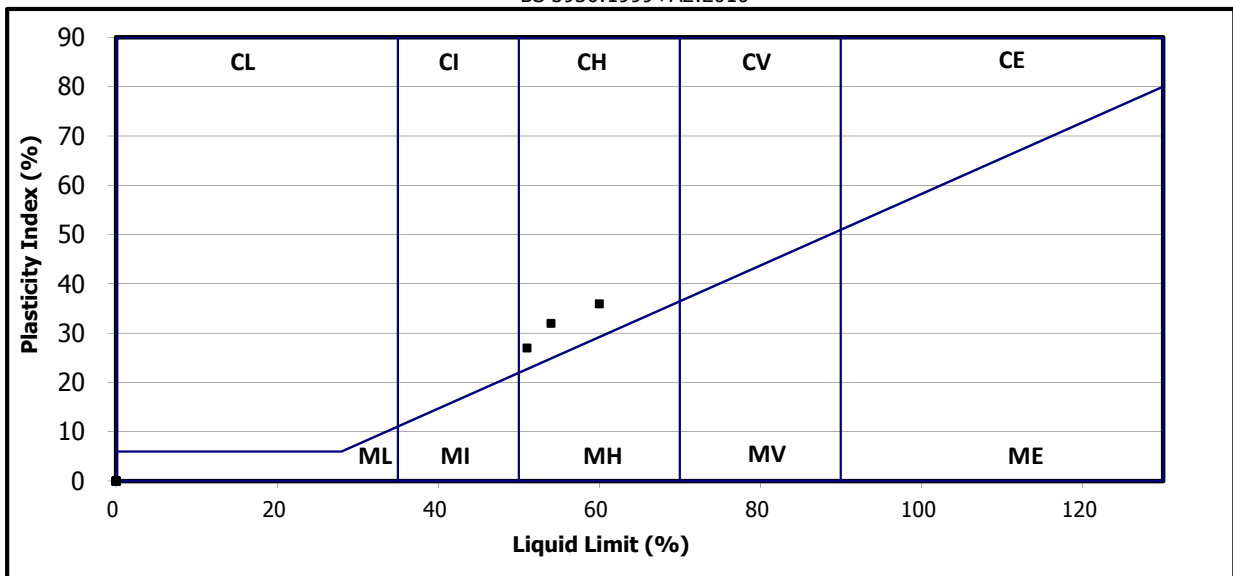
BS 5930:1999+A2:2010

Symbols: NP : Non Plastic # : Liquid Limit and Plastic Limit Wet Sieved
PLASTICITY CHART FOR CASAGRANDE CLASSIFICATION.
