GEOENVIRONMENTAL DESK STUDY REPORT

The Airfields Deeside

Reference	MT/DS/4671.v1
Date	July 2014
Version	1

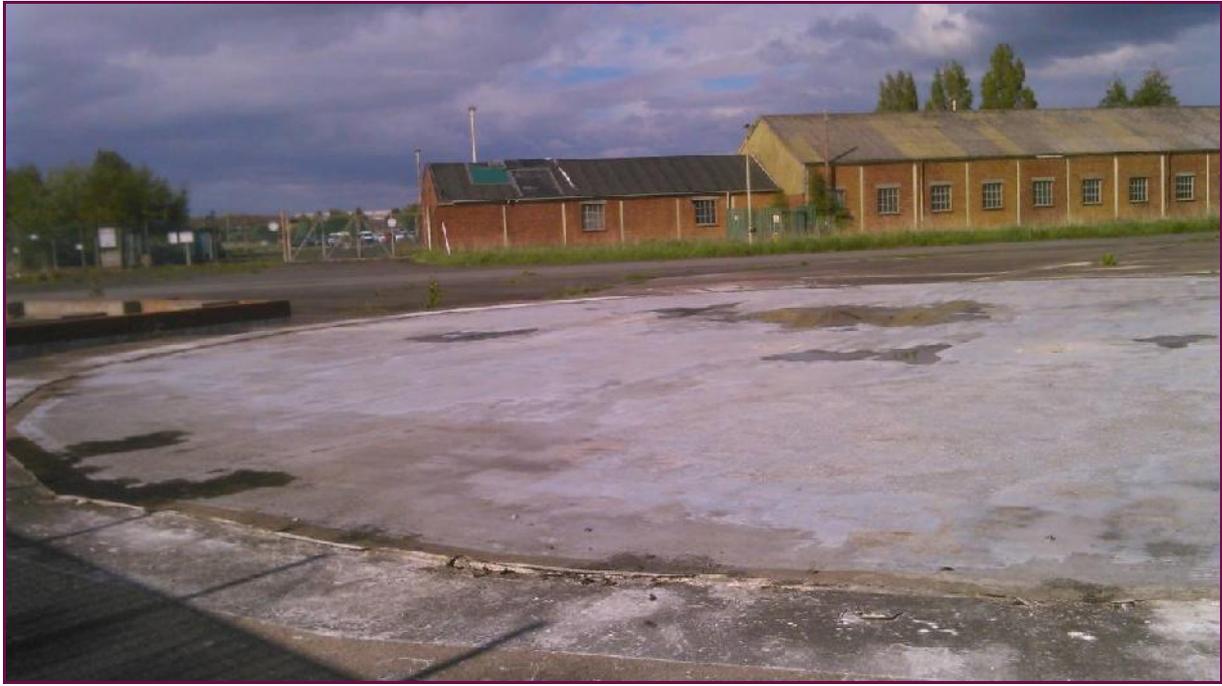
Photograph 7: View north across Radome foundation.

A large concrete foundation was identified at the position of building unit 296, of which photographs are included in Appendix A. A search of documents retained on site was carried out and this was identified to be the location of the T93 Radome. This was a radar facility used by the airfield. The surface mechanical and electrical equipment has been removed, leaving the concrete foundations in place. The design drawings indicate that the thickness of the concrete foundation was typically 250mm. For further details of the T93 Radome, reference should be made to the design and installation documents which are held on site. An electronic copy of relevant documents has been created for the project archive.

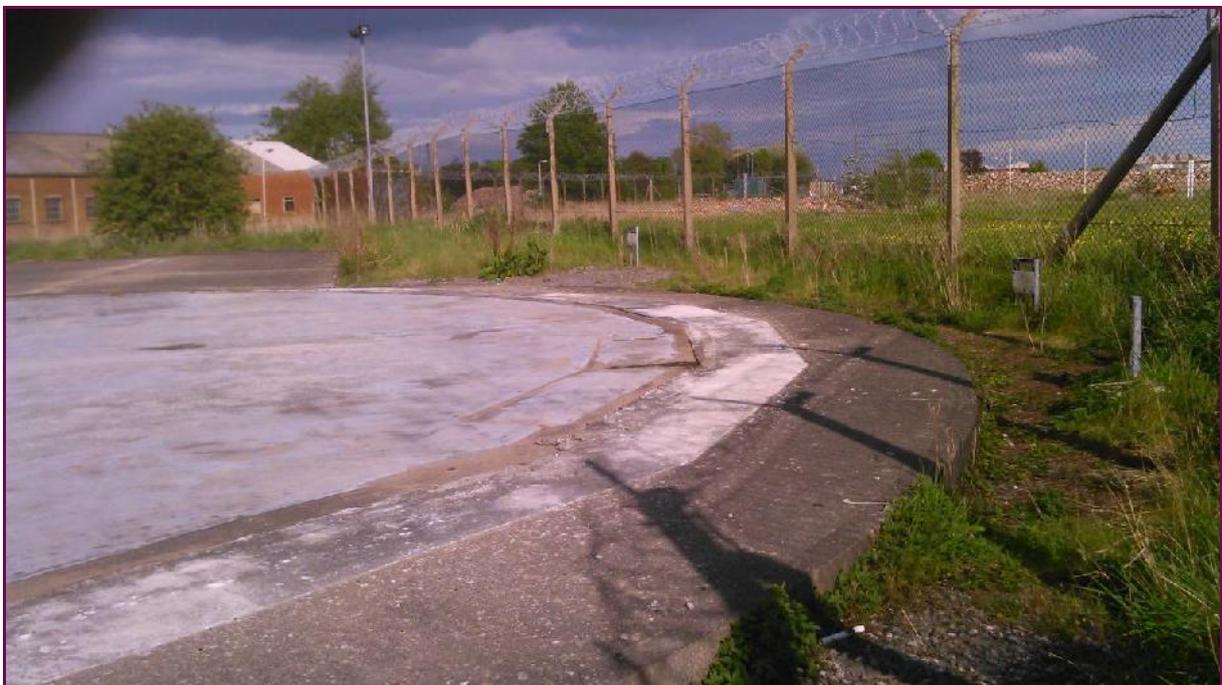
Photograph 8: View east across Radome foundation.

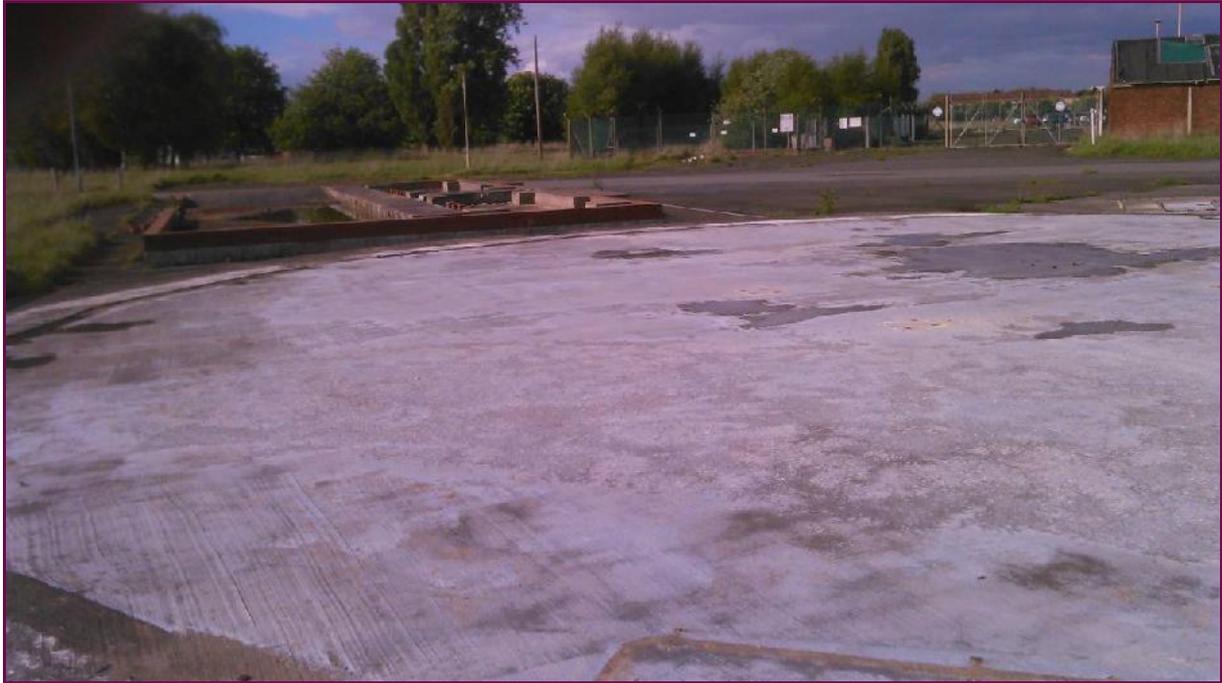
Photograph 9: View west across Radome foundation.
