## **GEOENVIRONMENTAL GROUND INVESTIGATION**

### **The Airfields Deeside Plots B & C**

**MHP/GI/4671.v1**

**December 2018**

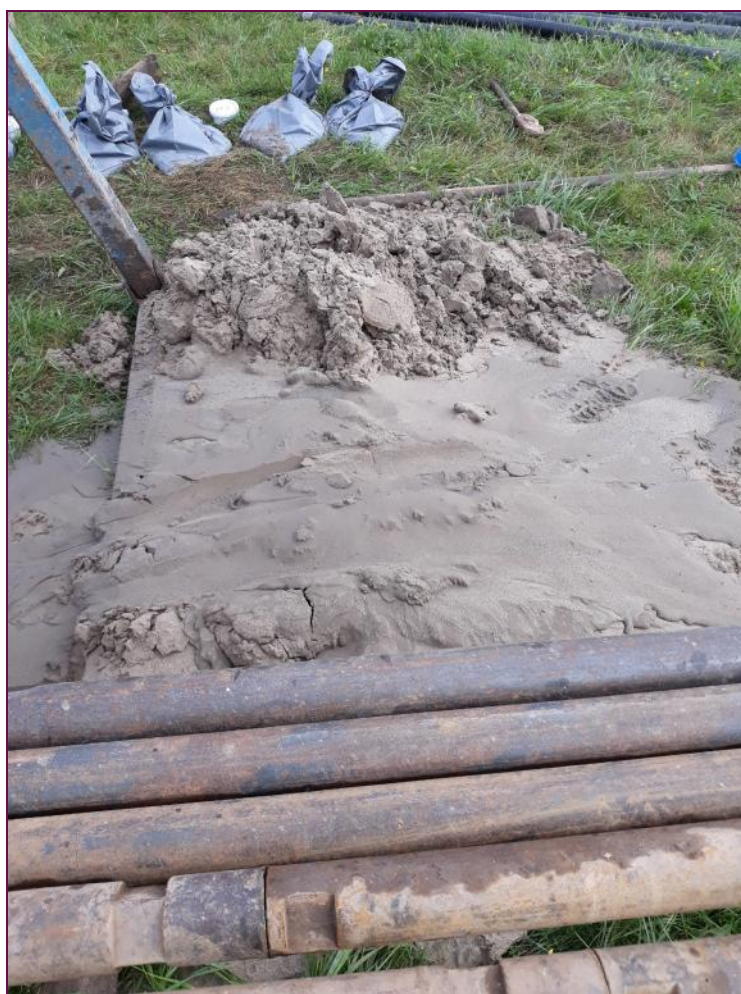
**Photograph 2: CP206, general view of sand drilling returns.**

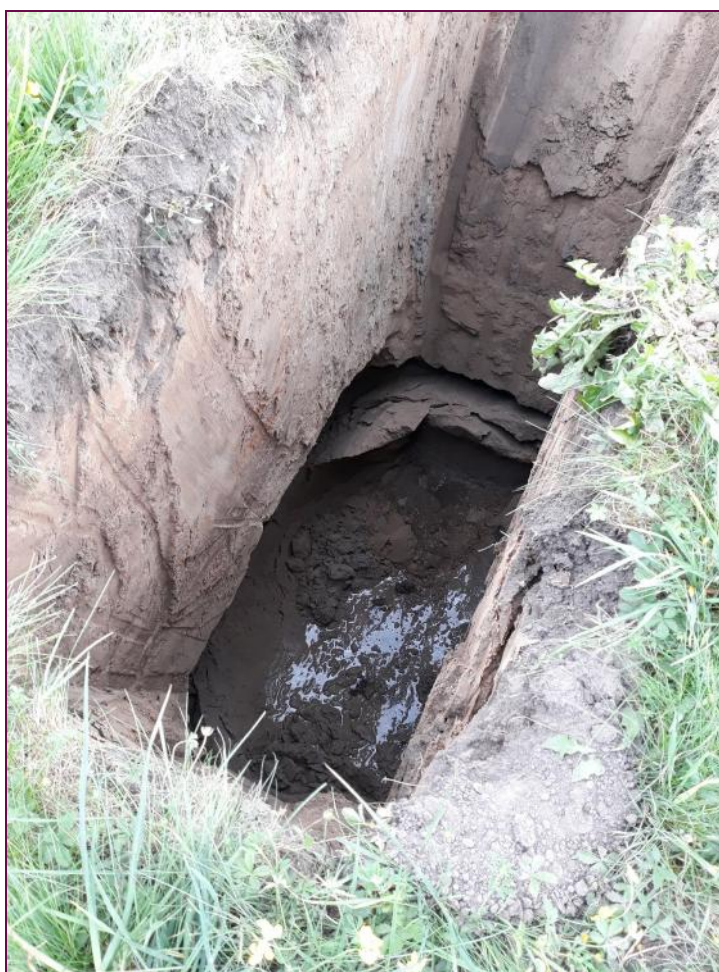
**Photograph 8: TP225, water ingress at the base of the pit.**

During the investigation, groundwater was encountered in 33 of the 35 trial pits and all six borehole locations. Groundwater seepages were noted within trial pits at depths of between 1.80m and 3.10m bgl. All trial pits terminated due to instability, often due to water ingress.
