## REMEDIAL STRATEGY REPORT

### Plots B & C The Airfields Deeside

<b>Reference</b>	<b>4671-JPG-XX-XX-RP-G-0608-S2-P01</b>
<b>Date</b>	<b>March 2019</b>
<b>Author</b>	<b>MHP</b>

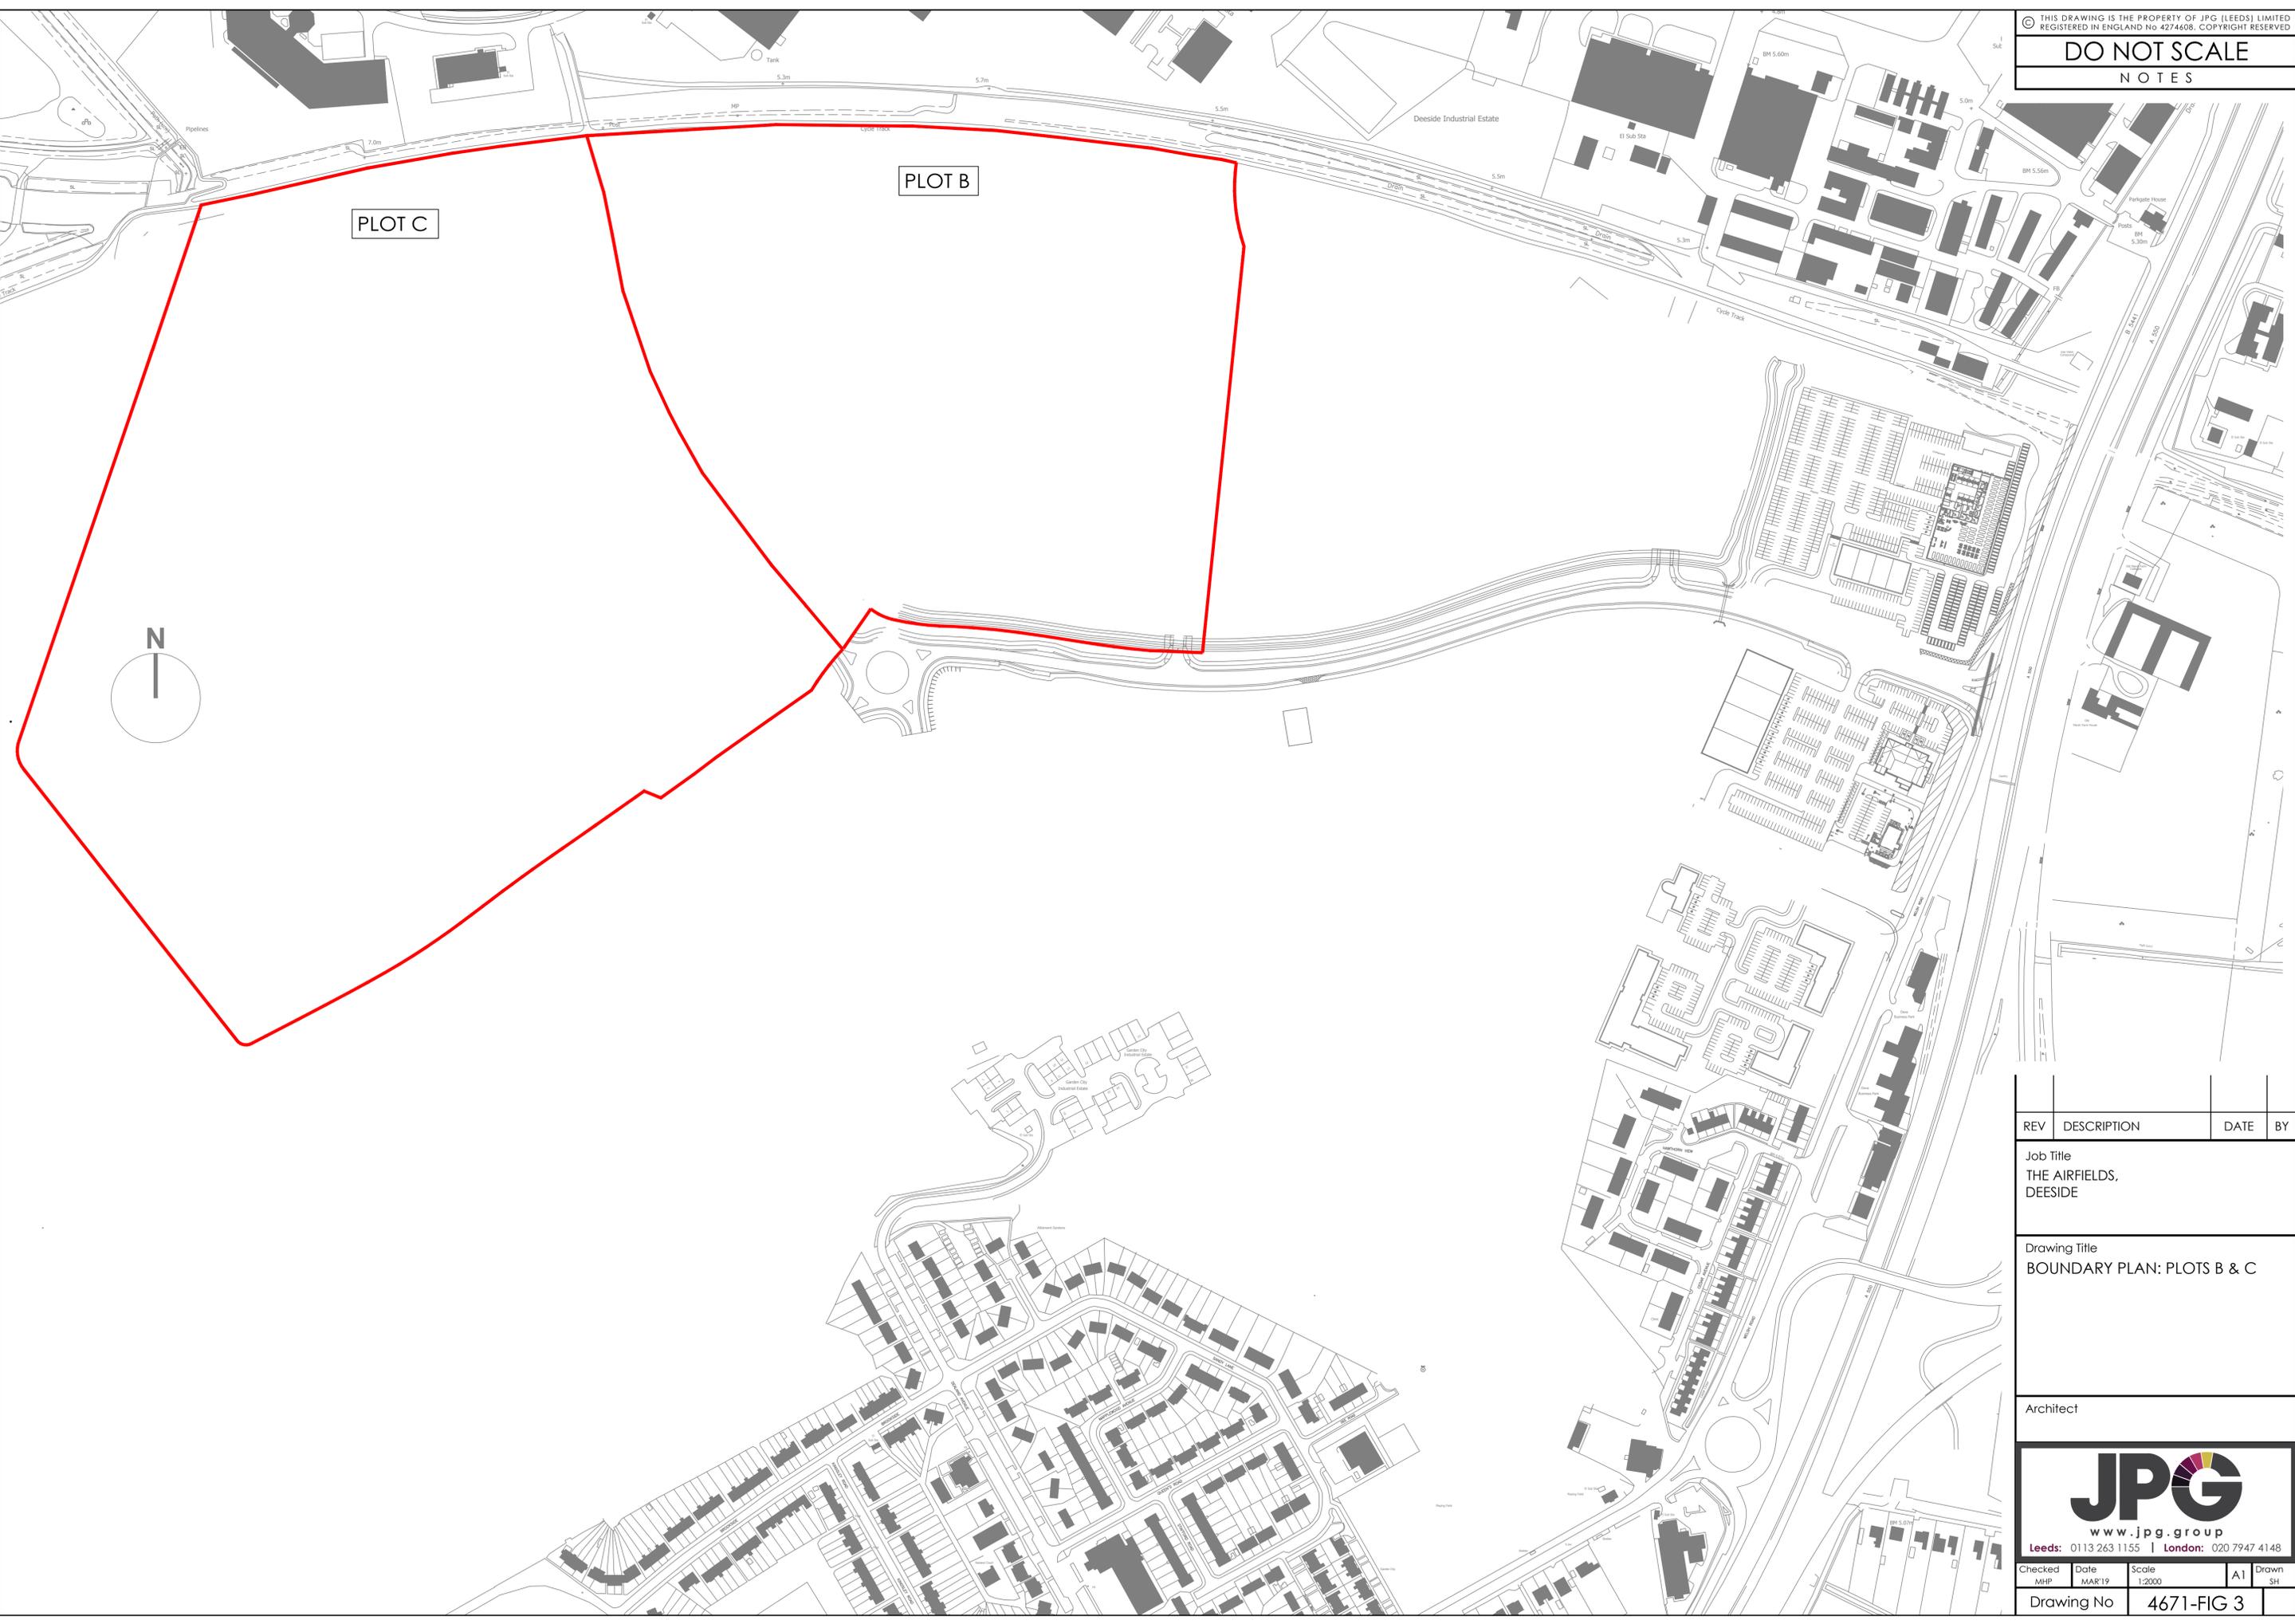
Drawing Title  
 BOUNDARY PLAN: PLOTS B & C

JPG (Leeds) Ltd. The Airfields, Deeside. Boundary Plan: Plots B & C. Drawing No. 4671-FIG 3. March 2019.

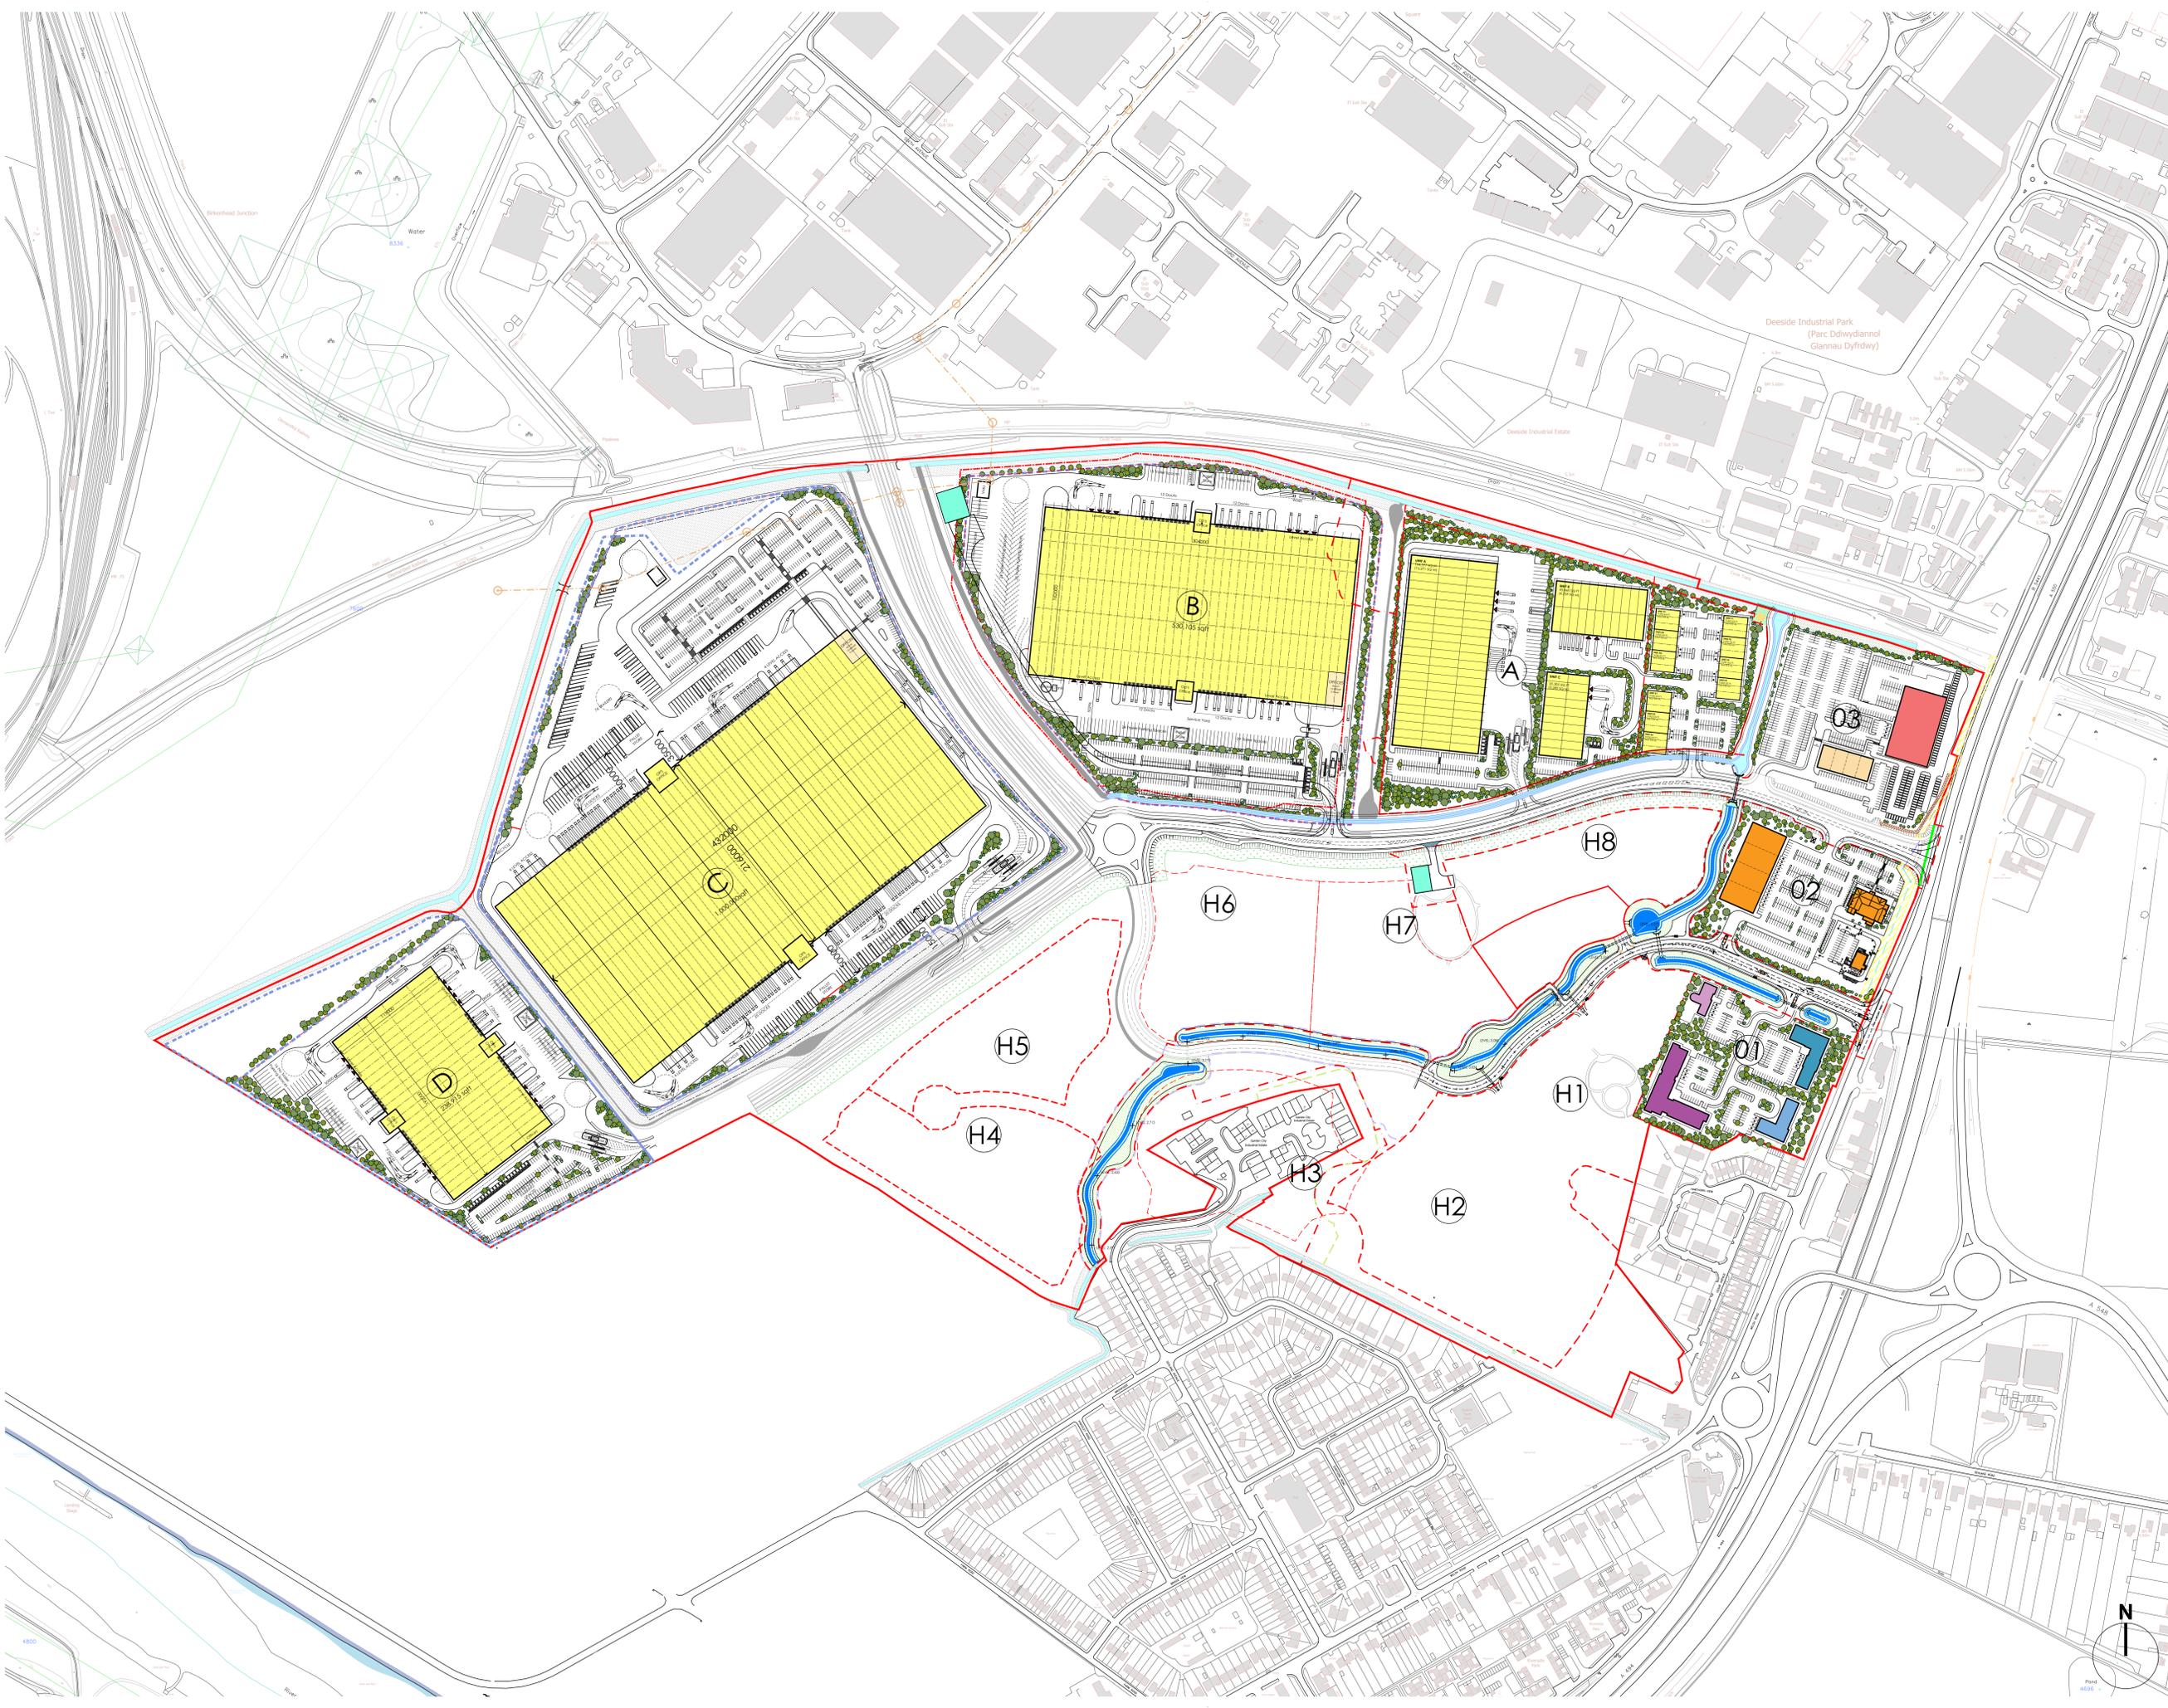
Project THE AIRFIELDS, DEESIDE  
 Drawing Description PROPOSED MASTERPLAN  
 Drawing No. 13001\_SK116 Rev. L

The proposed commercial development comprises two large commercial units with associated parking, landscaping and roads. An electricity substation is proposed in the centre of the site.

- J) Fletcher Rae. June 2017. The Airfields, Deeside. Proposed Masterplan. Drawing no. 13001\_SK116. Rev L.

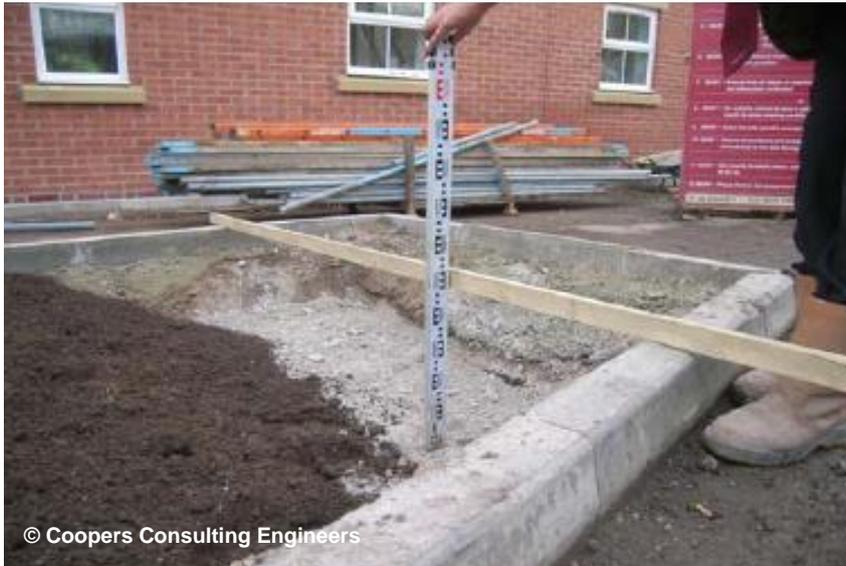
Photograph 1: Depth check of inert cover within area of public open space. Physical break layer and topsoil visible.

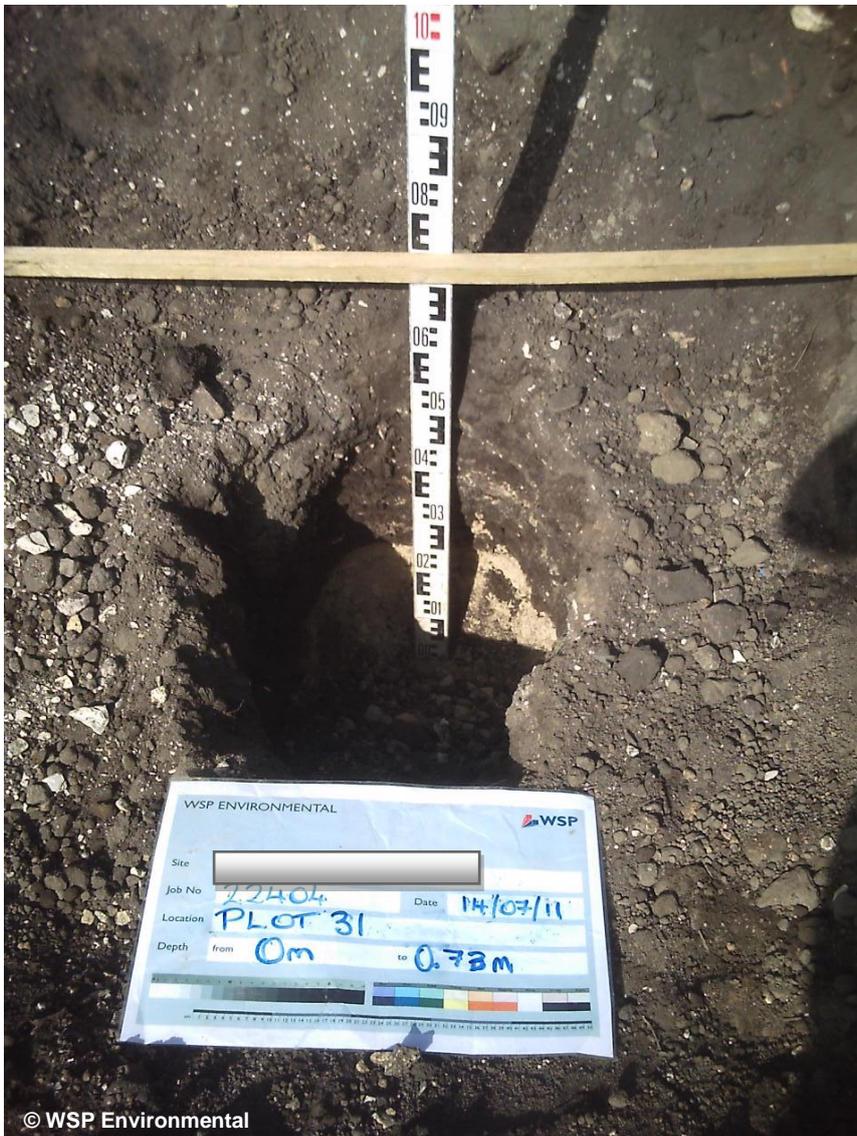
Photograph 2: Depth check of inert cover with Site & Location Information Board.

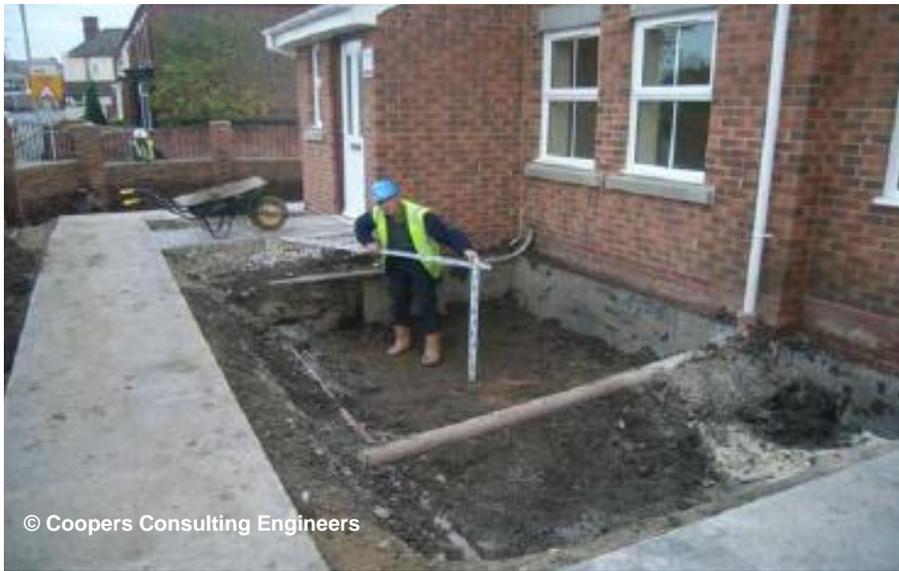
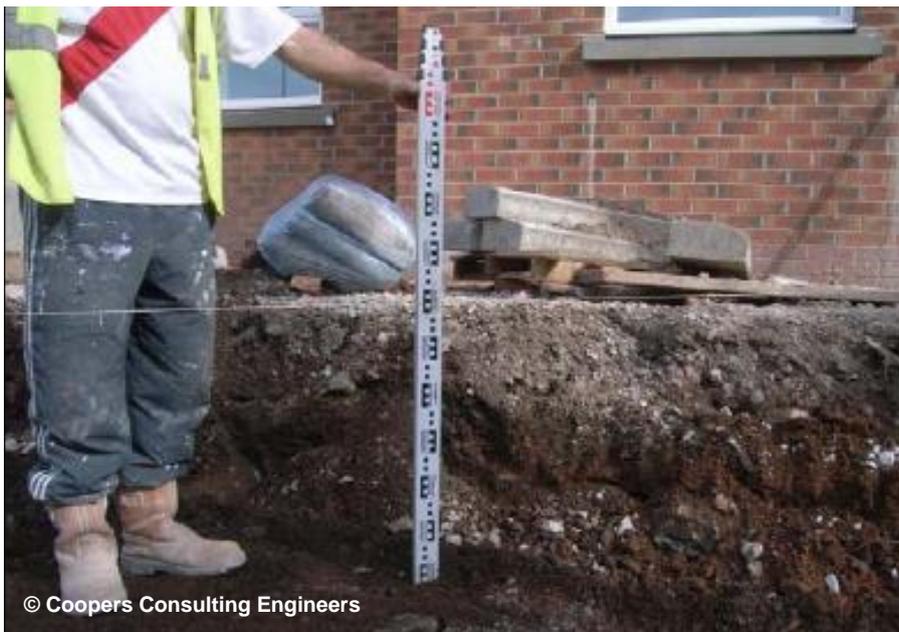
Photographs 3 & 4:  
Depth check of inert  
cover within areas of  
front gardens.

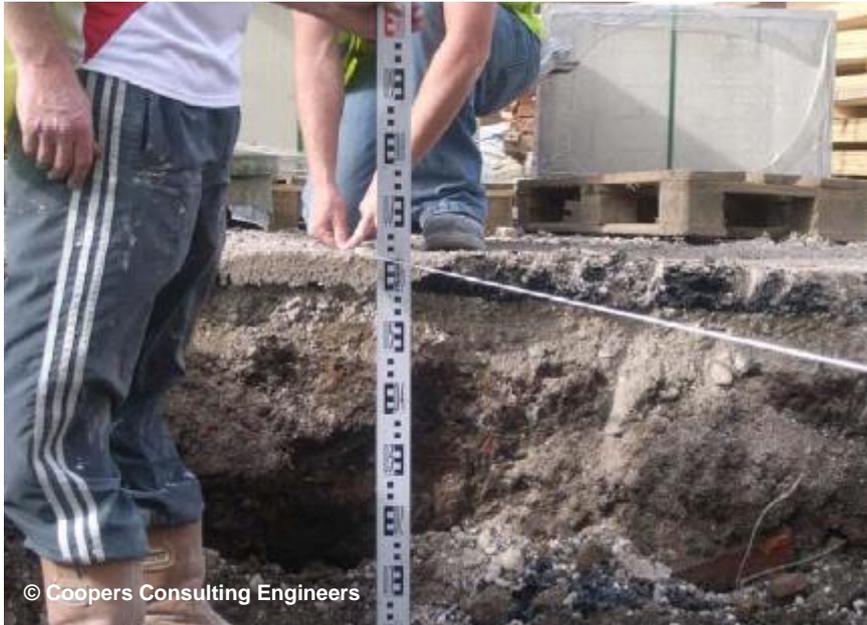
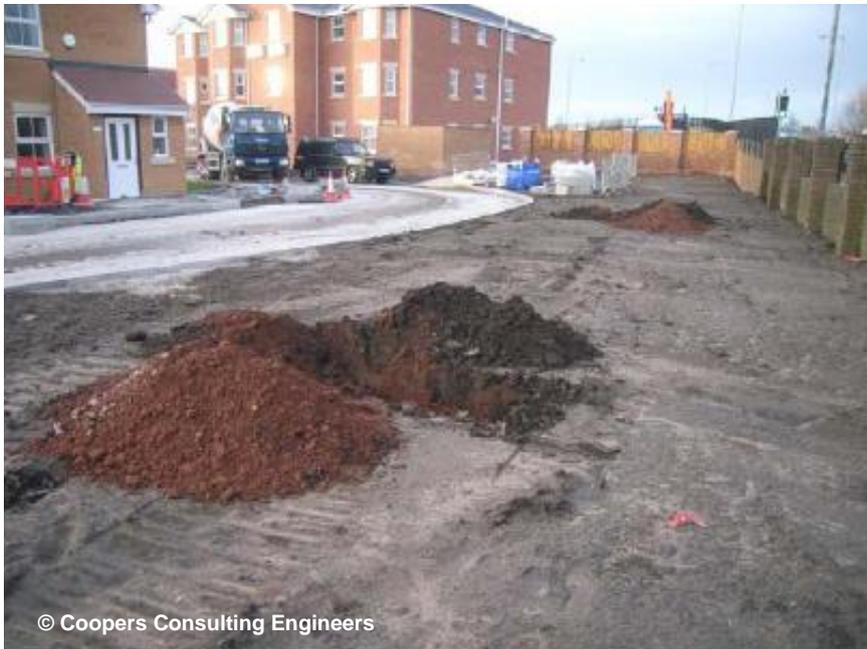
Photographs 5 and 6: Depth check of inert cover within rear gardens. Taut string line spans across excavation.

Photograph 7 shows the spatial location of the verification pit.

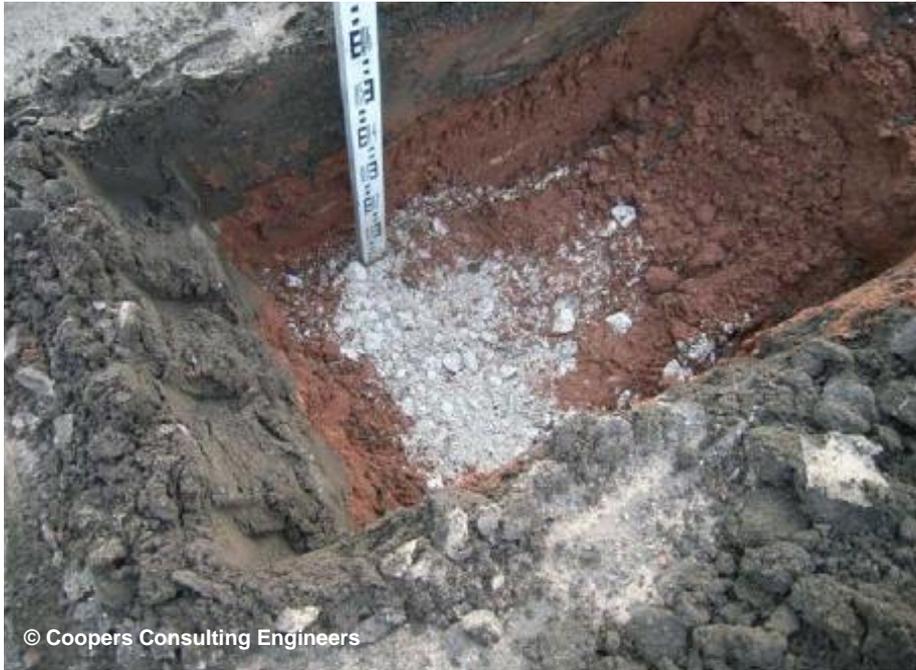
Photograph 8:  
Excavation within public open space and verification pit showing the presence of a remediation break layer at the base, a crushed sandstone inert fill overlain by topsoil.

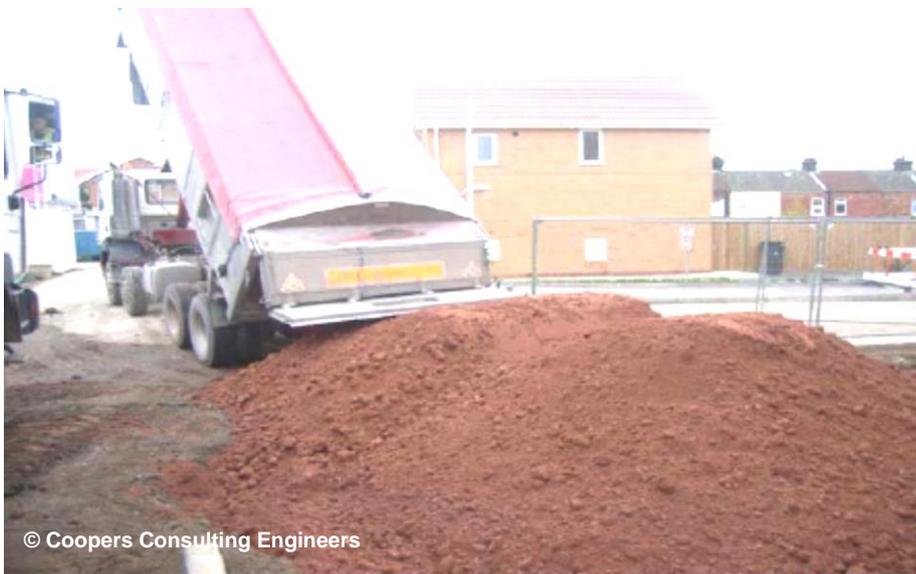
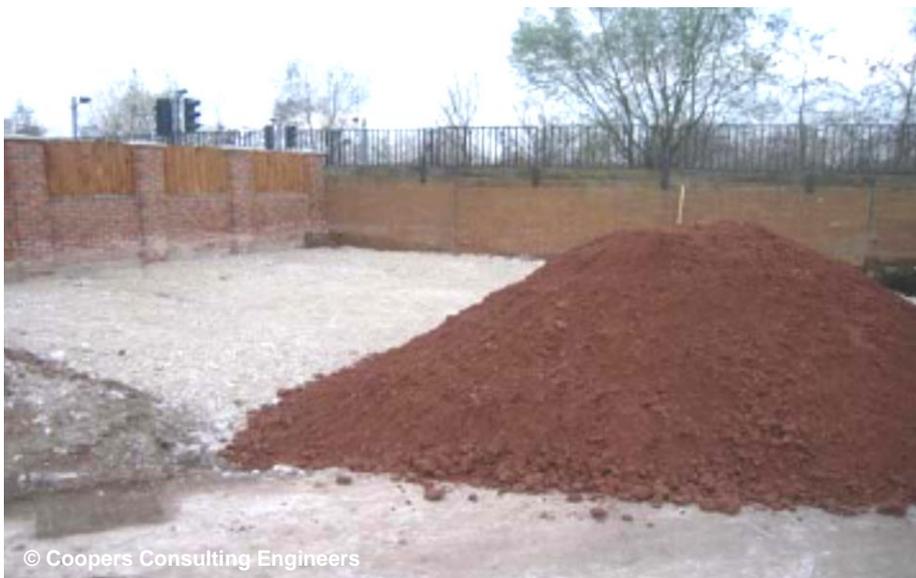
Photographs 9 and 10: Inert crushed sandstone being delivered with remediation break layer visible in Photograph 10. The spatial area of the remediation can be observed from these photographs (old terrace housing in Photograph 9 and traffic lights in photograph 10).

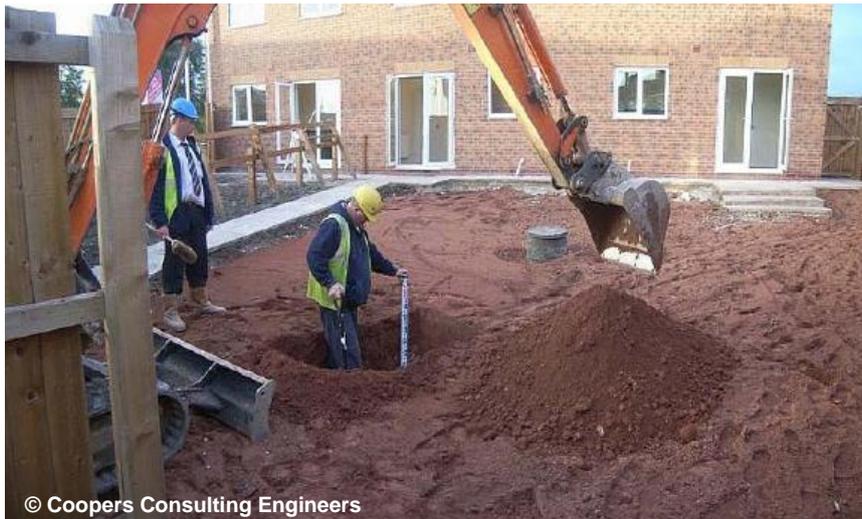
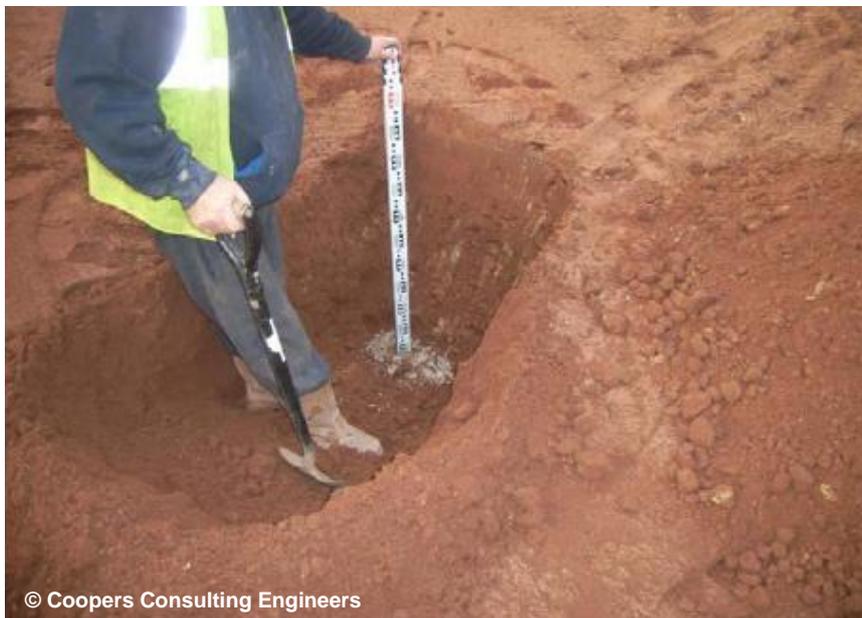
Photographs 11 and 12 show the remediation of the rear garden, with a significant depth (1.0m) of inert cover. Remediation break layer visible at the base of the excavation. Photograph 11 has been stitched to form a panoramic photograph and
