**EAST WASTE
MANAGEMENT SITE,
LLANWERN STEELWORKS**

PERMIT EAWML/30003

**2014 Annual Review of
Environmental
Monitoring**

Report Number 1435r1v1d0315

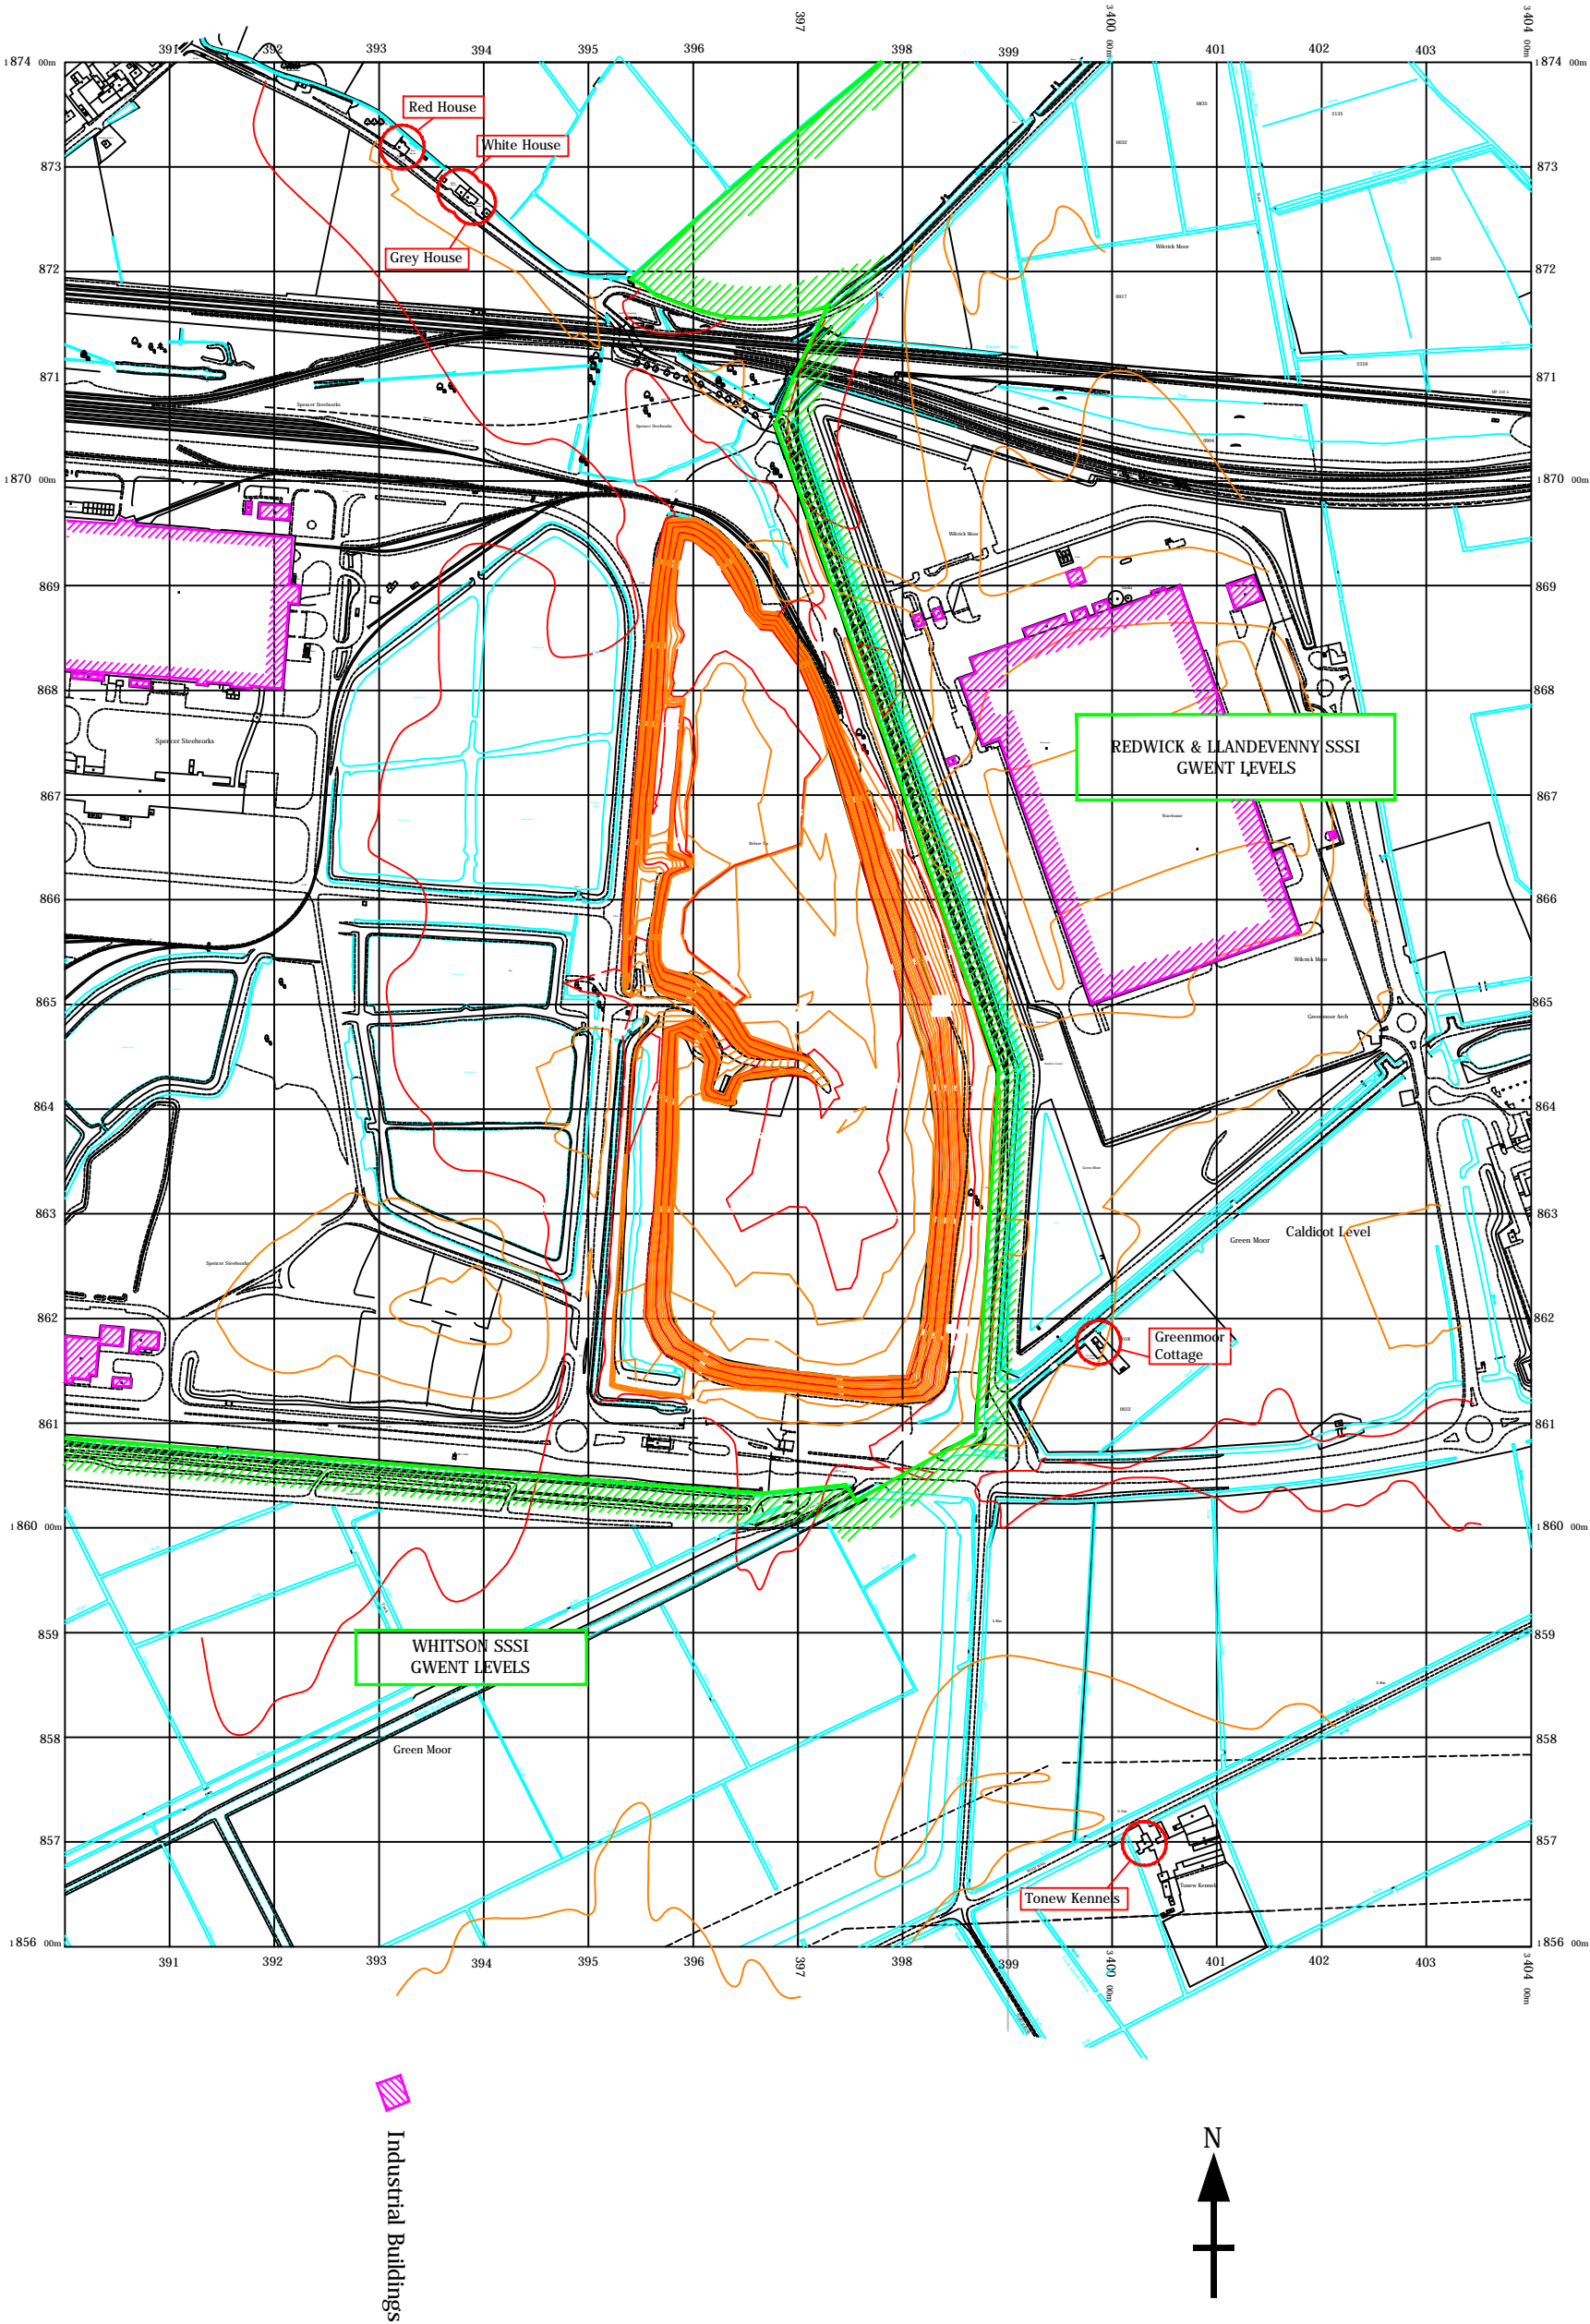
Figure 2 Environmental Setting

Key features and receptors are identified on Figure 2.

Llanwern Eastern Waste Management Site is located at Ordnance Survey Grid Reference ST 397 864, as shown on Figure 1 and Figure 2. The site lies at the eastern edge of the Tata Llanwern Steelworks and has accepted steelmaking and general wastes from the Llanwern site for four decades. The waste management site is a land raise, with wastes being deposited initially into very shallow excavations (circa 1 metre) onto natural ground. Disposal has developed a raised landform that now reaches 15m above Ordnance Datum (AOD), or some 10m above surrounding ground level.

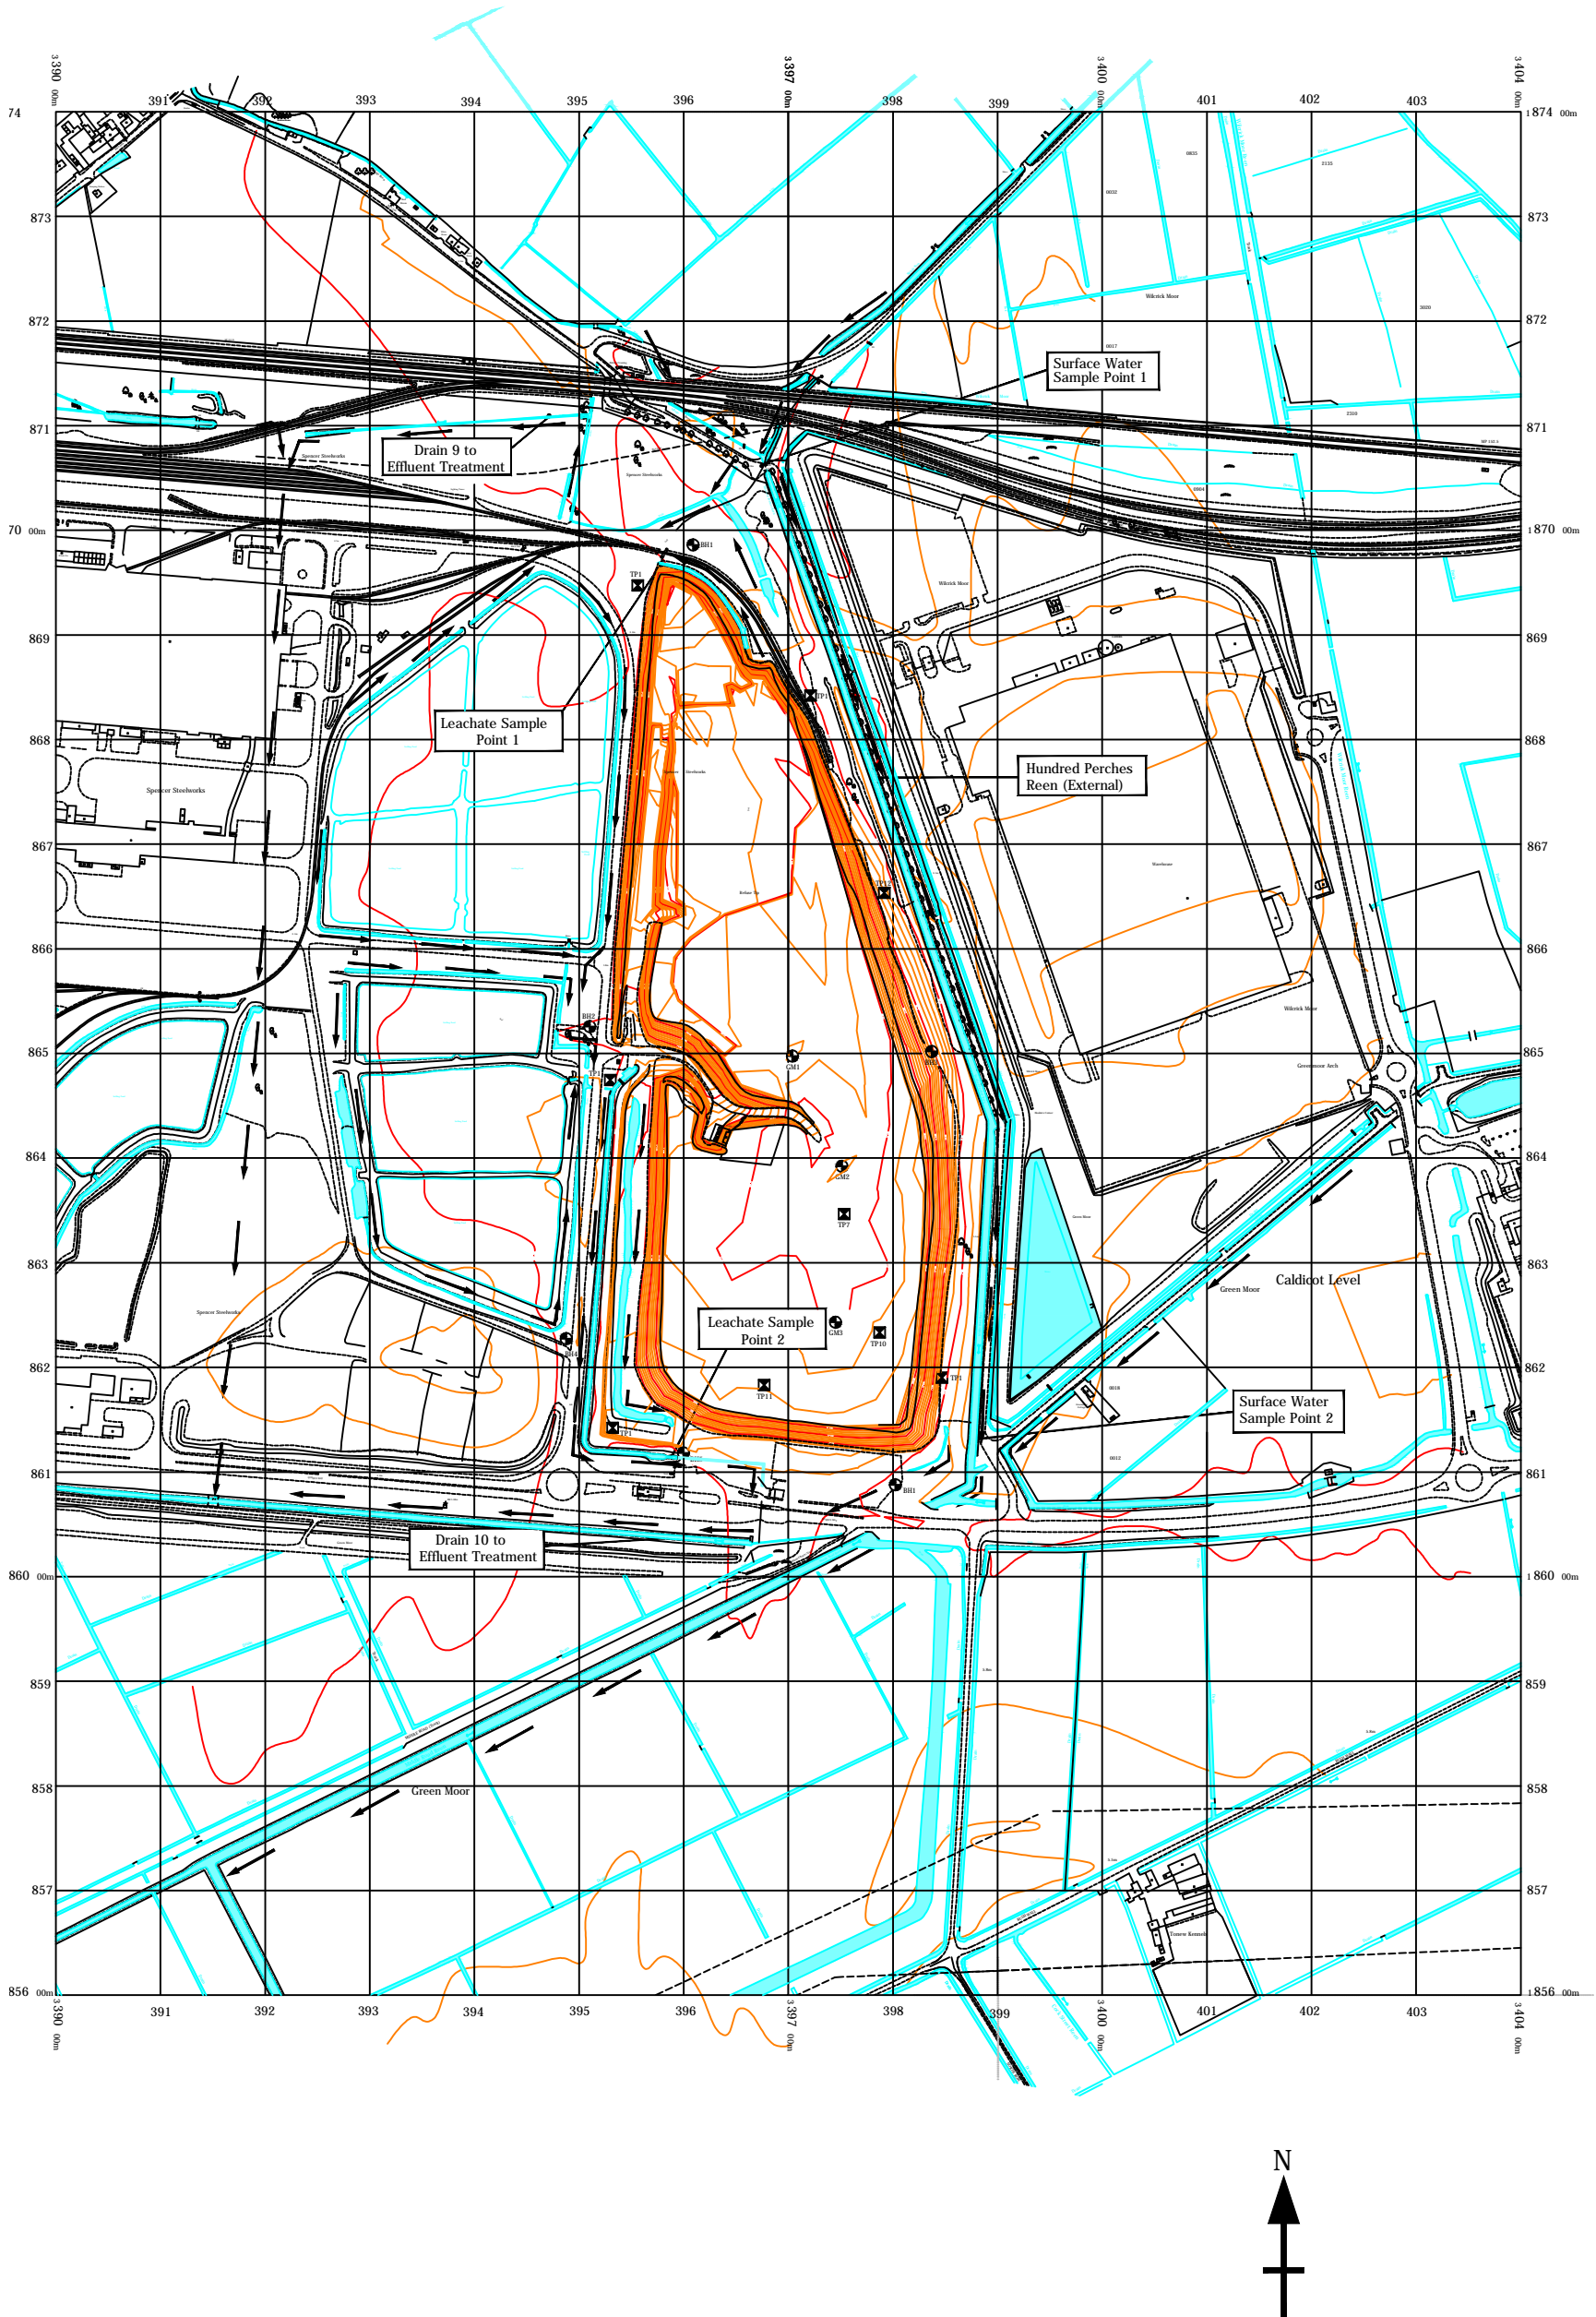
Figure 3 Hydrology

To the east, the landform slopes gently down to the steelworks boundary at Hundred Perches Reen, a slow flowing man-made ditch draining the surrounding levels. Mature vegetation has established itself along the eastern batter of the landfill, forming a tree and vegetation screen to the land raise. The western and southern boundaries of the site are steep waste slopes which drop from the waste plateau to site roads within the steel plant. These boundaries have leachate collection ditches running along 50% of their length, set between the toe of the waste slope and the site roads. Surface water flows within the open collection ditches are directed into Drain 10 of the works effluent treatment system, as shown in Figure 3.
