**EAST WASTE
MANAGEMENT SITE,
LLANWERN STEELWORKS**

PERMIT EAWML/30003

**2014 Annual Review of
Environmental
Monitoring**

Report Number 1435r1v1d0315

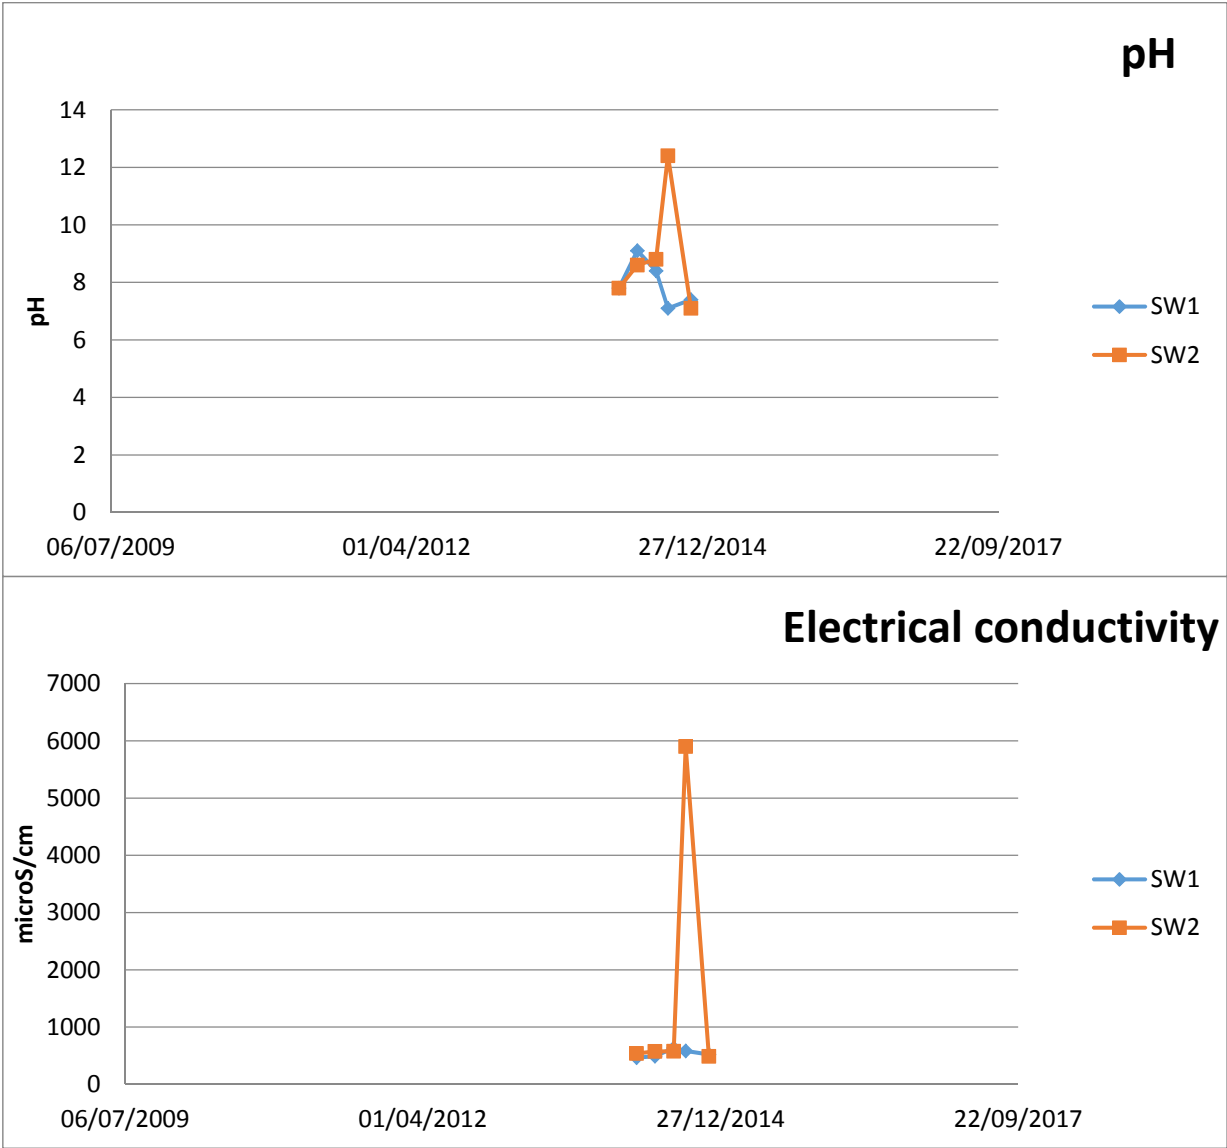
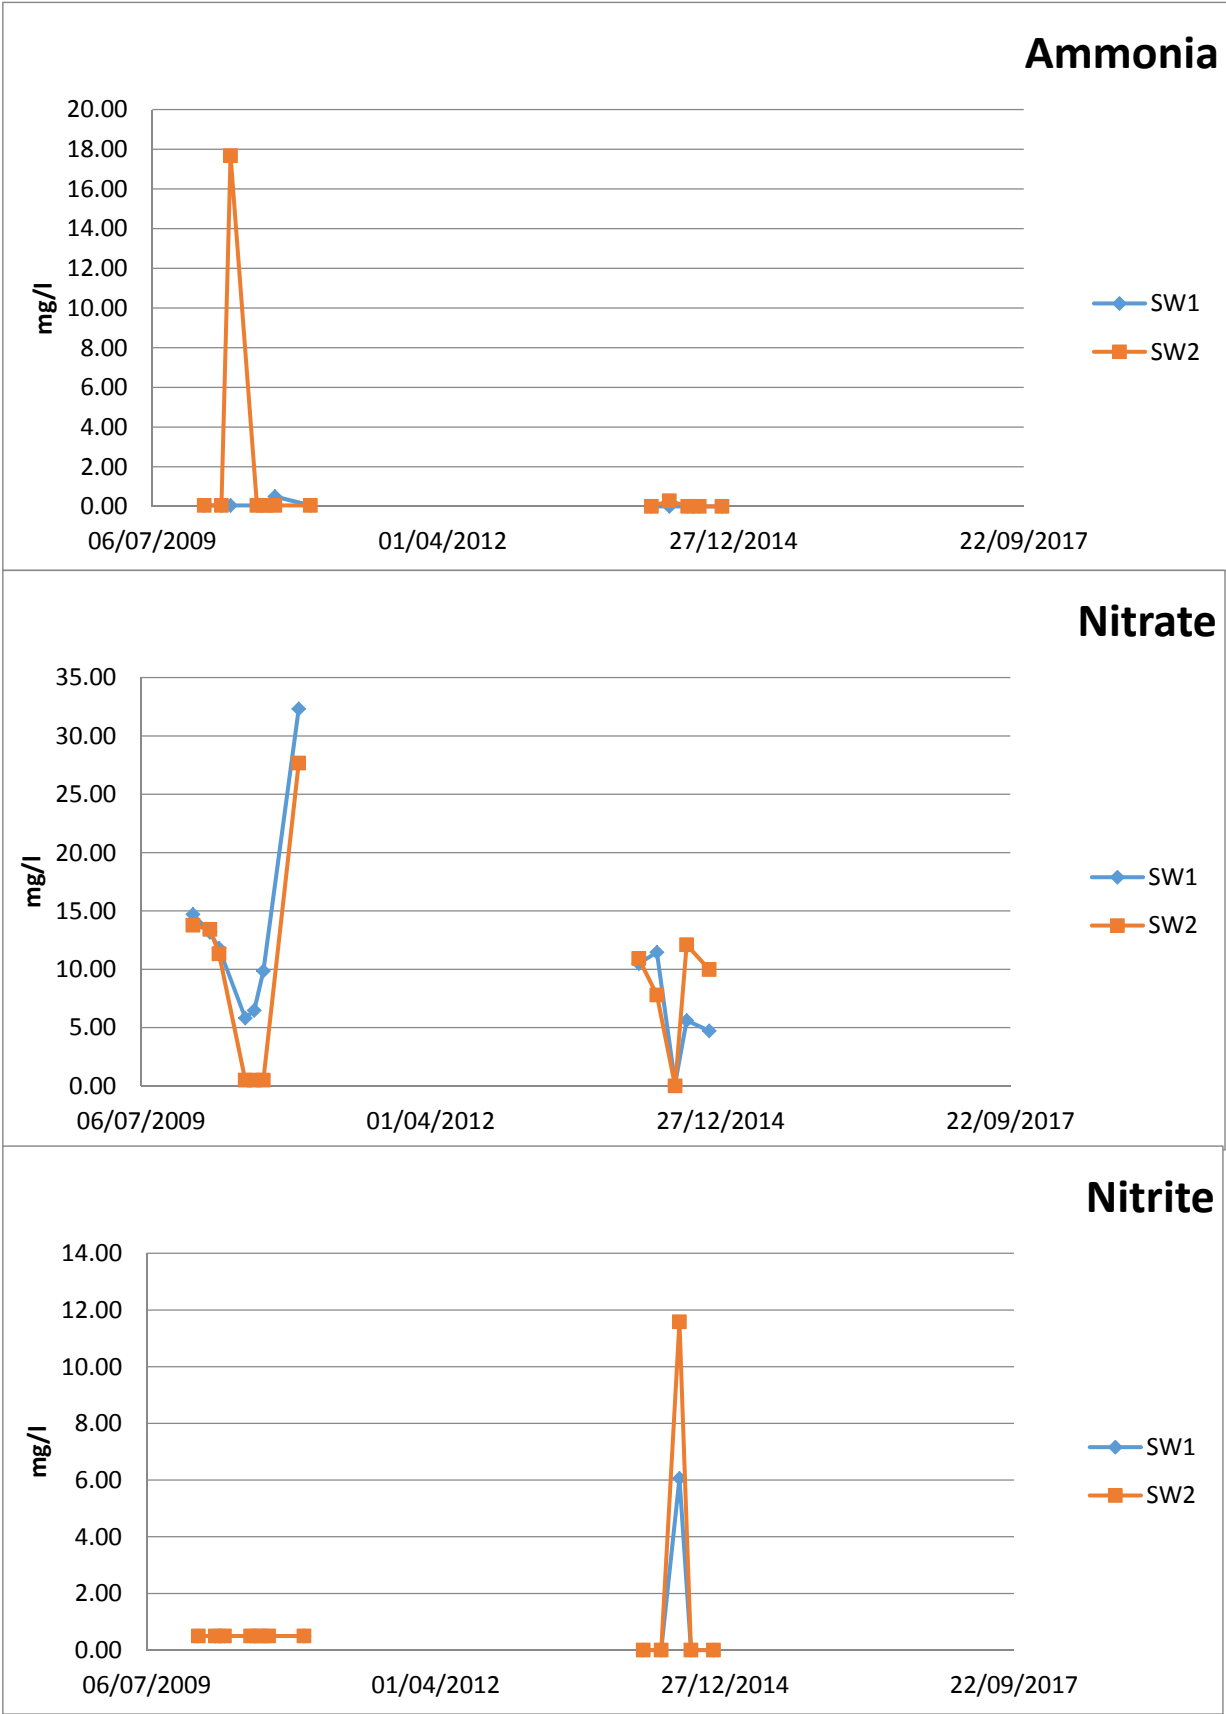
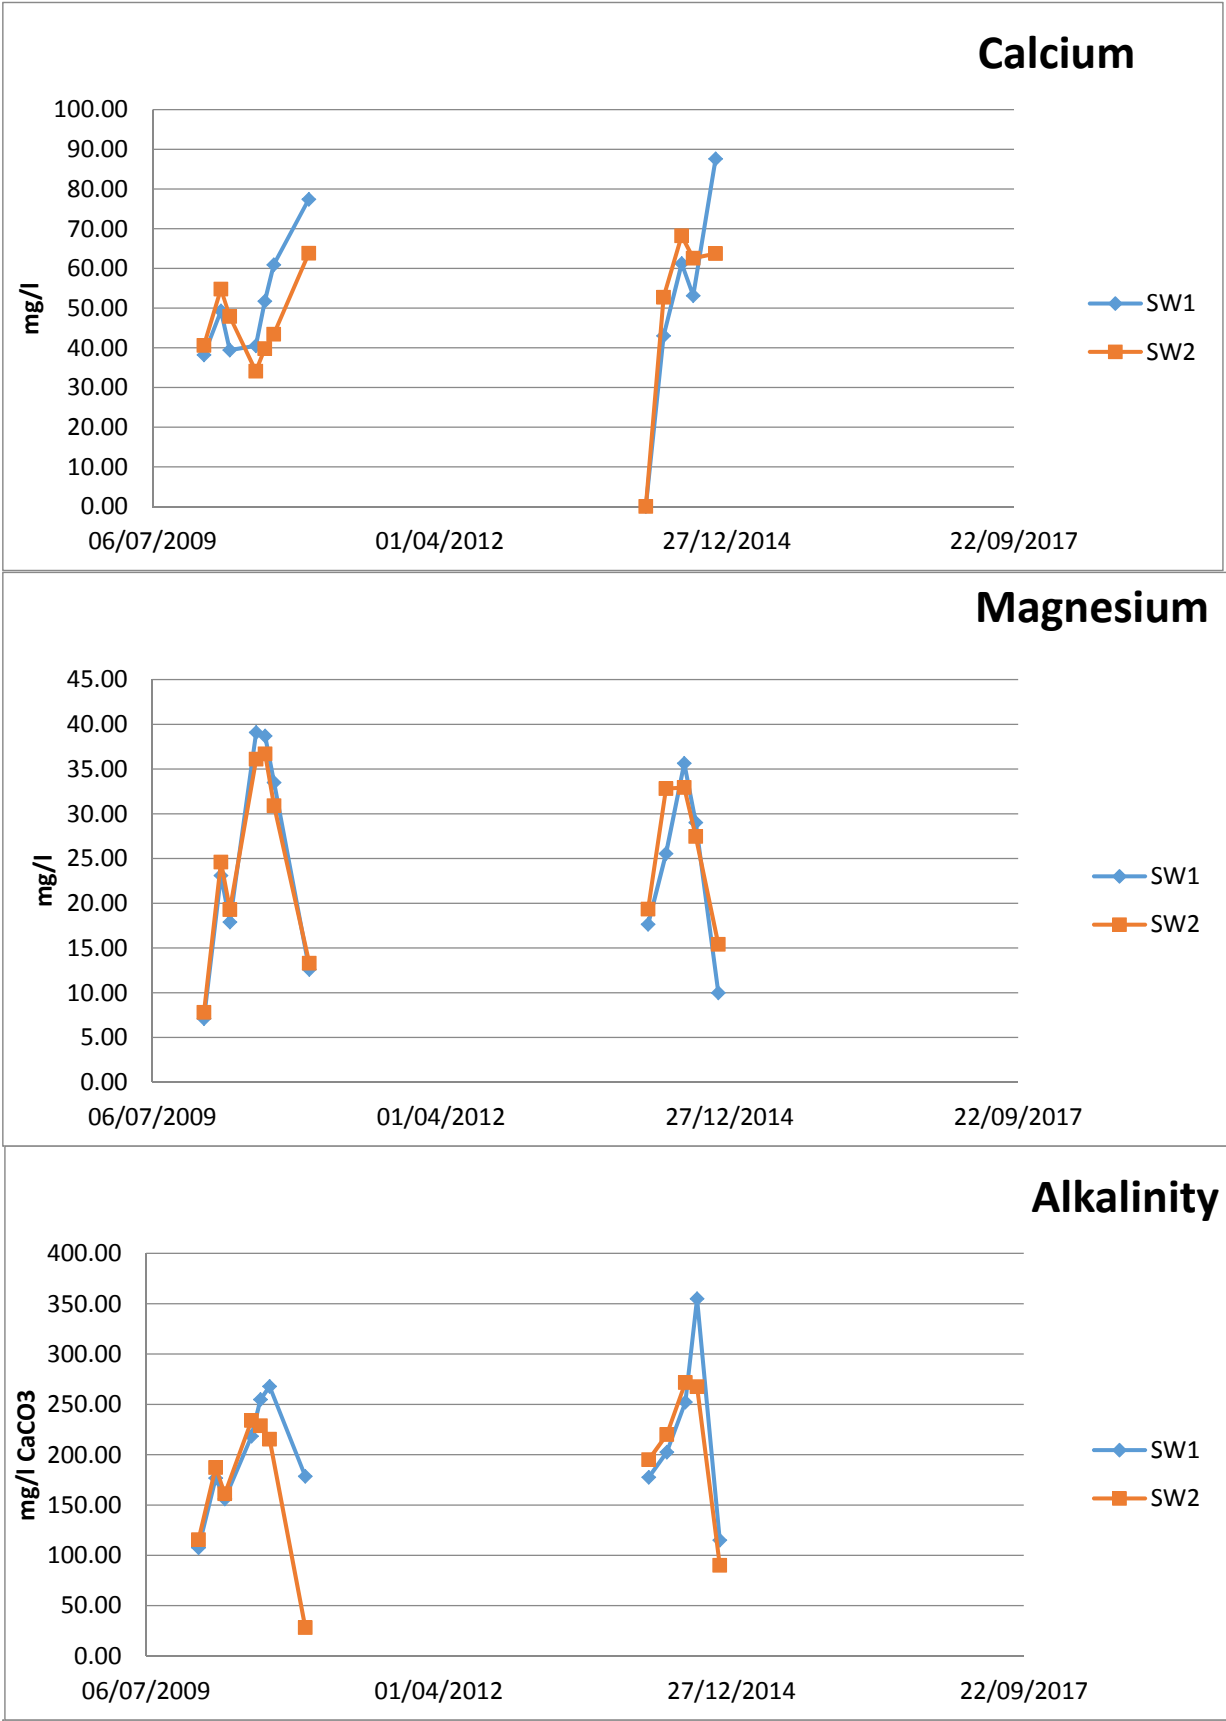
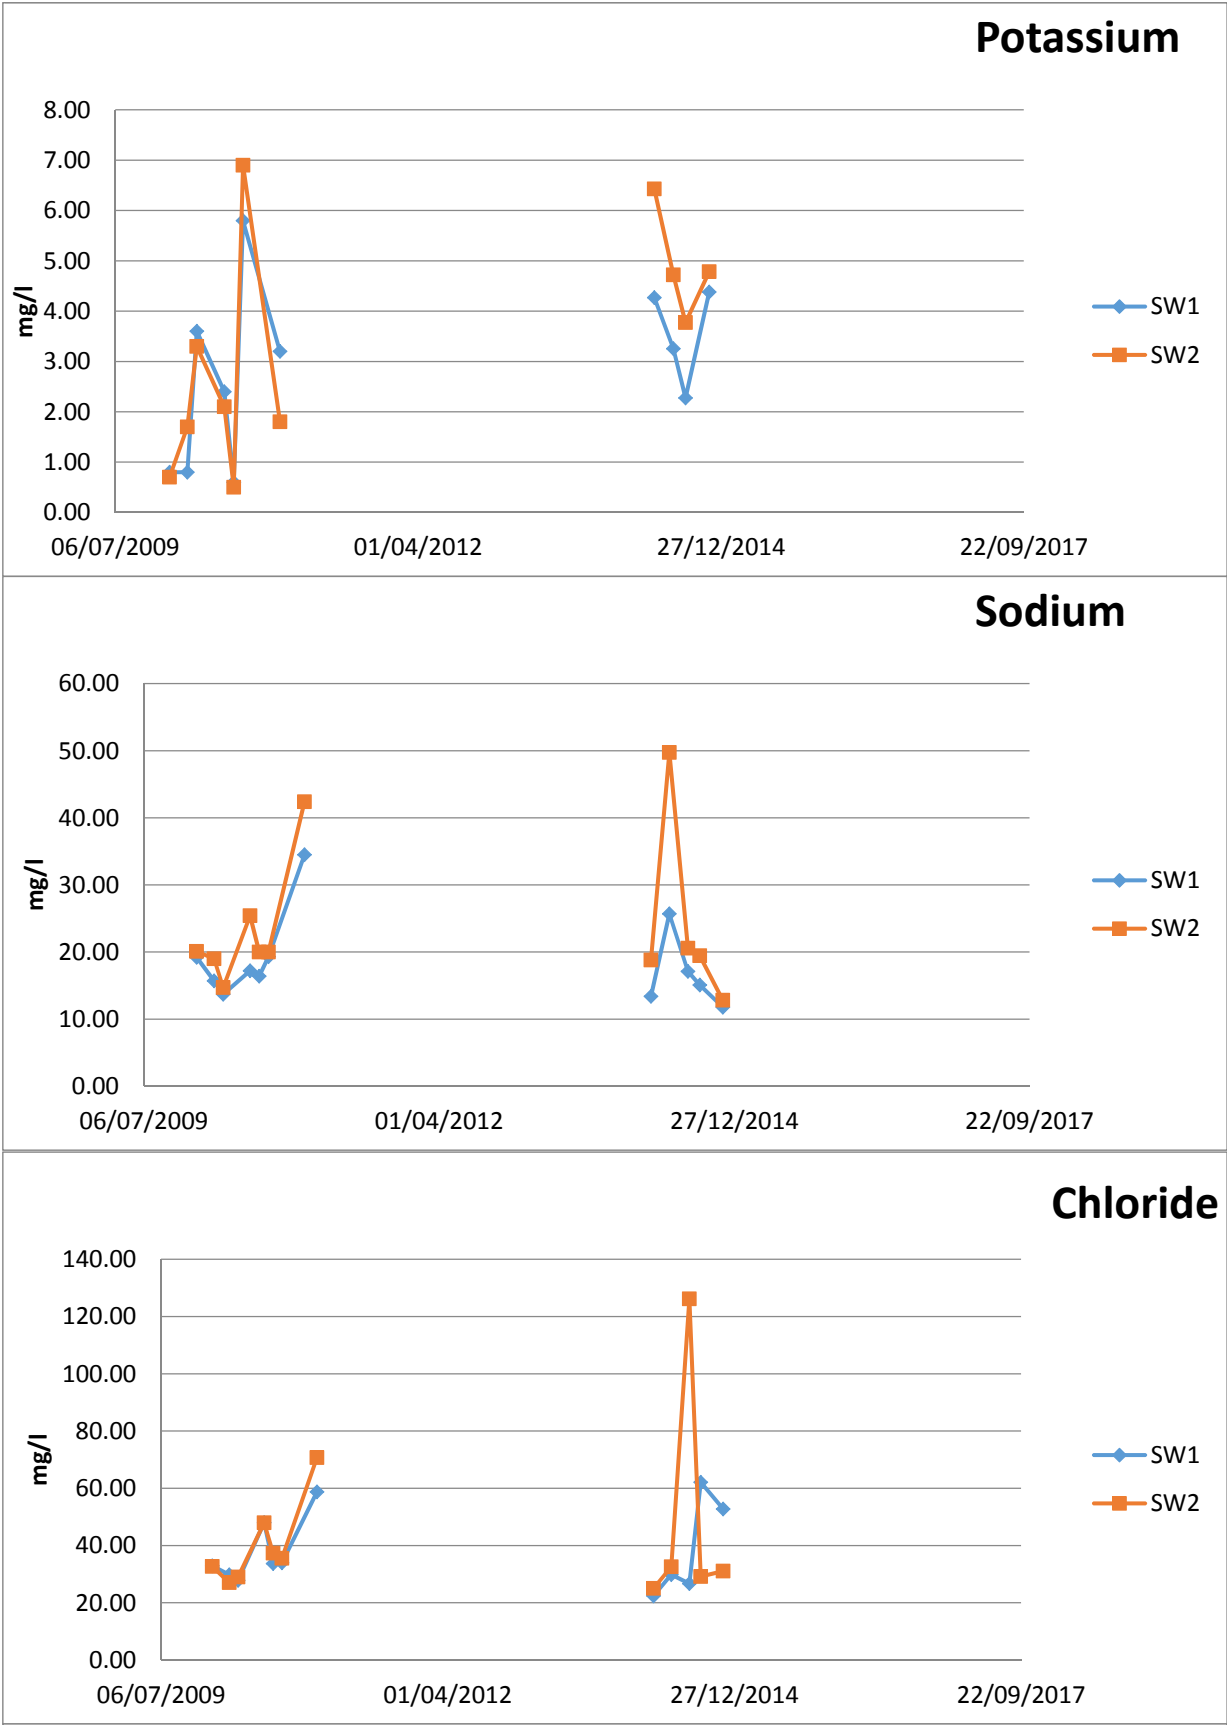
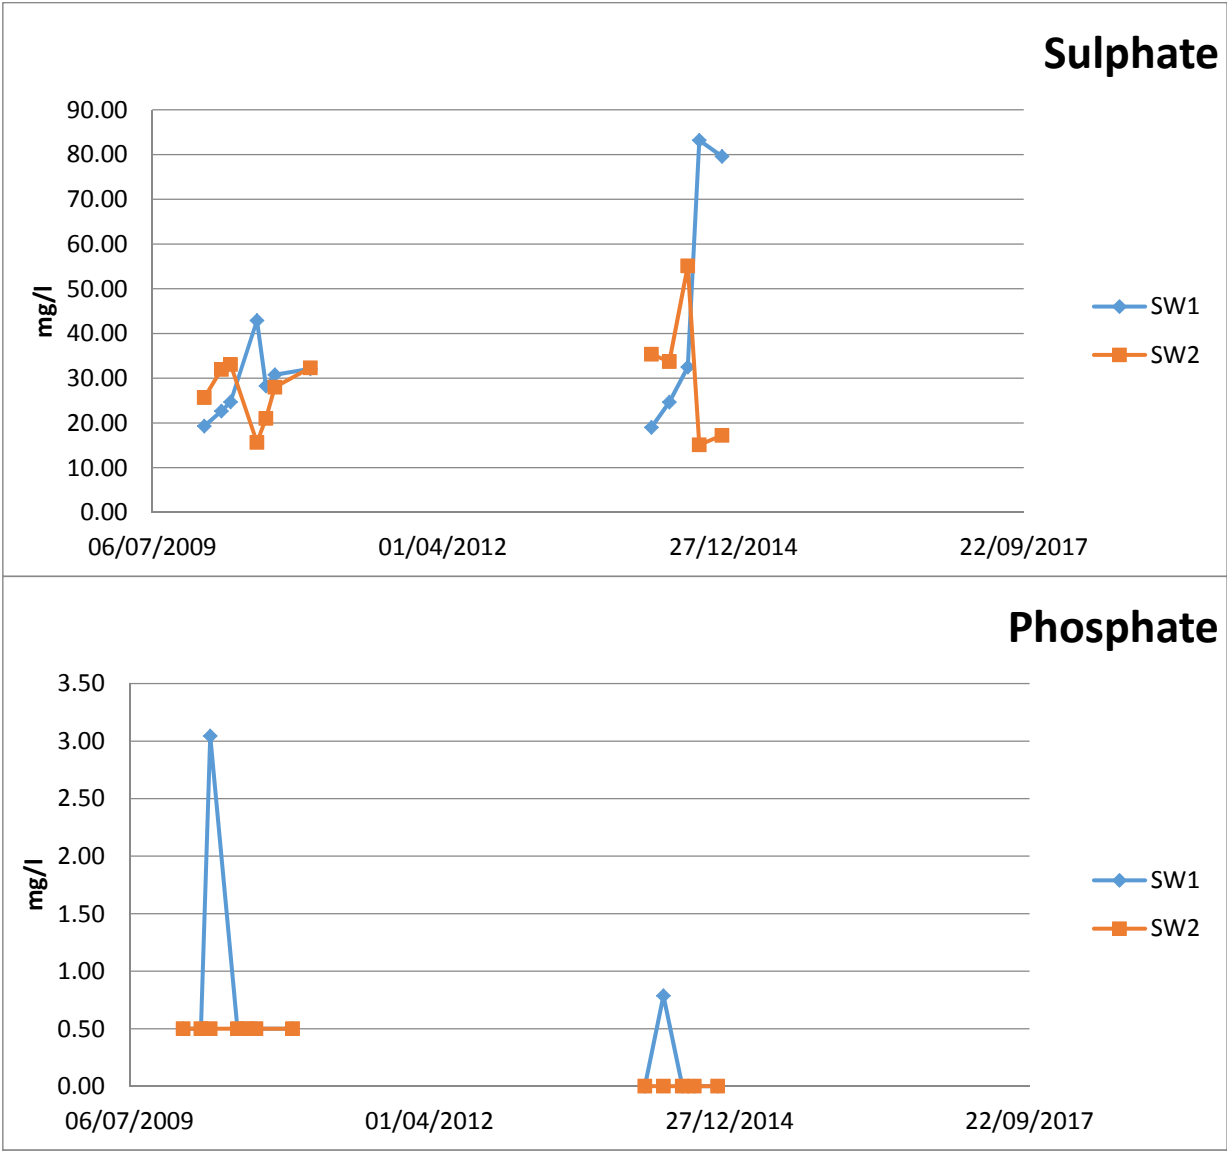
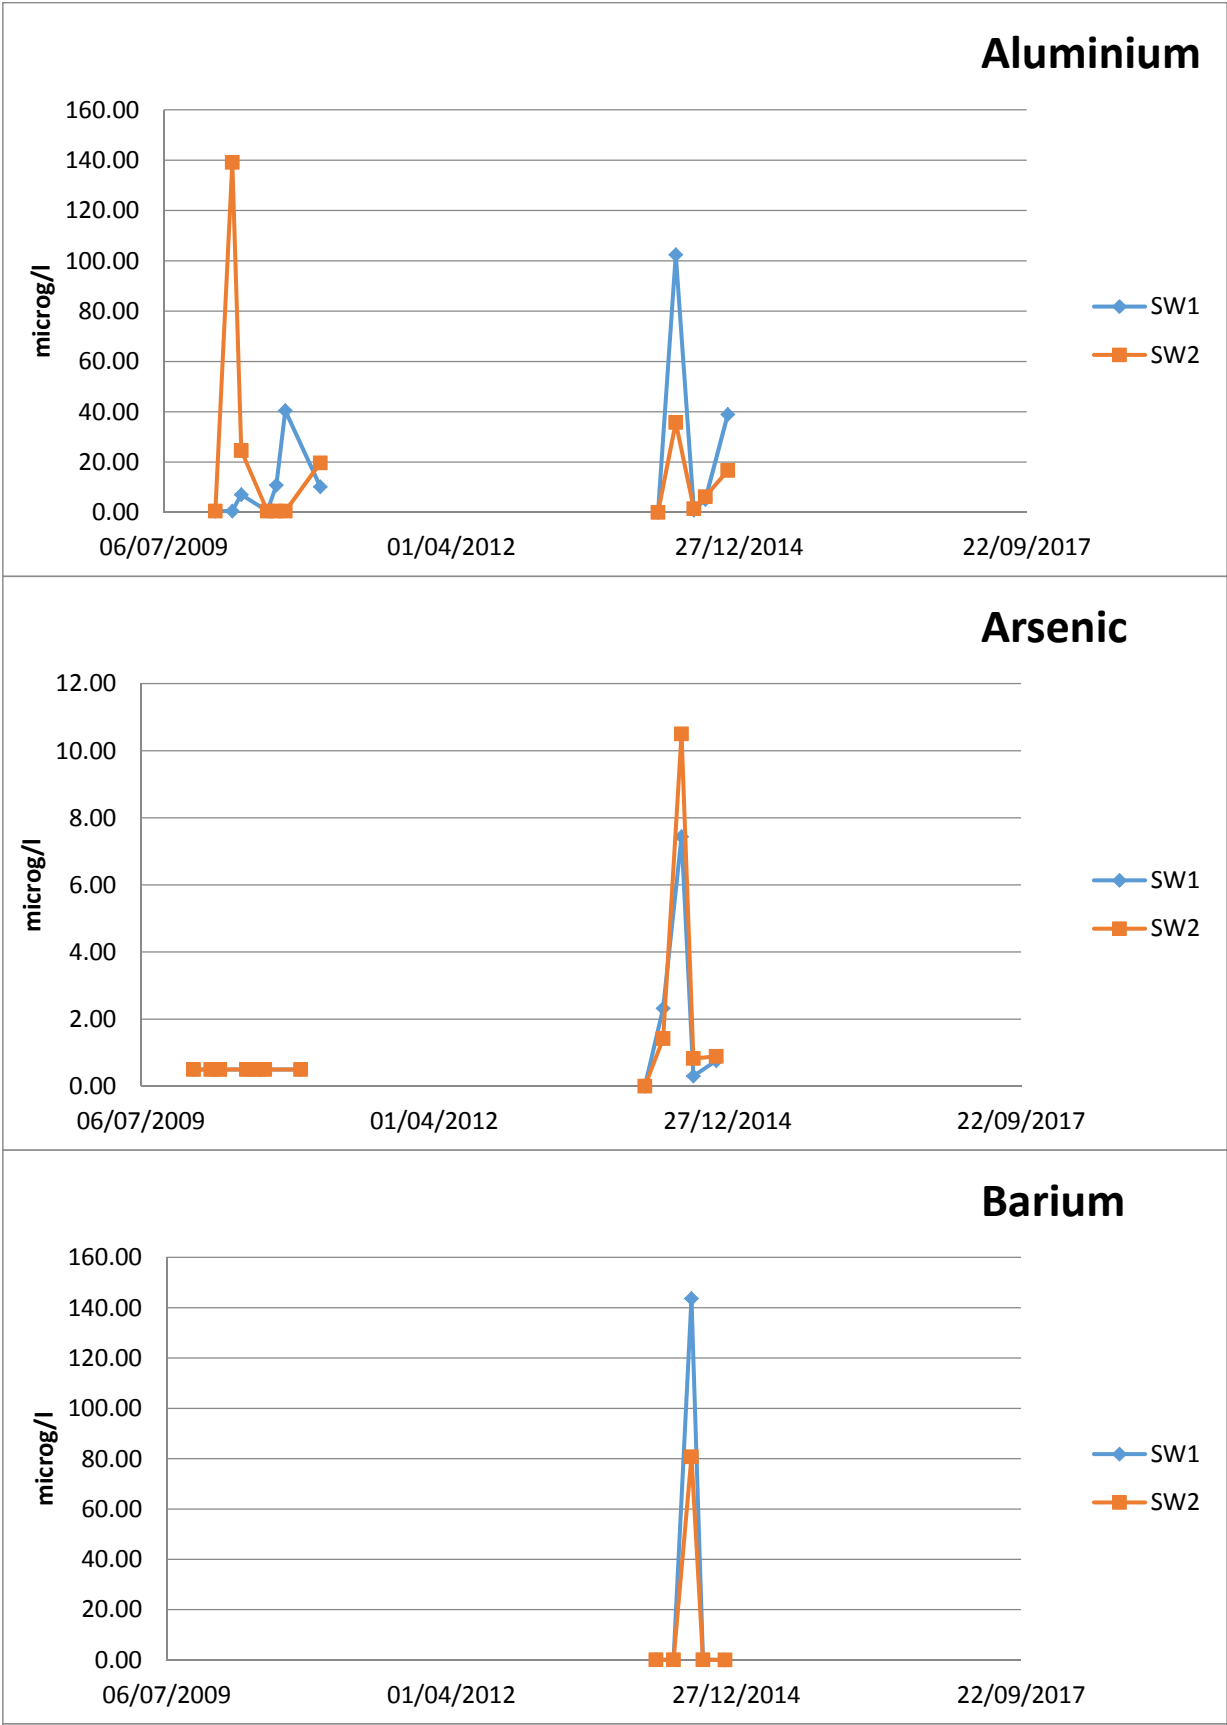
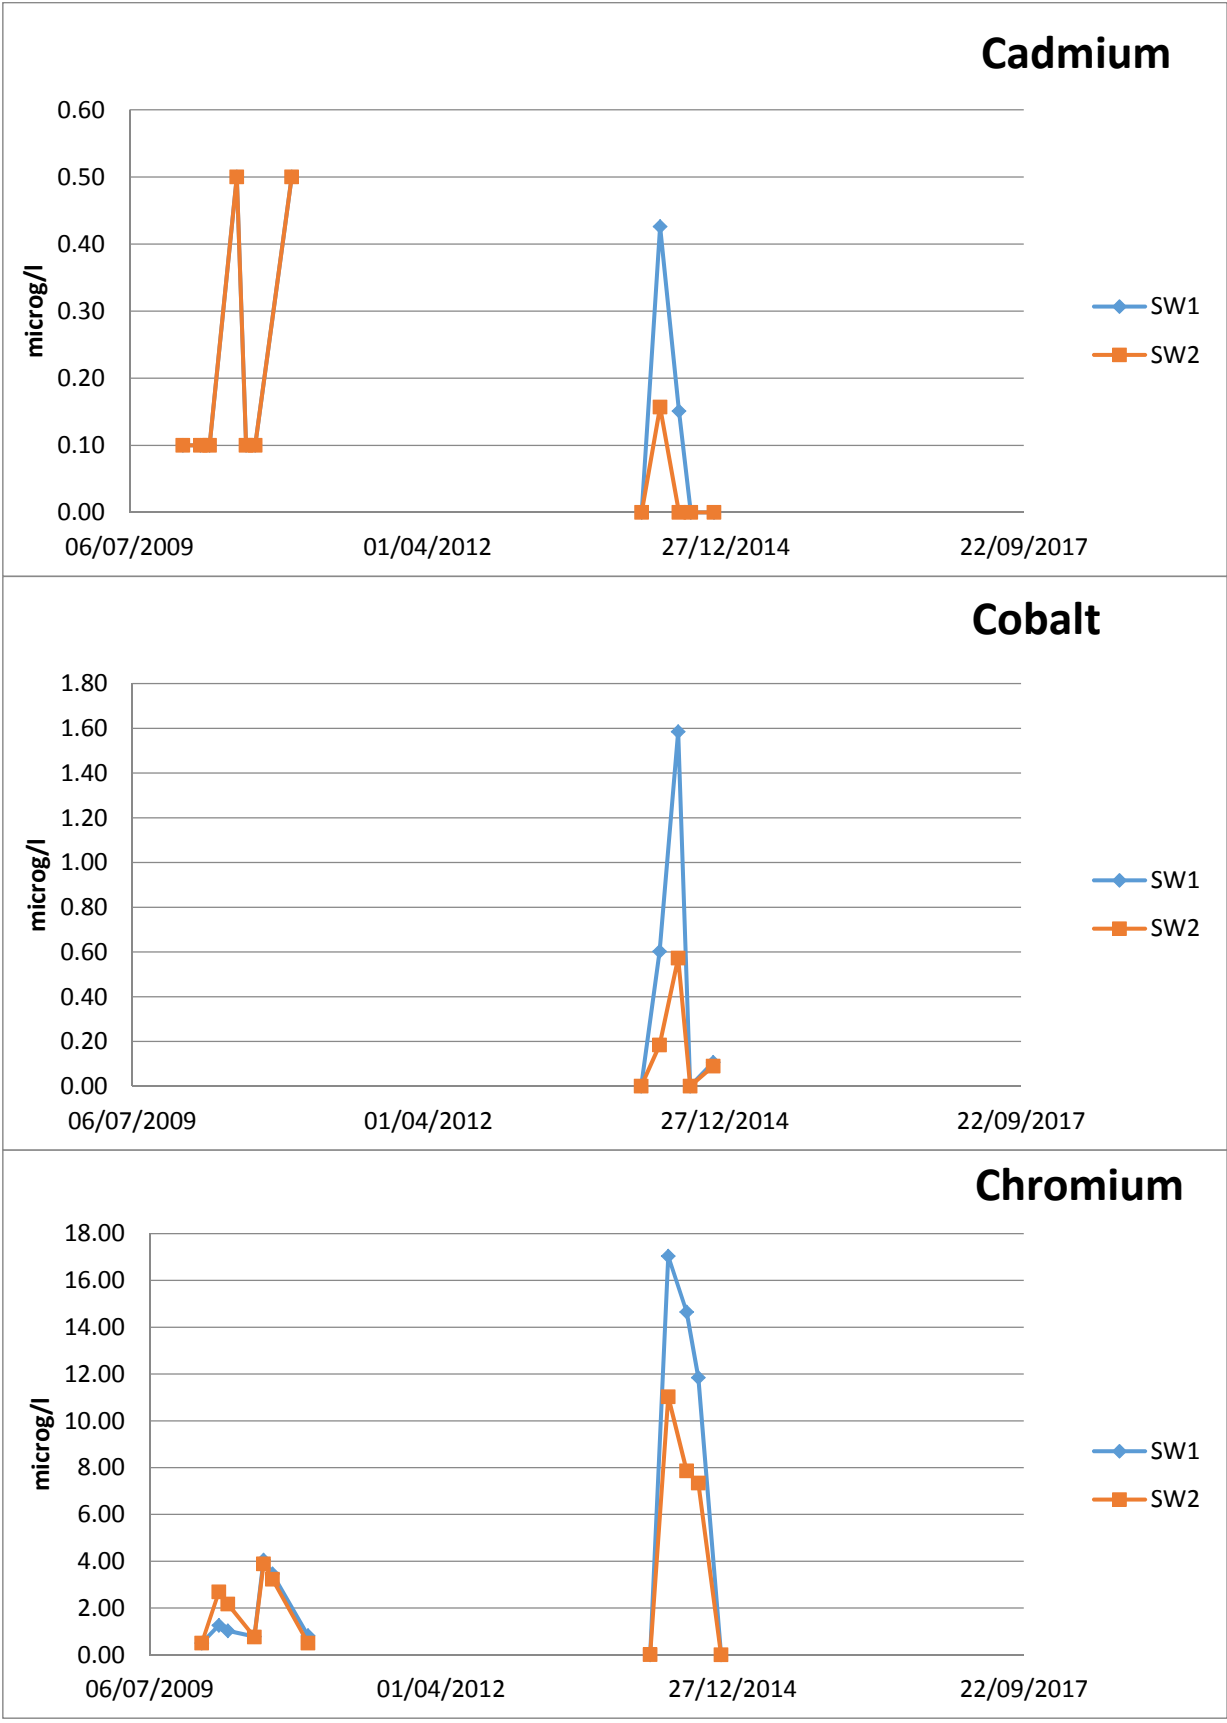
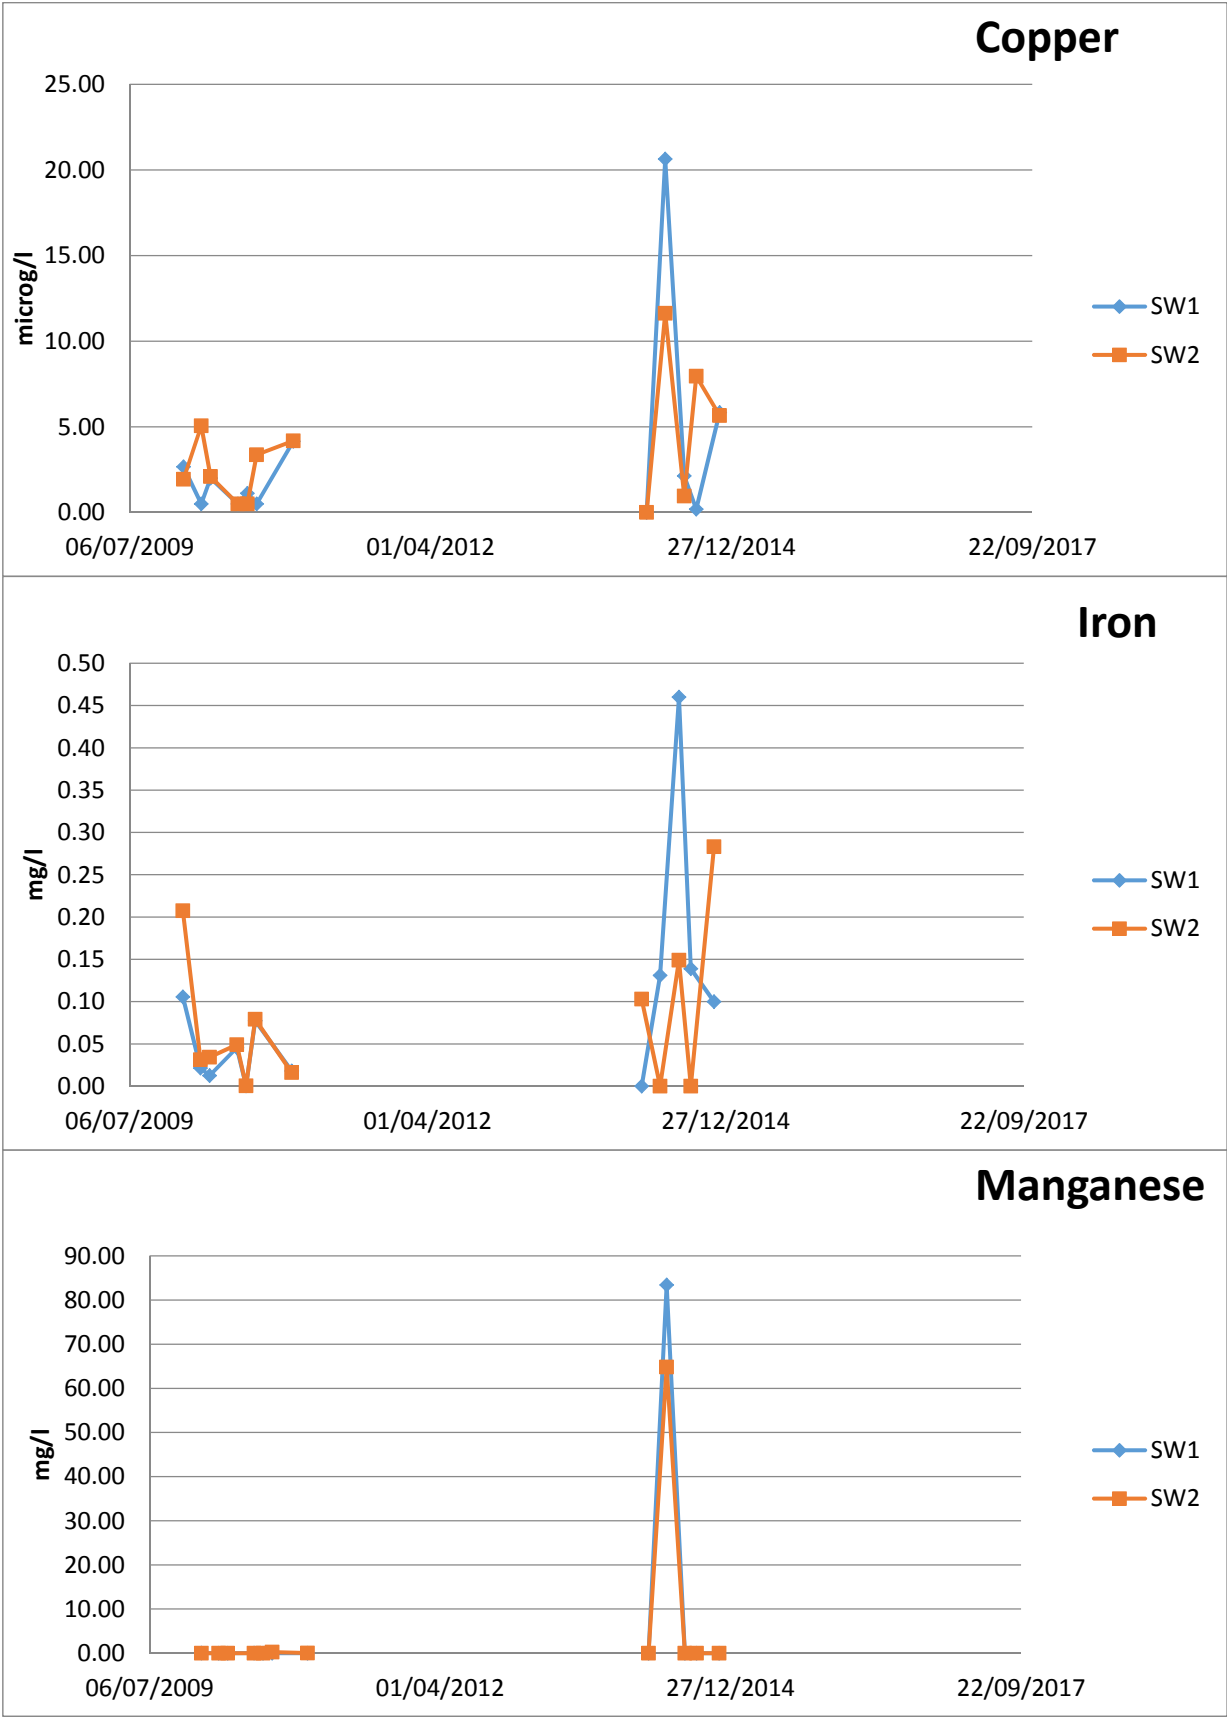
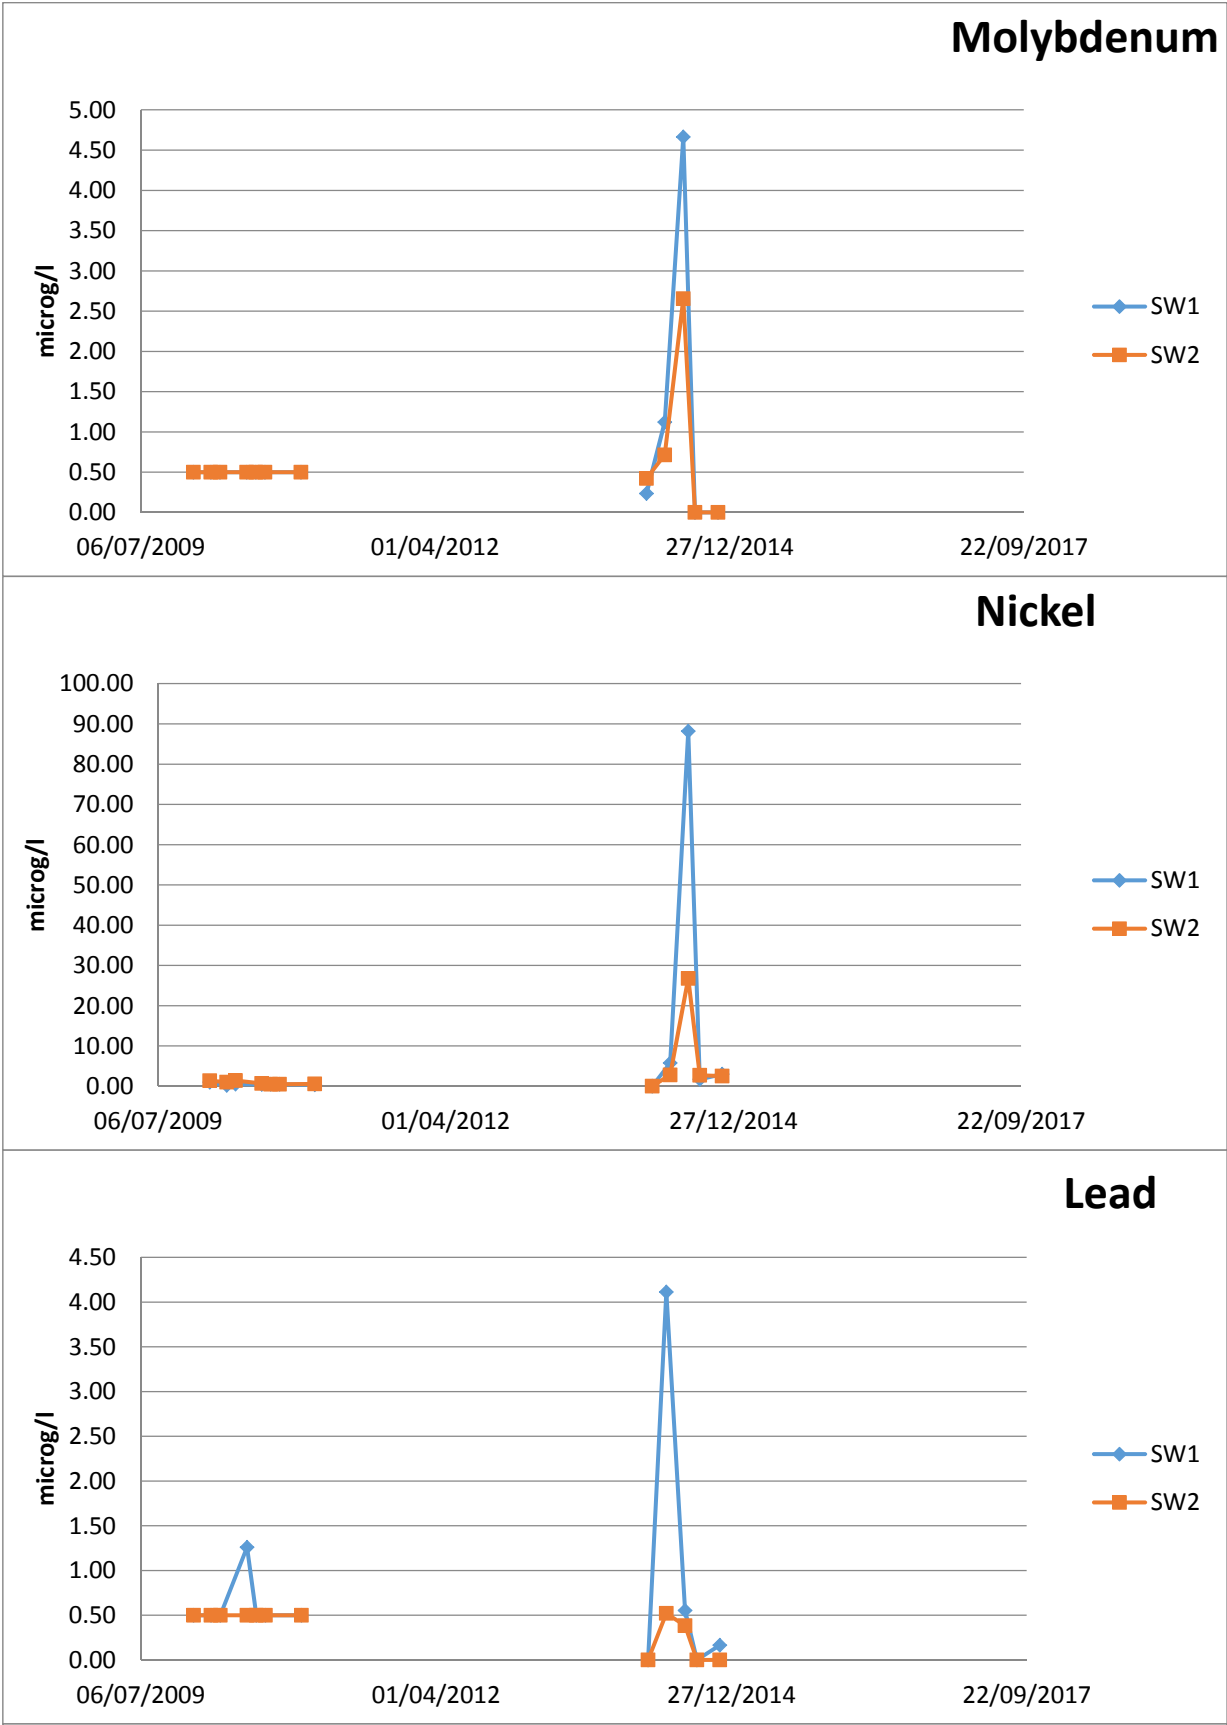
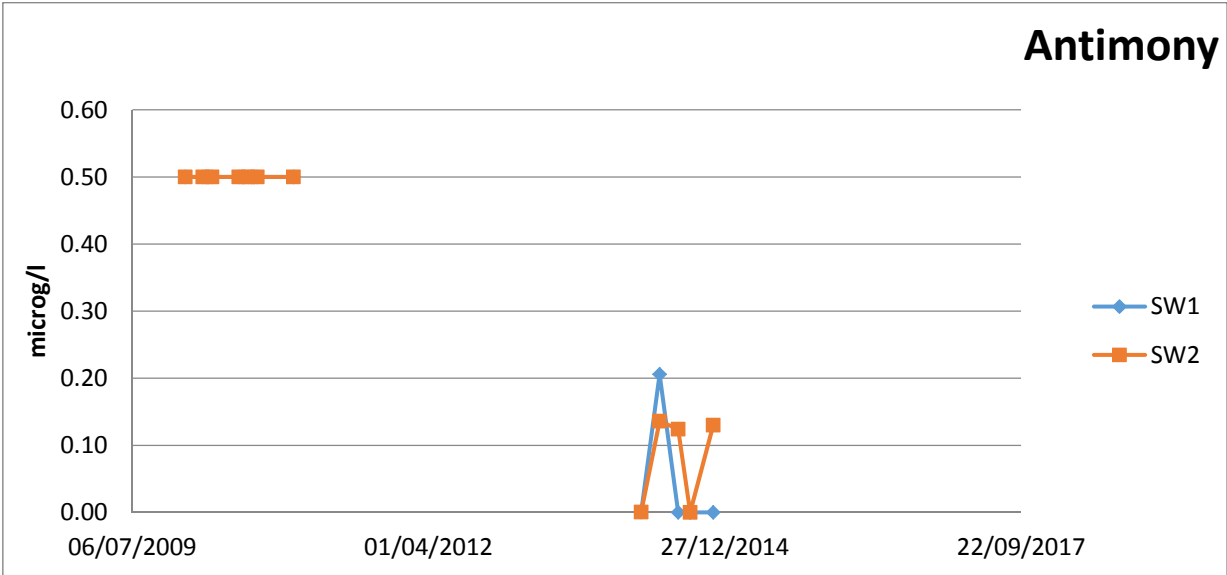
**Appendix 2
Temporal Variation of
Surface Water
Chemistry**

With one position upgradient (SW1) and one position downgradient (SW2) the surface water monitoring programme is designed to detect any influences the waste mass may be having on local surface water. At this stage, the monitoring data indicates that upgradient and downgradient surface water chemistry is generally very similar. However, in September there were abrupt changes in several parameters including pH and alkalinity. Subtle differences in the concentration of sodium, potassium, chloride, sulphate and alkalinity are also apparent and as leachate has potentially been observed along this flank and as the landfill is being capped, this dataset will continue to be closely scrutinised.
