Project Name:
SALMON FOR TOMORROW
PHASE 2
HONDDU FORGE

Drawing Title:
FOOTBRIDGE
SCOUR PROTECTION

Suitability.		Suitability Code.
FOR CONSTRUCTION		A
Internal Project Number.	Scale.	Rev.
277161	AS SHOWN	C02
Drawing Number.		
277161-ARP-03-XX-DR-XX-0007

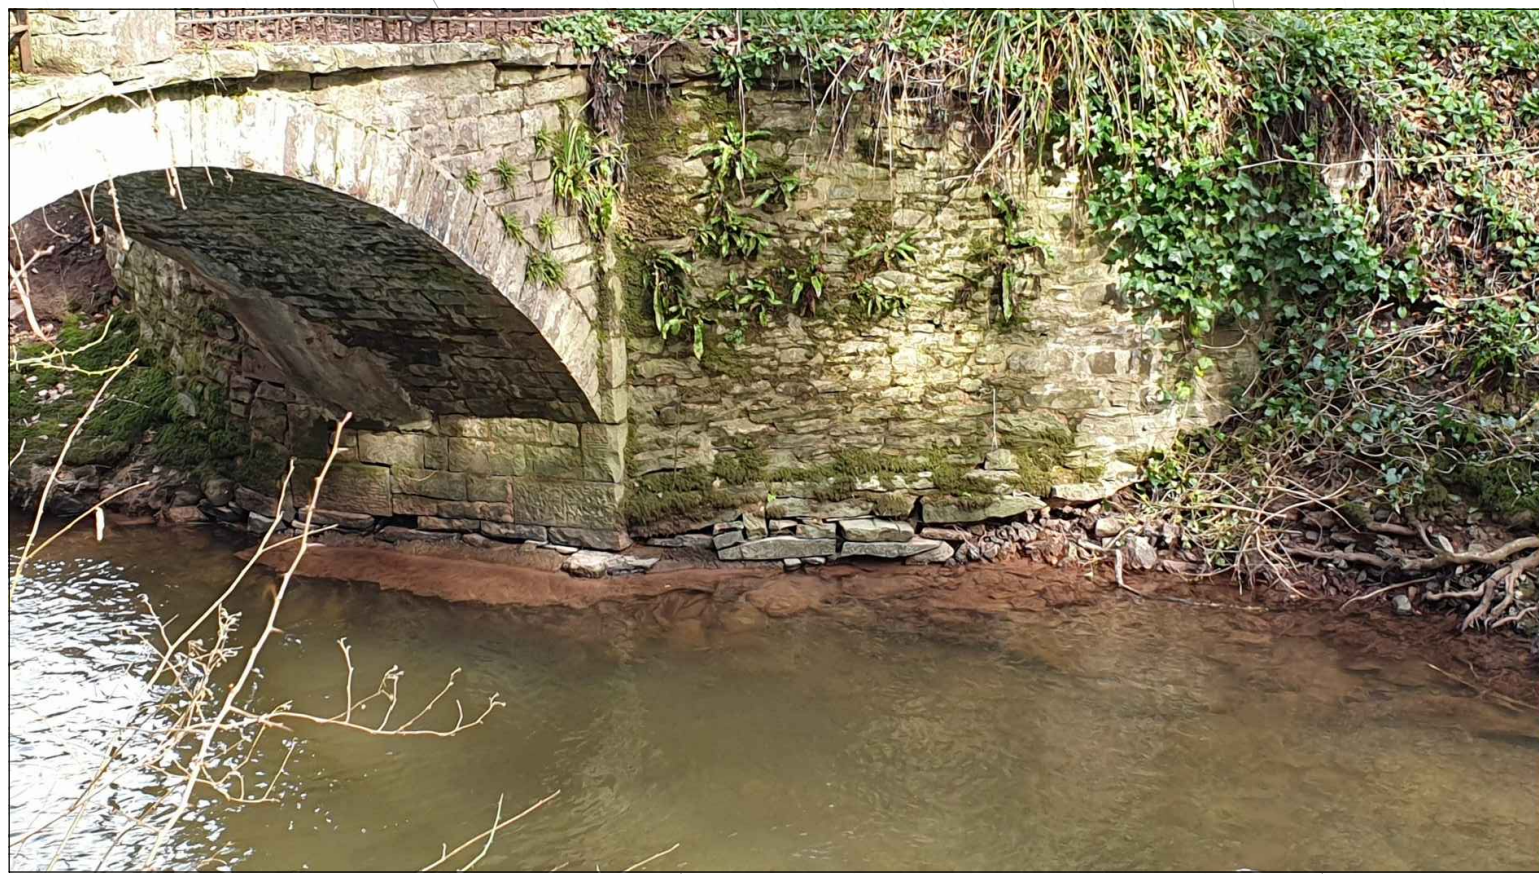
PHOTOGRAPH 2 - TYPICAL AREA FOR REPOINTING ON WEST BANK

REPOINTING TO BRIDGE ABUTMENTS WHERE EXISTING MORTAR HAS BEEN WASHED OUT
ASSUME FIRST 2 COURSES OF BRICKWORK FOR 20m
FOR PRICING PURPOSES. SEE PHOTOGRAPH 2

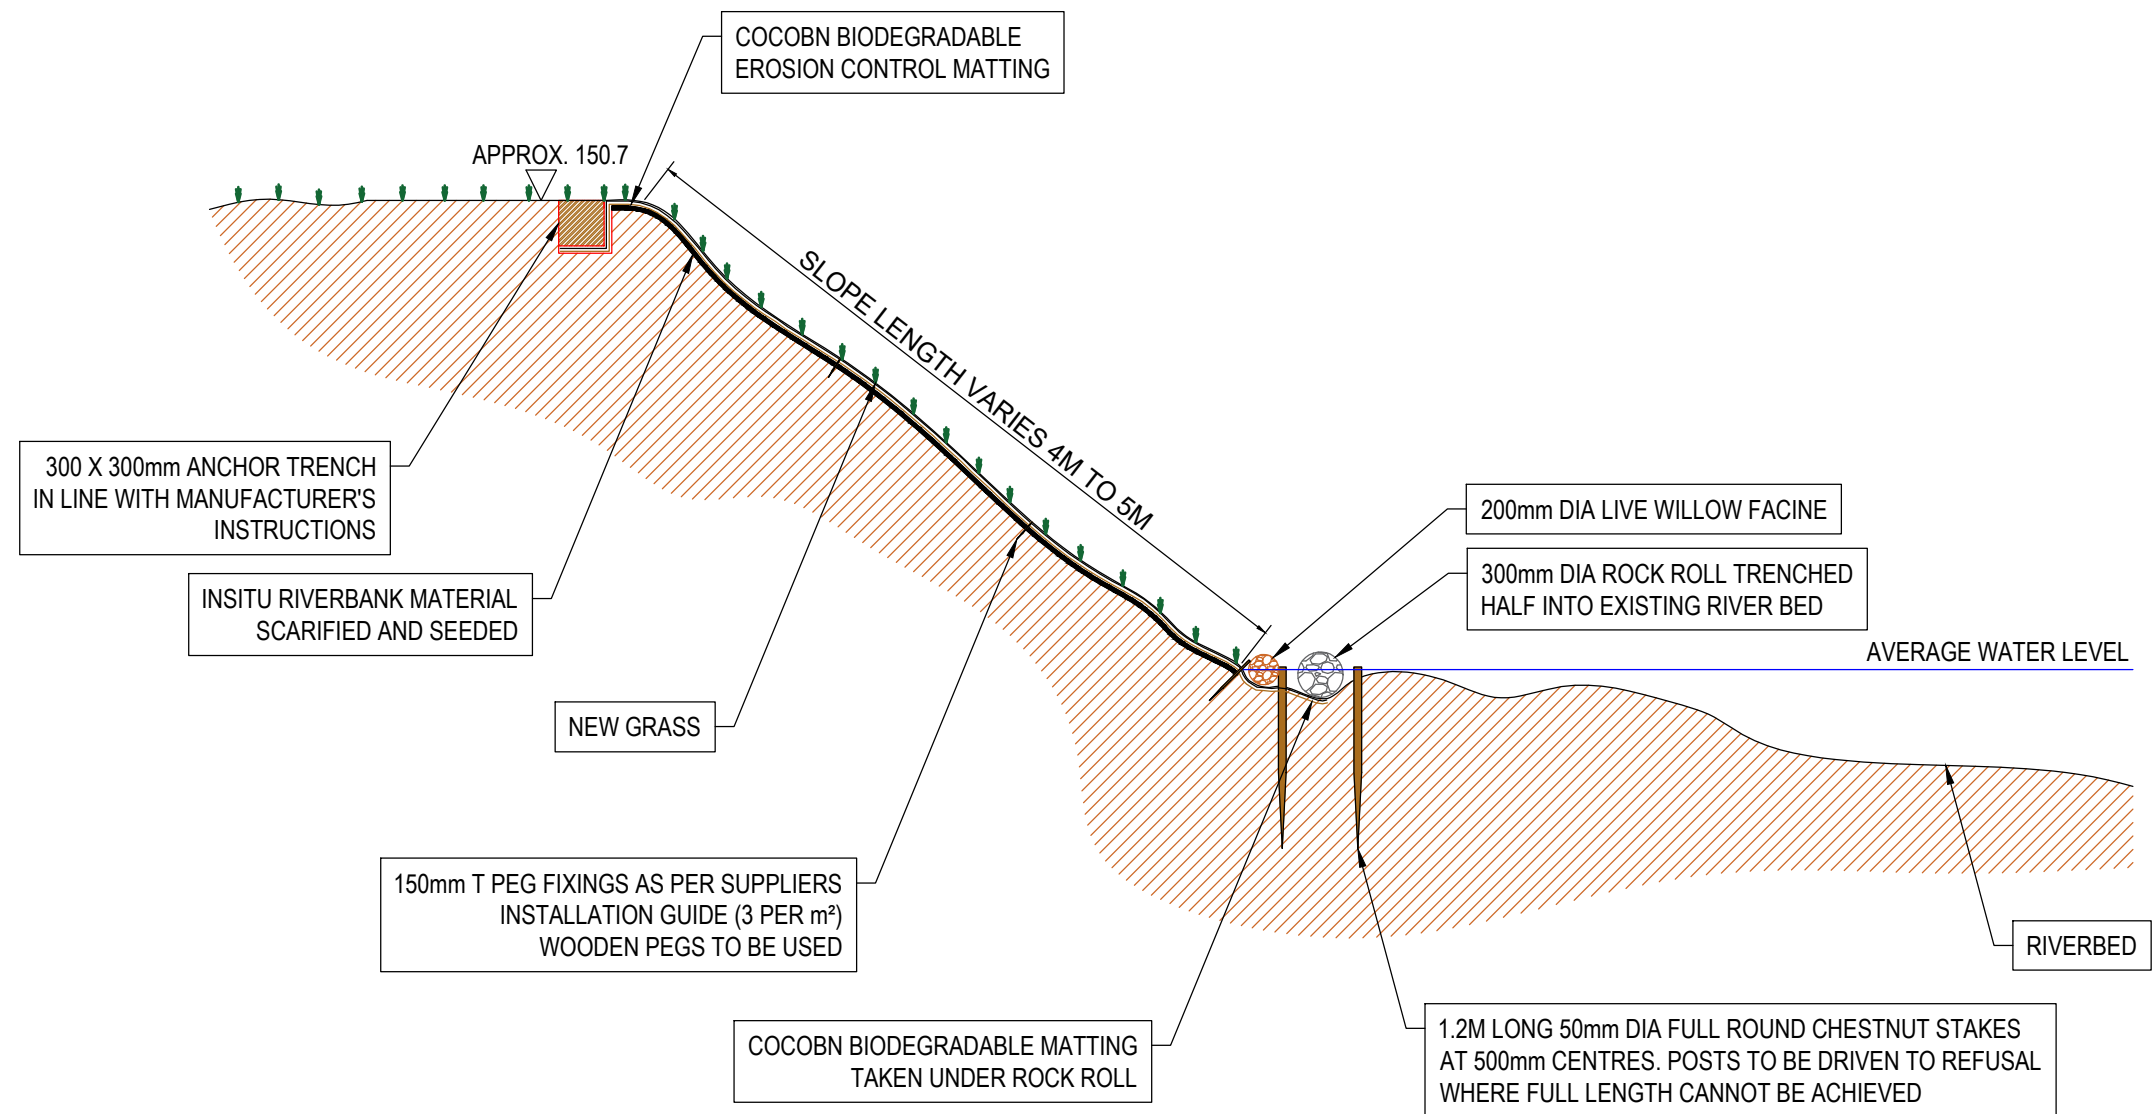
SECTION D-D
NTS

CONCRETE USED TO
REPAIR EXISTING SCOUR
PROTECTION UNDER
BRIDGE. SEE SECTION D-D
