Site	Twyn Dismantlers Ltd	Permit Ref	WP3395FT	
Operator/Permit holder	Caleb Griffiths			
Regime	Waste Operations			
Date of assessment	02/07/2019	Time in	11:00	Out 12:30
Assessment type	Site Inspection			
Parts of the permit assessed	B3, C2			
Lead officer's name	Lee, Jonathan			
Accompanied by	Warwick-Brown, David			
Recipient's name/position	Caleb Griffiths, Ashley Griffiths/ Permit Holder, Site Manager	Date issued	25/07/2019

**Report ID:
CAR_NRW0035478**

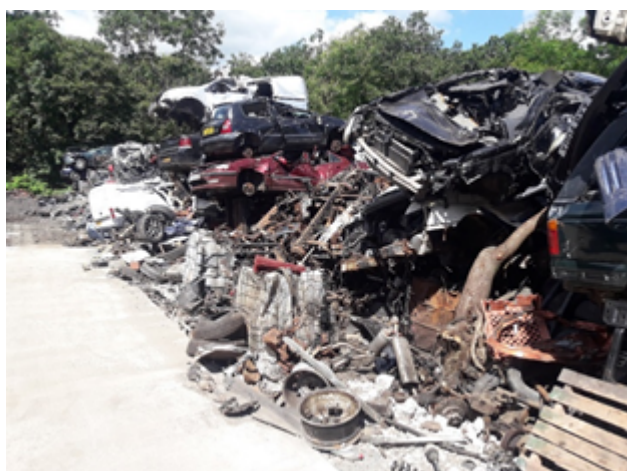
- Once oil/fuel/water-based fluids canisters had reached capacity, these fluids were shown to be transferred to IBC's which are stored in separated bunded areas. There were some IBC's containing oils and other fluids which were being stored outside of bunded areas (see photo 1).

- The storage of spare parts was sporadic and disorganised.
- The storage of baled depolluted car shells was non-compliant as they were being stored on the area of non-compliant hardstanding on site. In addition, the storage of stockpiles of vehicles on site was haphazard and poorly managed (see photos 1, 2 and 3).

Photo One – Stockpile of ELV waste

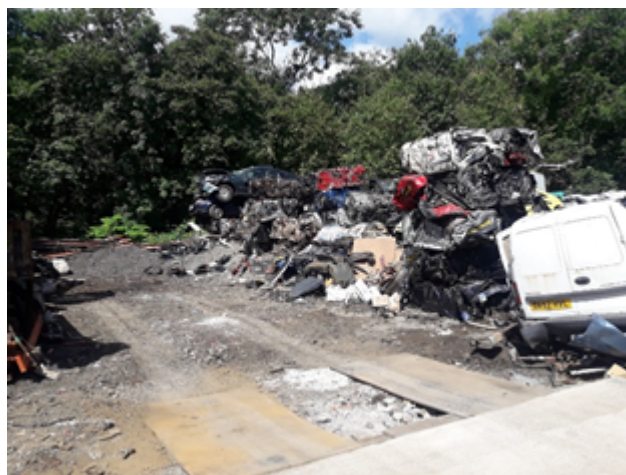
Photo Two – Area of hardstanding

- Investigate the extent of the contamination of the ground with oil and residual ELV wastes in area of hardstanding on site, provide initial findings of this investigation to NRW.
- Ensure that **ALL** contaminated ground and gravel currently present on the area of hardstanding is removed from site and recovered/disposed of appropriately.
- Ensure that the engineered surfaces and site drainage infrastructure are compliant with **ALL** requirements of permit condition 3.1.2 (and therefore Table 3.1.).

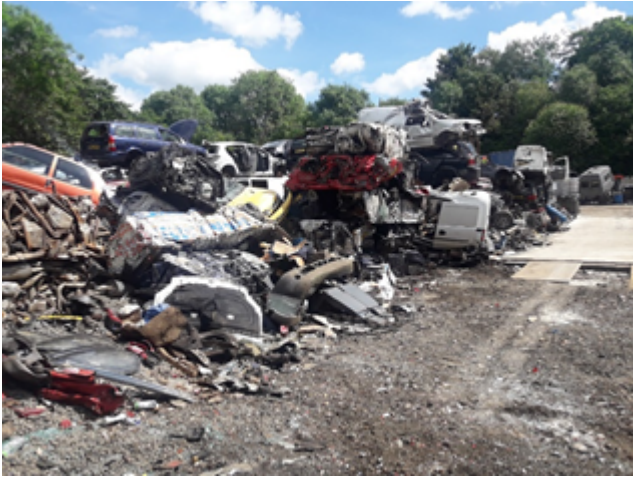
Photo Three – Area of hardstanding

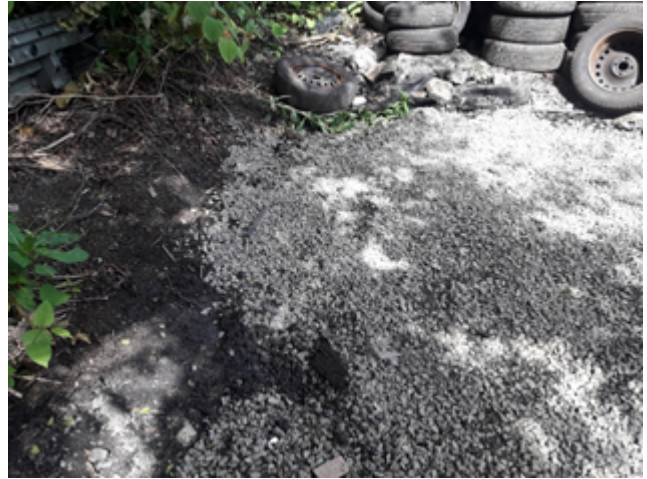
- The area of hardstanding on site was non-compliant with Table 3.1 (a); the area was not fully constructed with a suitable granular material, the area was not even, the area was heavily contaminated with oil and residual ELV wastes, in areas where new gravel materials had been laid it appeared to be on top of contaminated ground. These points suggest that the area of hardstanding on site remains **heavily contaminated** with oil and residual ELV wastes.
- Large portions of impermeable surface on site were not served by a sealed drainage system. Large portions of impermeable surface were not sealed along their perimeter.
- There was no clear distinction between areas of hardstanding, and areas of impermeable surface.
- Oil staining could be clearly seen on the entrance gully to the sealed drainage system (see photo 8).

Photo Four – Hardstanding surface

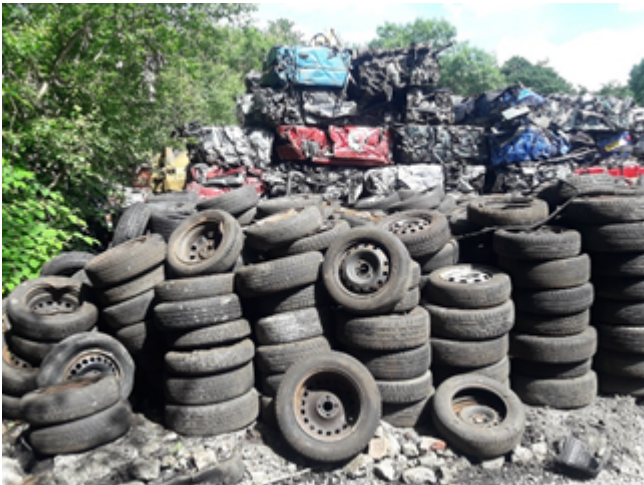
- The storage of waste tyres was non-compliant. Waste tyres were being stored sporadically and on the area of non-compliant hardstanding (see photo 5). There were several ELV's present on site which still had tyres fitted indicating poor management of the depollution process. This point was referenced as a non-compliance in the CAR for the site inspection on the 11th June 2019 (CAR_NRW0035274).

Photo Five – Stockpile of tyres and cubed ELV's

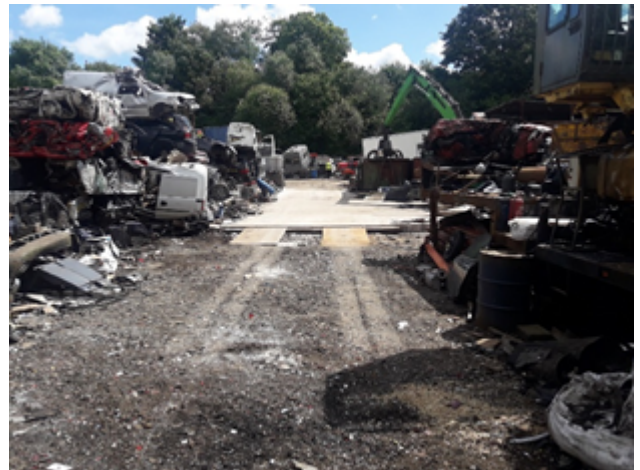
The operator had sought to construct some new sections of impermeable surface (shown partly in photo 6). Mr Caleb Griffiths stated that there was intention to continue construction of new portions of impermeable surface and install a suitable drainage system to collect or intercept contaminated run-off. Mr Caleb Griffiths also stated that he needed more time to complete the construction of the works specified in the notice.

Photo Six – Area of hardstanding

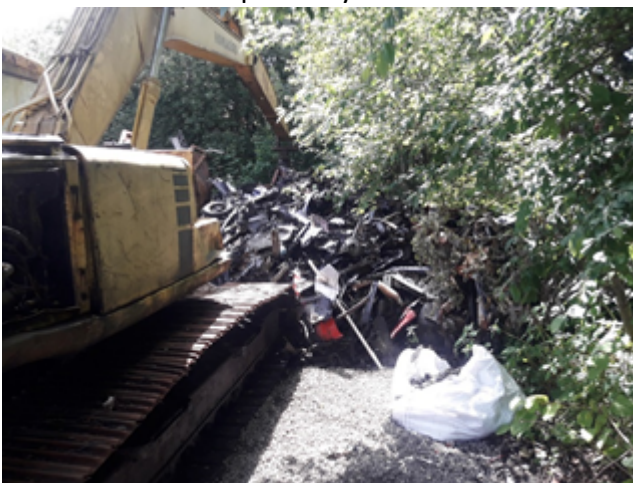
Photo Seven – Stockpile of metal in corner of site Photo Eight – Oil staining on entrance gully
