## Compliance Assessment Report CAR\_NRW0038892

**Permit being assessed:** FP3095ET.

For: Locks Yard, held by South West Wood Products Ltd

At: Heol Llan, Coity, Bridgend, CF35 6BU.

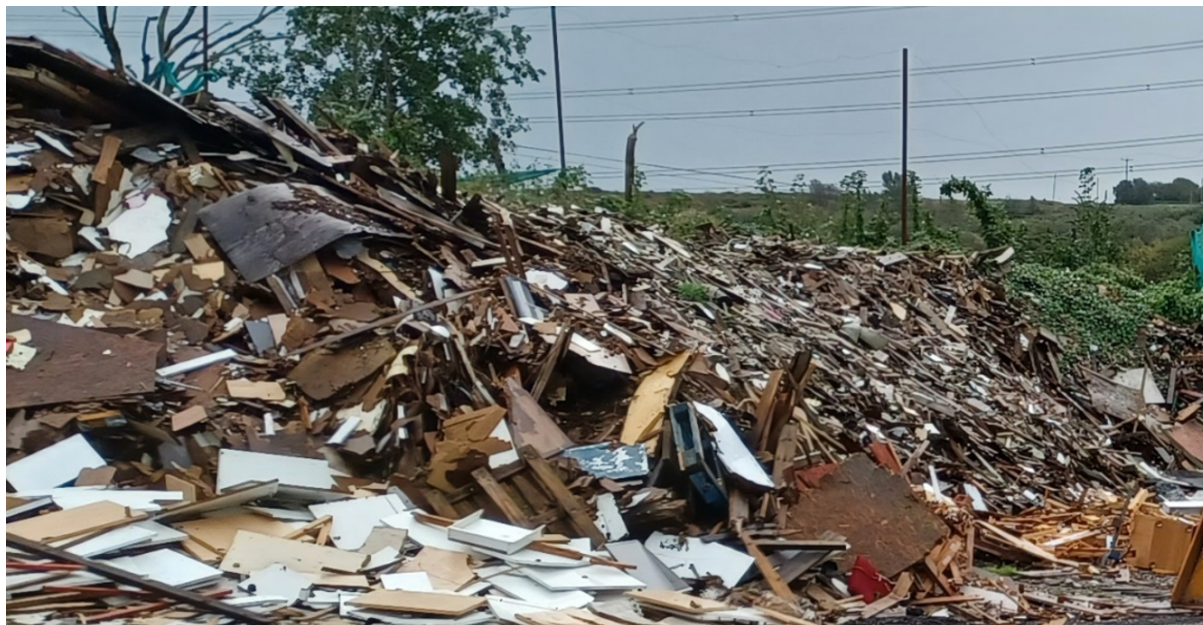
In stockpile 1, officers observed vegetation which can be seen in the below image and has also been observed by the Fire Service, therefore, this would suggest that this stockpile has been there for some time and as such, has not followed the 'first in, first out' approach as outlined in the sites Fire Prevention Plans submitted to date.

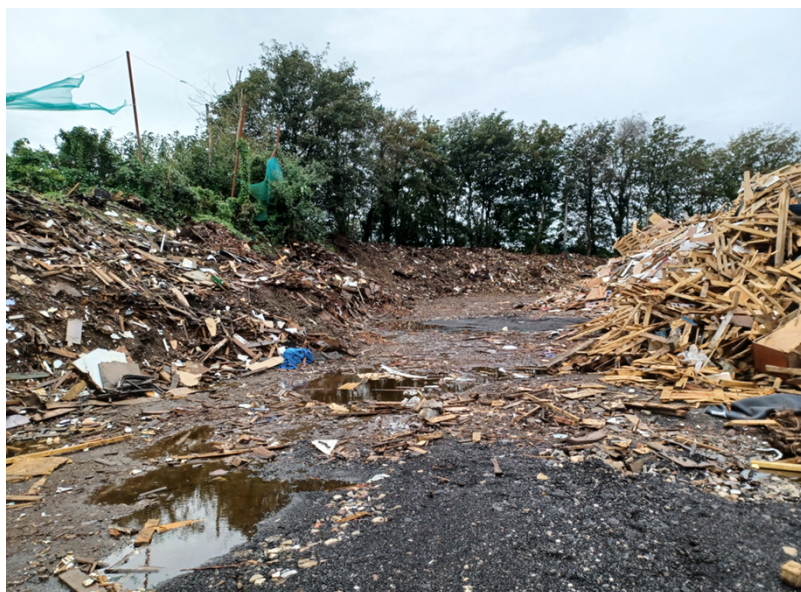
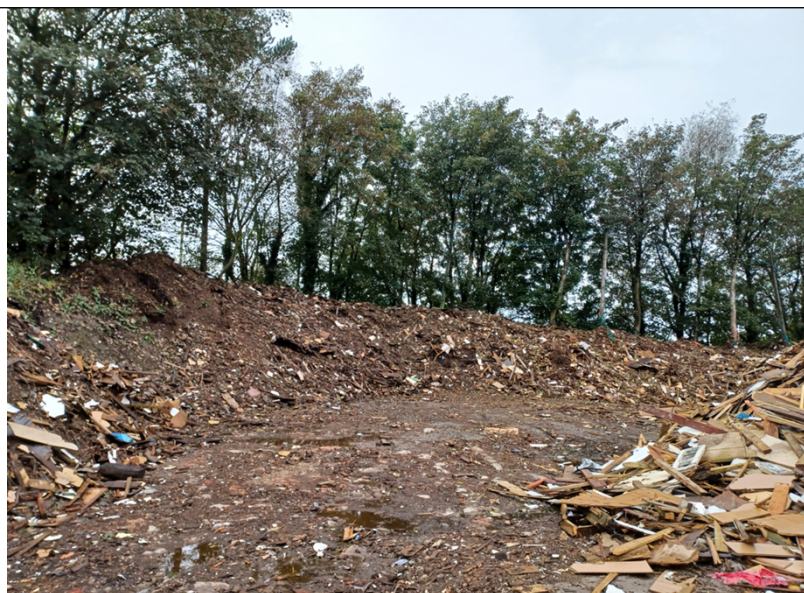
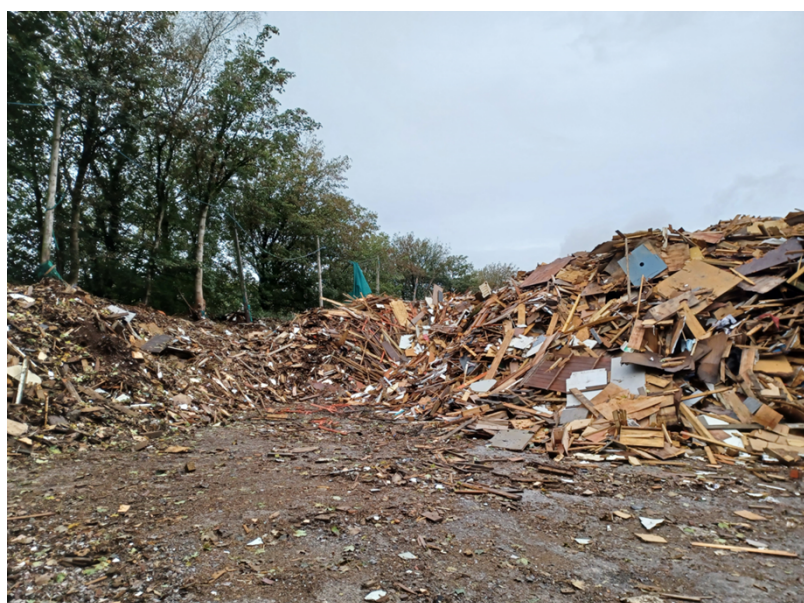
Due to the layout of the storage of waste found on site and the dimensions of stockpile 2 at the time of the visit, the far corner of the yard was impassable by officers. Please see below images which show the layout of the stockpile found on site during the visit.

In stockpile 2 being moved away from the boundary, the ground used to usually store all unprocessed wood waste was exposed and officers observed that the surface was unmade permeable ground, with uneven areas where surface water was pooling. This can be seen in the photographs included above.

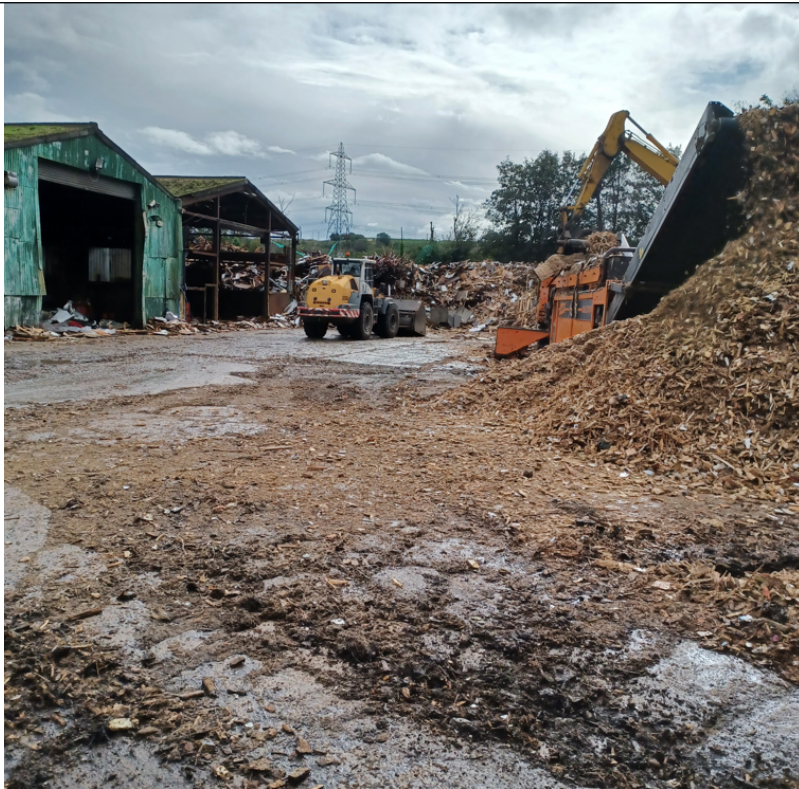
Please see below photograph taken from the other side of stockpile 2.

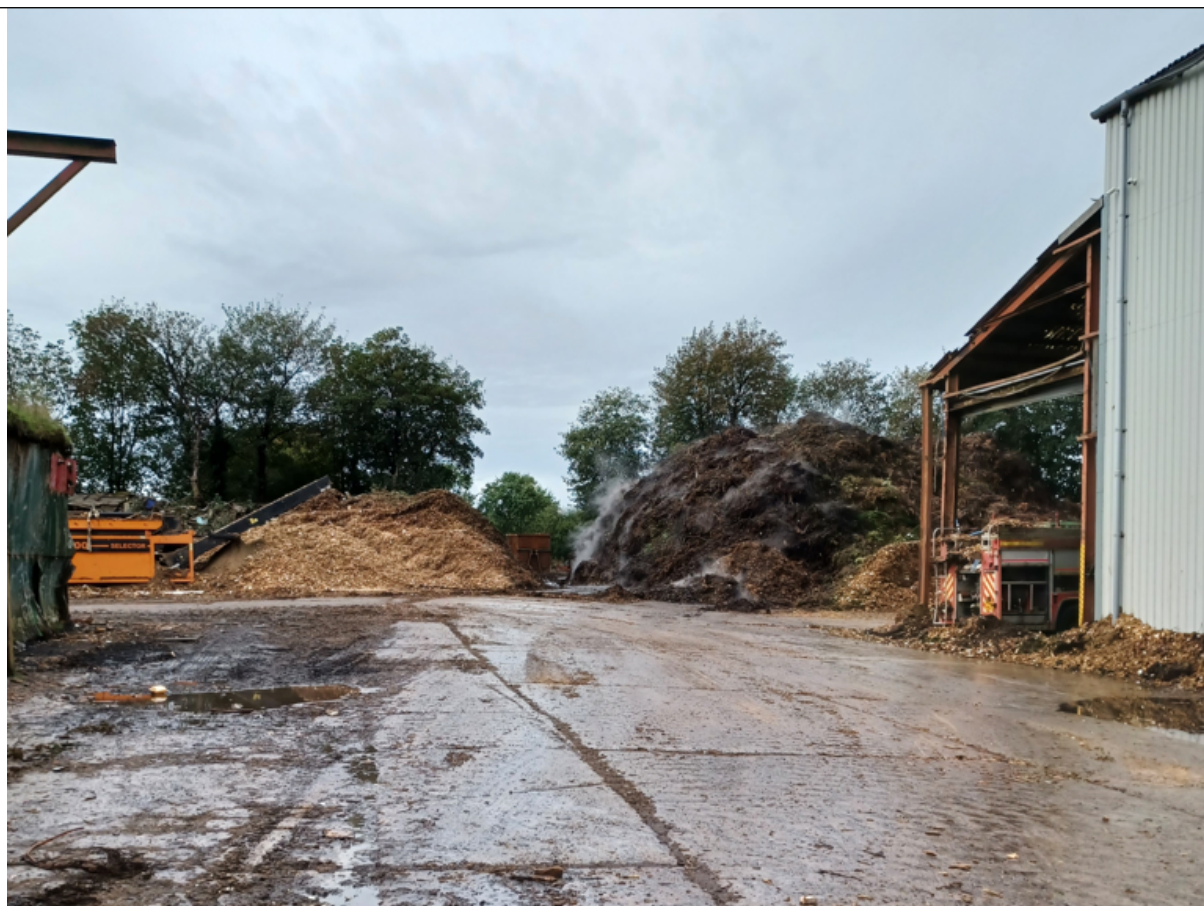
I understand, the green waste is brought to site and where there is suitable wood, this is separated and recycled with the wood, which is then recorded as a movement of 19 12 07 into the permitted site, with the remainder going for composting. Sorting is a treatment and the exemption does not allow sorting, therefore this activity would not be exempt.

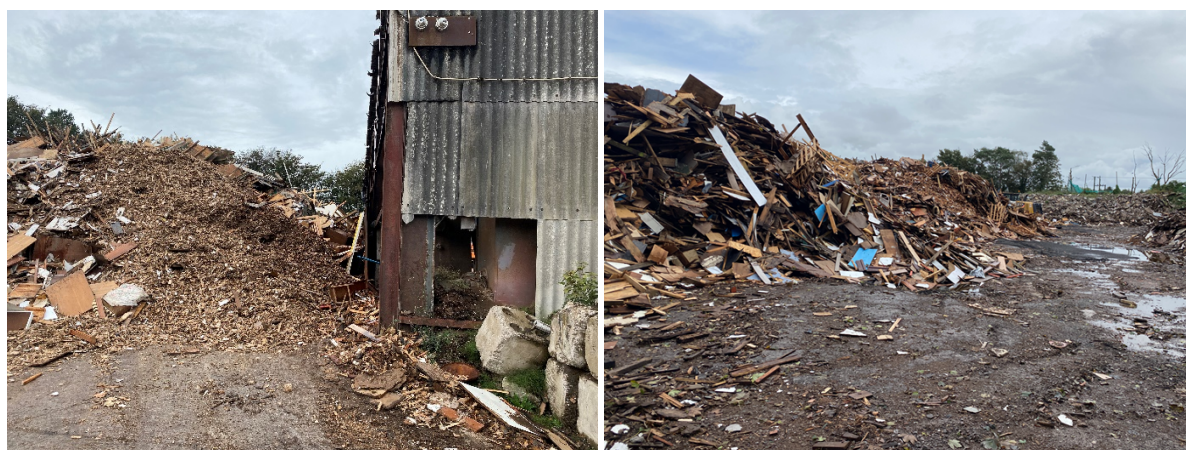
Officers observed stockpile 2 (as photographed below) to exceed the Fire Prevention Plan guidance in respect of the Length x Width x Height and found the stockpile to be within an unsuitable proximity to the building, with no appropriate firebreaks/separation distances (calculation required) between the building and the pile, the sites rear boundary, unprocessed wood, processed wood and processing.

Officer Damian Downes estimated stockpile 2 to be approximately 50m x 20m x 5m. The stockpile ran the length of the building and reached the boundary fencing at the rear of the site. Using aerial imagery, using the length of the building and distance to the rear fencing, the length has been calculated to be approximately 55.59m.

Following the visit, Natural Resources Wales were advised by the Site Manager that a de-stock of 4,389 tonnes had occurred at the site between July 2021 (date of Natural Resources Wales' last visit) and October 2021, with 1,600 tonnes remaining on site as of Friday 1<sup>st</sup> October 2021. Despite a site capacity of 5,000 tonnes, as outlined in the sites Environmental Management System, the wood waste was not being stored in line with the Fire Prevention and Mitigation Plan guidance.

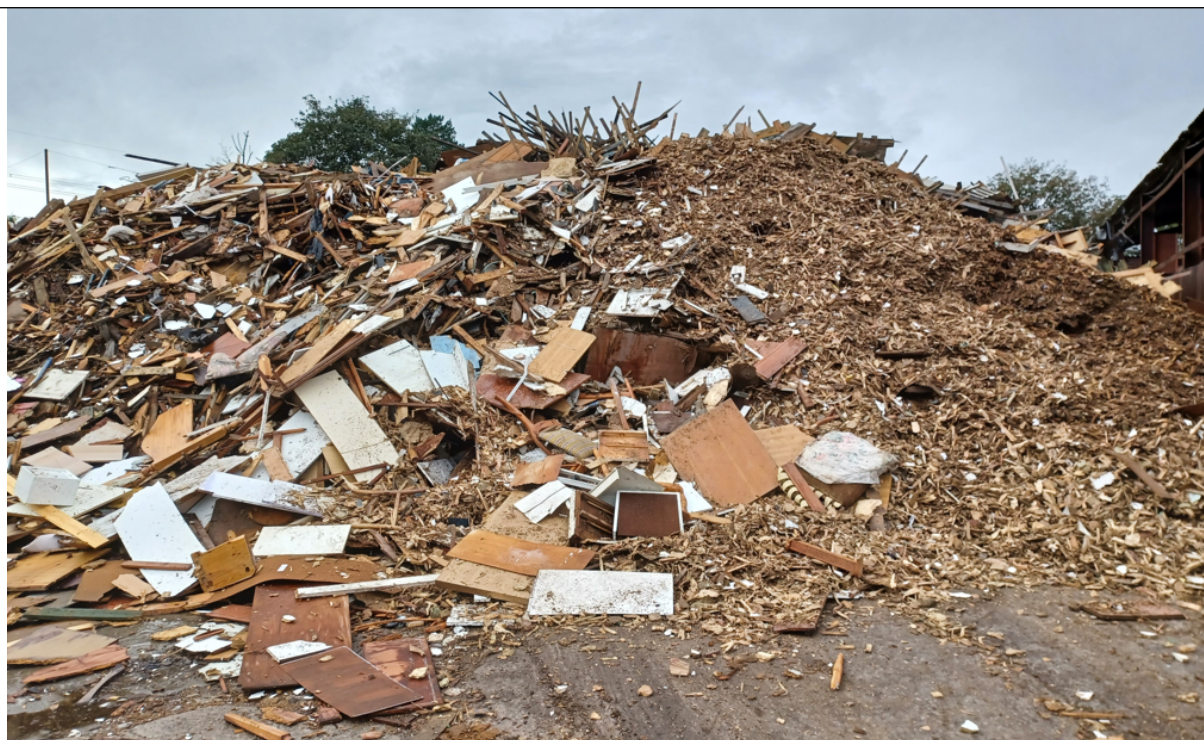
Furthermore, please see below photograph demonstrating the way in which waste wood was being stored on site during the visit, prior to processing. I note, there was waste wood that has been processed amongst unprocessed waste wood. The risk of self combustion is higher in processed wood and would therefore increase the risk of self combustion of the entire stockpile and would reduce storage time to 3 months.
