## Compliance Assessment Report

Report ID:  
CAR\_NRW0033799

| Site | Bridgend Paper Mill EPR/EP3738NG | | Permit Ref | EP3738NG | |
| Assessment type | Audit | | | | |

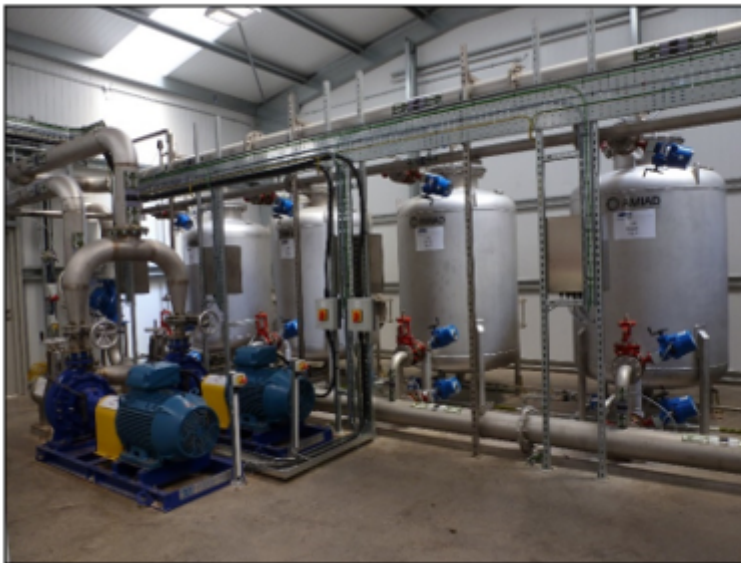
The new water treatment plant for the incoming river water to the mill had just entered another 90-day commissioning period. The operator explained that several mechanical issues had been encountered which included a breakdown of the individual backwash valves. The valves have since been replaced and the plant operated for a full week prior to the NRW visit. During the week of full operation, the operator saw an improvement in filtration and water efficiencies that could be gained from the new plant after commissioning. During the site tour the operator's contractor who is managing the project on their behalf was represented by Dave Robertson who provided an overview of the configuration of the plant. The contractor explained how there is a level gauge in the mills holding tank or 'spider tank'. When the water level drops the pumps automatically kick in and ramp up to top up the tank and this was reflected on the dedicated water meter. Paul Riley the mills facilities Engineer also met with NRW at the new plant and a discussion was had on the difference from the old sand filtration system to the new package plant that uses glass as a filter media. The senior process technologist was also able to provide an update on the initial efficiency of filtration results which were looking good from dirt and silt of around 29mg/l from the sand filter to <1mg/l using the new plant.

Prior to the site tour it was advised that one of the filter beds was still in operation while the new plant is being commissioned. Following this current 90-day commission it is expected that the new plant will be handed over to the mill subject to training. The issues experienced with the new water filtration plant have had an impact on water usage and this was evident in the figures report in the 2017 annual report. Long term however this will improve as the efficiencies are realised when fully operational.

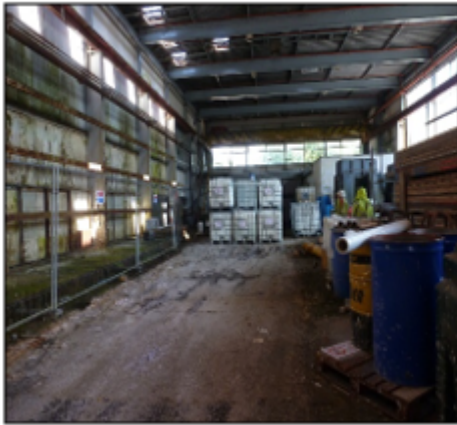
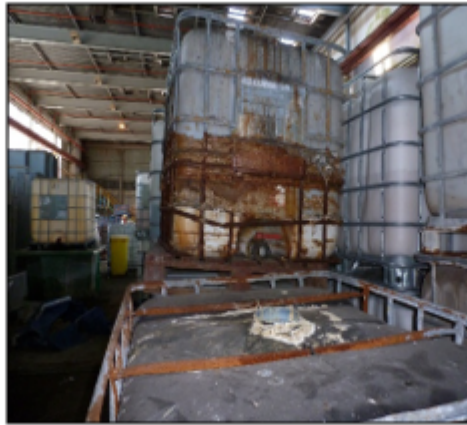
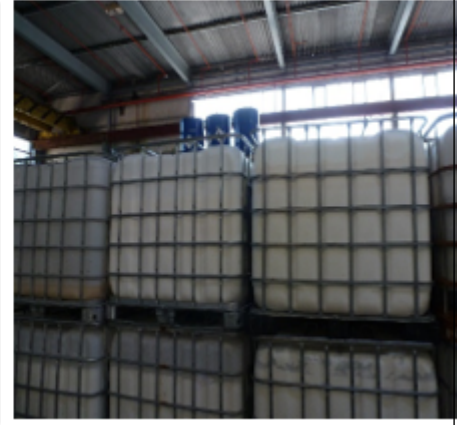
It was unclear if the Intermediate Bulk Containers (IBC) at the rear of the stored hazardous waste material were out of service and needed to be disposed of due to corrosion. Drums displaying hazardous properties (HP14 Ecotoxic) were stored on top of IBC's which had been isolated from the pile as more containers were placed in front. The following photographs were taken in the 'AGV' storage area showing waste stored in the building, the corroded containers which could fail if used and below left the blue hazardous drums on top of the pile.

**Action:** Operator to review the suitability of the storage of both hazardous waste in preparation for disposal and the raw materials / chemical store beneath Jonathan basement stored on top of unprotected drainage.

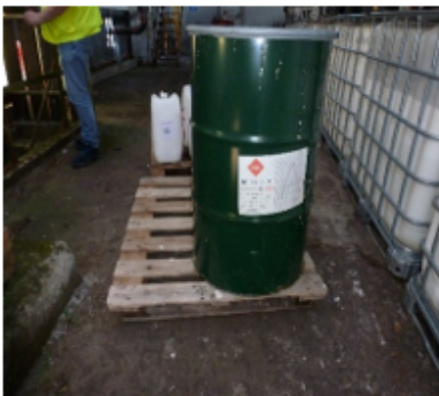
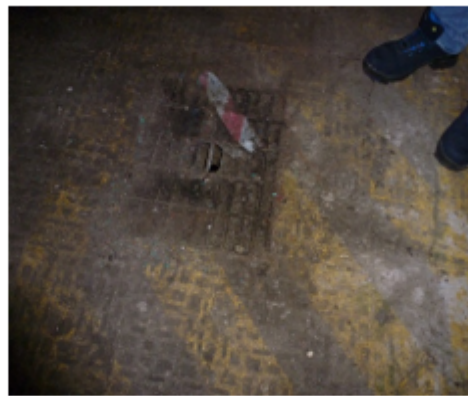
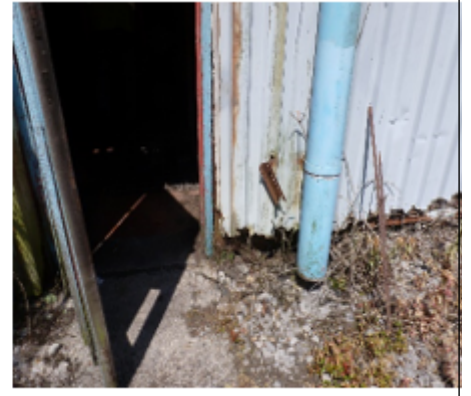
The stairs to the 'AGV storage' basement can be seen in the far-left photograph (boarded at the top and left of the green drum). The middle photograph below shows one of the blocked drains around the hazardous waste storage area and the open door across the floor to the nearby river. In the event of an incident it was considered that there was a real potential for the mobilisation of the hazardous waste along the pathway of nearest resistance through the open door to ground and the river. It is understood that anything entering the drains would initially enter the ETP however it would take manual intervention and reliance on a reactive response which could also knock out the plant. A preventative approach to secondary containment is required, and is discussed further below.

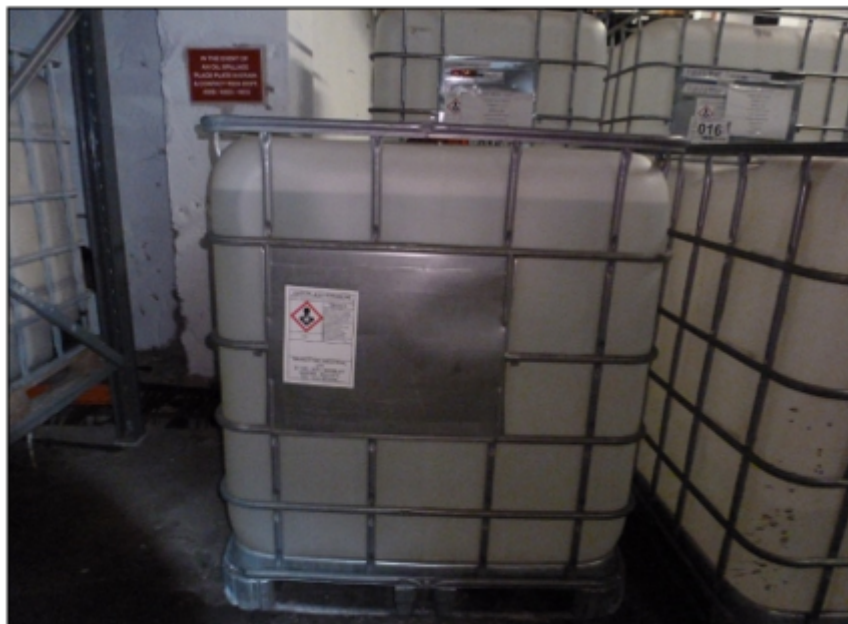
A request was also made by the inspecting officer to view the hazardous chemical store at the mill. KD was shown the area beneath 'Jonathan' (name of paper machine no-longer at the mill) basement which is being used to house incoming chemicals, inks, oils etc. used in the process. There was also some waste stored here, but it was mainly a store for incoming raw materials. The immediate concern was that the basement had been utilised and not originally designed for its intended use and contains numerous drainage lines along the floor for its original use. There was a flow of water through the drains and the operator explained that they all go to the ETP. It was apparent that space was at a premium in the basement and pallets of inks and hazardous materials in drums and IBC's had been placed on top of the drains. IBS's of kerosene used to wash the paper machine felt were also present and there was a sign on the wall which states that 'In the event of an oil spillage place plate in drain and contact Tech Dept 4519/4583/4615'.

The photograph opposite was taken of several IBC's of kerosene next to a drain with the red sign on the pillar advising of manual intervention in the event of a spill. If there was a significant incident such as a fire for example it is unclear how this place plate would be placed in the drainage line.

The current situation concerning the Jonathan basement and hazardous waste storage area is considered a category 2 breach of permit condition 3.2.3. the permit condition has been replicated below for ease of reference:

All non-compliances (except those relating to amenity) are categorised on their reasonable foreseeable impact on the environment and not their actual impact. A category 2 breach is a noncompliance at a regulated site that could foreseeably result in a significant incident. It is considered that in the event of an incident and the loss of the hazardous inventory within the Jonathan basement through a large spill or a fire there is unprotected drainage direct to the effluent treatment plant and controlled waters which relies upon manual intervention and a reactive response.

**Action:** Operator to provide NRW with an inventory of the materials held within the Jonathan basement.

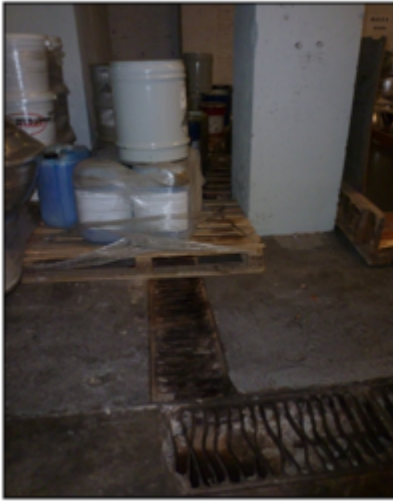
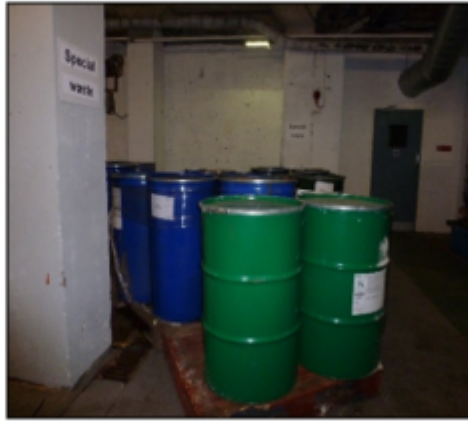
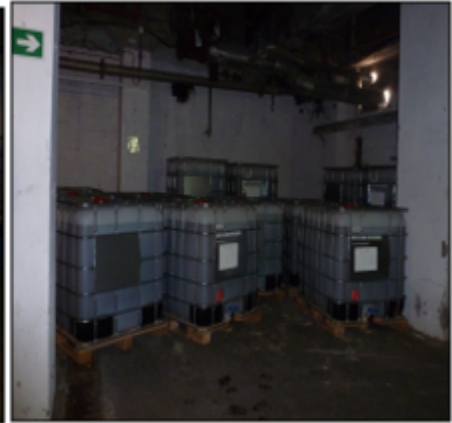
The following photographs were taken during the site tour and show drums of hazardous raw materials including inks on top of unprotected drainage. There was a flow of water within the drain

at the time of the visit. Although the drains go to the effluent treatment plant it would take manual intervention to control a discharge which would be reactive rather than a preventative measure. Space is at a premium and numerous full IBC containers and drums were on the basement floor. There was some racking for IBC containers however hydraulic oils, kerosene and other chemicals were also being stored on top of drainage. In the event of a significant incident it is considered that there is a foreseeable risk to the environment.

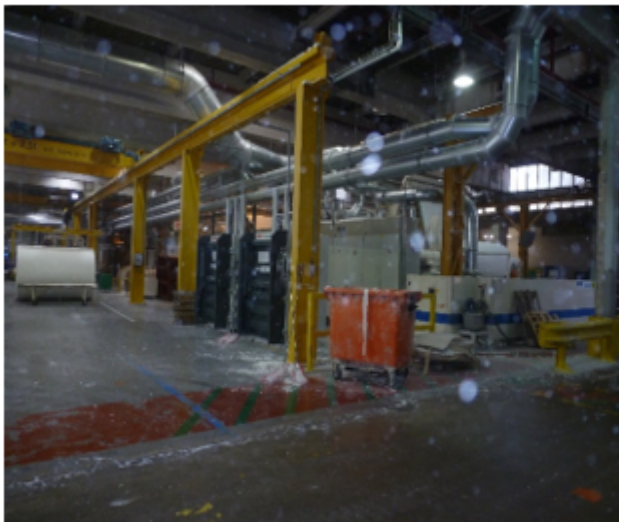
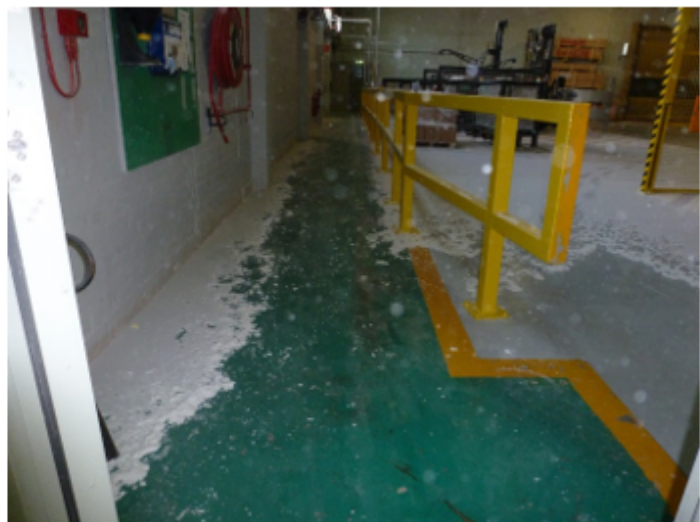
It was good to see the fruition of a capital expenditure project at the mill with 2 new converting lines which were proposed at the last NRW visit. A new state of the art converting line (line 20) is now in place and in production. The line has a flying splice and a swing arm on the package line which can accommodate both toilet and kitchen roll. The line is faster however due to the premium product (soft tissue) produced by 'Jupitar' (paper machine) dust has again become an issue with no extraction in this location. Dust needs to be managed carefully as it can cause fires which in turn can be environmentally damaging. The management of dust continues to be high on the agenda of the EA paper and pulp sector group which NRW still attends for regulatory consistency. The following photographs were taken during the site tour in the converting hall and show the dust falling in the picture as it was prevalent within the air and a noticeable greater than in the last visit. The operator explained that dust is blown down daily and this was evident on the converting hall floor ready to be picked up. This can be seen in the photograph below right.
