Mr Peter Kaminaris, Senior Property Surveyor,
Economy, Treasury and Constitution Group
Business and Regions, Property Infrastructure..

CEDM Ltd
Shoreline Management
Wales

SA1 SOUTHERN REVETMENT REPAIR	
LOCATION(s) SA1 - SWANSEA WATERFRONT	
DECEMBER 2025	AREA PLAN & SECTIONS

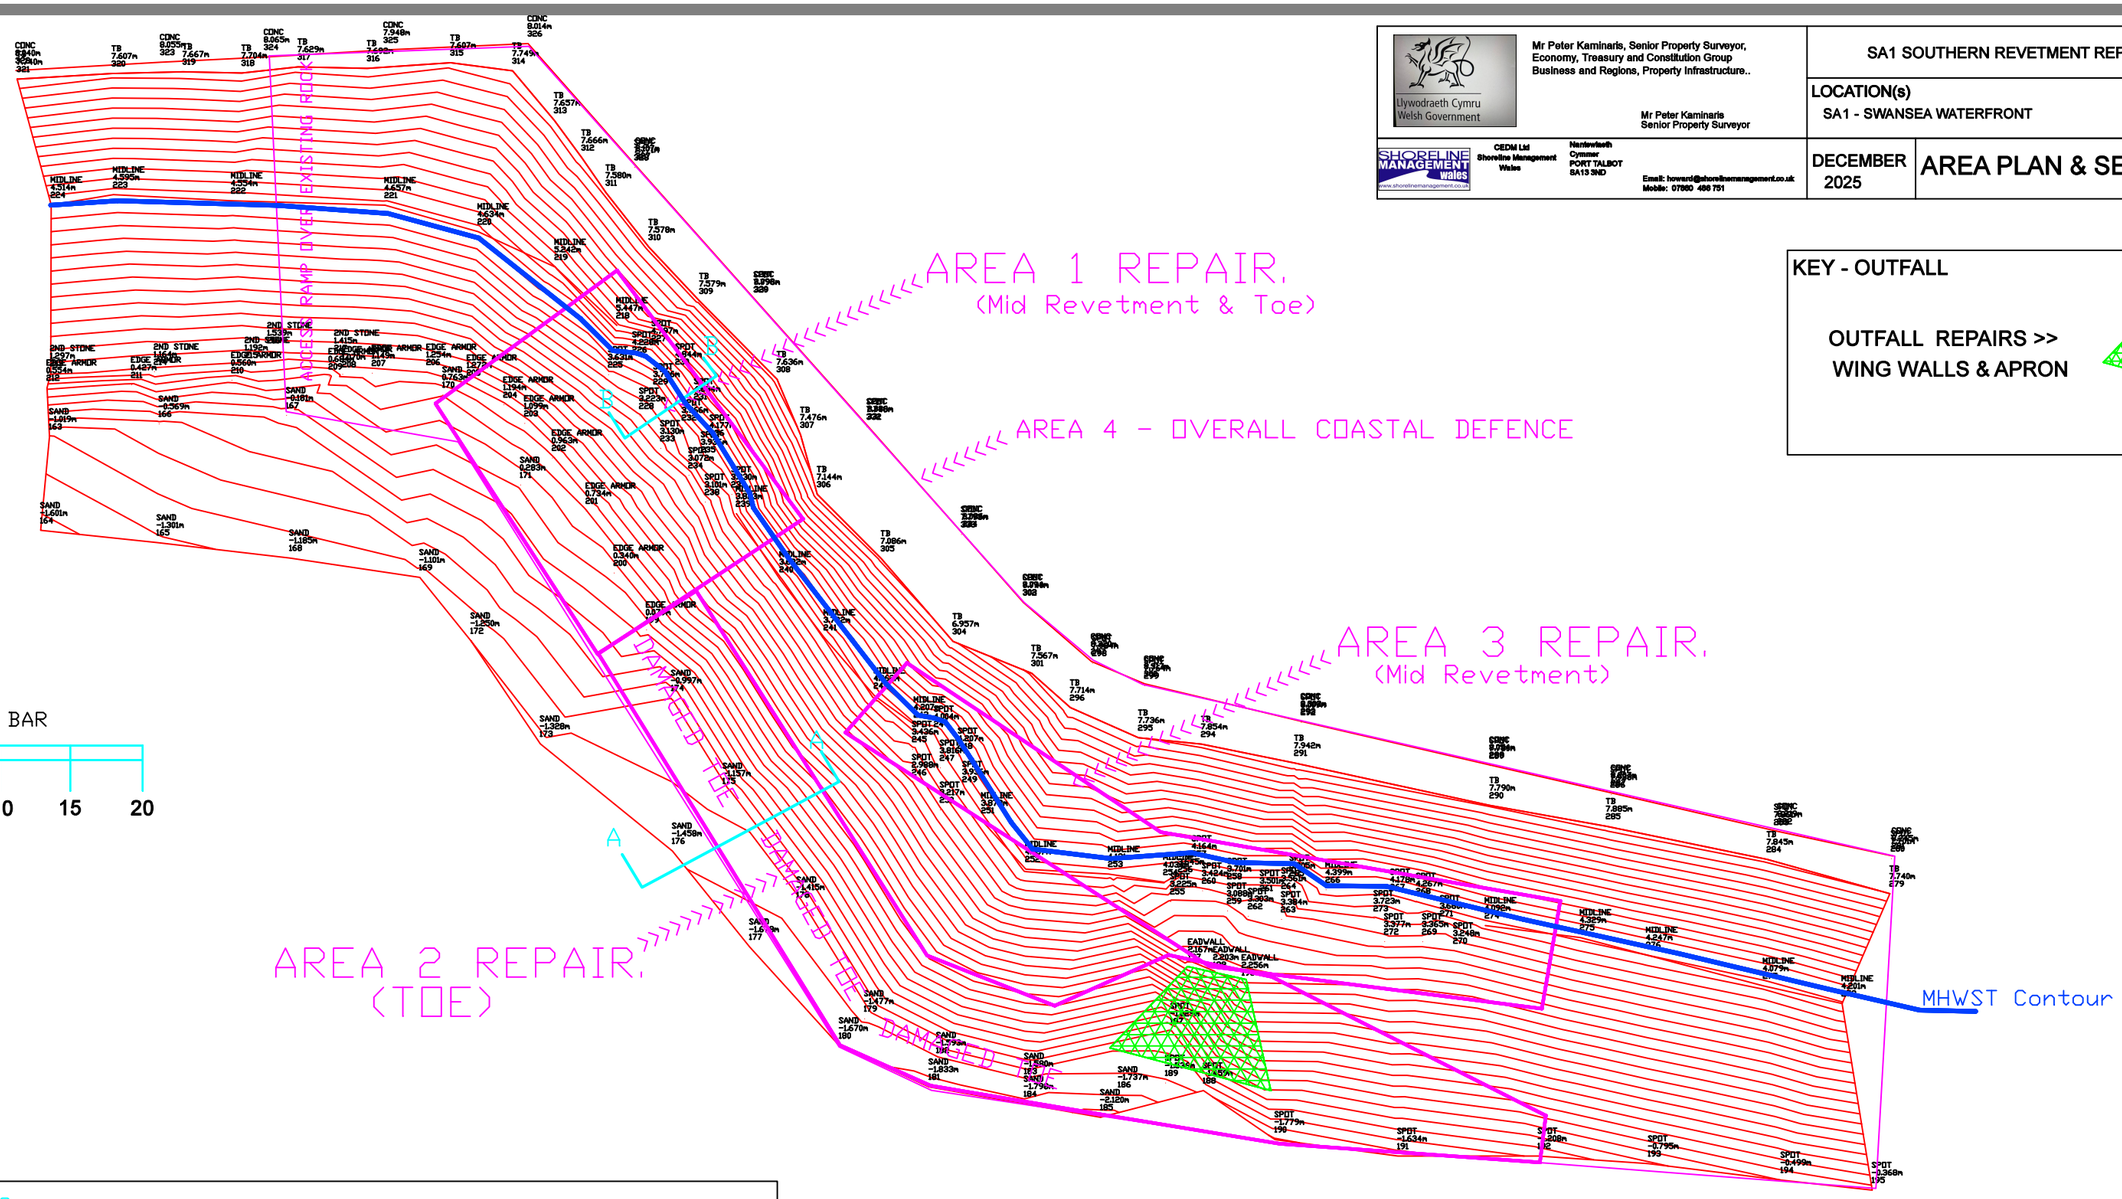
OUTFALL REPAIRS >>
WING WALLS & APRON

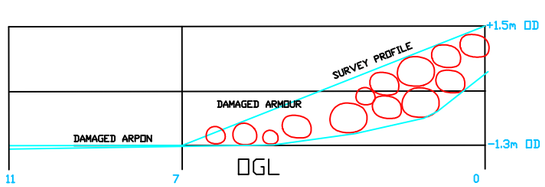
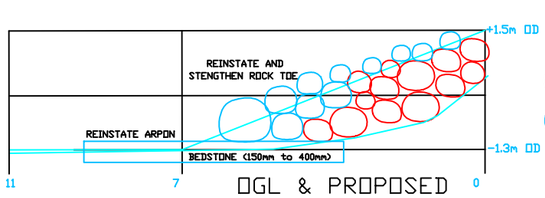
SECTION AA NTS:

AREA 2 and LOWER PART OF AREA 1 (Toe)
(X3 SCALE)

NEW ROCK ARMOUR - 0.5T to 3.5T

BEDSTONE (150mm to 400mm)

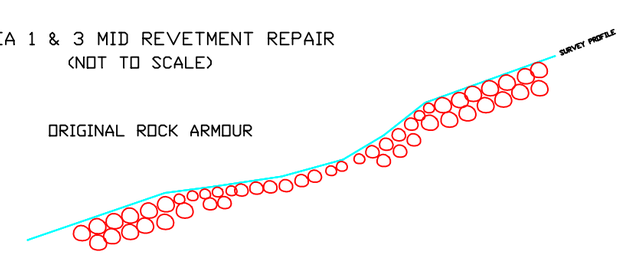
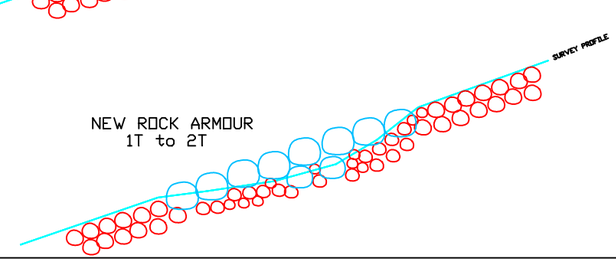
SECTION BB NTS:

AREA 1 & 3 MID REVETMENT REPAIR
(NOT TO SCALE)

NEW ROCK ARMOUR
1T to 2T

NEW ROCK ARMOUR - 1T to 2T
