GHR Developments Limited

Virginia Park, Phase 1A Areas 1 and 2, Caerphilly

Reclamation Validation Report

12476/GNS/24/RVR

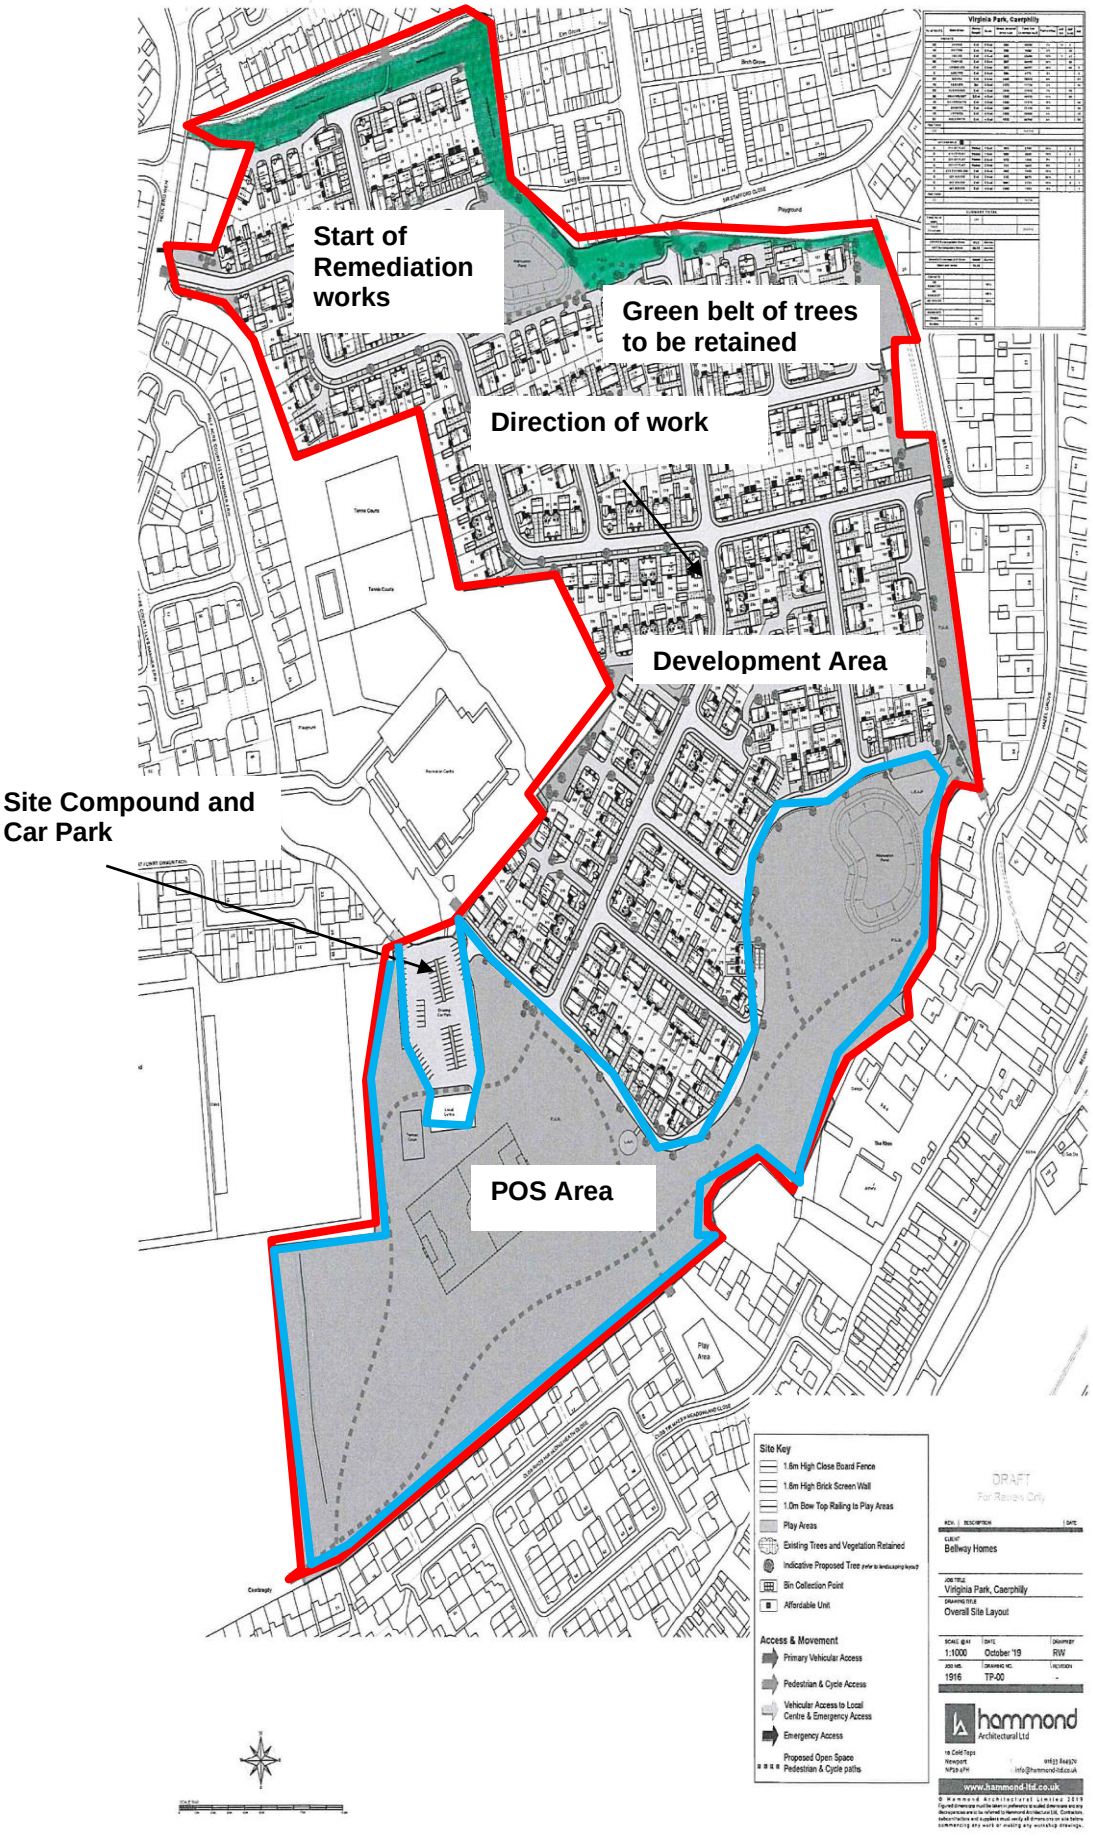
Figure 2: Development plan for the site

It should be noted that the eastern section of road within Phase 1A that borders Phase 1B and Phase 2 (see Figure 2) has been reclaimed and the landfill materials and underlying peat removed. However, since deep drainage needs to be constructed beneath the road, this part of the site currently remains low and will need to be brought up to finished levels once the drainage has been installed.

It should also be noted that a strip of land that borders the southern edge of Phase1A and Phase 2 (see Figures 2) in which the substation is to be constructed, has been reclaimed and the landfill materials and underlying peat removed. The ground has been brought back up to a level, but the upper 1m needs to be excavated and recompacted to finished ground level, in well compacted layers, in accordance with the earthworks specification.

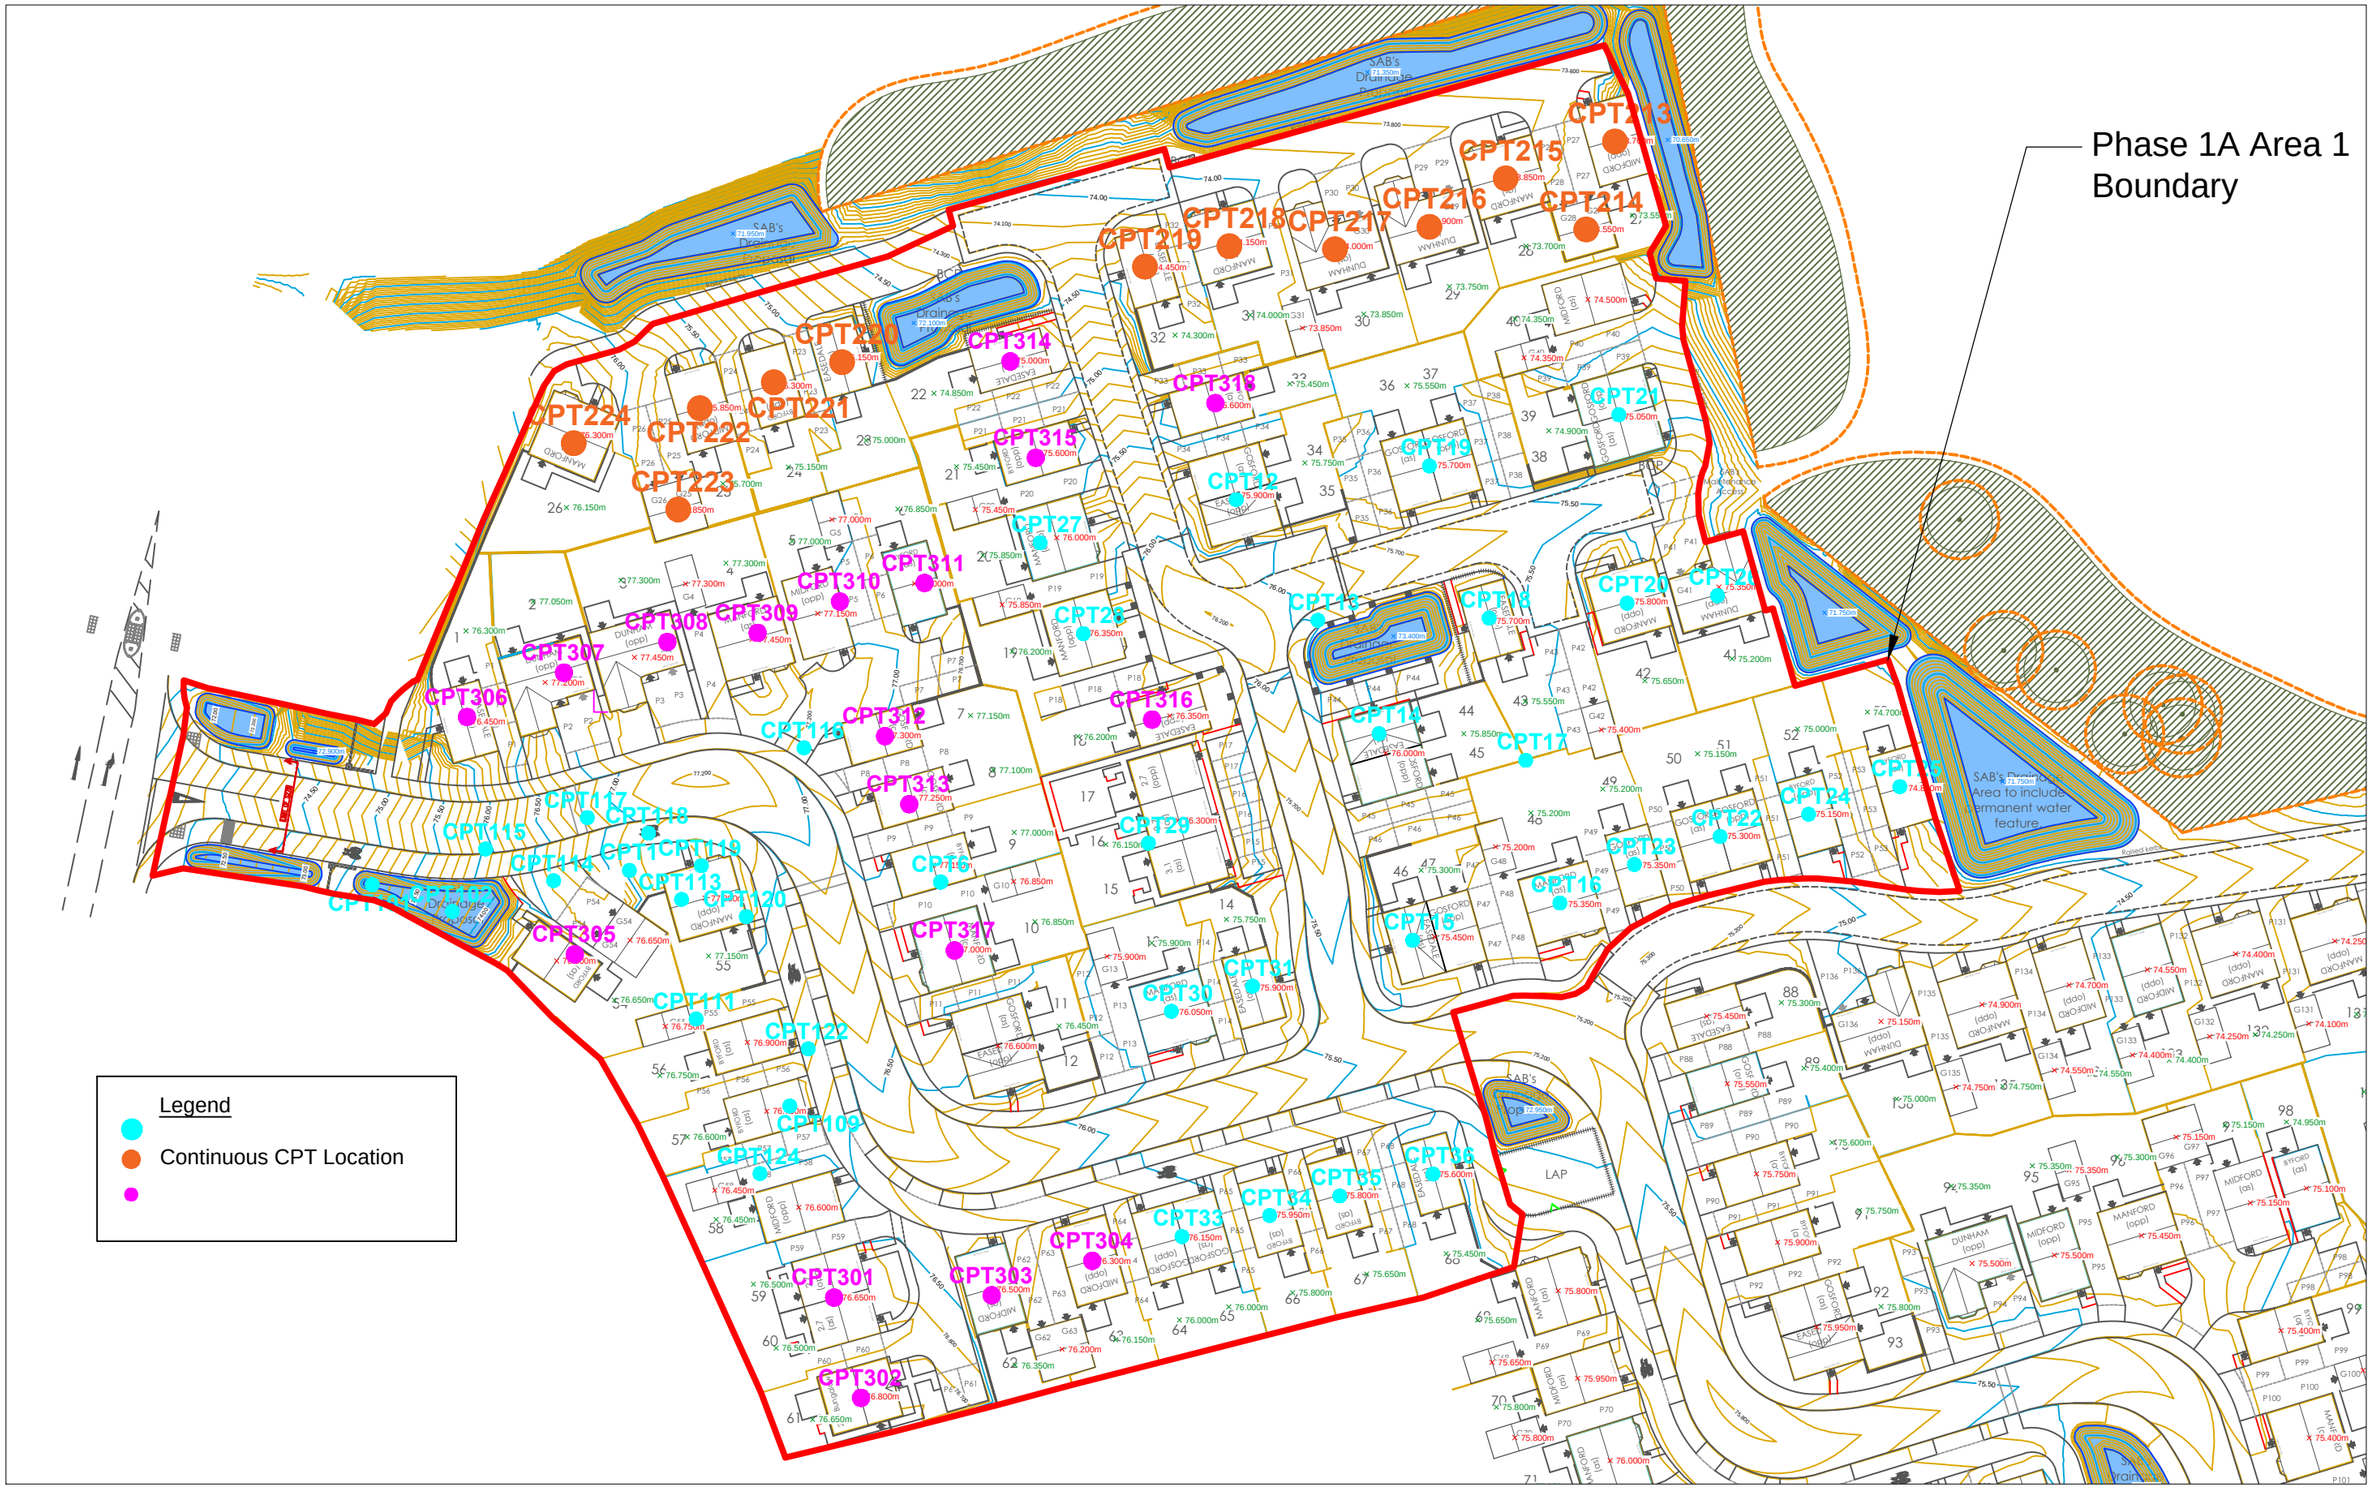
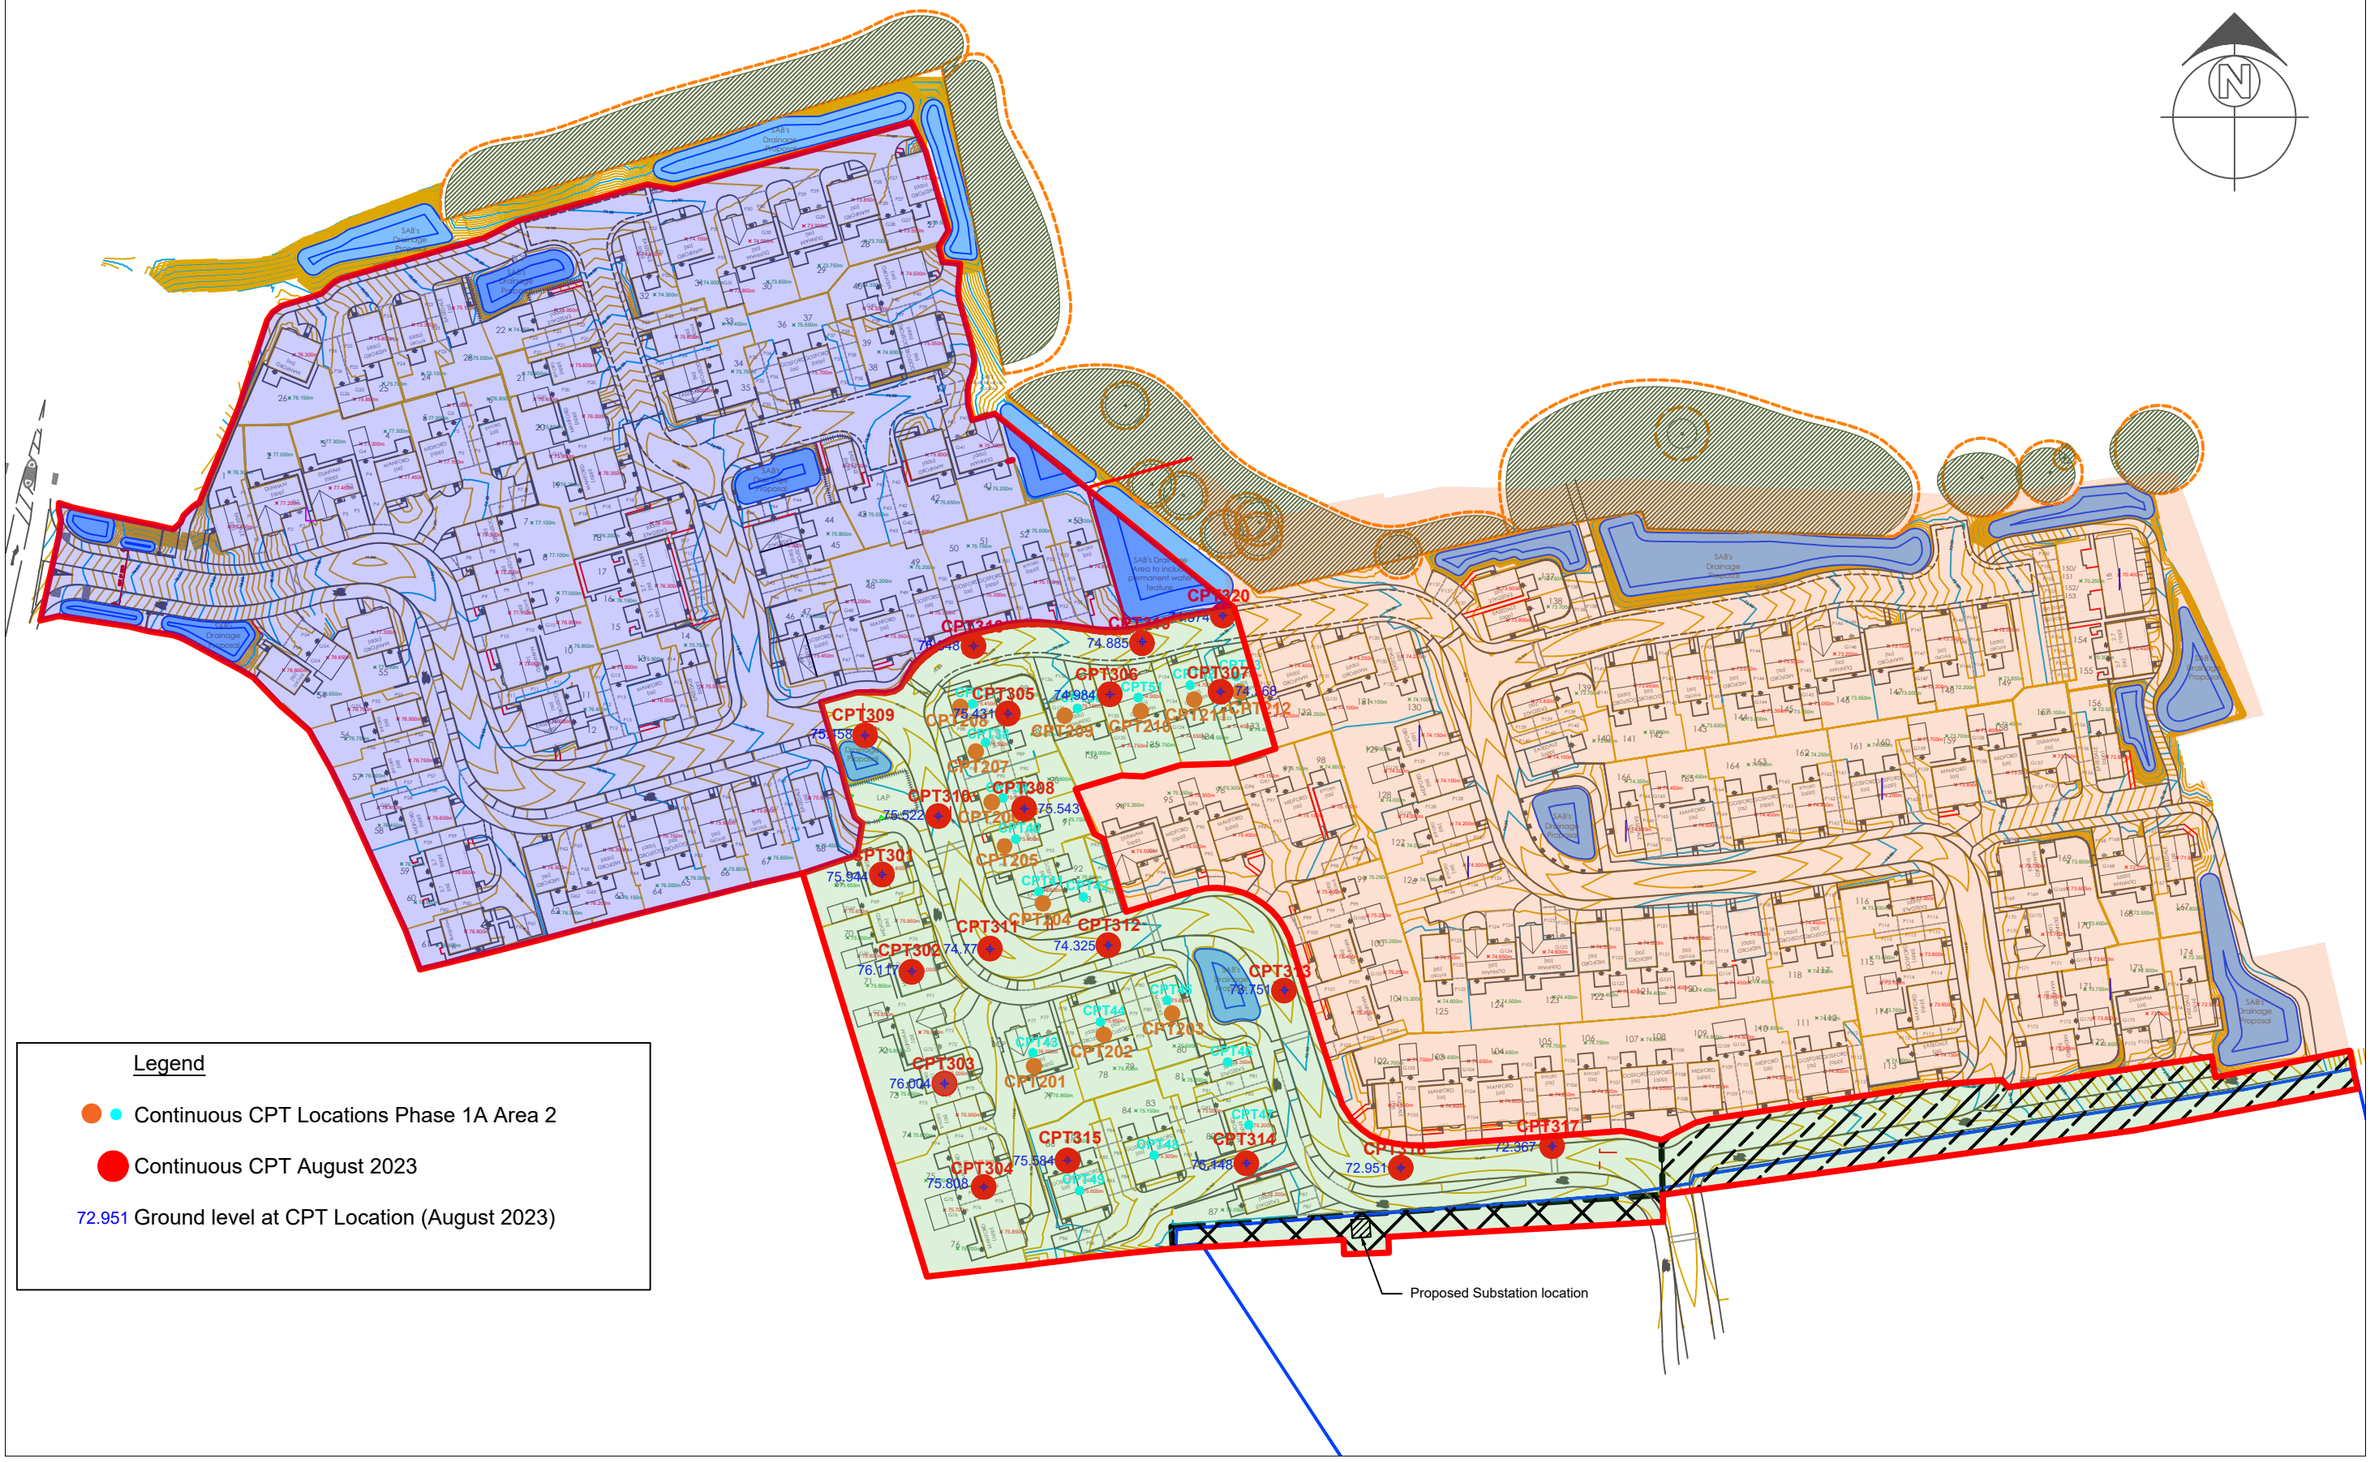
Figure 3A Phase 1A Area 1 - Continuous Cone Penetration Test Locations

The continuous CPT testing reported N values of >5 (typically >10) in the top 2.0m of the engineered fill, which is considered satisfactory when considering the foundation proposals to be adopted on site.

- CPT tests 37 to 53 – some soft spots identified. Materials excavated and replaced.
- CPT201 to 212 – placed materials identified as consistent and satisfactorily compacted.

If the initial CPT testing identified a soft spot at the CPT locations the area of the failed test would be investigated and any soft spots replaced with suitable structural fill at the location. The location would then be retested to confirm the adequate placement of engineer fill.

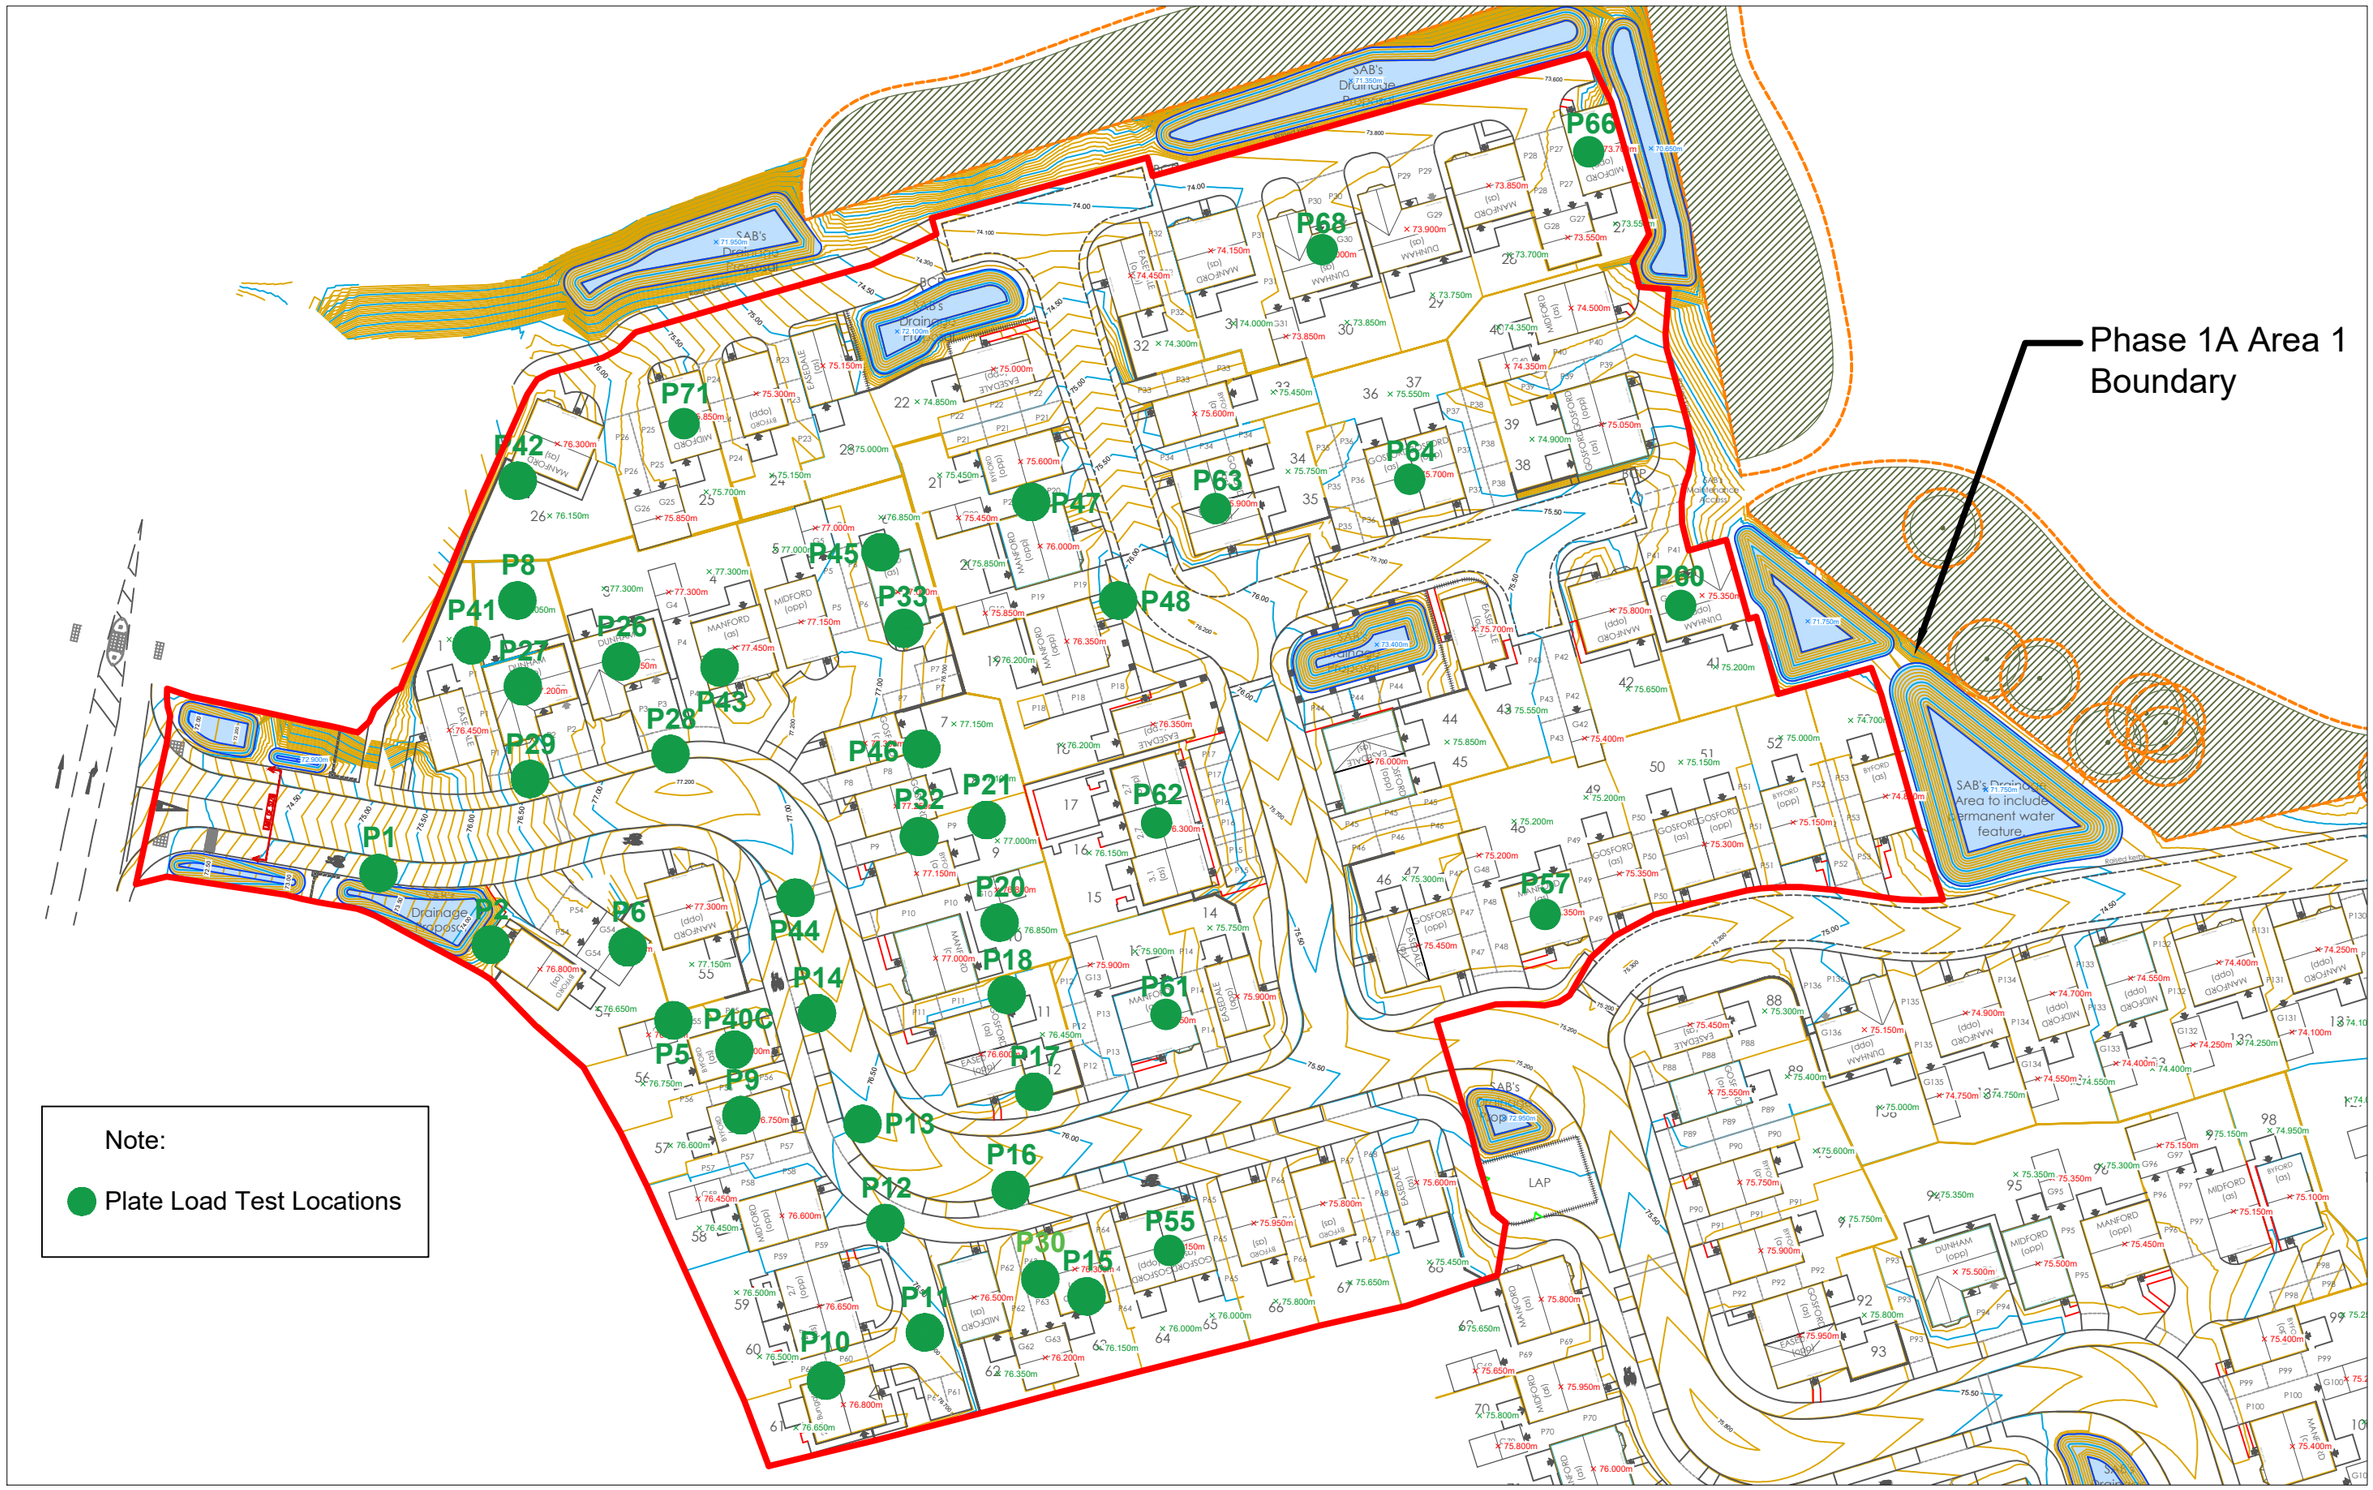
Figure 3C Plate Load Tests Locations

Plate load testing was completed in Area 1 only. The plate load tests were taken to a maximum applied pressure of typically 150kN/m^2 in three load cycles. The results have been summarised and are presented below in Table 1. Where tests originally failed, placed materials were excavated, conditioned and placed again in thin layers. The area of plate failure was re-tested following the conditioning works.

Following the remedial works above and at the recommended maximum allowable bearing pressure of 50kN/m^2 average settlements ranged between 0.69mm up to 3.34mm.

If the initial plate load testing identified a soft spot at the plate test locations the area of the failed test would be investigated and any soft spots replaced with suitable structural fill at the location. The location would then be retested to confirm the adequate placement of engineer fill.
