EAST WASTE MANAGEMENT SITE, LLANWERN STEELWORKS

PERMIT EAWML/30003

Annual Review of Environmental Monitoring for 2025

Report Number 2462r1v1d0226

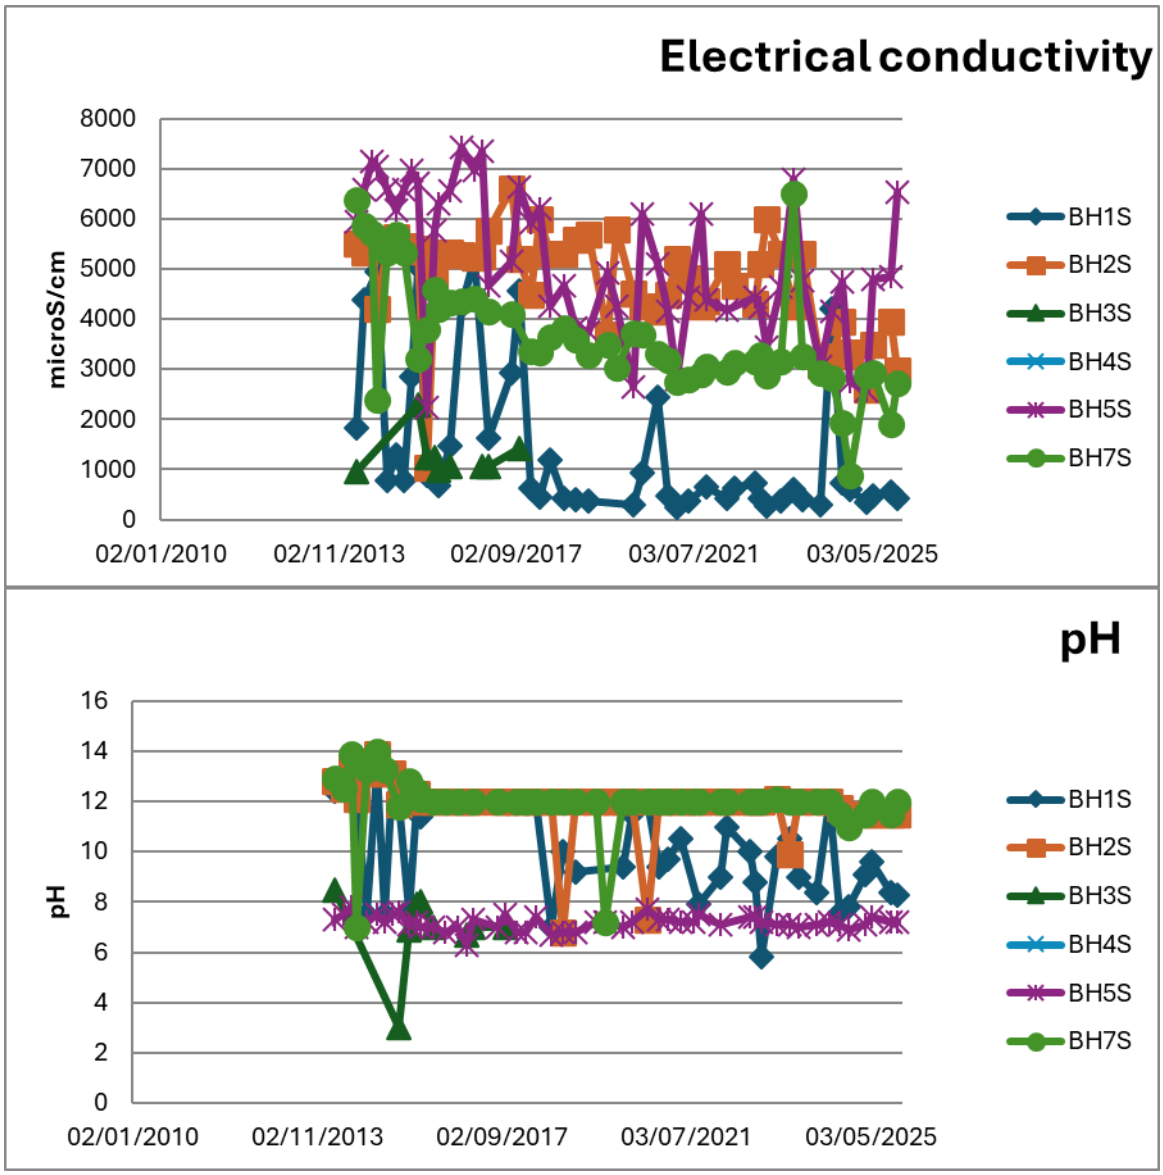
Plate 8-1 Groundwater Chemistry

As noted previously, groundwater in close proximity to the landfill typically contains low levels of non-hazardous substances which sometimes exceed Environmental Quality Standards. Short-term fluctuations in the concentration of several parameters including ammonia, phosphate, Cr, Cu, Fe, Pb, V and Zn has occurred in recent years but the lack of persistently elevated levels is considered to reflect the nature of the waste and the alkaline pH. There is no clear long-term upward trend evident, and some parameters have reduced in concentration. The highest concentrations tend to be found at BH5 and BH7, and also sometimes BH2. This latter borehole is located to the west of the landfill on the opposite side of the works access road and cut-off drainage ditch. As a consequence, the groundwater chemistry at BH2 may be influenced by other areas and processes.

The precise cause of the short-term variations in concentration is unclear at this stage but the initiation of capping in the south may be influencing groundwater quality in the shallow aquifer. The variations could also be due to variable leaching of the waste mass in response to vegetation being cleared ahead of capping and also subtle changes in groundwater levels causing flushing of secondary precipitates.

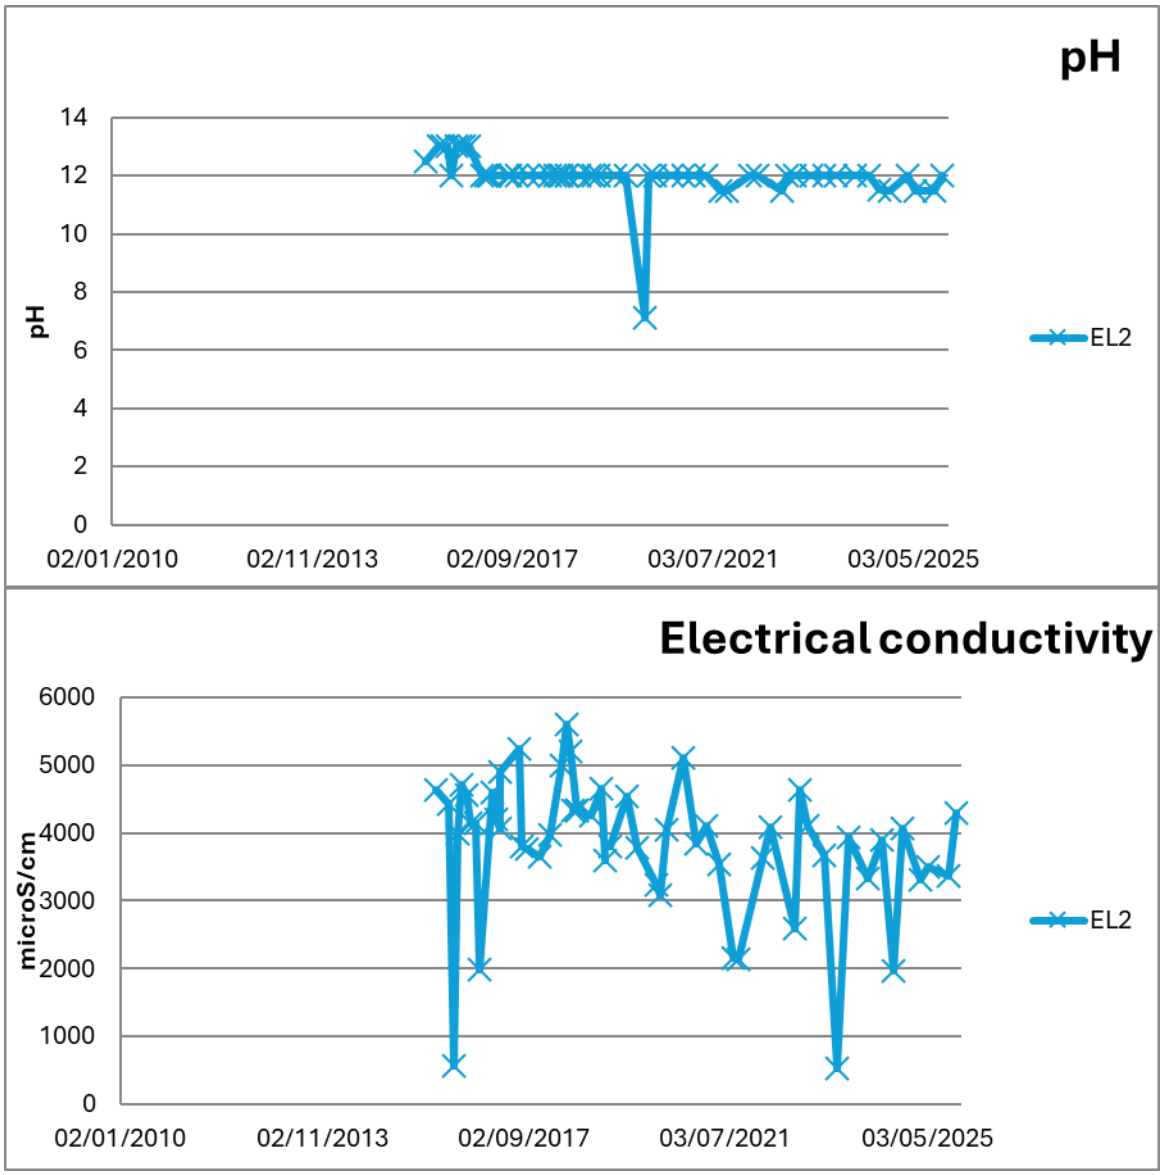
Plate 8-2 Chemistry of drainage ditch

As anticipated, the monitoring reveals that surface water running in the leachate collection ditch is dominated by leaching of slag wastes and is characterised by high pH, alkalinity and calcium and low metals. The mobility of many metals will be reduced under the alkaline conditions, although some, such as aluminium, is detectable. This may be influenced by the ability of some metals to forms oxyanions.

The ditch water has a pH that is persistently over 12 and EC typically over 3000 microS/cm and dominated by a Ca-HCO_3 hydrochemical signature, as the leachate has passed through steelmaking slags with soluble alkaline phases. Since 2021, the leachate sample has become slightly more dilute than that encountered in previous years, possibly due to the influence of the capping completed to date. Ammonia and phosphate have been impersistently detected at elevated concentrations but most trace metals are at low levels, due to the strongly alkaline conditions. In May, alkalinity spiked to 2600 mg/l but this concentration has not persisted.
