SOUTH SIDE QUEENSWAY WASTE MANAGEMENT SITE, LLANWERN STEELWORKS

2025 Annual Review of Environmental Monitoring

Report Number 2462r2v1d0226

February 2026

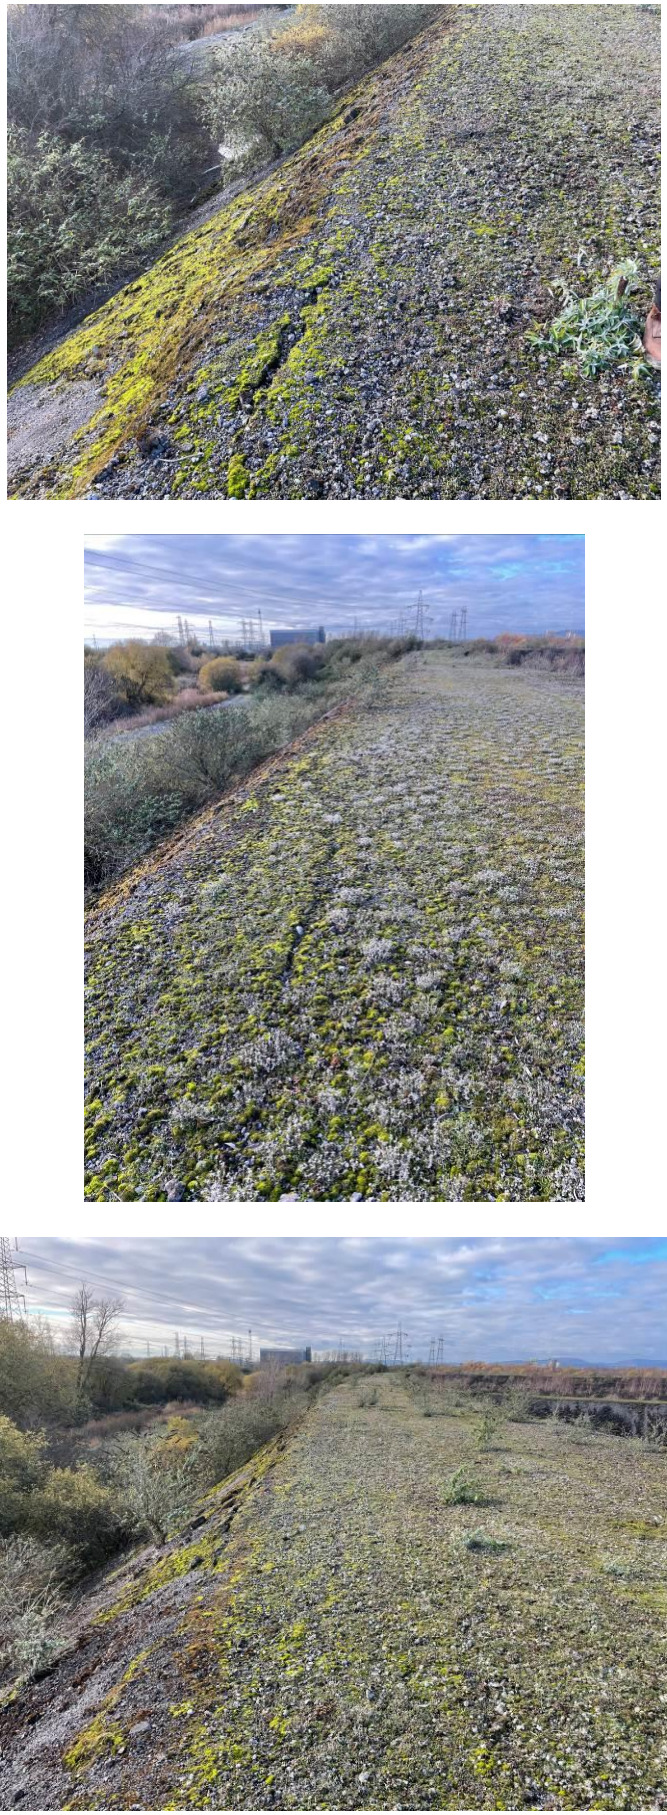
Plate 4-1 Tension Cracks on Surface of Embankment of Lagoon 27

However, in recognising that there is a possibility that part of the eastern bund of Lagoon 12 is not cemented and could have an inadequate Factor of Safety (though failure is not indicated) there should be an annual walk-over each springtime to look for evidence of shallow translational slips.

During the 2022 walkover, tension cracks on the upper surface of the embankment of Lagoon 27 were observed, as shown in Plate 4-1. These have not notably changed.

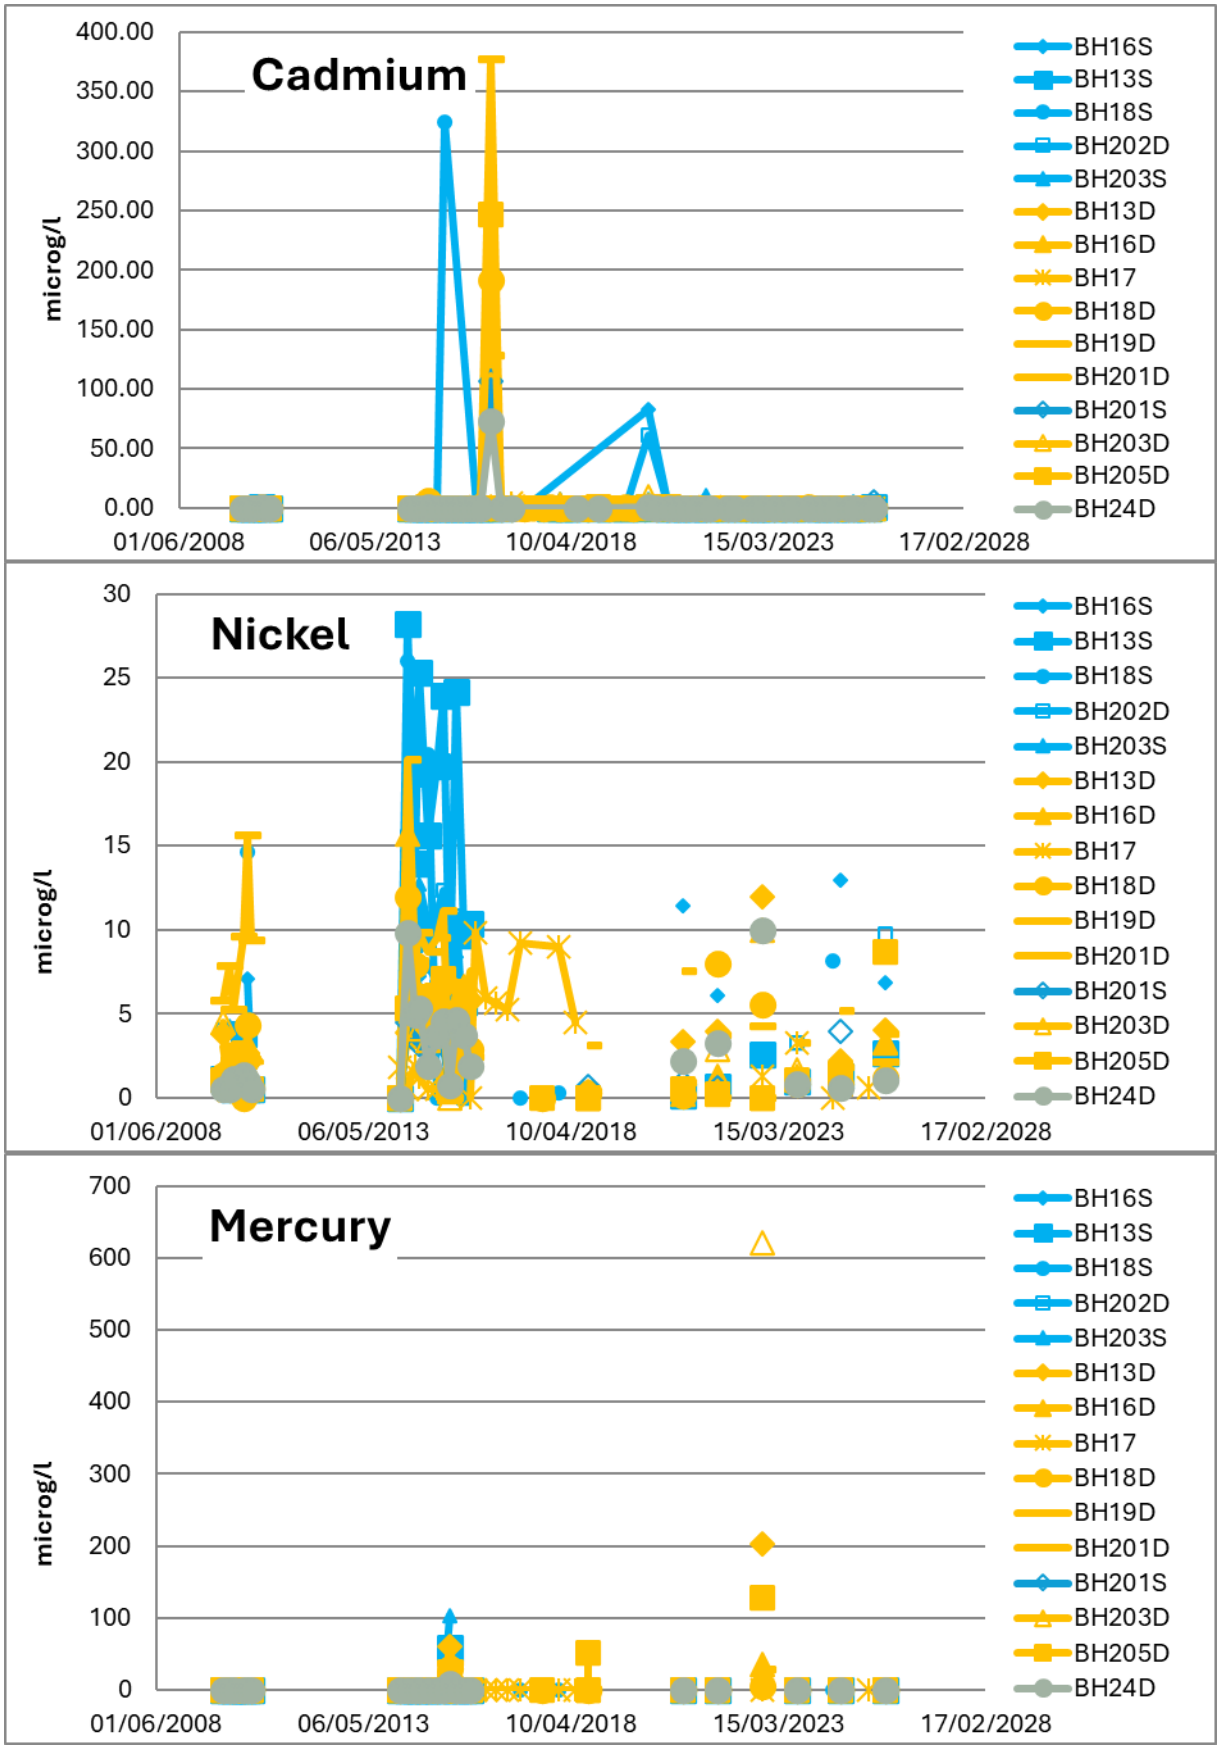
Figure 5-1 Concentrations in groundwater of selected substances

Testing of the slag development platform by Tata Steel (and others) has revealed that the development platform contains low levels of trace metals and that hydrocarbons and volatile compounds are typically absent or at trace levels. Further, because of the highly alkaline pH, any trace metals released to solution have low solubility with many found below detection limits or at low concentrations in the groundwater recovered from the made ground. Occasionally, some are detected above detection limit, and rarely EQS, but these occurrences are not persistent, as shown in Figure 5-1.

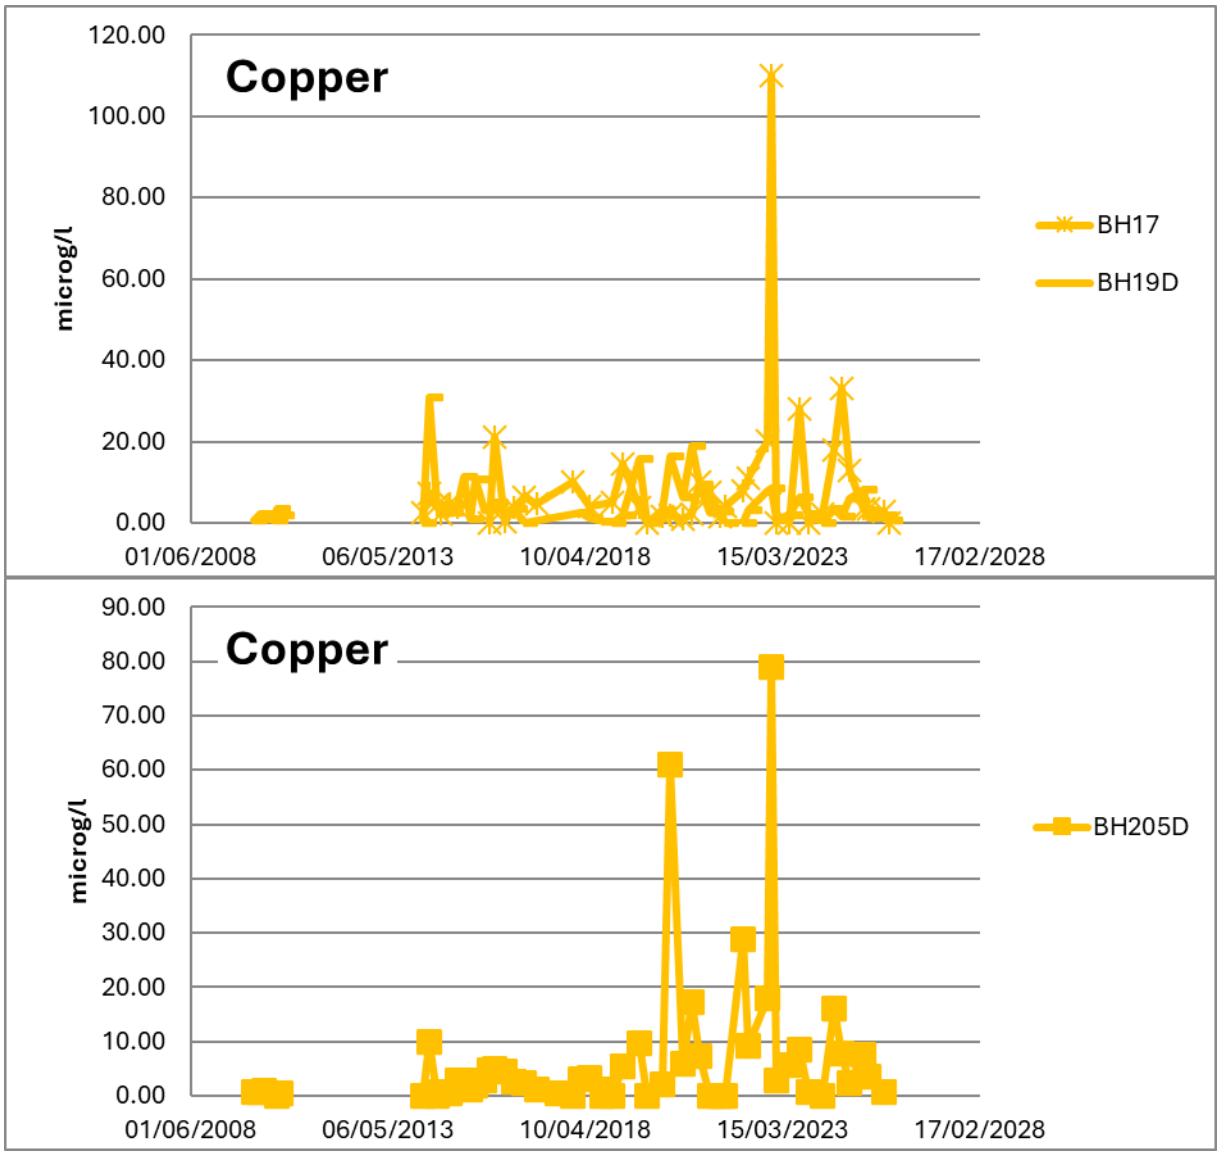
Figure 5-2 Copper concentrations at BH205

Chromium, copper, lead (and other metals) have also been found above their freshwater Environmental Quality Standards (EQS) from time to time, although there is no general upward trend. Exceptions do however occur, with copper detected at its highest concentration at BH17 in December 2022 and copper increasing at BH205D during 2022. As shown in Figure 5-2, such trends have not, however, persisted. This position is upstream of the lagoons and has also shown increasing concentrations of chloride, phosphate and ammonia in recent years.

The temporal variation of many trace metals could be described as 'spikey' with no clear trends. This variation may be a consequence of the low analytical detection limits (that sometimes appears to change) and potentially suggests that there is no widespread persistent change or deterioration in groundwater quality. Rather, the shallow perched groundwater chemistry is suspected to be influenced by antecedent rainfall and leaching/flushing of primary and secondary precipitates within the made ground. Previously, long-term increases in mineralisation were evident at several positions (e.g. BH17, BH19, BH201) but these trends are less distinct since 2020.

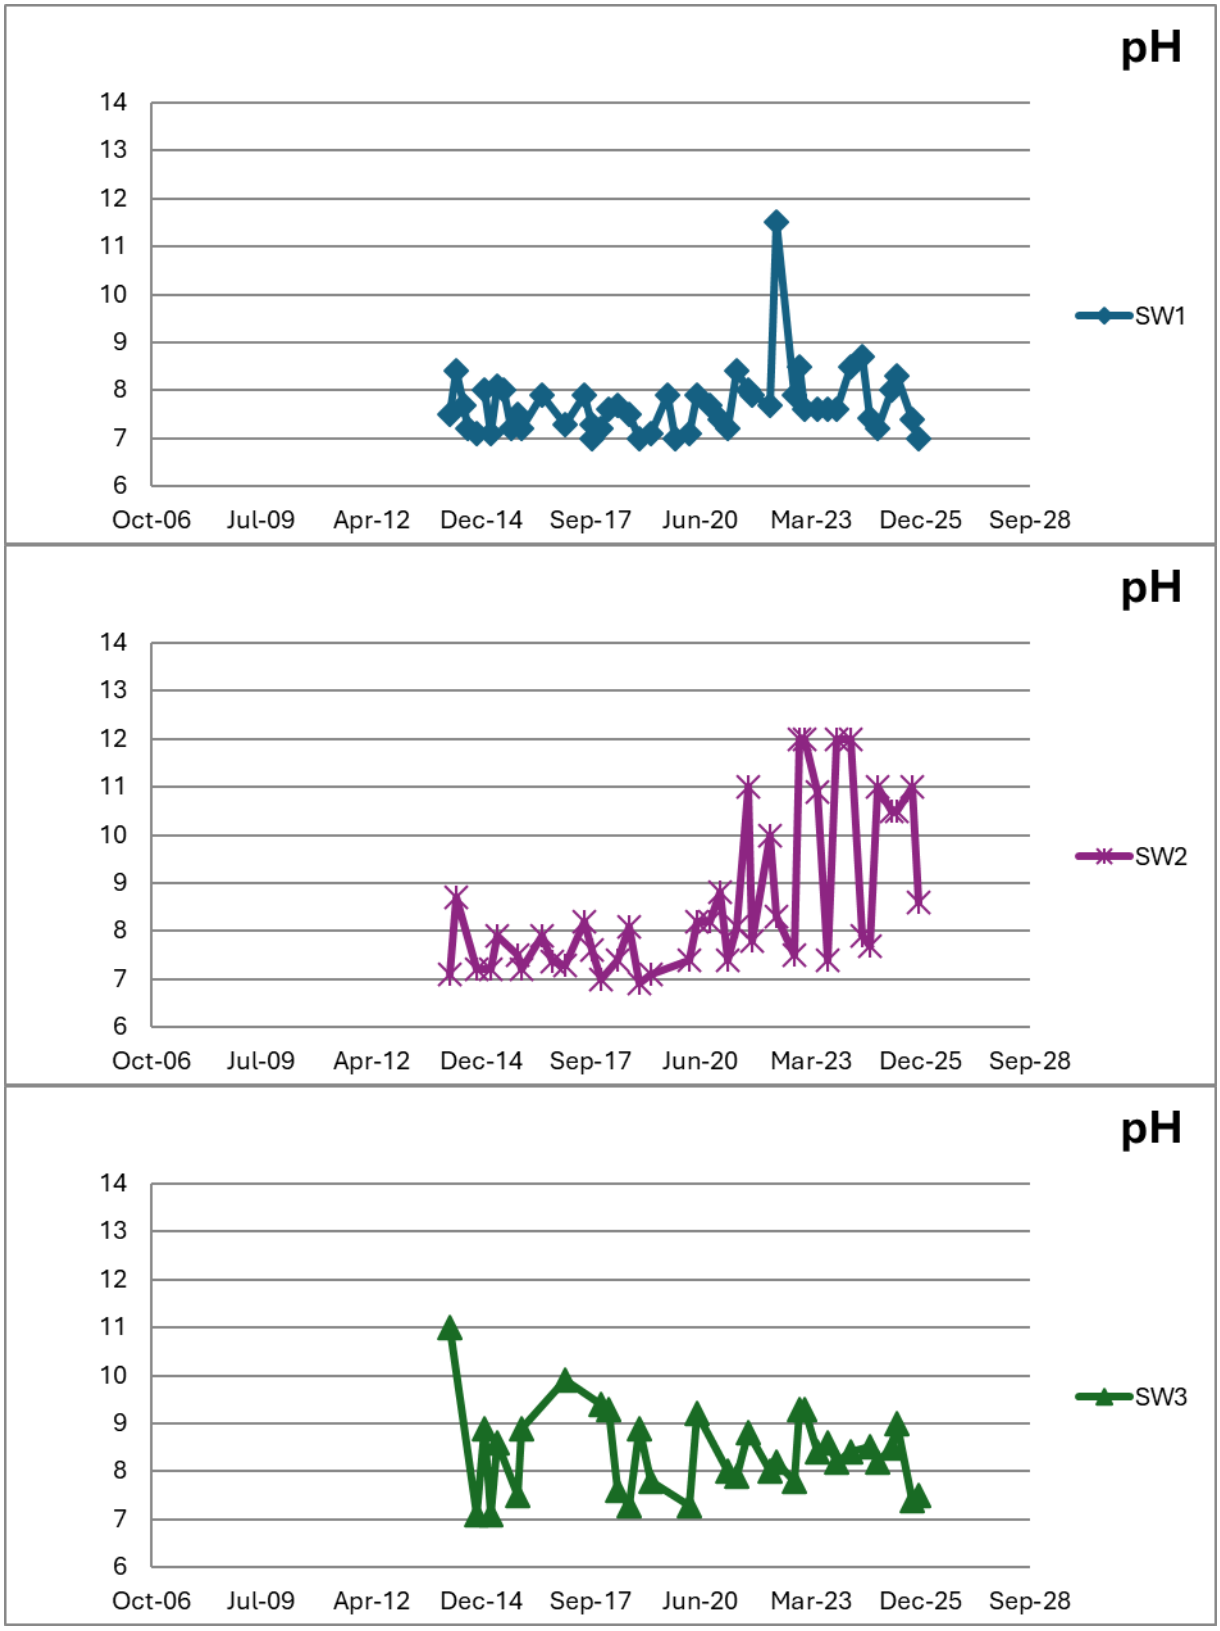
Figure 6-1 Changes in pH at SW1, SW2 and SW3

SW1 and SW3 are collected from the outer cut—off ditch whilst SW2 is taken from the inner cut-off ditch. The data clearly indicates that the inner ditch contains water that is more alkaline as it receives the discharge of perched groundwater from the upper layer of made ground. The persistently lower pH at SW1 and SW3, and the decrease in EC as the surface water passes the site suggests that the cut-off ditches are effective. There are sometimes short-term variations in trace metal concentrations but no persistent trends indicating deteriorating water quality.
