SOUTH SIDE QUEENSWAY WASTE MANAGEMENT SITE, LLANWERN STEELWORKS

2024 Annual Review of Environmental Monitoring

Report Number 2381r2v1d0125

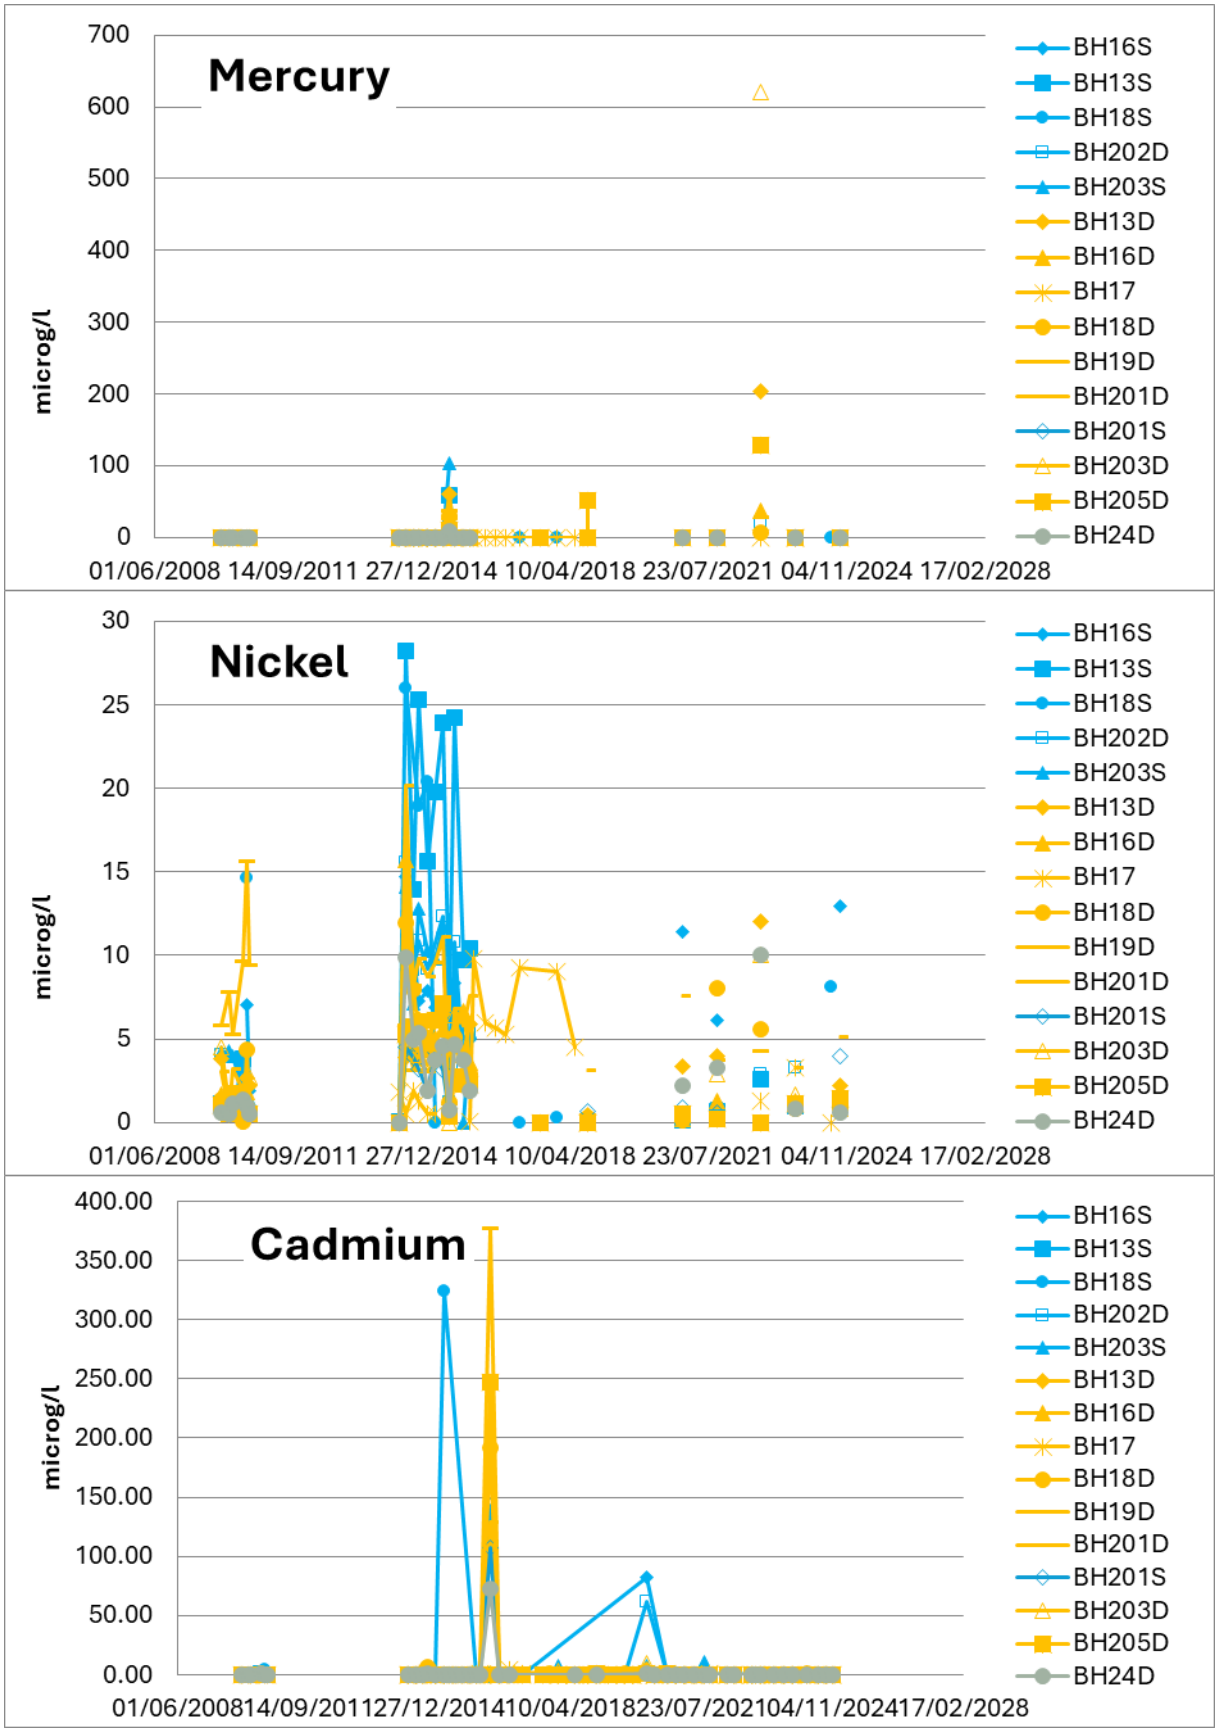
Chart 5-1 Concentrations in groundwater of selected substances

Testing of the slag development platform by Tata Steel (and others) has revealed that the development platform contains low levels of trace metals and that hydrocarbons and volatile compounds are typically absent or at trace levels. Further, because of the highly alkaline pH, any trace metals released to solution have low solubility with many found below detection limits or at low concentrations in the groundwater recovered from the made ground. Occasionally, some are detected above detection limit, and rarely EQS, but these occurrences are not persistent, as shown in Chart 5-1.

Chromium, copper, lead (and other metals) have also been found above their freshwater Environmental Quality Standards (EQS) from time to time, although there is no general upward trend. Exceptions do however occur, with copper detected at its highest concentration at BH17 in December 2022 and copper increasing at BH205D during 2022. As shown in Chart 5-2, such trends have not however persisted. This position is upstream of the lagoons and has also shown increasing concentrations of chloride, phosphate and ammonia in recent years.

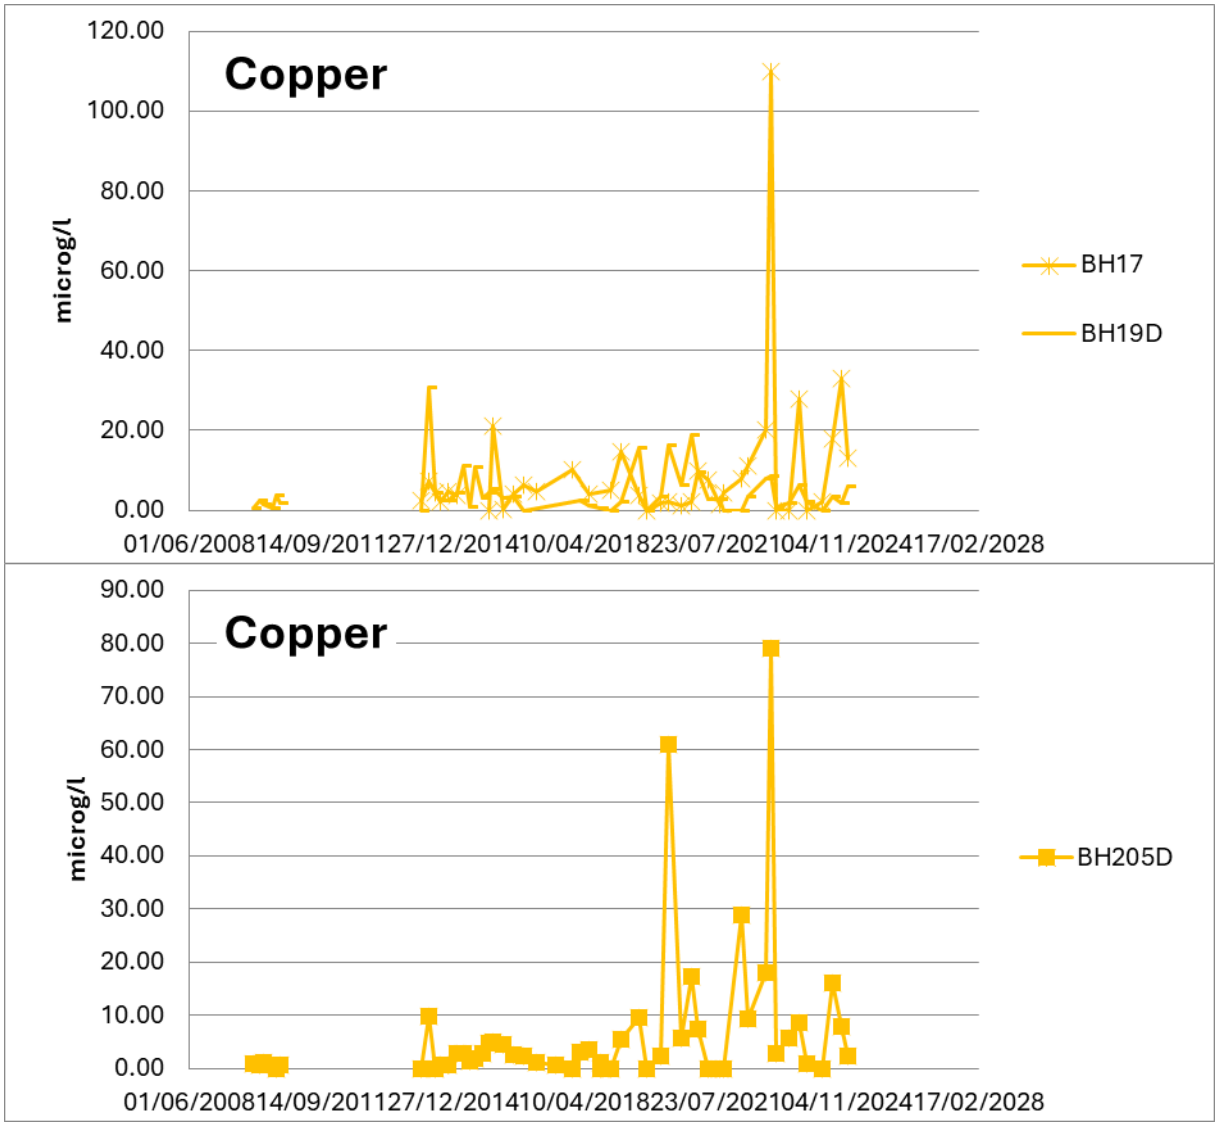
Chart 5-2 Copper concentrations at BH205

The temporal variation of many trace metals could be described as 'spikey' with no clear trends. This variation may be a consequence of the low analytical detection limits (that sometimes appears to change) and potentially suggests that there is no widespread persistent change or deterioration in groundwater quality. Rather, the shallow perched groundwater chemistry is suspected to be influenced by antecedent rainfall and leaching/flushing of primary and secondary precipitates within the made ground. Previously, long-term increases in mineralisation were evident at several positions (e.g. BH17, BH19, BH201) but these trends are less distinct since 2020.

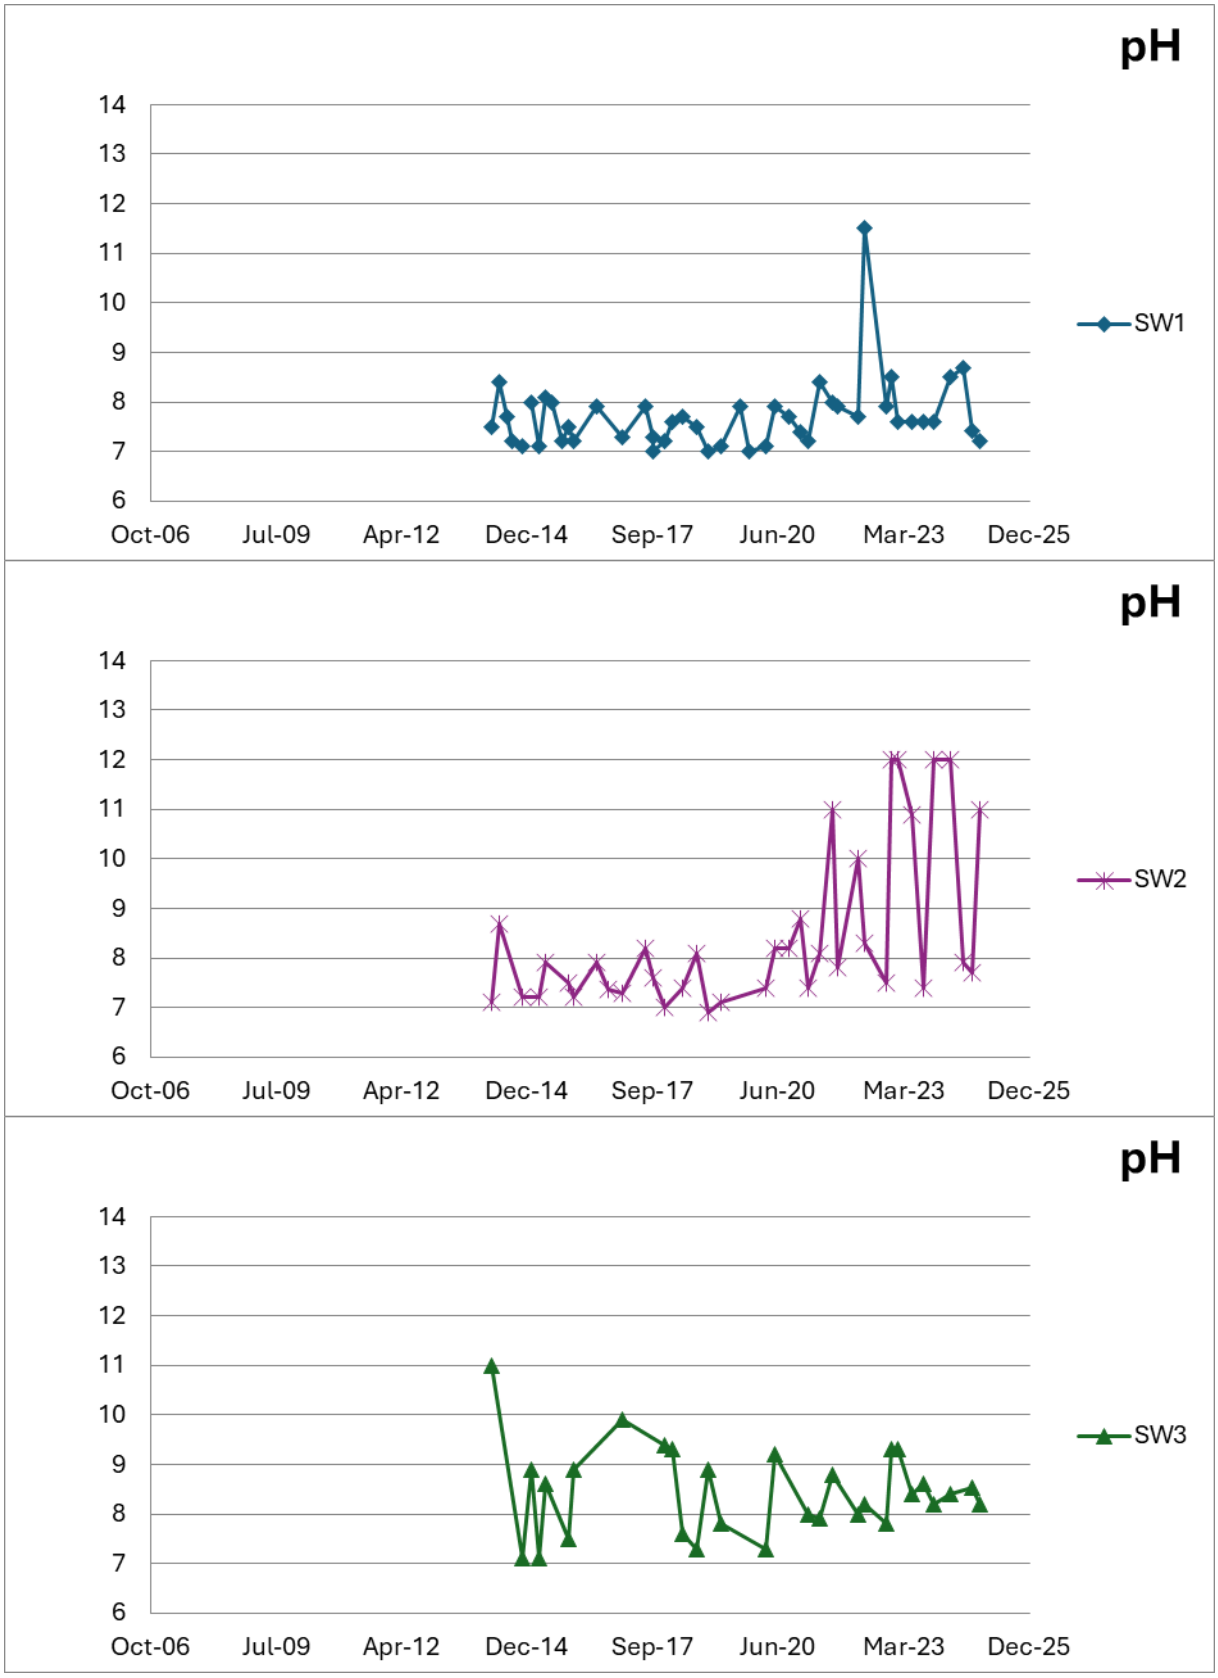
Chart 6-1 Changes in pH at SW1, SW2 and SW3

SW1 and SW3 are collected from the outer cut—off ditch whilst SW2 is taken from the inner cut-off ditch. The data clearly indicates that the inner ditch contains water that is more alkaline as it receives the discharge of perched groundwater from the upper layer of made ground. The persistently lower pH at SW1 and SW3, and the decrease in EC as the surface water passes the site suggests that the cut-off ditches are effective. There are sometimes short-term variations in trace metal concentrations but no persistent trends indicating deteriorating water quality.
