EAST WASTE MANAGEMENT SITE, LLANWERN STEELWORKS

PERMIT EAWML/30003

2024 Annual Review of Environmental Monitoring

Report Number 2381r1v1d0125

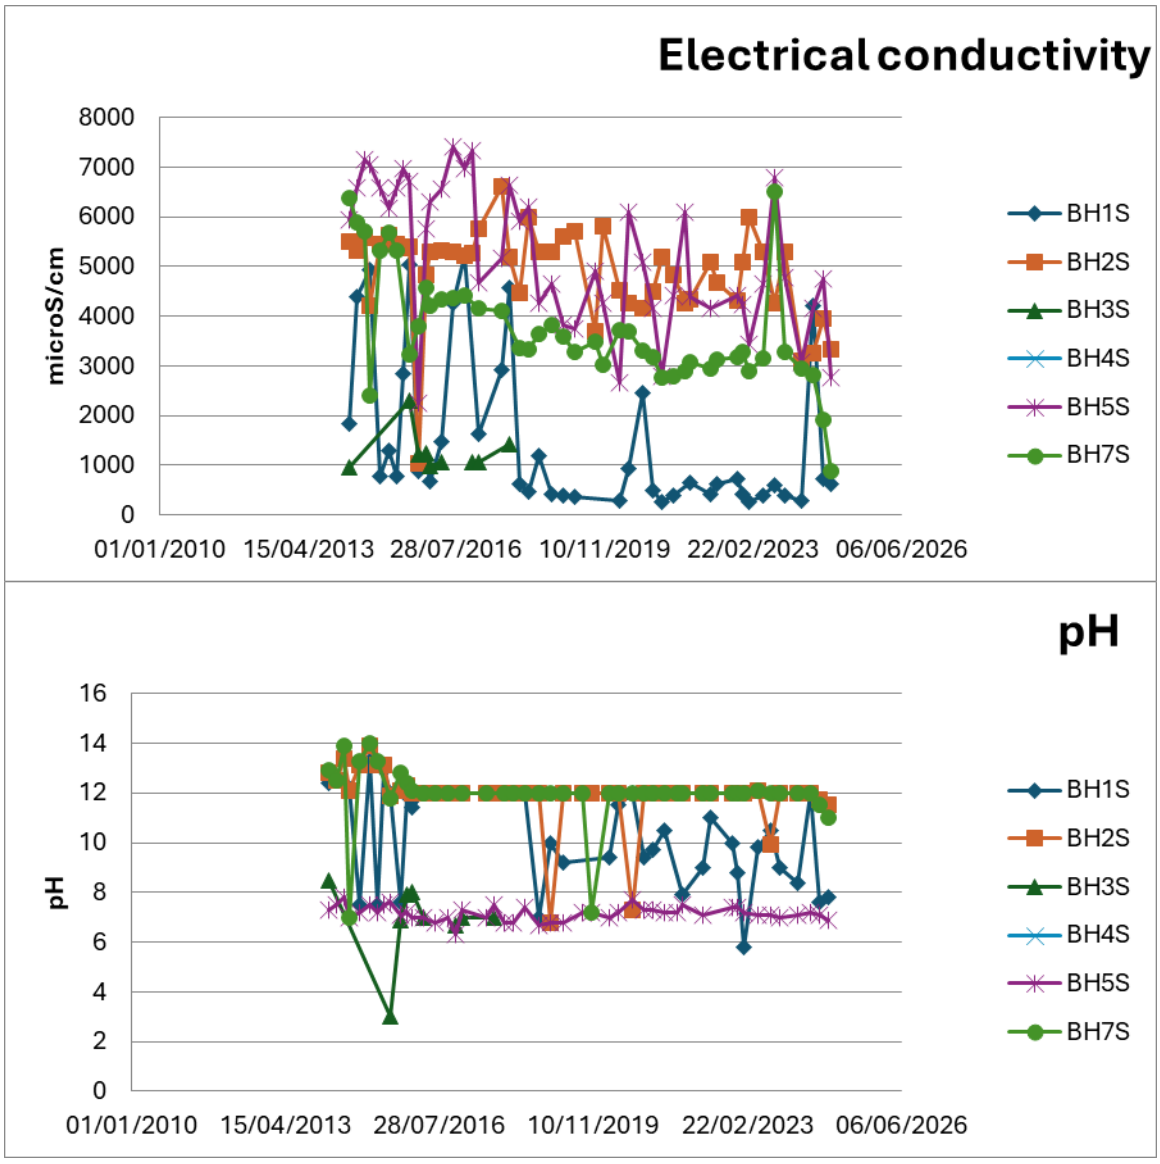
Chart 8-1 Groundwater Chemistry

As noted previously, groundwater in close proximity to the landfill typically contains low levels of non-hazardous substances which sometimes exceed Environmental Quality Standards. Short-term fluctuations in the concentration of several parameters including ammonia, phosphate, Cr, Cu, Fe, Pb, V and Zn has occurred in recent years but the lack of persistently elevated levels is considered to reflect the nature of the waste and the alkaline pH. There is no clear long-term upward trend evident, and some parameters have reduced in concentration. The highest concentrations tend to be found at BH5 and BH7, and also sometimes BH2. This latter borehole is located to the west of the landfill on the opposite side of the works access road and cut-off drainage ditch. As a consequence, the groundwater chemistry at BH2 may be influenced by other areas and processes.

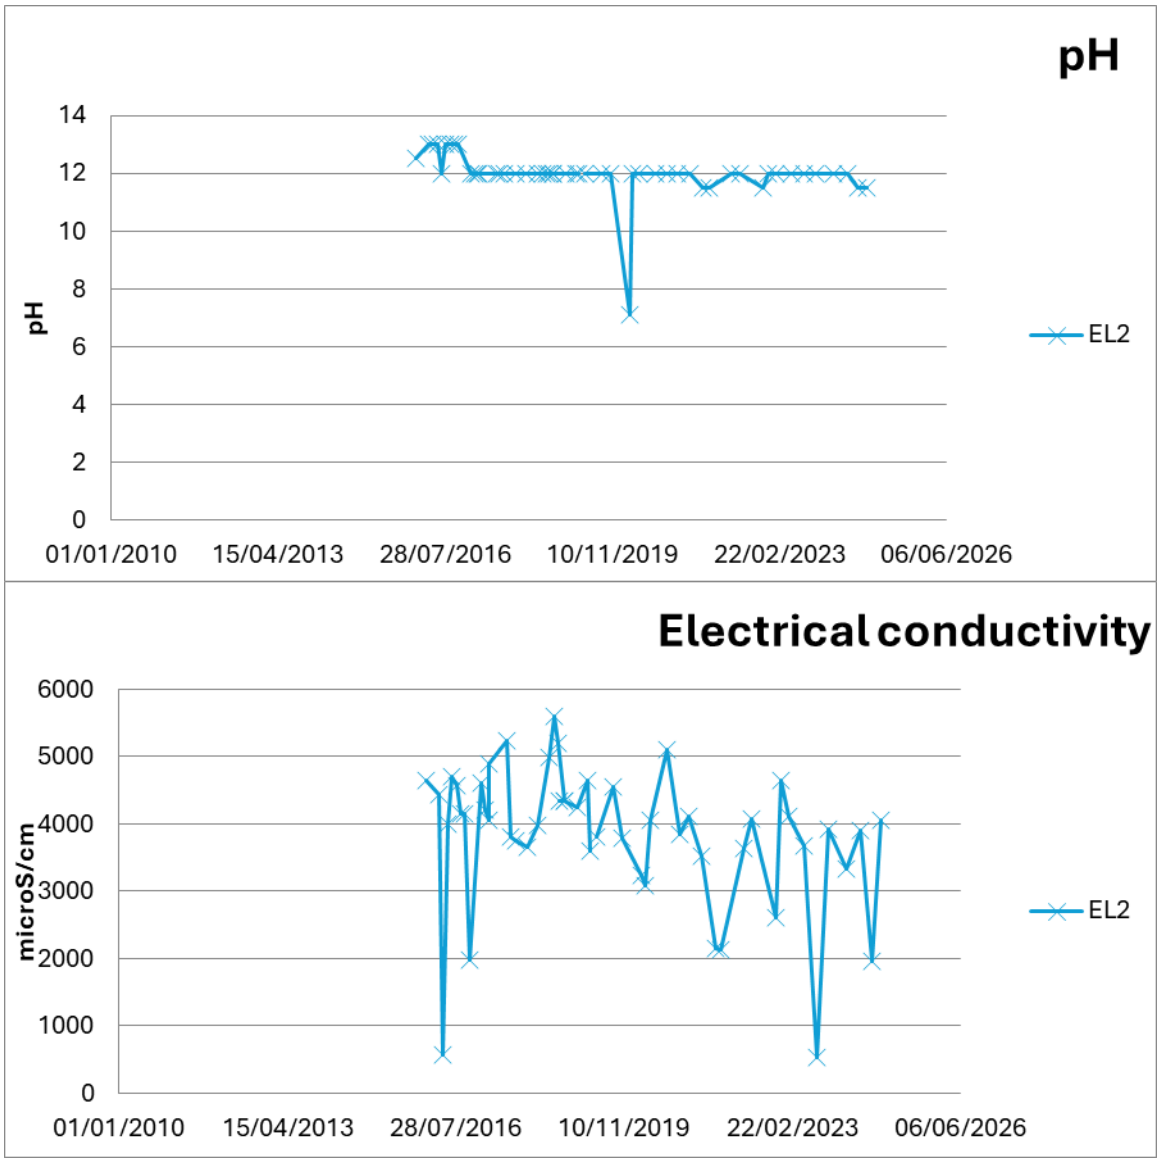
Chart 8-2 Chemistry of drainage ditch

As anticipated, the monitoring reveals that surface water running in the leachate collection ditch is dominated by leaching of slag wastes and is characterised by high pH, alkalinity and calcium and low metals. The mobility of many metals will be reduced under the alkaline conditions, although some, such as aluminium, is detectable. This may be influenced by the ability of some metals to forms oxyanions.

The ditch water has a pH that is persistently over 12 and EC typically over 3000 microS/cm and dominated by a Ca-HCO_3 hydrochemical signature, as the leachate has passed through steelmaking slags with soluble alkaline phases. Since 2021, the leachate sample has become slightly more dilute than that encountered in previous years, possibly due to the influence of the capping completed to date. Ammonia and phosphate have been impersistently detected at elevated concentrations but most trace metals are at low levels, due to the strongly alkaline conditions.
