**SOUTH SIDE  
QUEENSWAY WASTE  
MANAGEMENT SITE,  
LLANWERN STEELWORKS**

**2016 Annual Review of  
Environmental  
Monitoring**

*Report Number 1555r2v1d0117*

**January 2017**

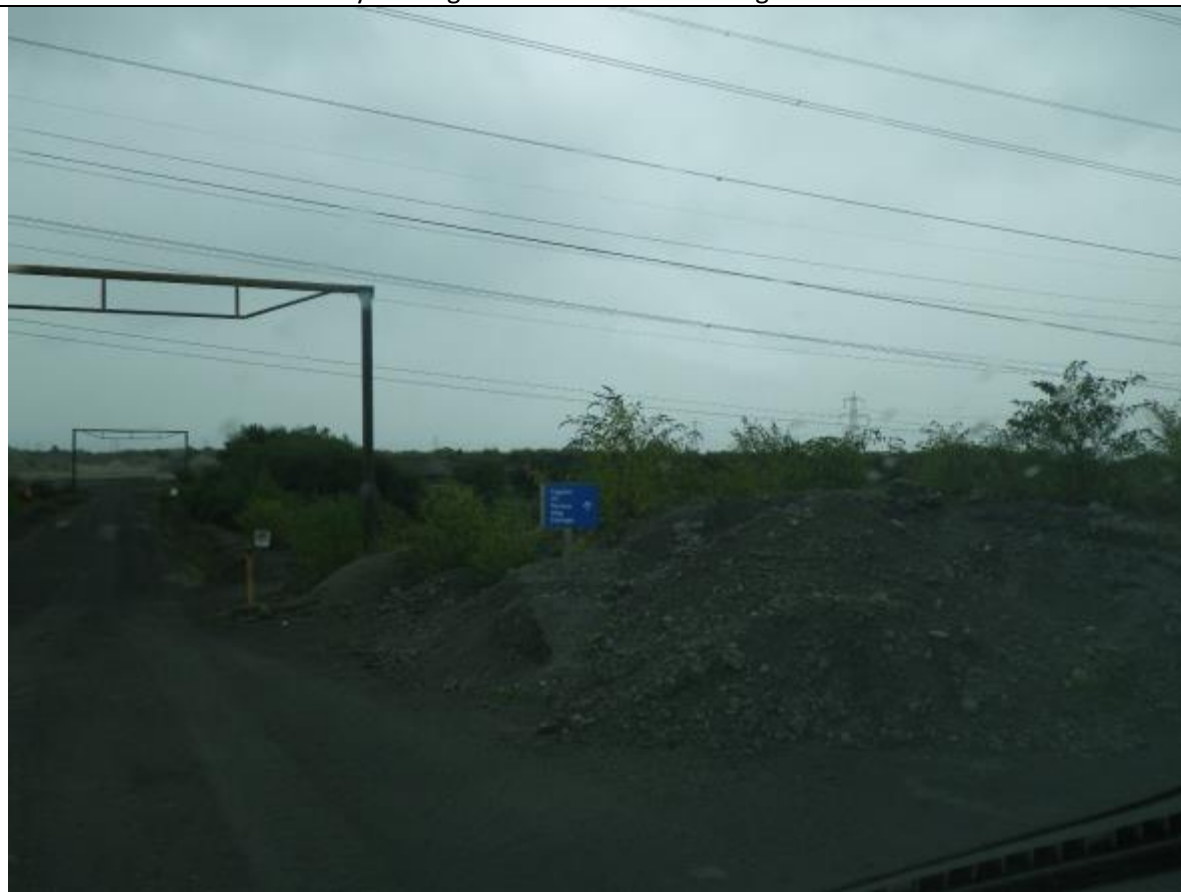
Photo 128 – Power lane valley looking towards BFS East and Lagoon 25

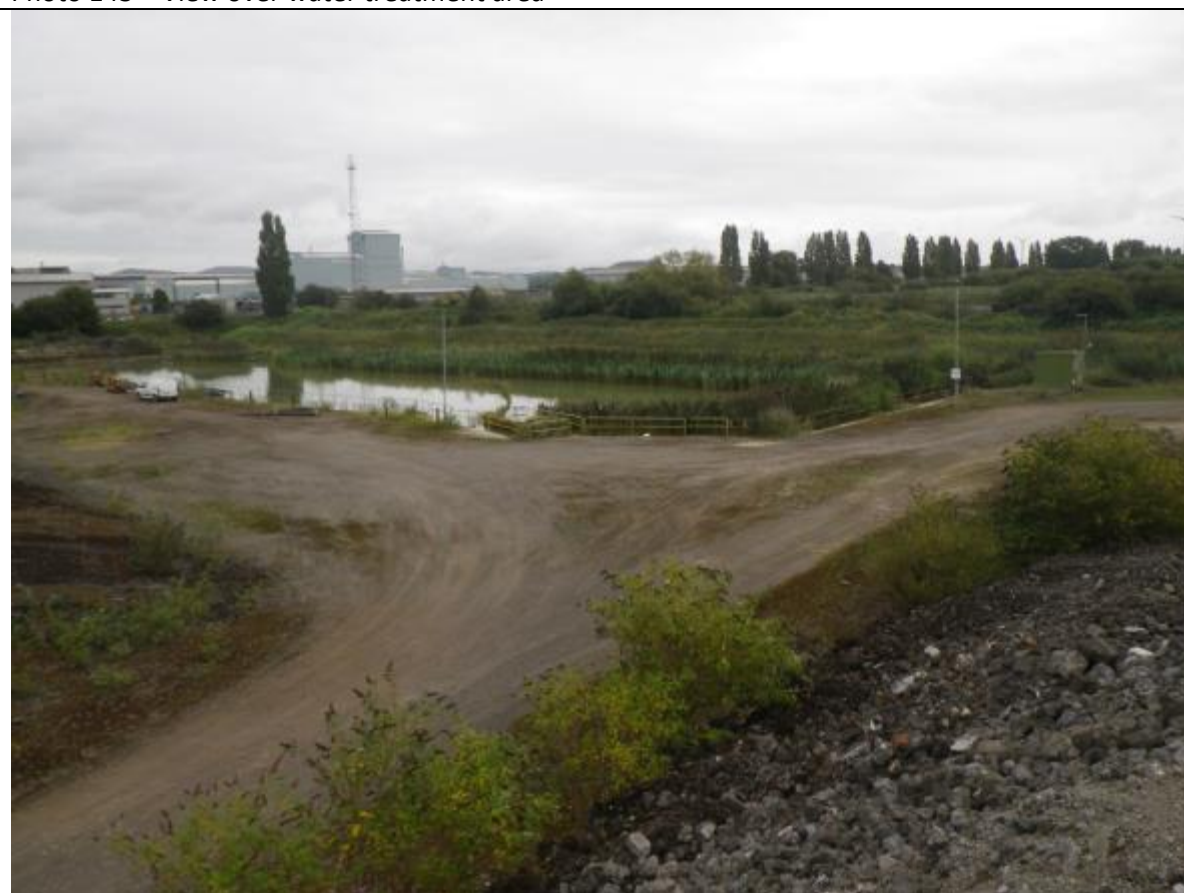
Photo 143 – View over water treatment area

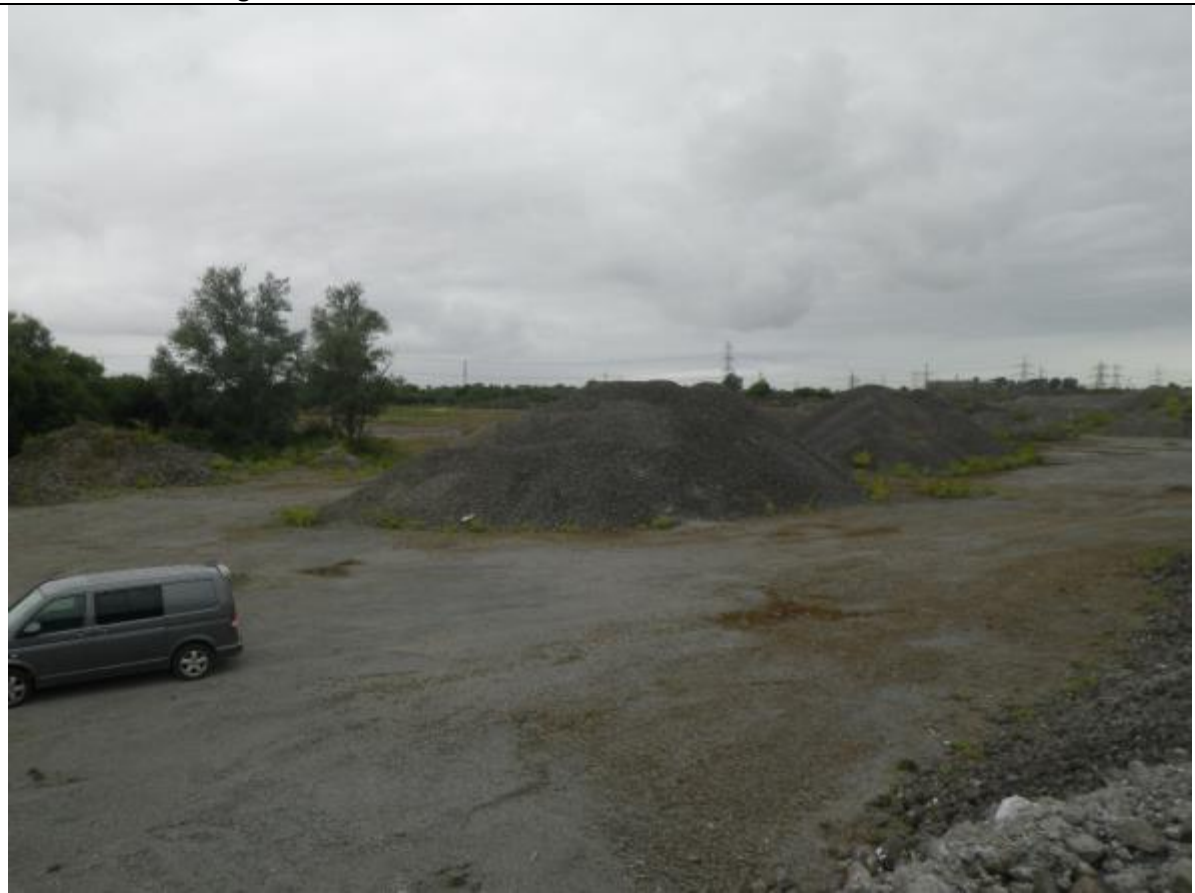
Photo 144 – Looking south over SSQ PPC site
