## Brookhill Landfill Site

## Leachate and Landfill Gas Management Review and Audit

**Document Reference:** 1850.4.FCC.ÅKS.JDM.A0

February 2014

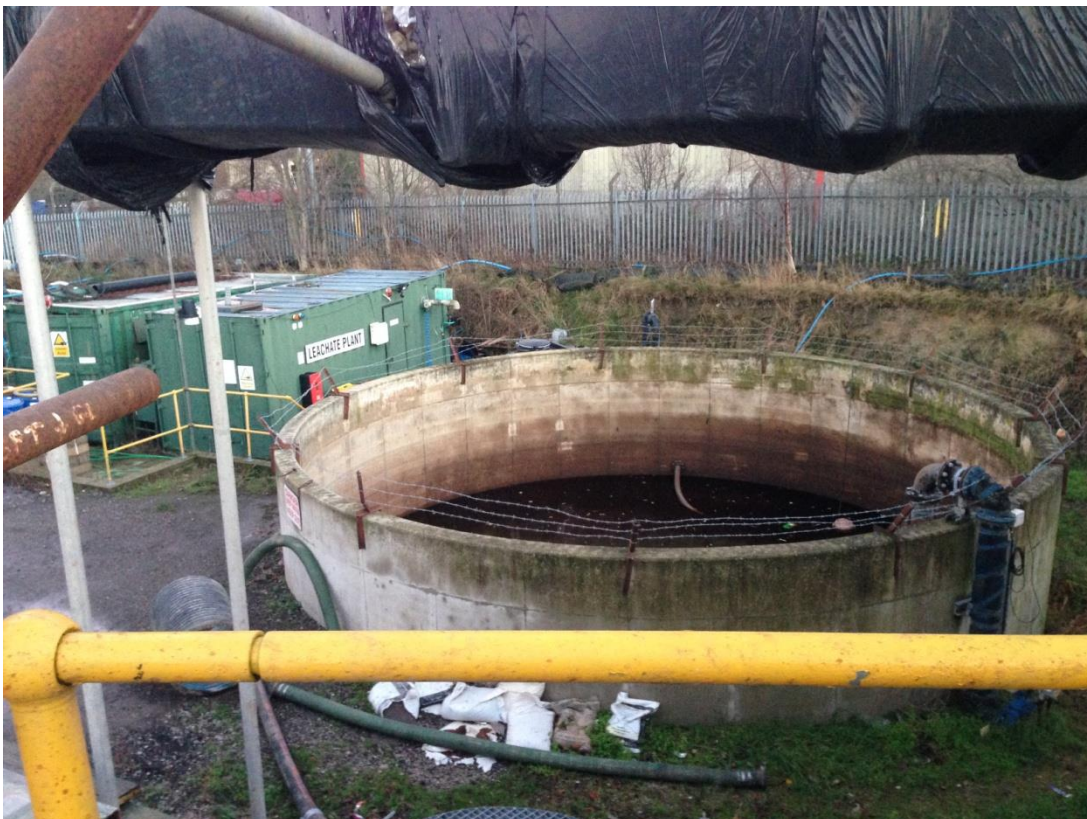
**Plate 2**

- 2.3.1 The leachate treatment plant is a SBR. It consists of a collection/balancing tank into which the leachate is pumped from site (Plate 2, Appendix 2), and this tank also receive the leachate from Standard Landfill. The leachate is subsequently pumped into the SBR reactor for biological treatment (nitrification) (Plate 3, Appendix 2). Following treatment the leachate is pumped to the effluent tank (Plates 4 and 5, Appendix 2), where it is discharged to sewer following testing of leachate quality.

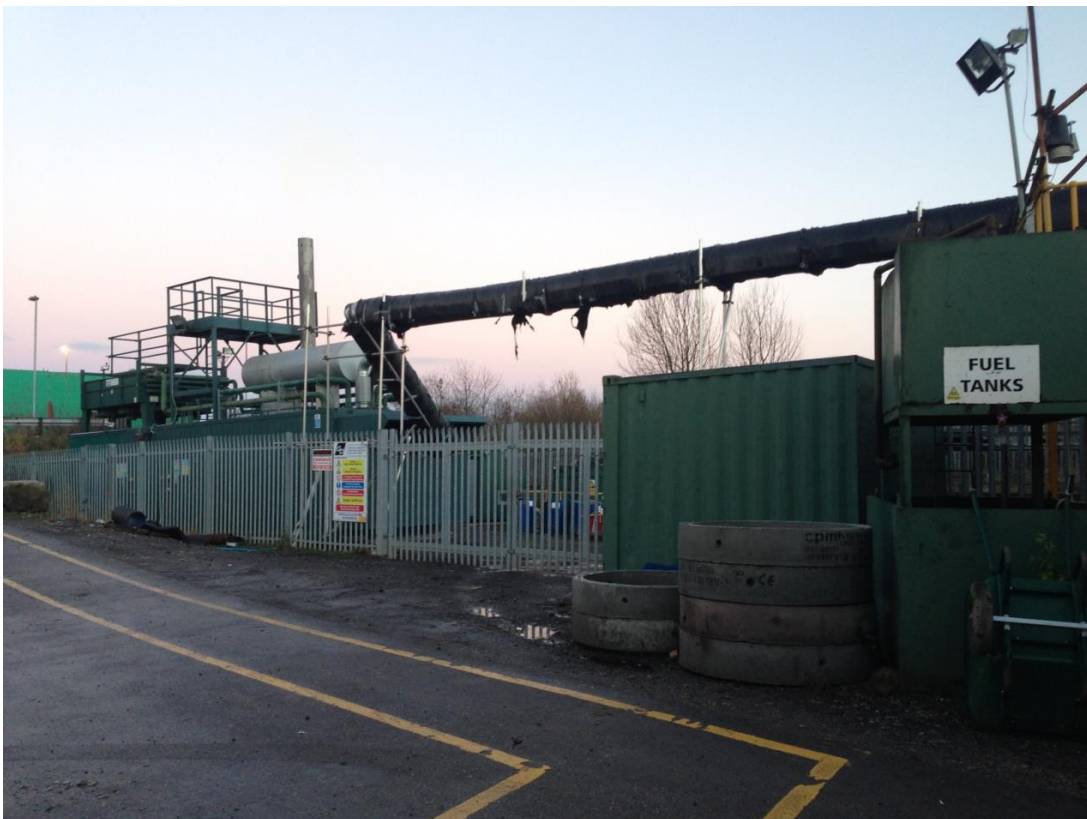
**Plate 8**

- 2.3.3 A crude heat exchanger was constructed a few years ago, where exhaust heat from the engine is piped across to the SBR reactor (see plates 8, 9 and 10 in Appendix 2). This has improved the treatment efficiency during the winter month, and is a good example of how internal resources can be used. However, this heat source is only available when the landfill gas engine is operational and is therefore not a consistently available.

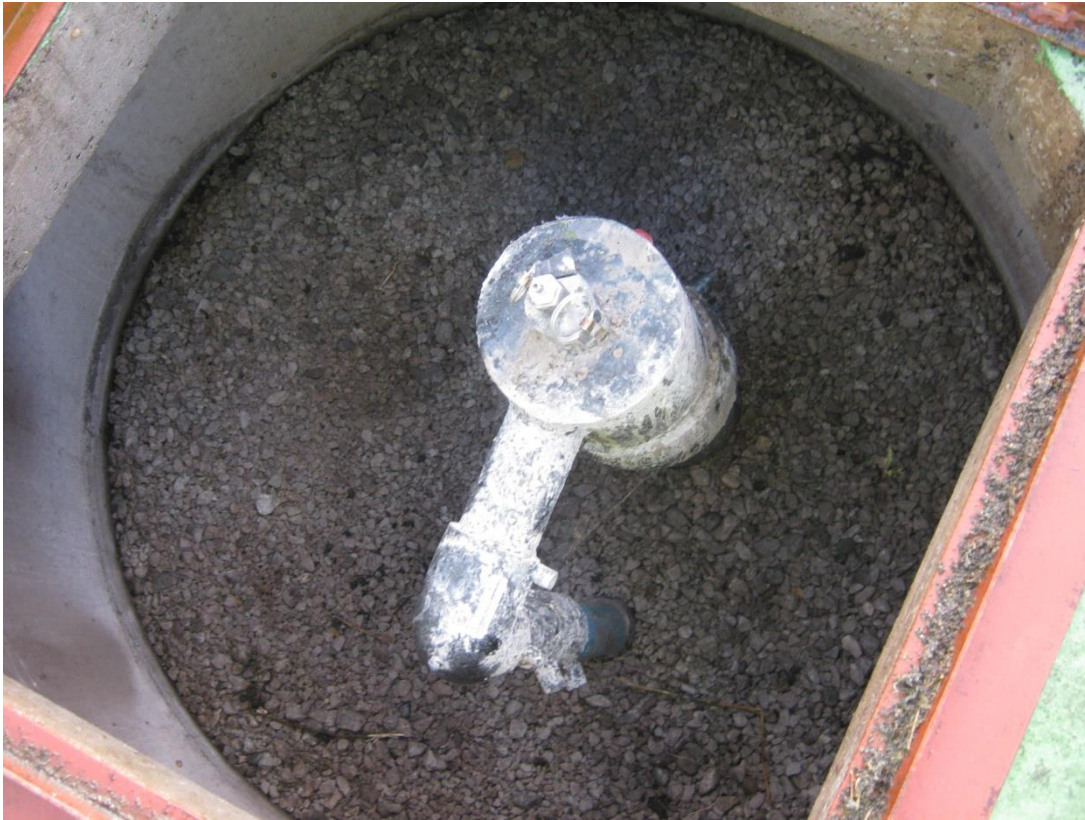
**Plate 1**

| GEX Well | Condition of Wellhead | Pipe Circ. (cm) | Condition of Pipework | VP at Wellhead (%) | VP (%) at Manifold | Seconds | CH4 | CO2 | O2 | Bal | H2S | CO | RP |
|---|---|---|---|---|---|---|---|---|---|---|---|---|---|
| GV2 | Ok. Dirty. Photo 1&2. | 63 | Good | N/A | 0 | 30 | 63.2 | 38.2 | 1.2 | 0.0 | 46 | 3 | 4.79 |

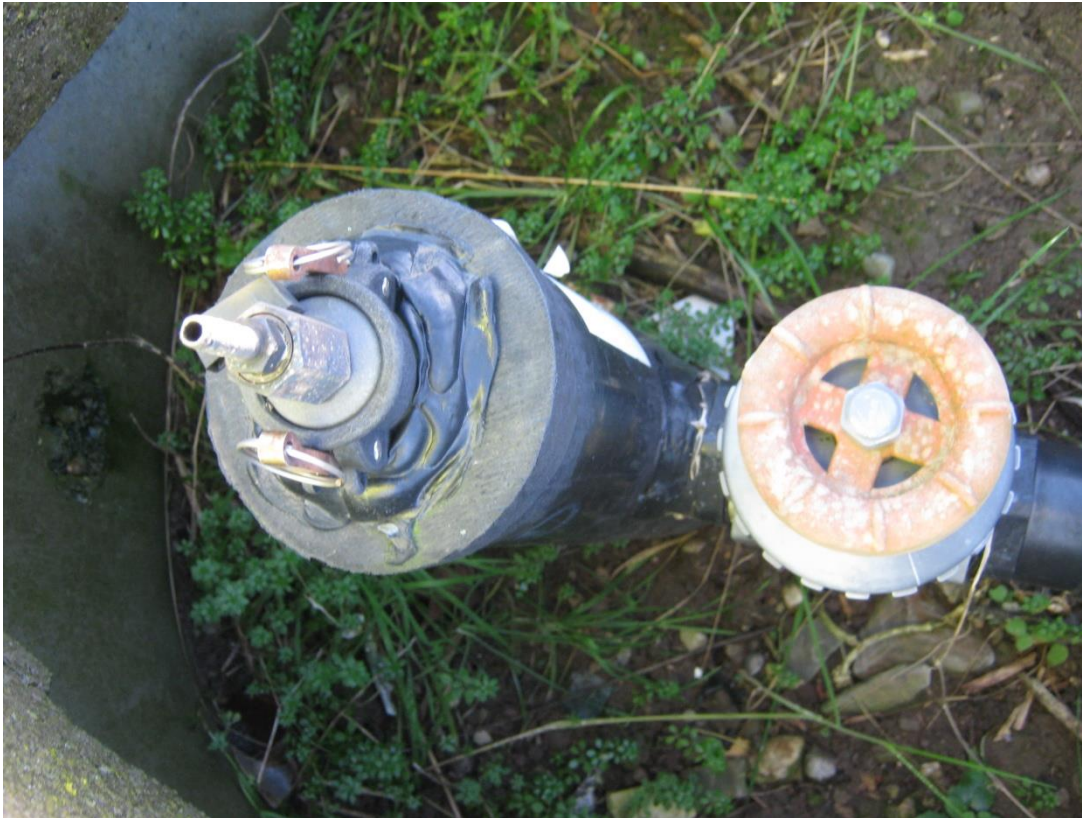
**Plate 5**

| GEX Well | Condition of Wellhead | Pipe Circ. (cm) | Condition of Pipework | VP at Wellhead (%) | VP (%) at Manifold | Seconds | CH4 | CO2 | O2 | Bal | H2S | CO | RP |
|---|---|---|---|---|---|---|---|---|---|---|---|---|---|
| GV7 | OK | 63 | Good | 50. photo 5 | 100 | 30 | - | - | - | - | - | - | - |
