**SOUTH SIDE  
QUEENSWAY WASTE  
MANAGEMENT SITE,  
LLANWERN STEELWORKS**

**2021 Annual Review of  
Environmental  
Monitoring**

*Report Number 2103r2v1d0122*

**January 2022**

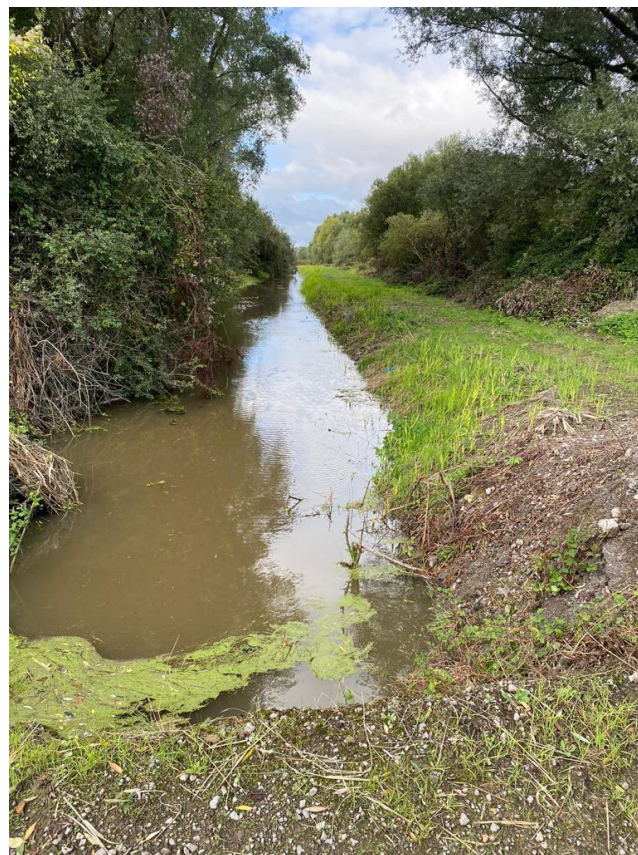
Surface water is typically circumneutral, moderately mineralised with low levels of non-hazardous and hazardous substances. There are sometimes short-term variations in trace metal concentrations but no persistent trends indicating deteriorating water quality. Some of the data trends may be influenced by the timing of sampling relative to ditch clearance and maintenance, as shown in Plate 6-2. During 2021, there were no breaches of the Annual Average EQS at any of the surface water monitoring points. In October 2021, some of the highest surface water levels observed were found at SW1 (compare Plates 6-2 and 6-3). This was due to significant rainfall in the preceding 24 hrs.

**Plate 6-3 Raised surface water levels in October 2021**
