Project Name                                      2 Sisters Remedial

Start Date                                              19/06/2017

| Purpose: <b>Post inspection of repairs or renovations</b> | Flow Control: |

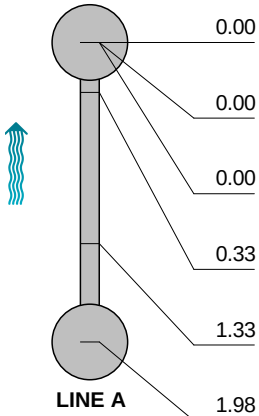
| 1:50 | Position m | Code | Observation | MPEG | Photo | Grade | | | |
|---|---|---|---|---|---|---|---|---|---|
| | 0.33 | LC | Sewer lining changes/starts/finishes at this point: start of repair patch | 00:00:13 | | 0 | | | |
| | 1.33 | LC | Sewer lining changes/starts/finishes at this point: end of repair patch | 00:00:34 | | 0 | | | |

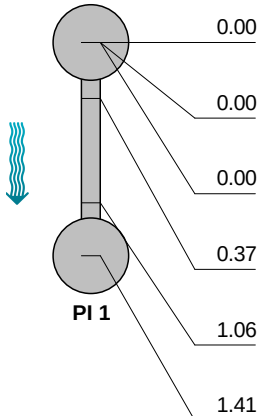
<table><tr><td></td><td>0.00</td><td>ST</td><td>Start of survey</td><td>00:00:00</td><td></td><td>0</td></tr><tr><td></td><td>0.37</td><td>LC</td><td>Sewer lining changes/starts/finishes at this point: START OF REPAIR PATCH</td><td>00:00:00</td><td></td><td>0</td></tr><tr><td></td><td>1.06</td><td>LC</td><td>Sewer lining changes/starts/finishes at this point: END OF REPAIR PATCH</td><td>00:01:03</td><td></td><td>0</td></tr></table>

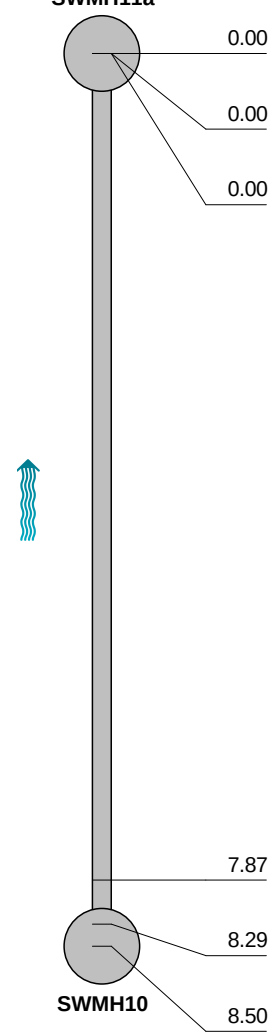
| 1:72 | Position m | Code | Observation | MPEG | Photo | Grade | | | |
|---|---|---|---|---|---|---|---|---|---|
| | 7.87 | LC | Sewer lining changes/starts/finishes at this point: start of repair patch | 00:00:24 | | 0 | | | |
| | 8.29 | LC | Sewer lining changes/starts/finishes at this point: end of repair patch | 00:00:40 | | 0 | | | |

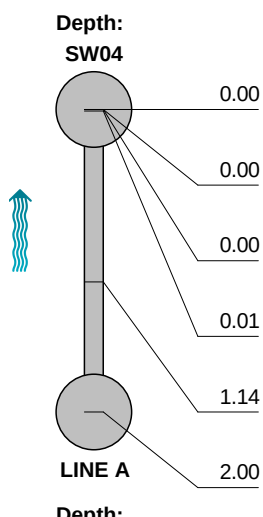
| 1:50 | Position m | Code | Observation | MPEG | Photo | Grade |
|---|---|---|---|---|---|---|
| | 0.01 | LC | Sewer lining changes/starts/finishes at this point: start of repair patch | 00:00:00 | | 0 |
| | 1.14 | LC | Sewer lining changes/starts/finishes at this point: end of repair patch | 00:00:55 | | 0 |

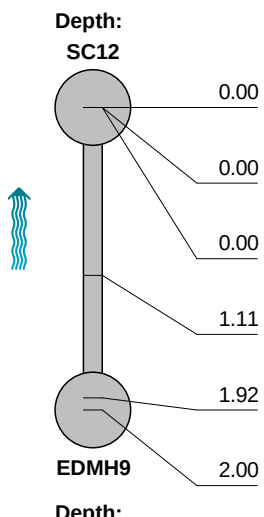
| 1:50 | Position m | Code | Observation | MPEG | Photo | Grade |
|---|---|---|---|---|---|---|
| | 1.11 | LC | Sewer lining changes/starts/finishes at this point: start of patch repair | 00:00:14 | | 0 |
| | 1.92 | LC | Sewer lining changes/starts/finishes at this point: end of patch repair | 00:00:35 | | 0 |

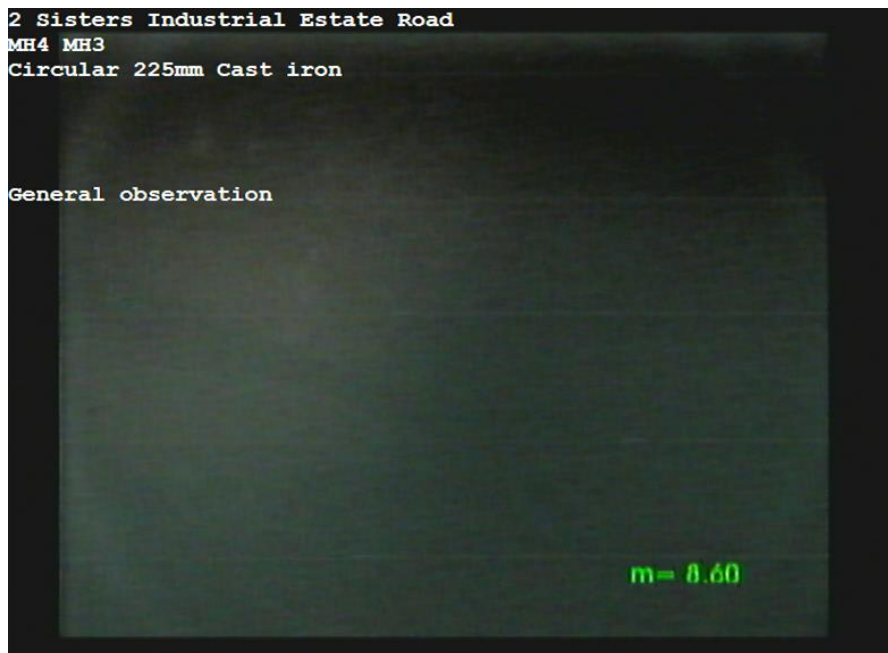
MH4X\_4fb7f44a-4363-4648-a26a-c8f01d422142\_20170623\_150213\_686.jpg, 00:00:20, 8.57m  
General observation

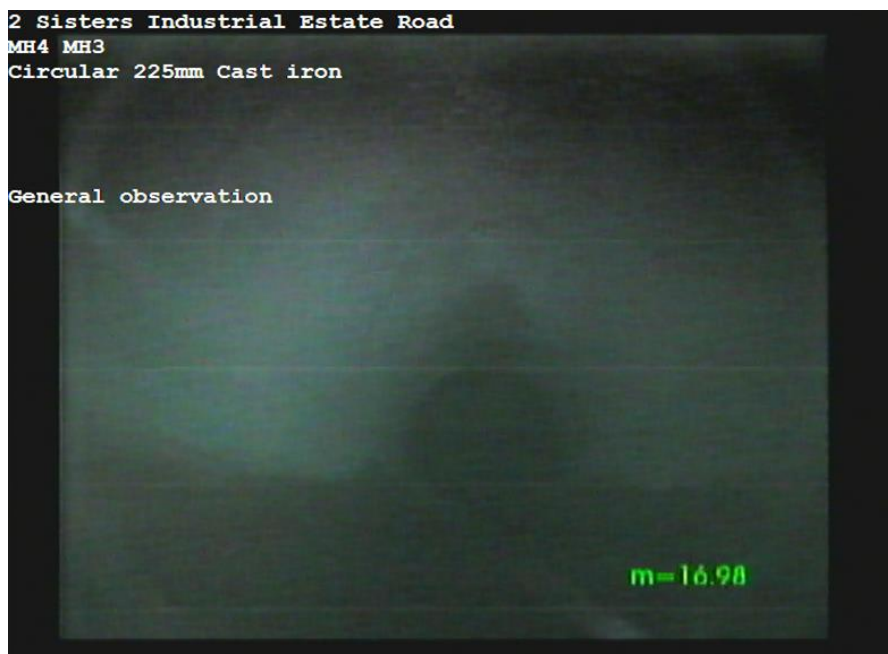
MH4X\_769206cb-55be-4d24-87d2-f92dce9deaf2\_20170623\_150315\_109.jpg, 00:01:04, 16.98m  
General observation
