Incident Investigation Report Dangerous Occurrence / Near Miss Event	
Site / Area: Kronospan Lorry Park	Reference:
Date of Incident: 06/06/2013	Time of incident: 10:05
Name of person(s) involved in the incident: Stephen Ellard (Synthite Driver)	
If a contractor name & address of employer: Synthite, Alyn Road, Denbigh Works, Mold, CH7 1BT	
Occupation(s): Tanker Driver	
Name of Witnesses: None	
Department / Area: Formalin / Despatch Lorry Park (a reception area prior to entering the site)	
Manager/supervisor: In Site Formalin Plant – Chris Taylor (Formalin Plant Manager)	
Date & time of preliminary investigation: 06/06/2013 (written report 07/06/2013)	
Place where incident occurred: Kronospan Lorry Park	
Date and time of formal investigation: 06/06/2013 (written report 07/06/2013)	
Whether reported to the HSE inspector: Yes, also reported to the NRW, WCBC and the Local parish Councillors

Medium / High Level Investigation Report

Site / Area: Kronospan / Lorry park (Lorry tanker reception area)

Nature of Occurrence: A Synthite tanker delivering methanol to the Kronospan Site was driving around the Lorry Park reception area when the rear axle on the left hand side of the vehicle buck

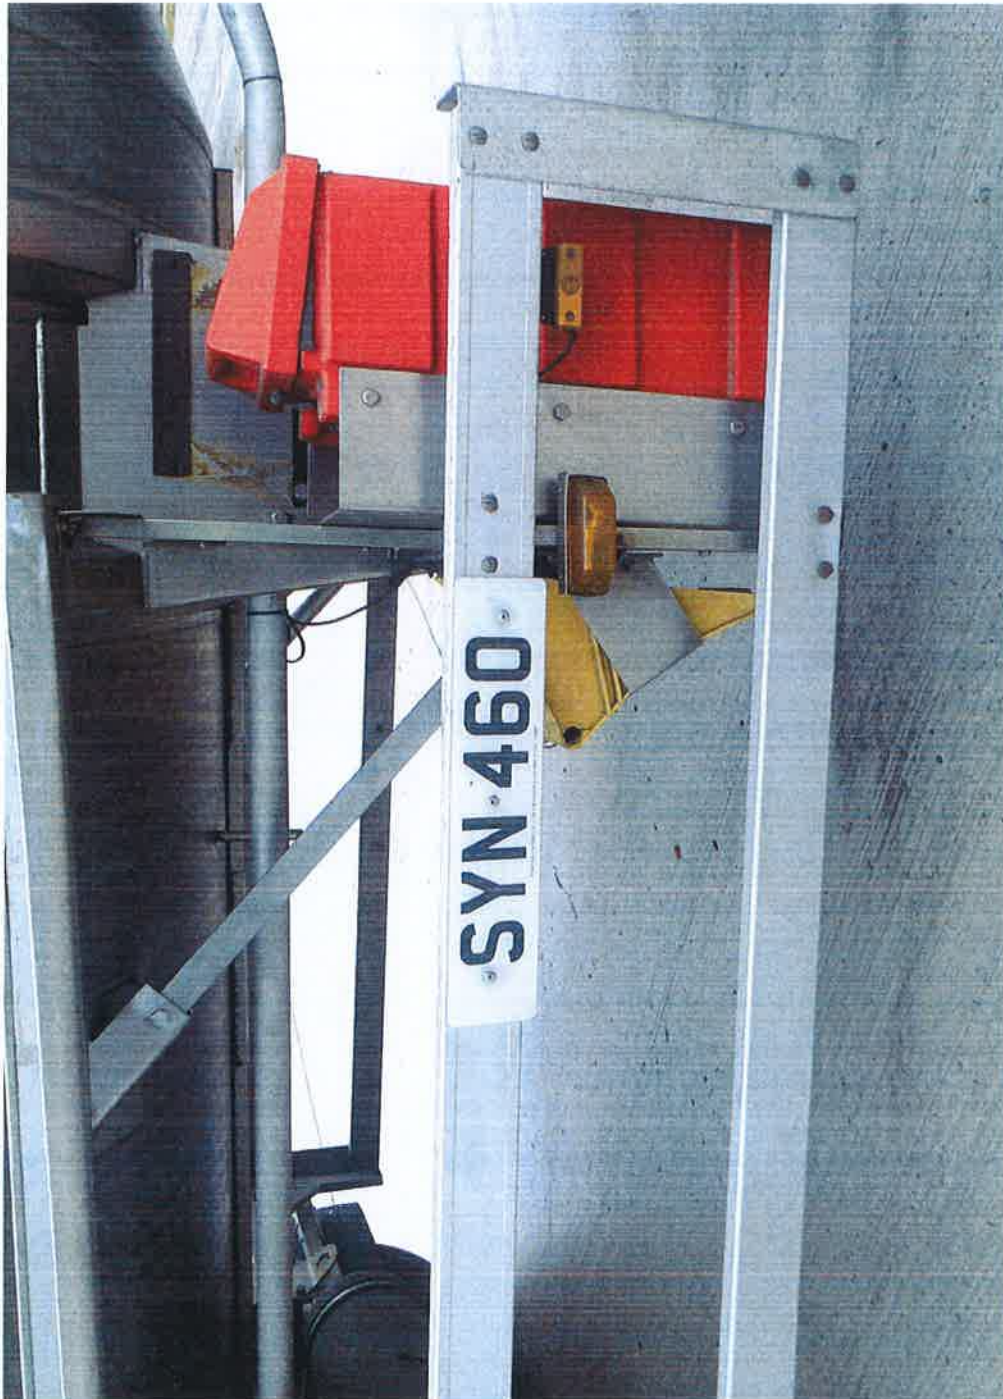
Appendix 3 Various Photographs

He stopped his vehicle and initially isolated the power via the tanker isolation switch, he then got out of his cab to find out what had happened. On examination he found that the rear axle on the left hand side of the vehicle had buckled and there was a tyre blow out on the same side. This had resulted in a weep of methanol from a flange on the delivery pipe that was going to floor.
