**WYNNSTAY GROUP PLC  
LLYSONNEN MILL, TRAVELLERS REST,  
CARMARTHEN**

**DISCHARGE OPTIONS APPRAISAL AND  
DRAINAGE IMPROVEMENT SPECIFICATIONS**

**FEBRUARY 2011**

| <b>REPORT No.:</b> | <b>129-01-02.R1</b> |

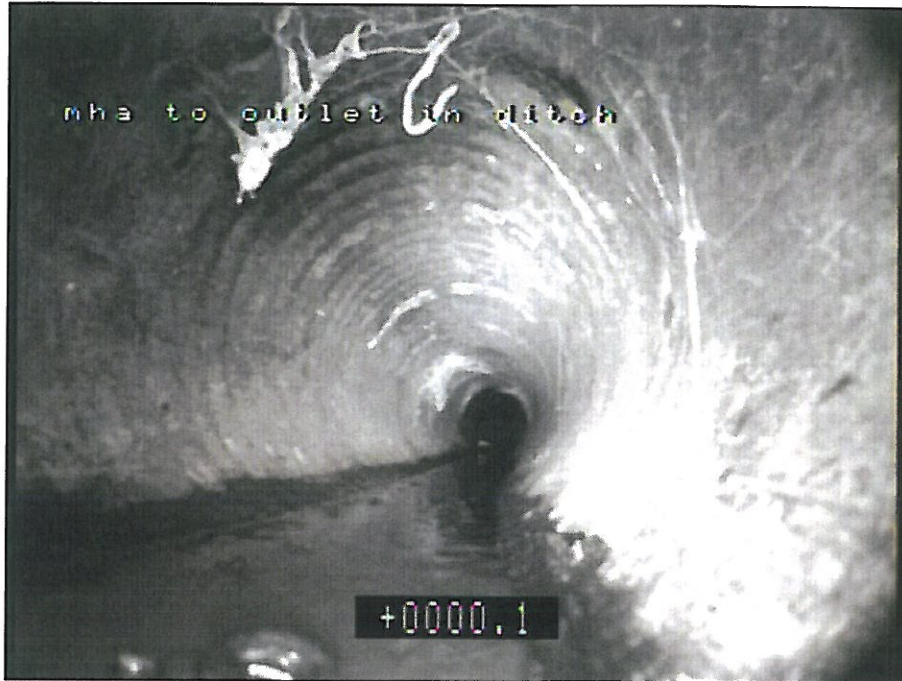
Photo: 2\_2a, Tape No.: 01, 00:00:00  
0m, Manhole Remark: MH A

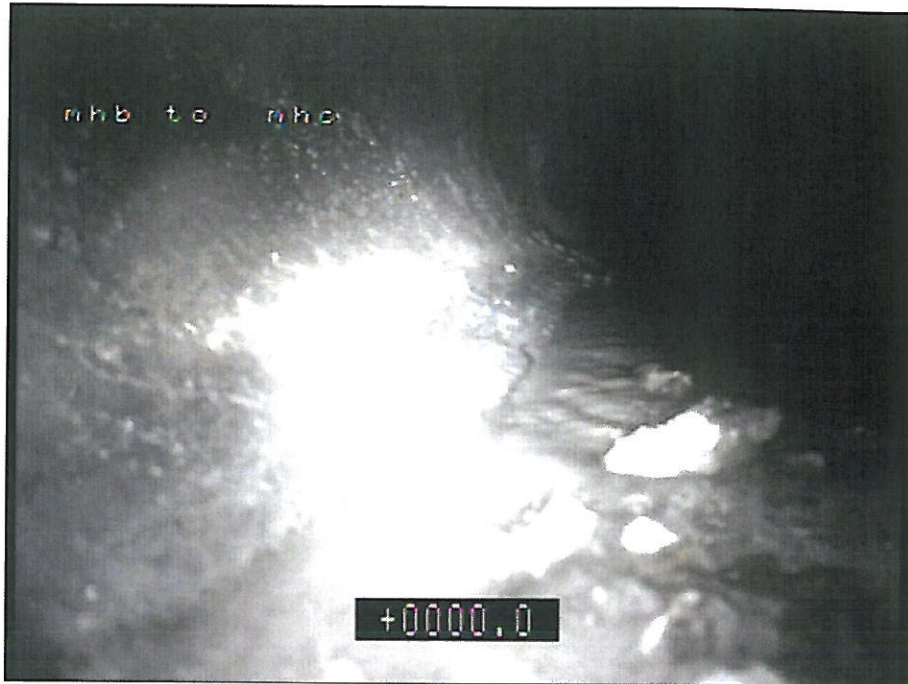
Photo: 15\_2a, Tape No.: 01, 00:00:00  
0m, Manhole Remark: MH B

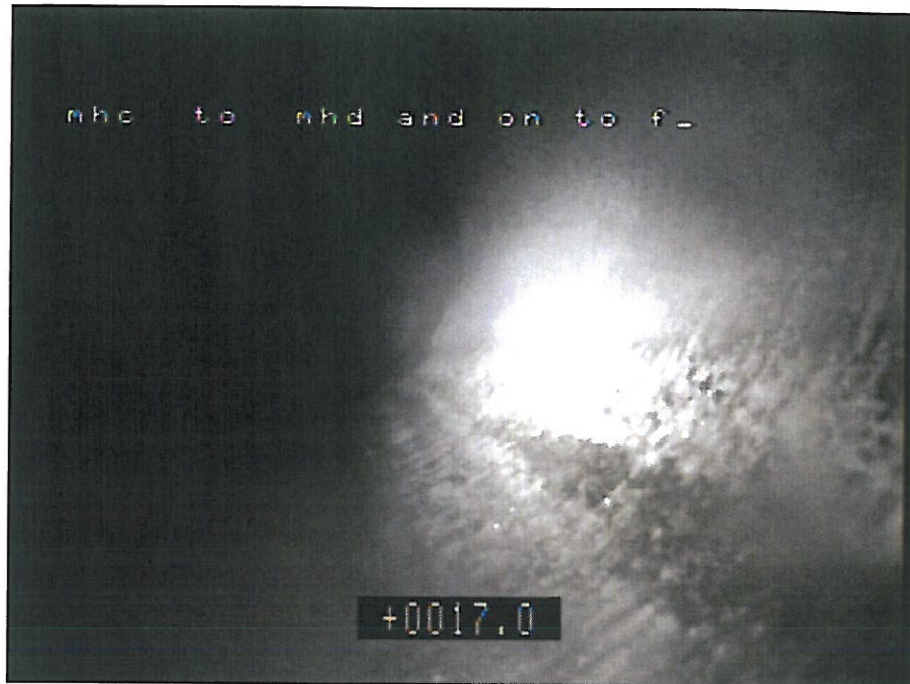
Photo: 38\_6a, Tape No.: 01, 00:03:30  
17m, General Observation, Remark: START OF MH D

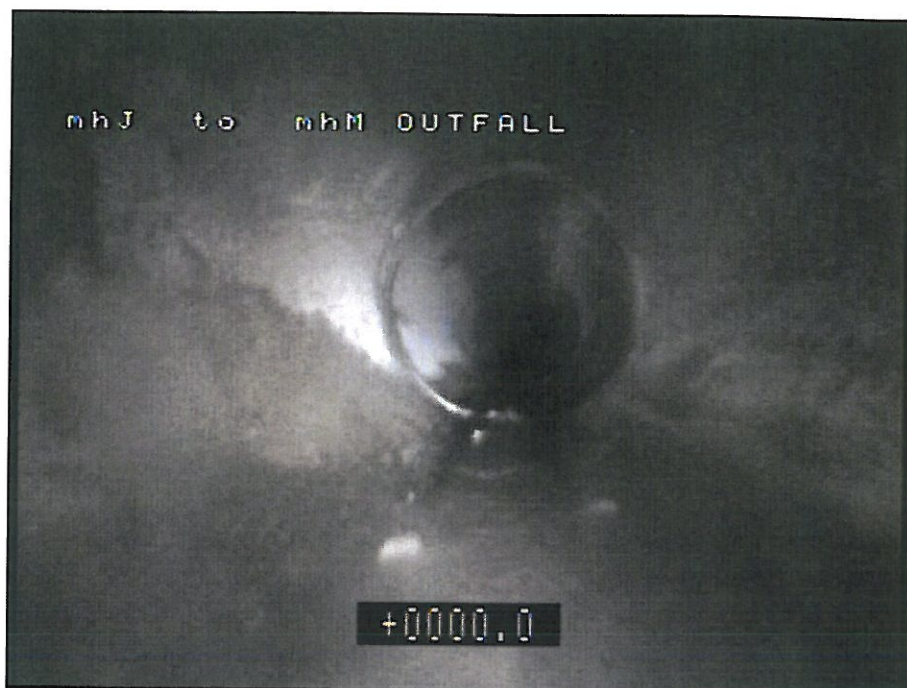
Photo: 74\_3a, Tape No.: 01, 00:00:00  
0m, Water level, 05 % height/diameter

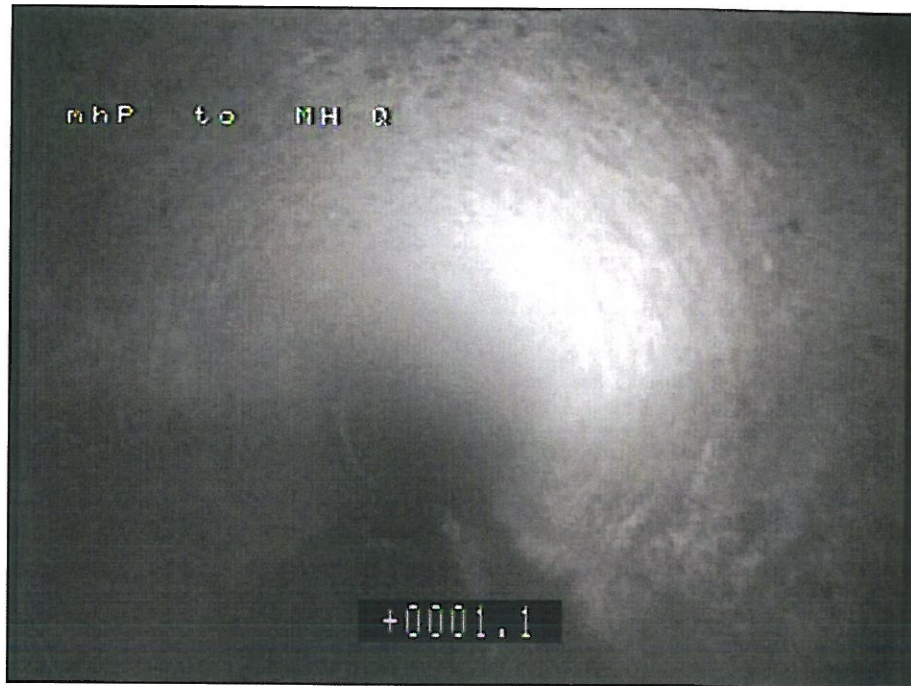
Photo: 104\_3a, Tape No.: 01, 00:00:00  
0m, Water level, 05 % height/diameter

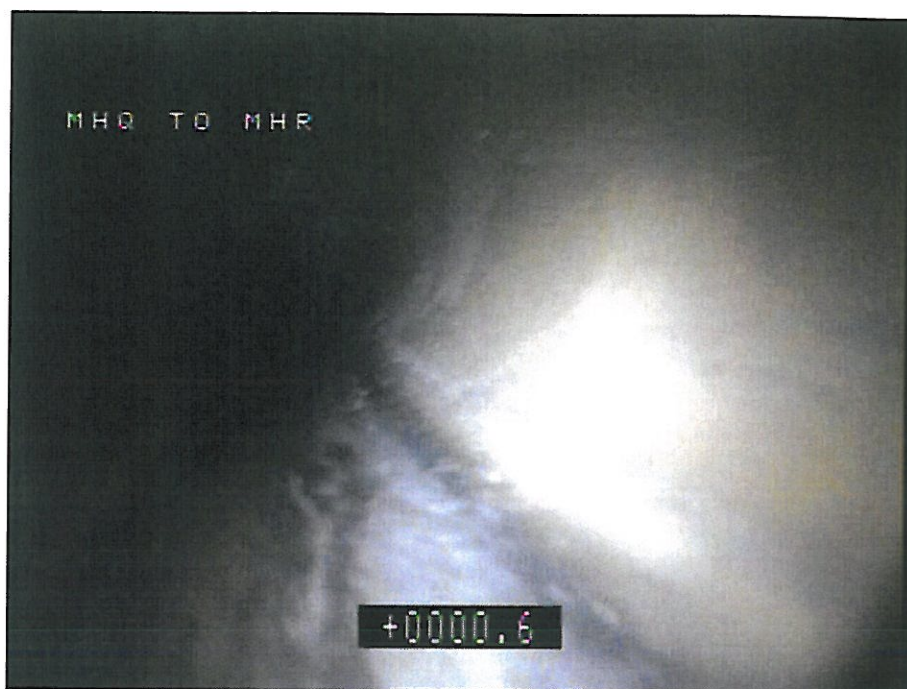
Photo: 113\_3a, Tape No.: 01, 00:00:00  
0m, Water level, 05 % height/diameter

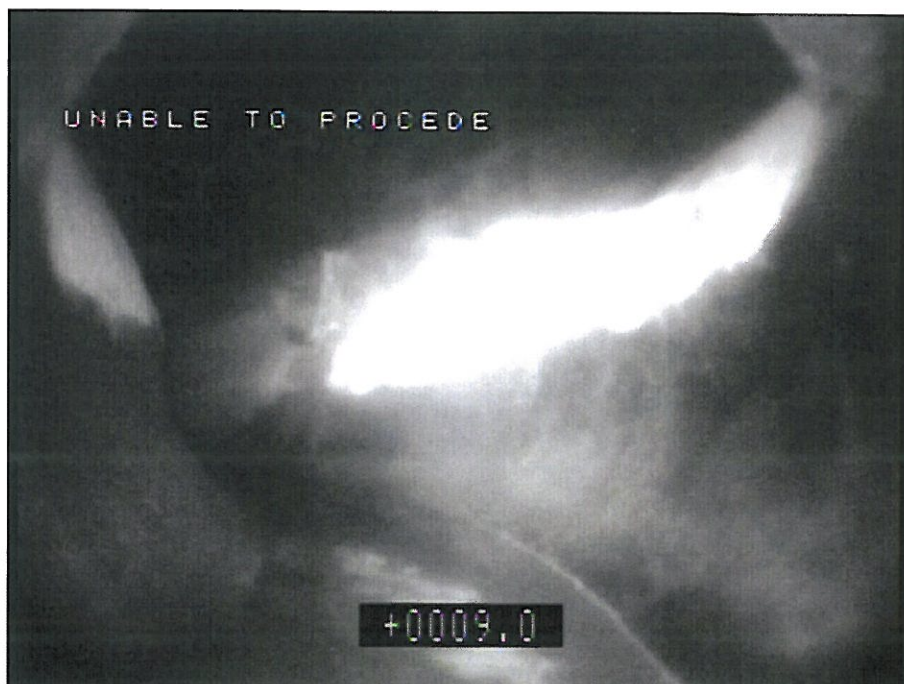
Photo: 115\_5a, Tape No.: 01, 00:04:27  
9m, Manhole Remark: MH R
