## / Main sections

| Project name :<br><b>Protherics UK Ltd, Wales, Drainage</b> | Project number :<br><b>J48577</b> | Contact : | Date :<br><b>26/09/2017</b> |

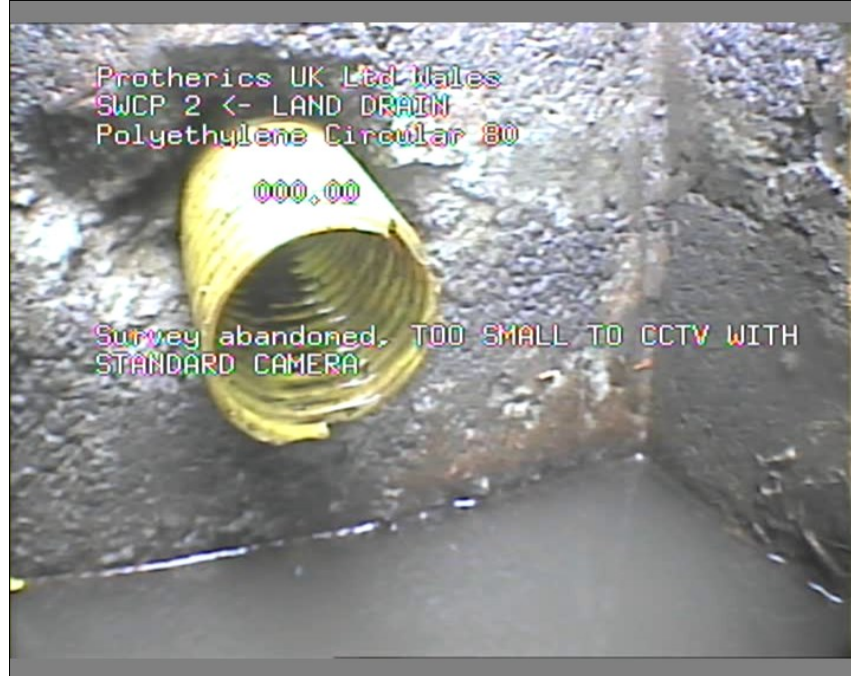
Photo: 25\_25\_143\_A.JPG  
0m, Survey abandoned

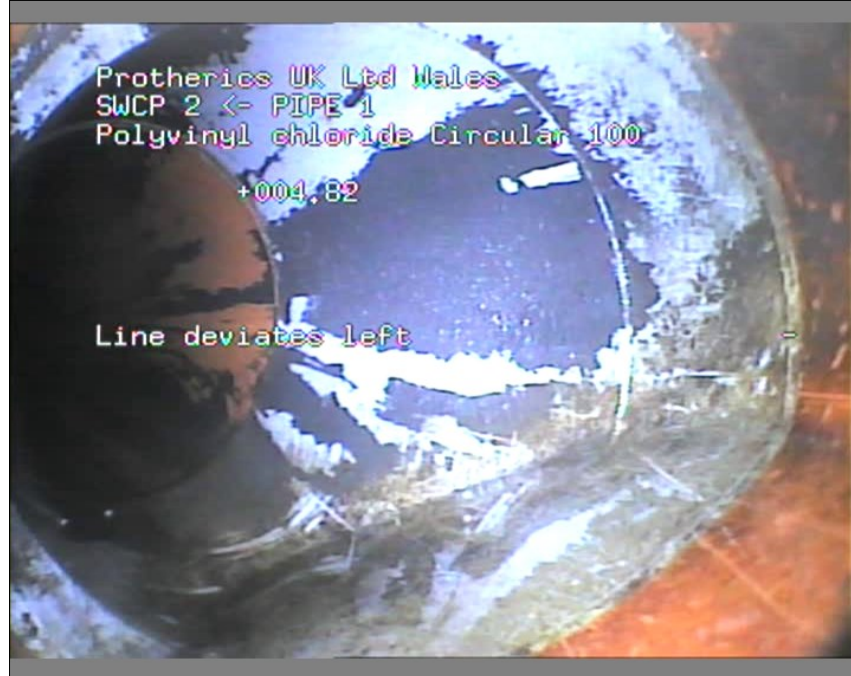
Photo: 26\_26\_\_A.JPG  
 4.82m, Line deviates left

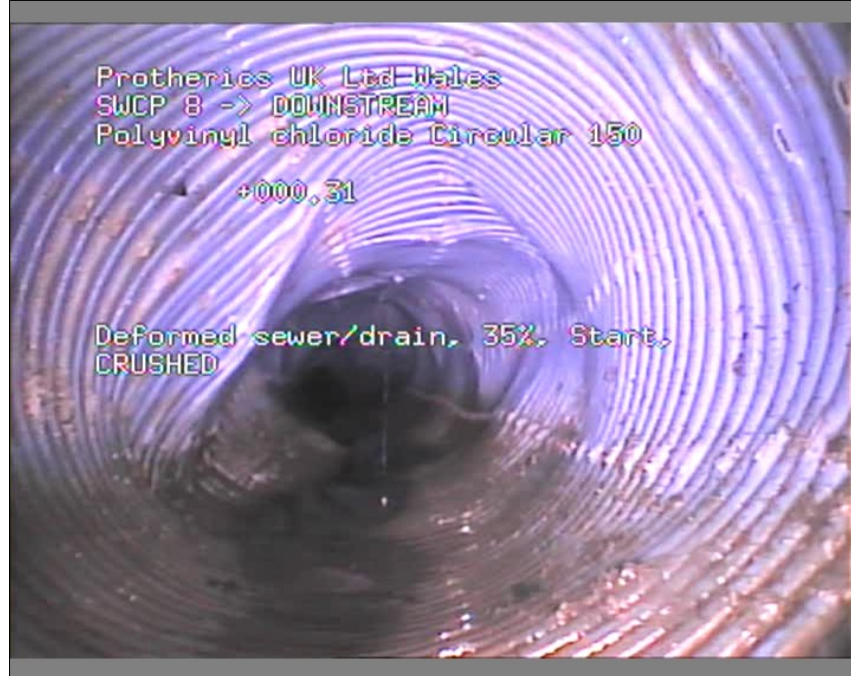
Photo: 47\_47\_288\_A.JPG  
 0.31m, Deformed sewer/drain, 35%, Start

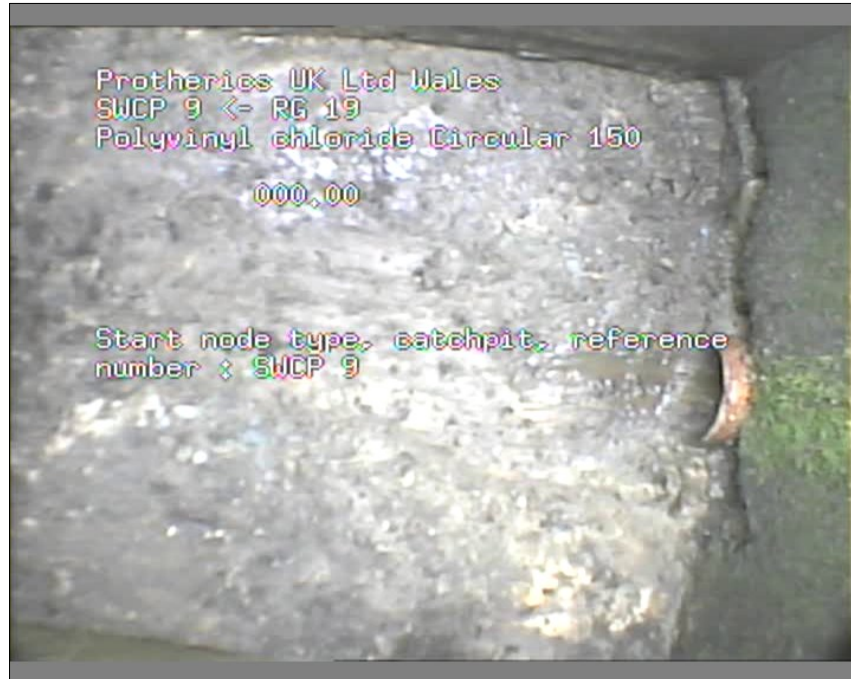
Photo: 50\_50\_312\_A.JPG  
 0m, Start node type, catchpit, reference number : SWCP 9

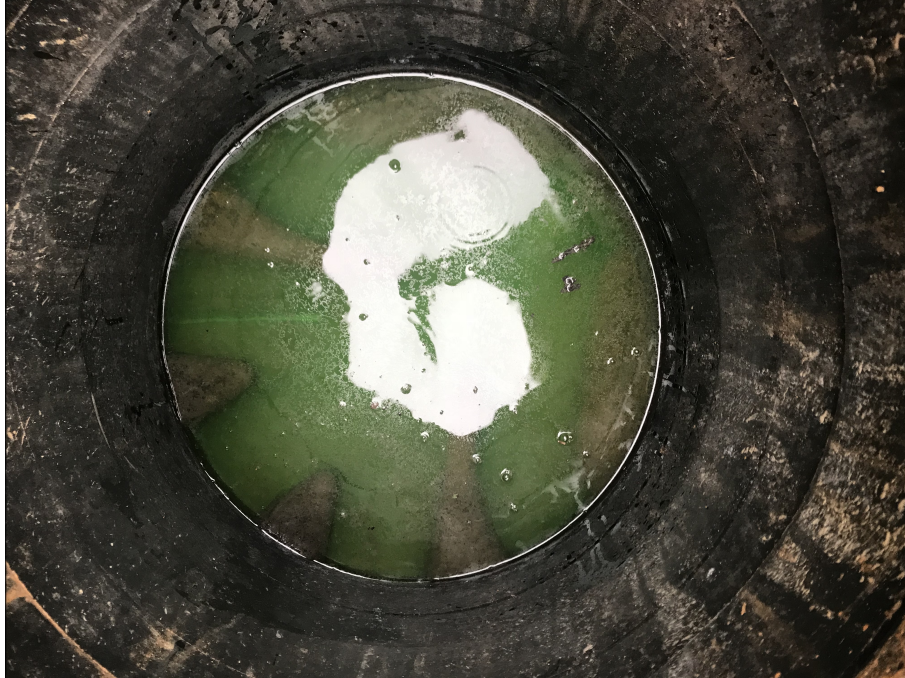
Photo: FWMH 1 Surcharged.JPG  
 0m, General remark

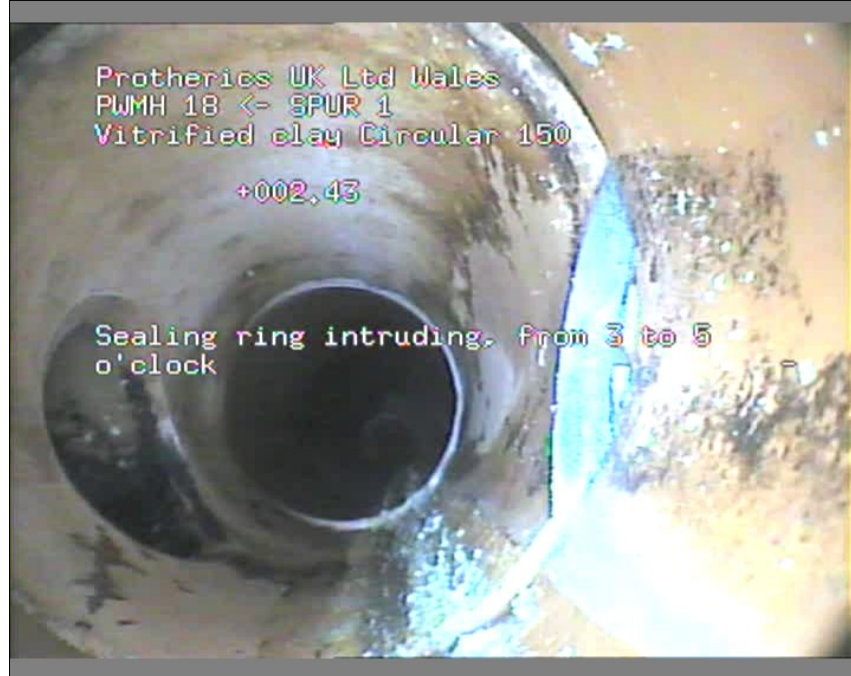
Photo: 111\_111\_712\_A.JPG  
 2.43m, Sealing ring intruding, from 3 to 5 o'clock

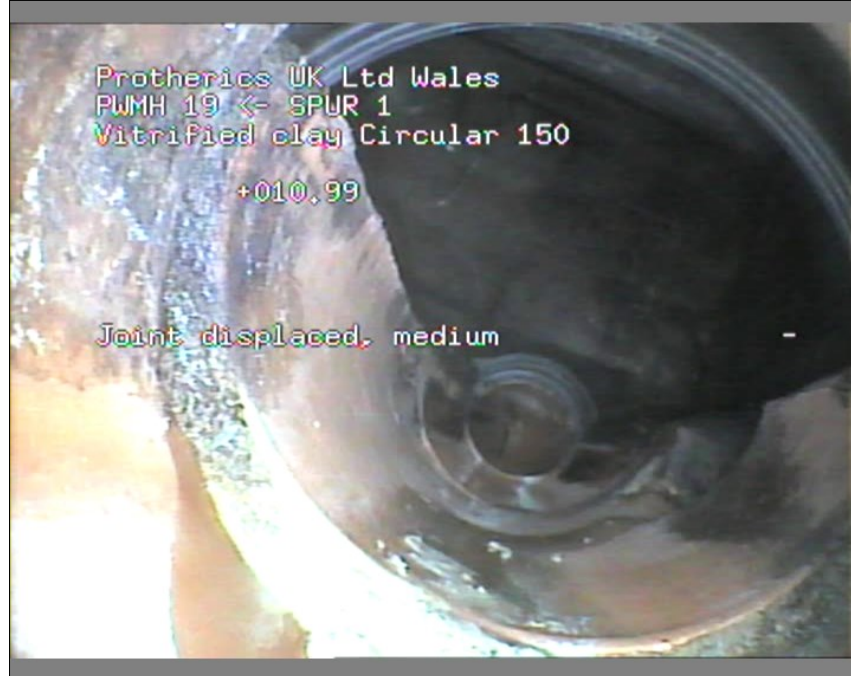
Photo: 113\_113\_733\_A.JPG  
 10.99m, Joint displaced, medium

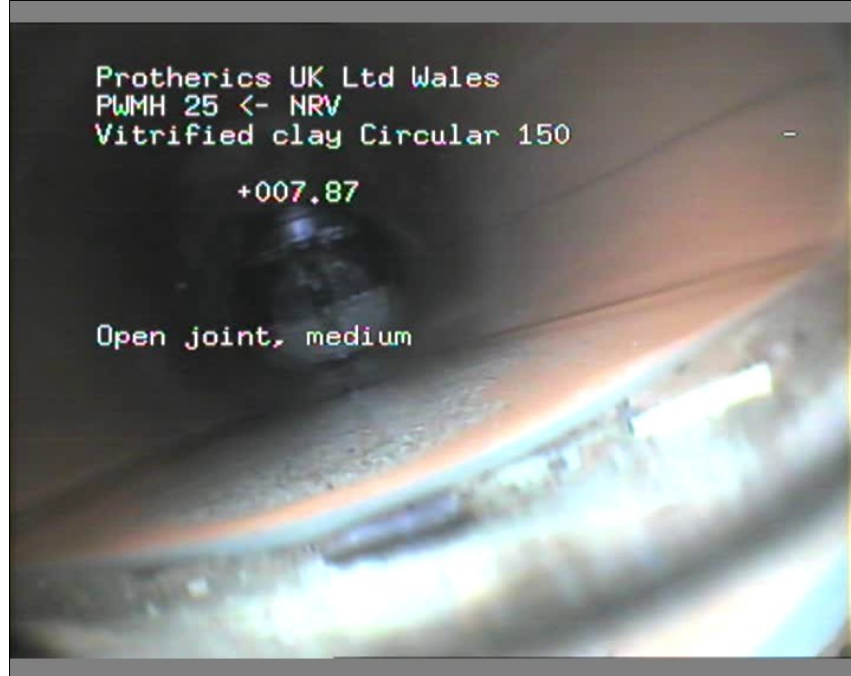
Photo: 126\_126\_832\_A.JPG  
 7.87m, Open joint, medium

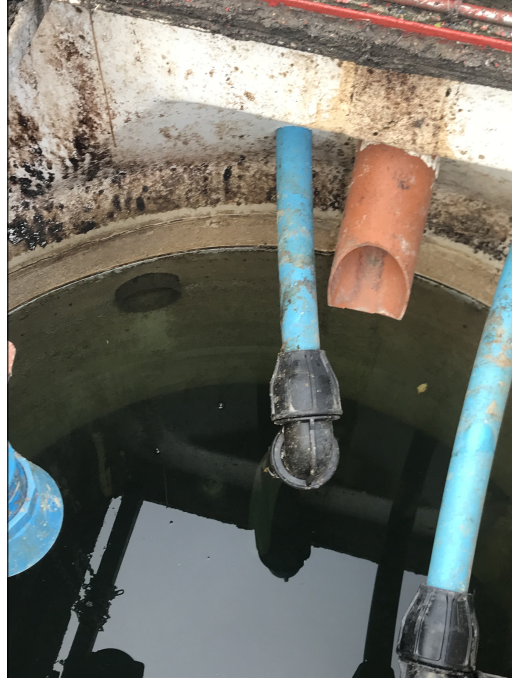
Survey abandoned Remarks: PUMP UNDER WATER

Photo: TANK Pipe from NRV Underwater.JPG  
 0m, General remark

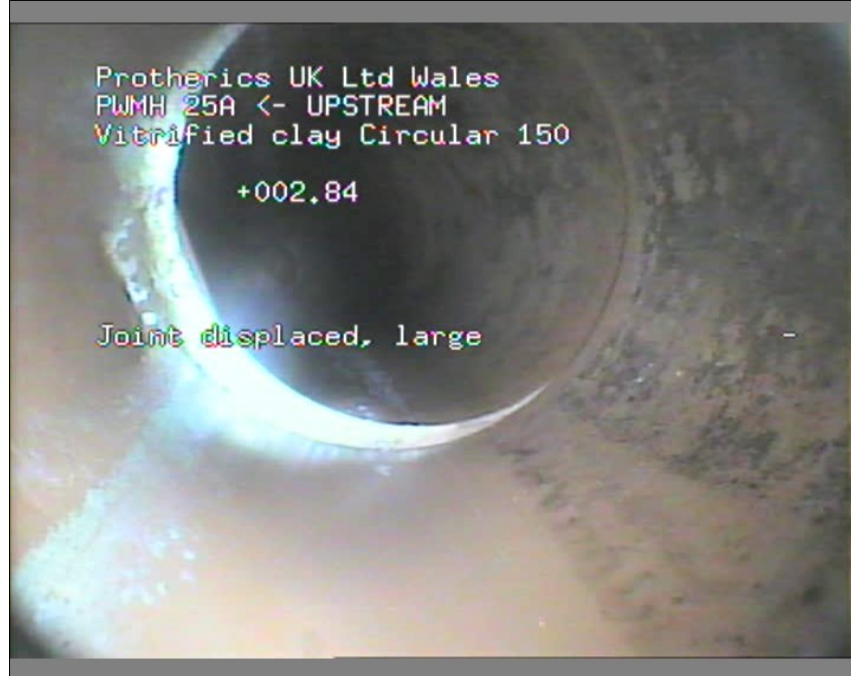
| 1:50 | Position | Observation | Grade | | | | | | |
|---|---|---|---|---|---|---|---|---|---|
| | 2.84 | Joint displaced, large | 1 | | | | | | |

Photo: 131\_131\_865\_A.JPG  
2.84m, Joint displaced, large
