REPORT ON

**TREHIR LANDFILL SITE
ASSESSMENT OF LANDFILL SLOPE STABILITY**

January 2003

02523476.500/B.0

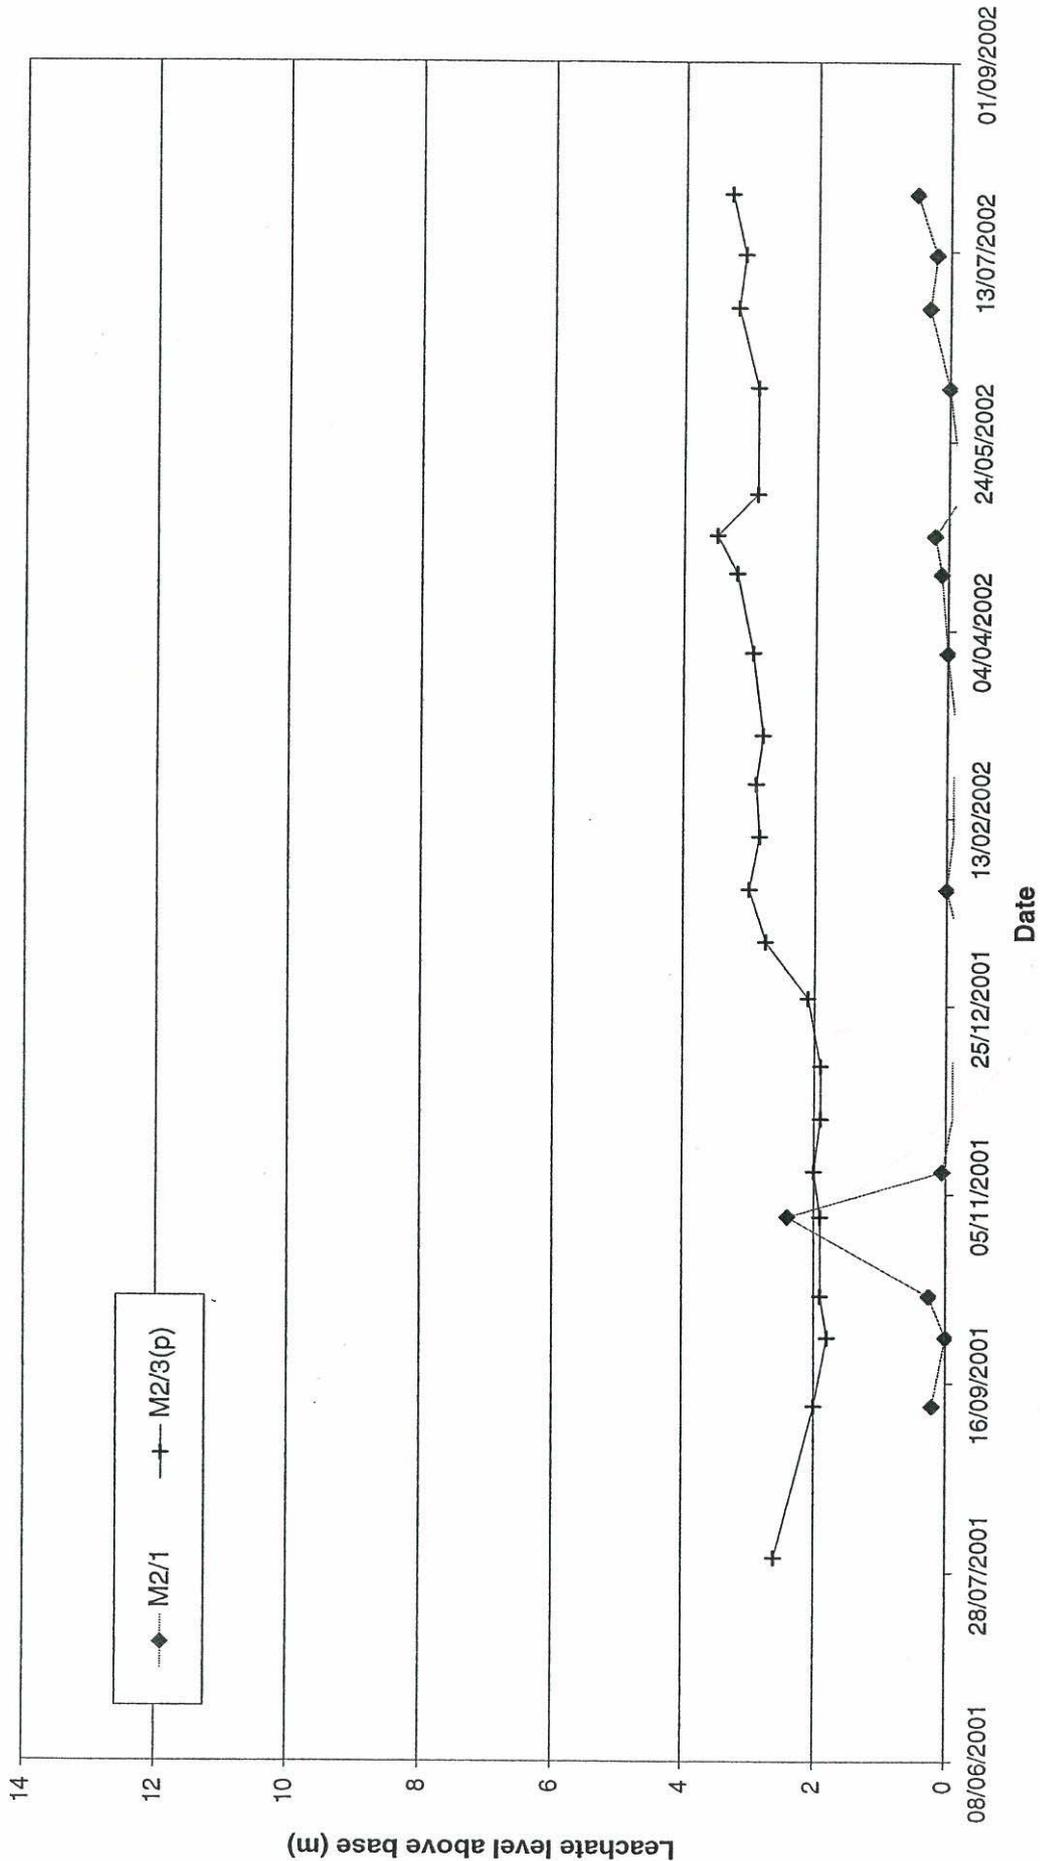
Summary of leachate monitoring Aug 2001 - July 2002
Section C-C

The measured leachate levels in the vicinity of Section C-C are relatively low compared to the other two cross-sections and this is seen in the higher calculated factors of safety. The factor of safety against a circular failure within the waste body for the initial condition is 1.90 and this decreases with increasing leachate levels to 1.34 for 14 m and 18 m of leachate at M2/1 and M2/4 respectively.

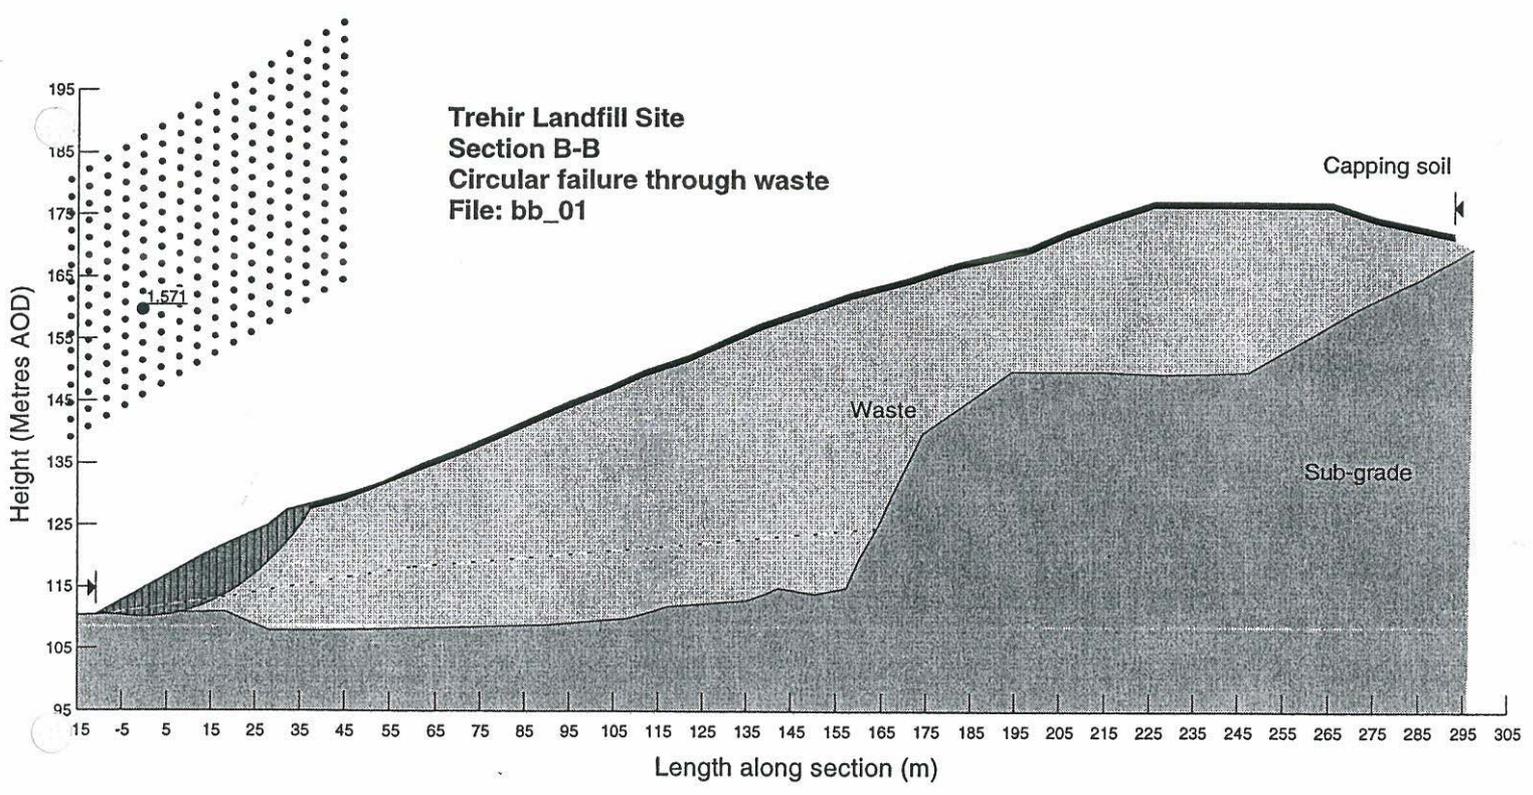
Trehir Landfill Site
Section B-B
Circular failure through waste
File: bb_02

Ref	Description	Factor of Safety
bb_01	Circular failure, leachate: 3m at M2/2, 10m at M2/5	1.57
bb_02	Circular failure, leachate: 4m at M2/2, 11m at M2/5	1.51

The calculated factor of safety for the initial condition, i.e. the highest recorded leachate levels, is 1.57. The factor of safety decreases with increasing leachate levels. If leachate is considered to rise in 1 m increments at both monitoring boreholes M2/2 and M2/5, a factor of safety less than 1.3 is obtained for leachate levels greater than 7 m and 14 m at M2/2 and M2/5 respectively. However if the leachate level at the toe of the slope (M2/2) is maintained at 3 m, then the level at M2/5 can rise to around 20 m before the factor of safety reduces below 1.3.

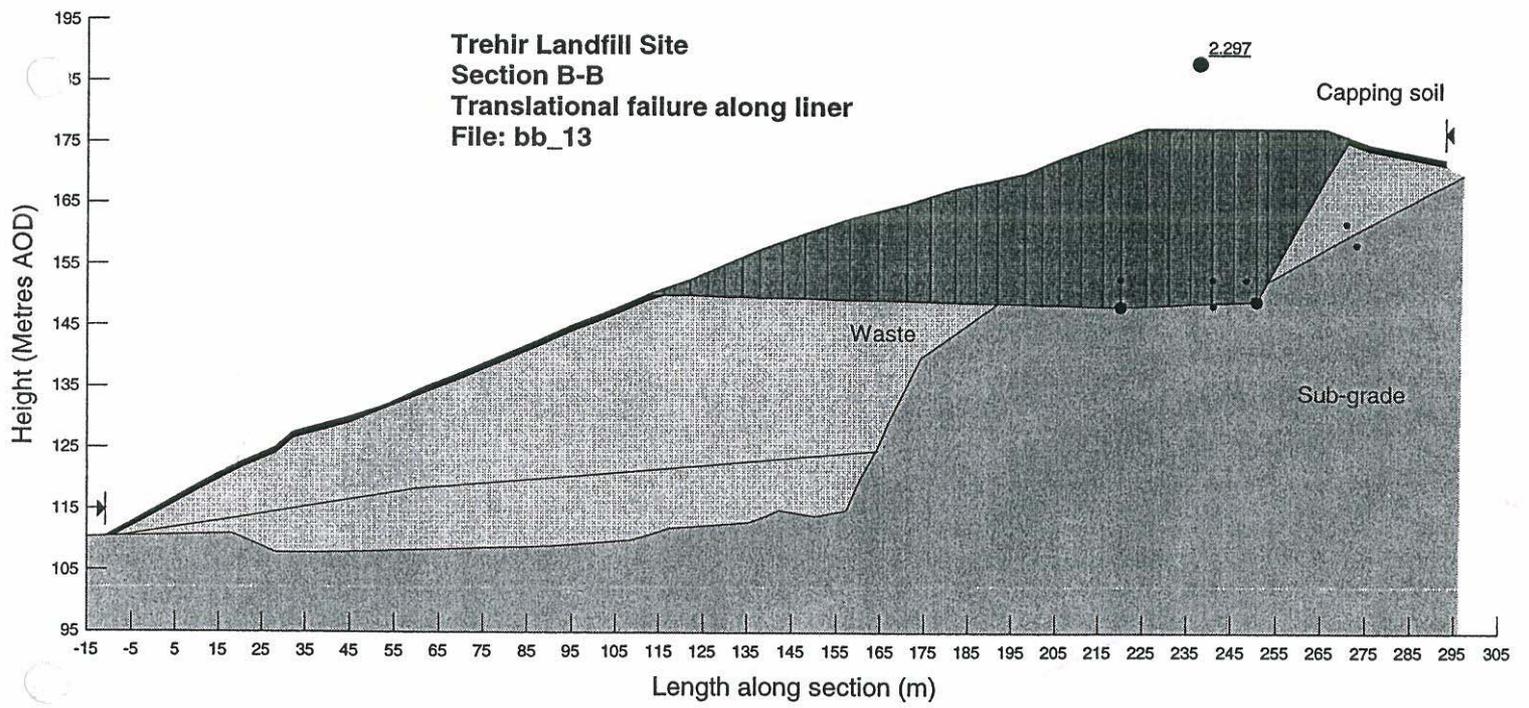
Trehir Landfill Site
Section B-B
Translational failure along liner
File: bb_13

Translational failure of the waste along the liner in the upper section of landfill is considered unlikely with a calculated factor of safety of 2.01 using pessimistic values for geosynthetic interface friction and pore water pressure at the interface.
