**Structural Assessment of
Bunds At Mekatek Ltd, Amex
Park, Llanstephan Road,
Johnstown, Carmarthen,
SA31 3NF**

TDA-01276-REPT-01

Structural Engineer's Report

Assessment of existing bund walls and bases on storage areas at Mekatek.

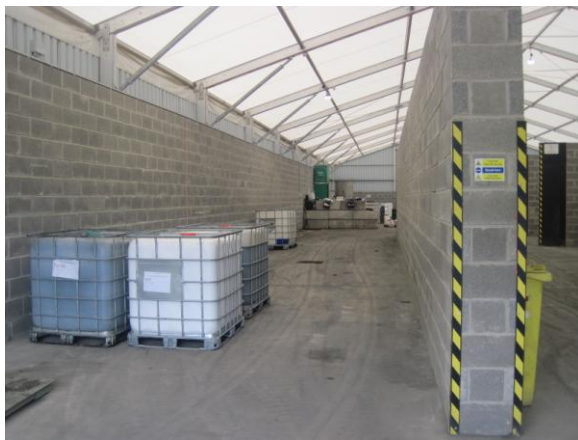
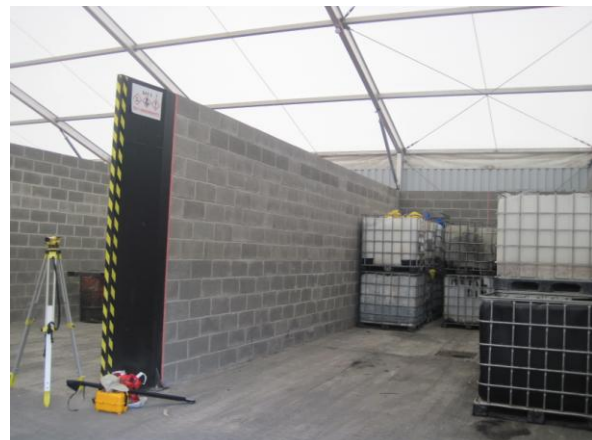
Photograph 2.1, Typical Views (Internal) Of The Transfer Building

The floors and bay walls are in good condition with no signs of deterioration observed during the inspection. Any cracking present in the floor slab is classed as non-structural.

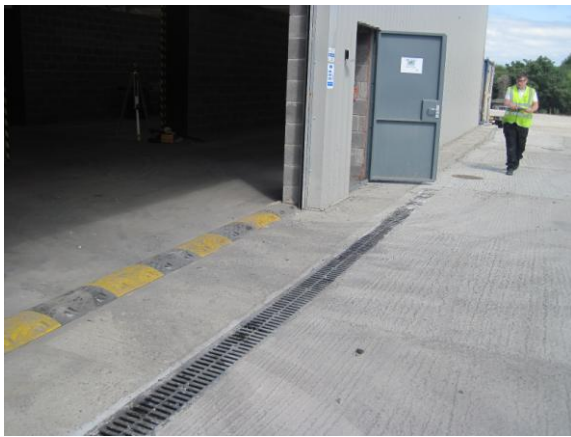
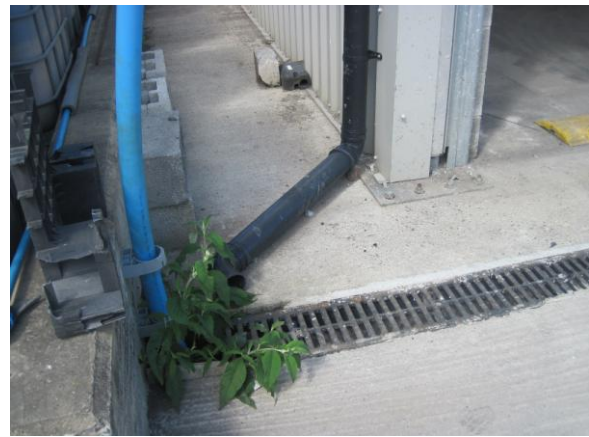
Photograph 2.3, View of “Aco” type drainage currently installed to prevent water ingress into the building.
