| Location Plan: | | Sudbrook Wall | |
| | | Structure Reference: | <b>13 50</b> |

# COASTAL ASSET CONDITION SURVEY REPORT

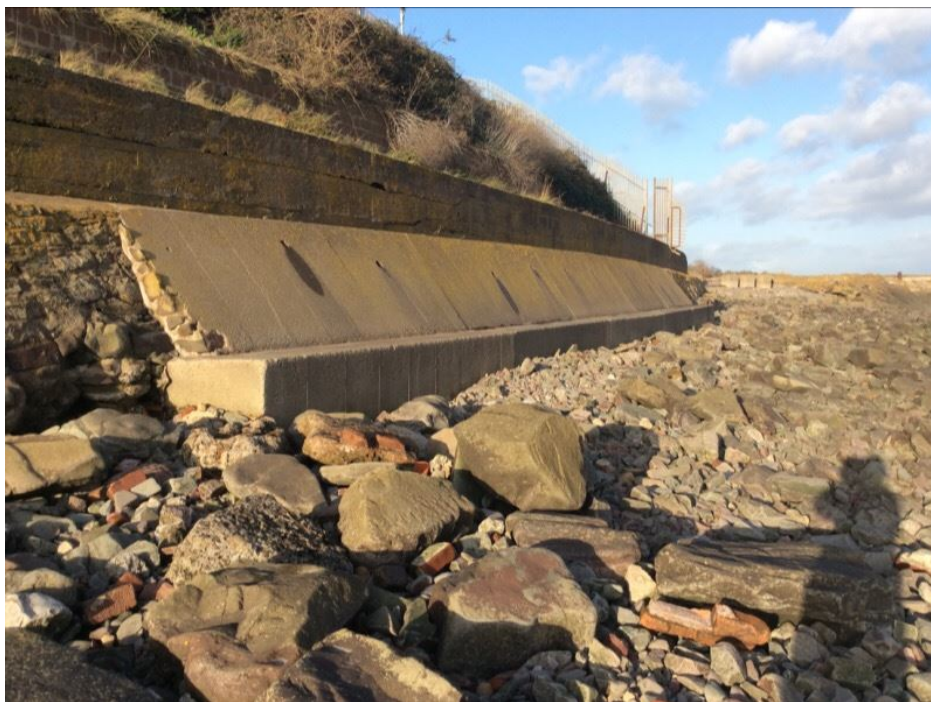
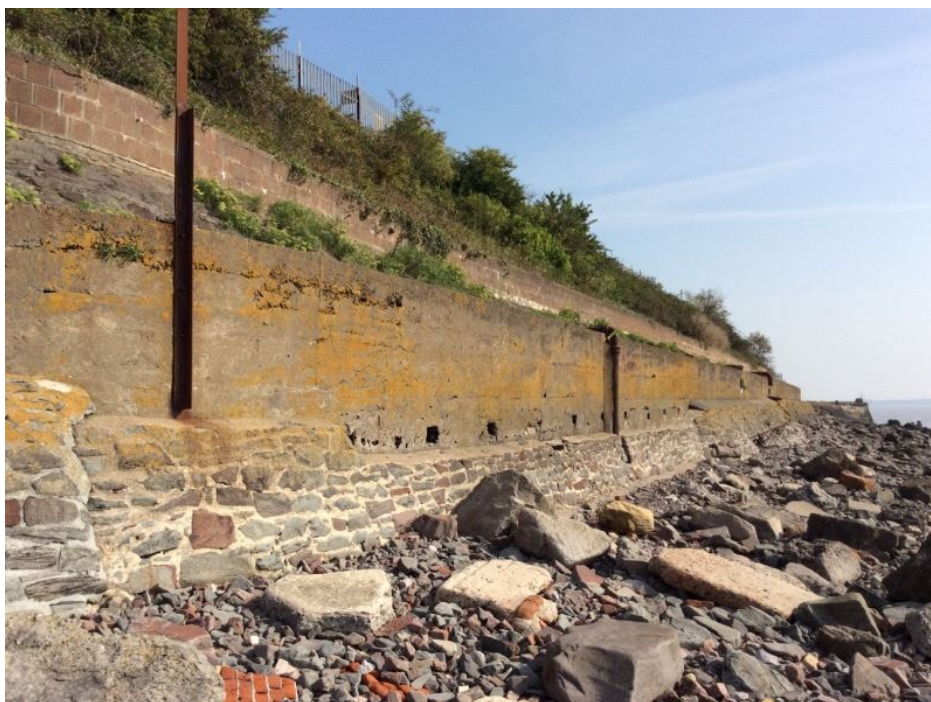
| Minor Elements | Photo No. | Attributes and General Notes | Condition Grade | Weighting (1-9) | Overall (CG x W) |
|---|---|---|---|---|---|
| Wall section | 11, 14 | Concrete (Concrete (spalling, fractures)). | 4 | 7 | 28 |

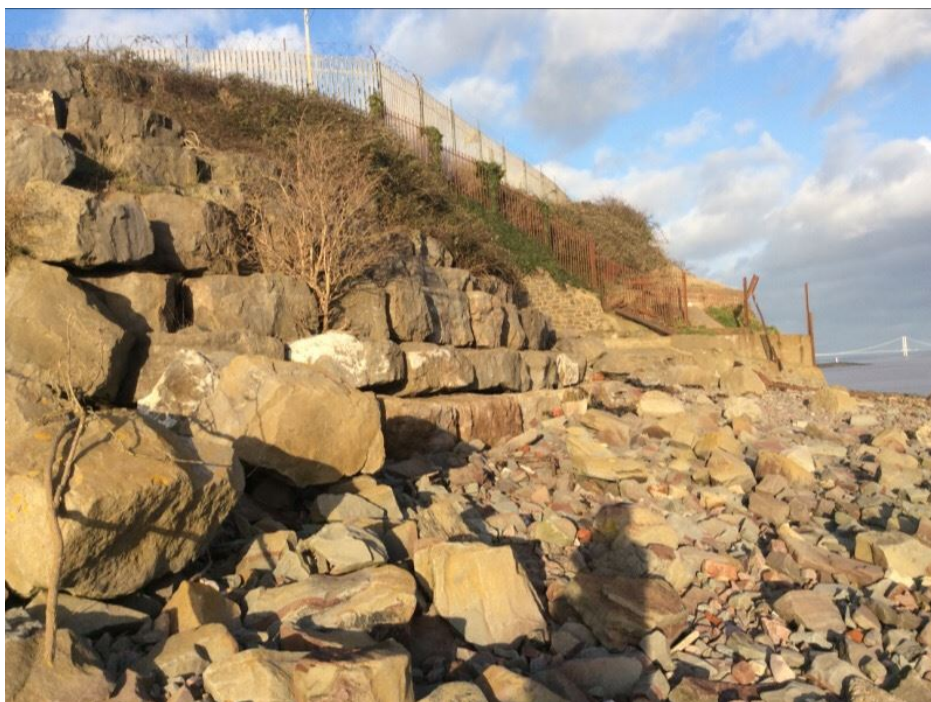
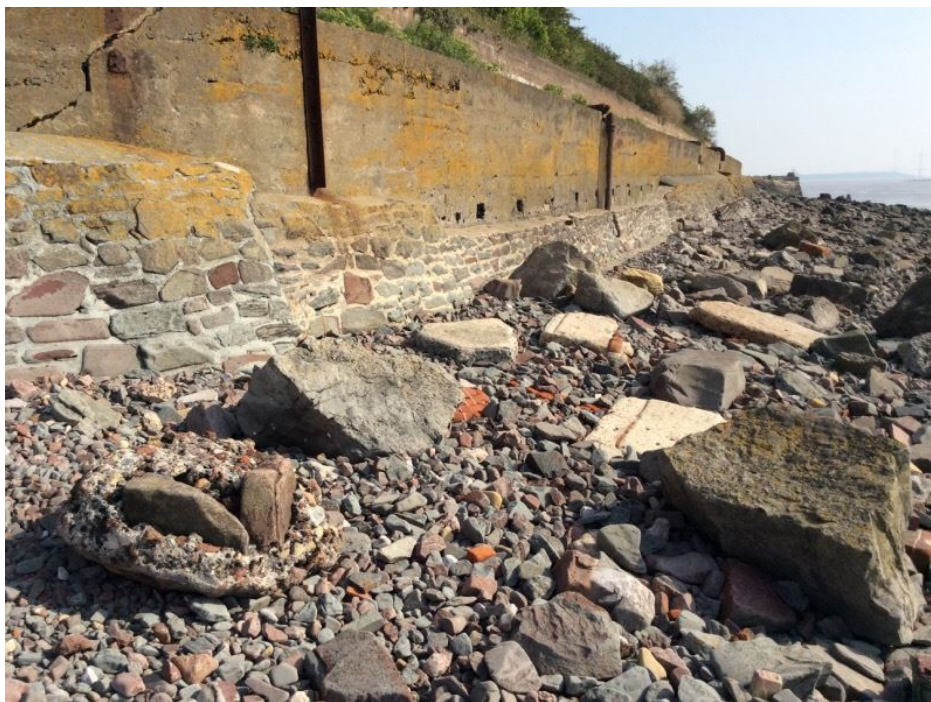
| Minor Elements | Photo No. | Attributes and General Notes | Condition Grade | Weighting (1-9) | Overall (CG x W) |
|---|---|---|---|---|---|
| Wall section | 12, 13 | Masonry (Masonry (failing lower section, undermining, hollow structure with large voids)). | 5 | 9 | 45 |

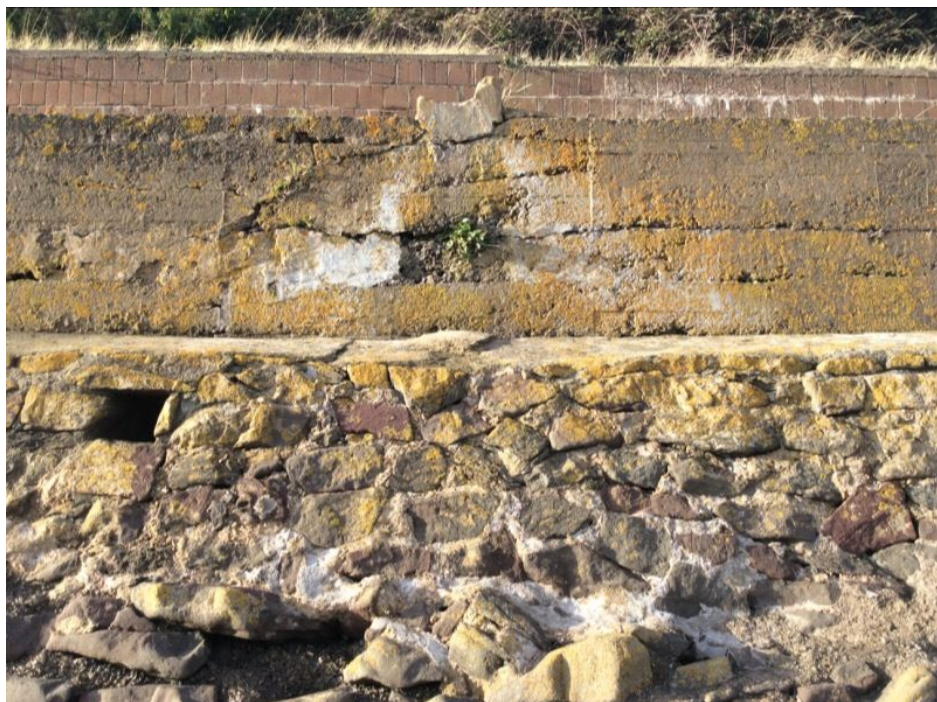
| Defect Ref No. | Defect Location (NGR) | Major Element | Minor Element | Photo Ref | Severity | Probability | Risk Score | Below MHWS | Defect Group | Defect Description | Recommendations | Defect Priority |
|---|---|---|---|---|---|---|---|---|---|---|---|---|
| D1 | 350700, 187300 BSW 13.1022 | Wall | Wall section | 17, 56, 64, 108 | 2 | 5 | 10 | N/A | Concrete damage | Spalling concrete. There has been minor changes between the 2020 and 2021 inspections with evidence that this is occurring throughout most of the structure. | Break out spalled areas and replace concrete. | 19 |

**Section A**  
**Wall section**  
**Defect Ref: D1**  
**Description:** Spalling concrete. There has been minor changes between the 2020 and 2021 inspections with evidence that this is occurring throughout most of the structure.  
**Photo number: 56**

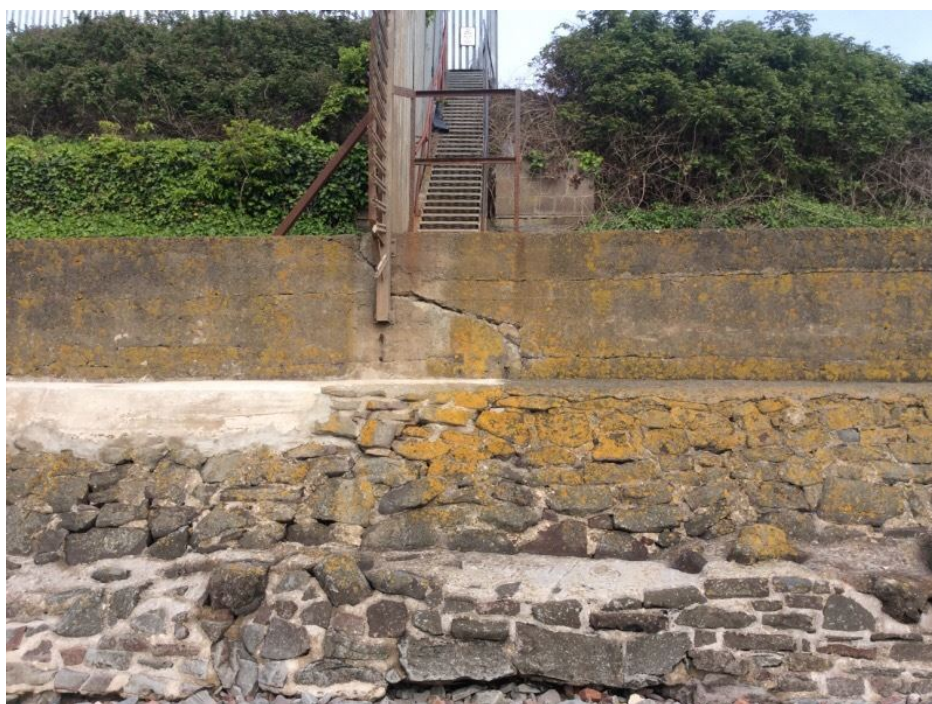
| Defect Ref No. | Defect Location (NGR) | Major Element | Minor Element | Photo Ref | Severity | Probability | Risk Score | Below MHWS | Defect Group | Defect Description | Recommendations | Defect Priority |
|---|---|---|---|---|---|---|---|---|---|---|---|---|
| D2 | 350700, 187300 BSW 13.1022 | Wall | Wall section | 18, 44, 65, 106 | 2 | 4 | 8 | N/A | Concrete damage | Cracks in concrete. No change between 2020 and 2021 inspections. | Fill void and fractures. | 20 |

**Section A**  
**Wall section**  
**Defect Ref: D2**  
**Description:** Cracks in concrete. No change between 2020 and 2021 inspections.  
**Photo number: 106**

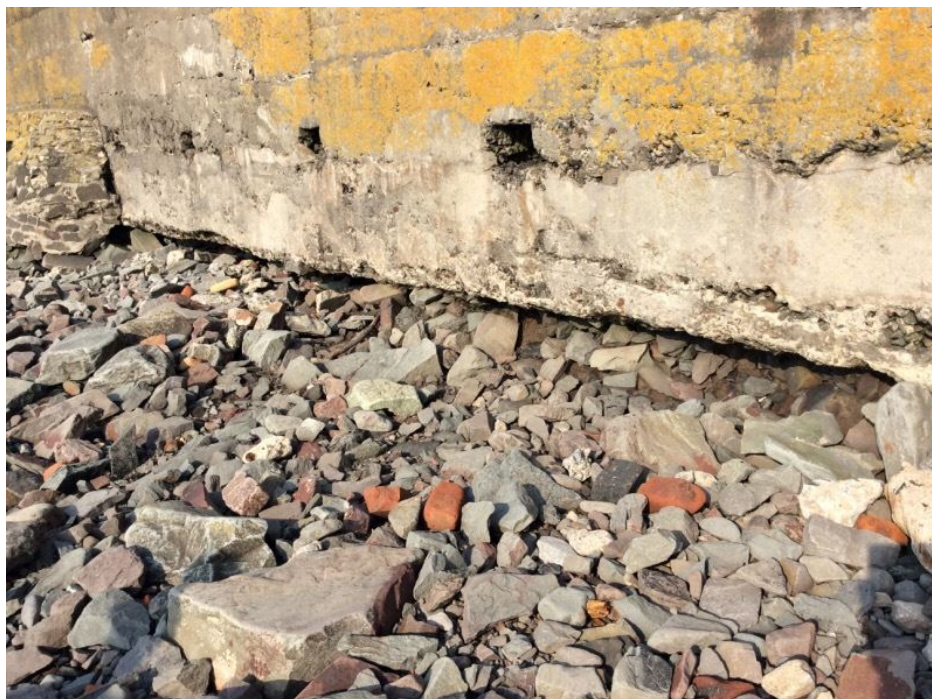
| Defect Ref No. | Defect Location (NGR) | Major Element | Minor Element | Photo Ref | Severity | Probability | Risk Score | Below MHWS | Defect Group | Defect Description | Recommendations | Defect Priority |
|---|---|---|---|---|---|---|---|---|---|---|---|---|
| D3 | 350833, 187423 BSW 13.0951 | Wall | Wall section | 19, 20, 33, 34, 35, 67, 101 | 4 | 3 | 12 | N/A | N/A | 2021 toe repairs and beach level higher. Undermining of wall toe. No change between 2019 and 2020 inspections | Detailed structural survey to be undertaken to help inform suitability of remedial works. Wall toe needs underpinning and protecting. | 7 |

**Section A**  
**Wall section**  
**Defect Ref: D3**  
**Description:** 2021  
toe repairs and beach  
level higher.  
Undermining of wall  
toe. No change  
between 2019 and  
2020 inspections  
**Photo number: 67**

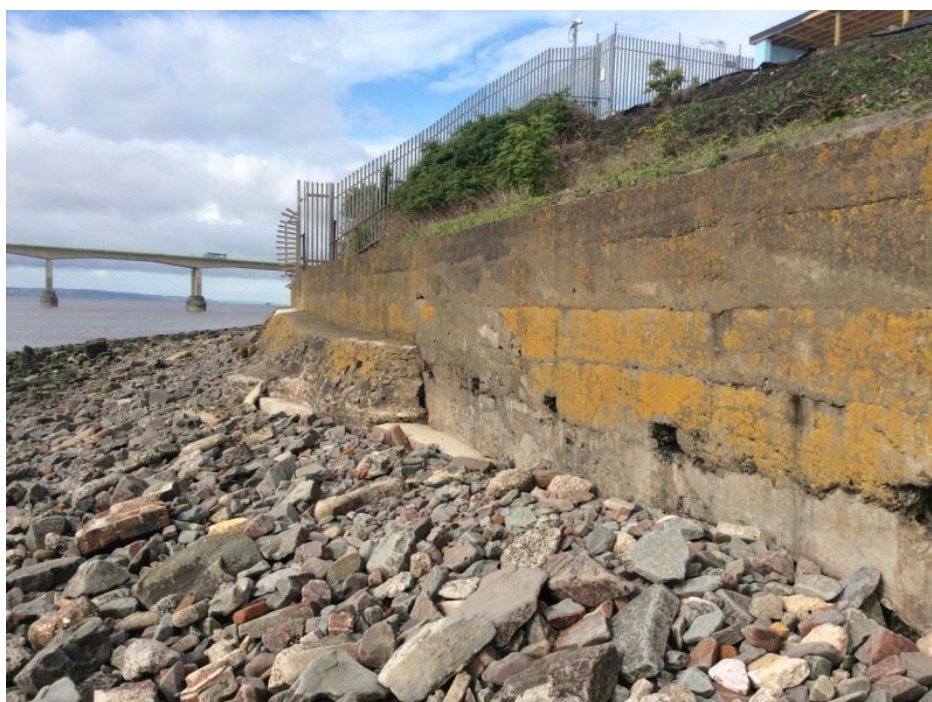
**Section A**  
**Wall section**  
**Defect Ref: D3**  
**Description:** 2021  
toe repairs and beach  
level higher.  
Undermining of wall  
toe. No change  
between 2019 and  
2020 inspections  
**Photo number: 101**

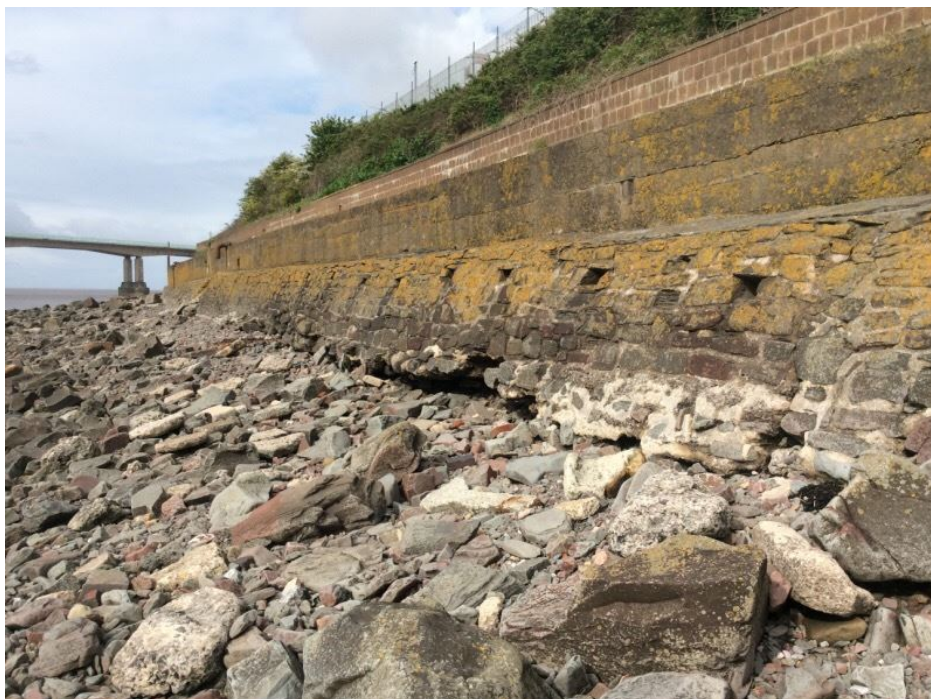
| Defect Ref No. | Defect Location (NGR) | Major Element | Minor Element | Photo Ref | Severity | Probability | Risk Score | Below MHWS | Defect Group | Defect Description | Recommendations | Defect Priority |
|---|---|---|---|---|---|---|---|---|---|---|---|---|
| | 350833, 187423 BSW 13.0951 | Wall | Wall section | 21, 36, 66, 102 | 2 | 4 | 8 | N/A | Scour/undermining | Undermining of wall toe. Between the 2020 and 2021 inspections, the concrete defect has roughly been repaired and cobbles placed under the toe. | Monitor the effectiveness of the repair. | 28 |

**Section A**  
**Wall section**  
**Defect Ref: D4**  
**Description:**  
Undermining of wall  
toe. No change  
between 2020 and  
2021 inspections.  
**Photo number: 118**

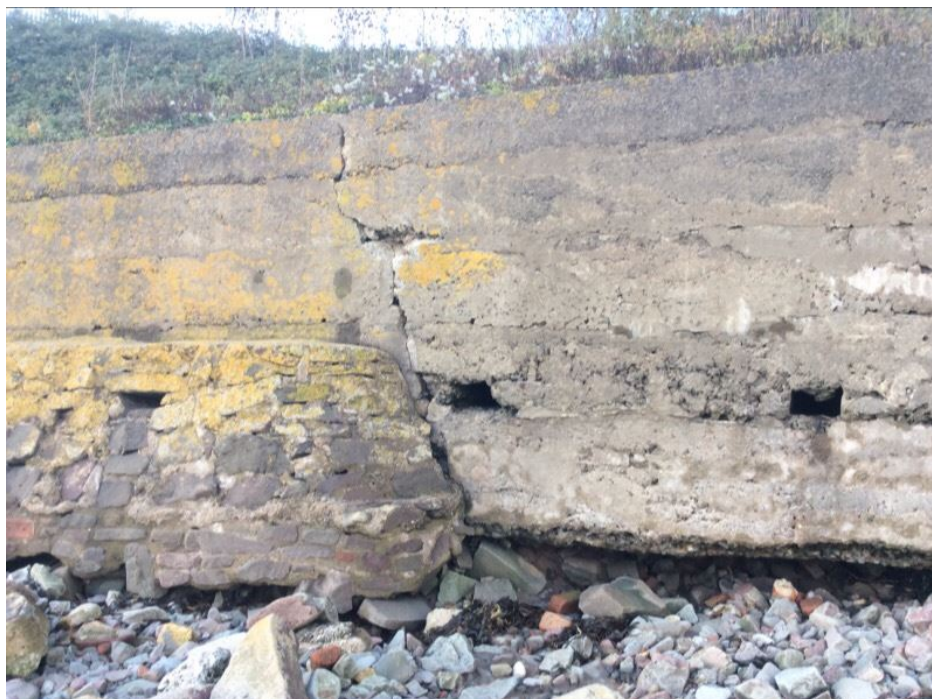
| Defect Ref No. | Defect Location (NGR) | Major Element | Minor Element | Photo Ref | Severity | Probability | Risk Score | Below MHWS | Defect Group | Defect Description | Recommendations | Defect Priority |
|---|---|---|---|---|---|---|---|---|---|---|---|---|
| D5 | 350828, 187415 BSW 13.0953 | Wall | Wall section | 22, 37, 68, 103 | 4 | 2 | 8 | N/A | Concrete damage | Vertical fracture in wall indicates possible subsidence. No change between 2020 and 2021 inspections. | Fill voids in wall and monitor for signs of subsidence. | 17 |

**Section A**  
**Wall section**  
**Defect Ref: D5**  
**Description:** Vertical fracture in wall indicates possible subsidence. No change between 2020 and 2021 inspections.  
**Photo number: 37**

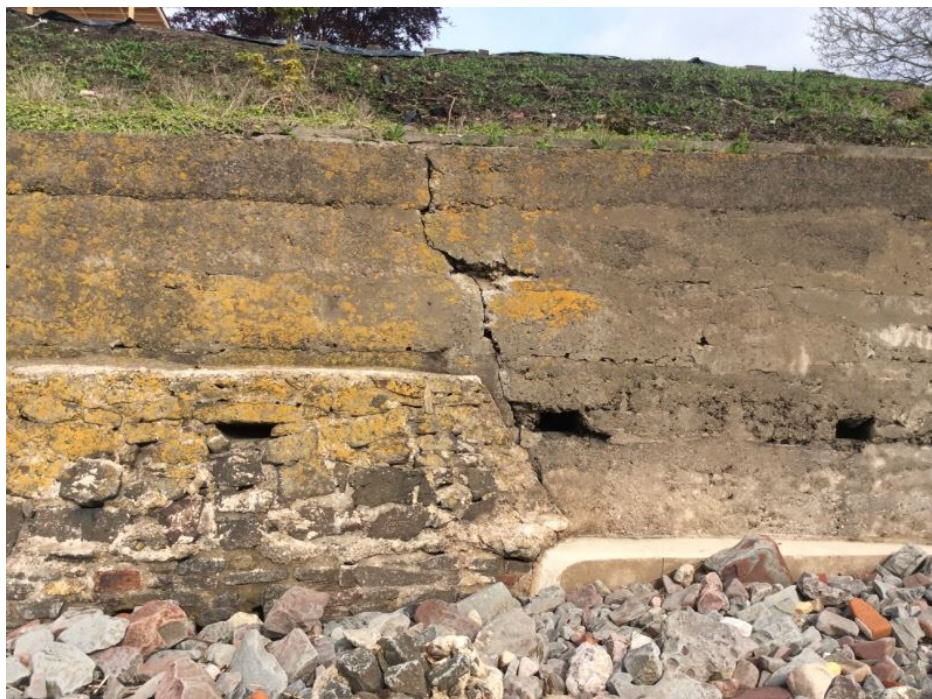
**Section A**  
**Wall section**  
**Defect Ref: D5**  
**Description:** Vertical fracture in wall indicates possible subsidence. No change between 2020 and 2021 inspections.  
**Photo number: 103**

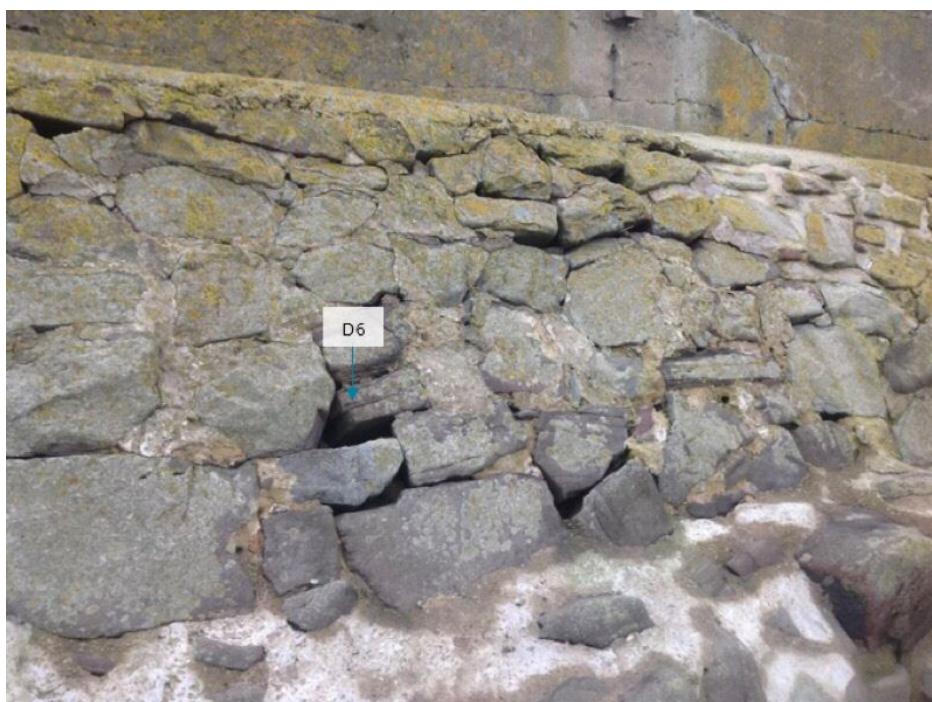
**Section A**  
**Wall section**  
**Defect Ref: D6**  
**Description:** Open joints in the masonry wall section. No change between 2020 and 2021 inspections.  
**Photo number: 23**

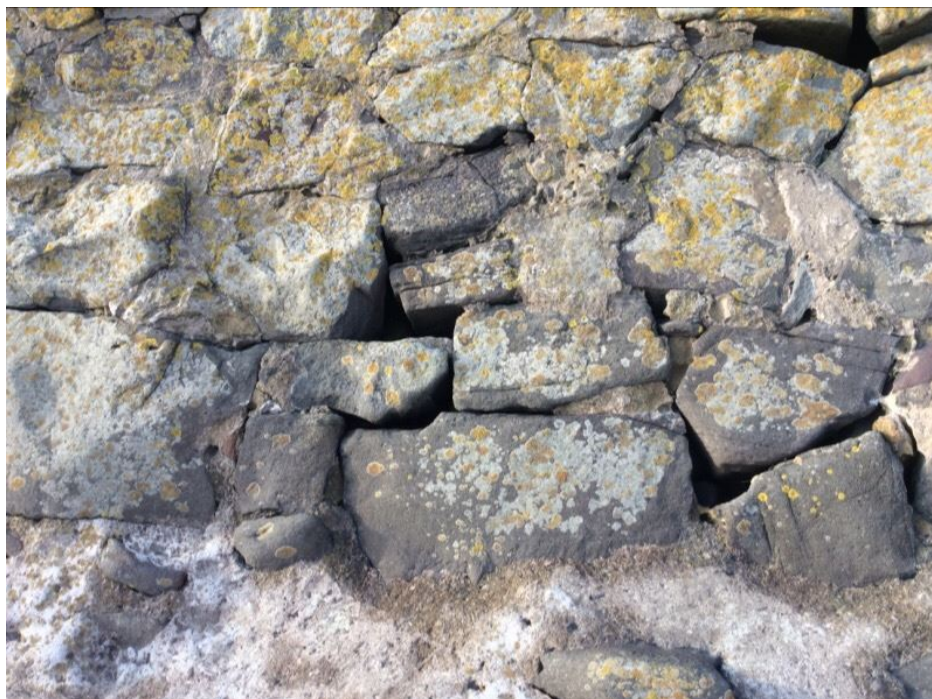
**Section A**  
**Wall section**  
**Defect Ref: D6**  
**Description:** Open joints in the masonry wall section. No change between 2020 and 2021 inspections.  
**Photo number: 40**

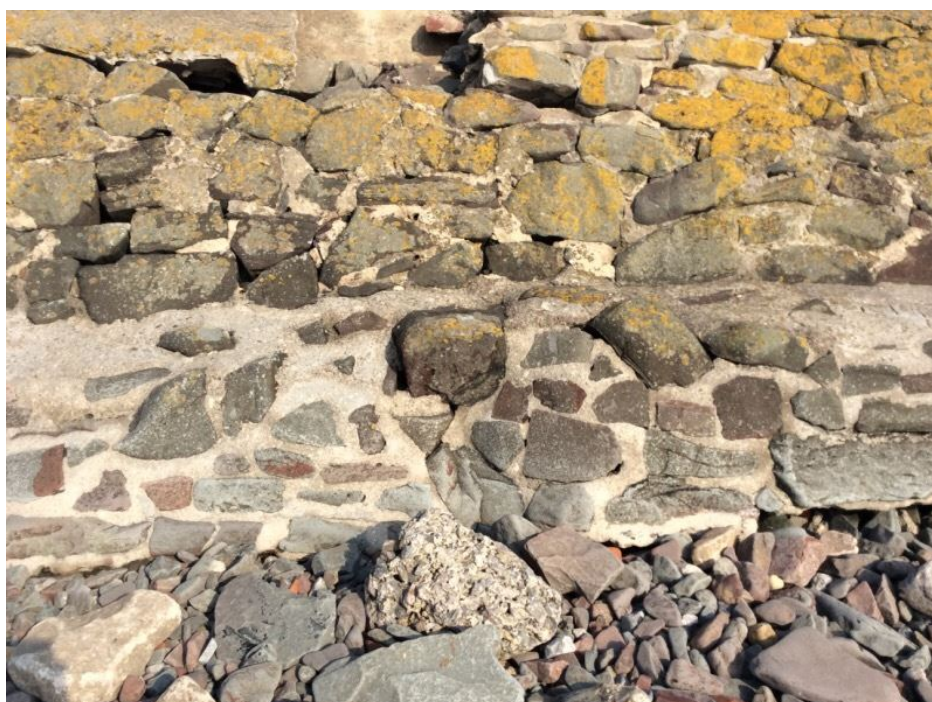
**Section A**  
**Wall section**  
**Defect Ref: D6**  
**Description:** Open joints in the masonry wall section. No change between 2020 and 2021 inspections.  
**Photo number: 70**

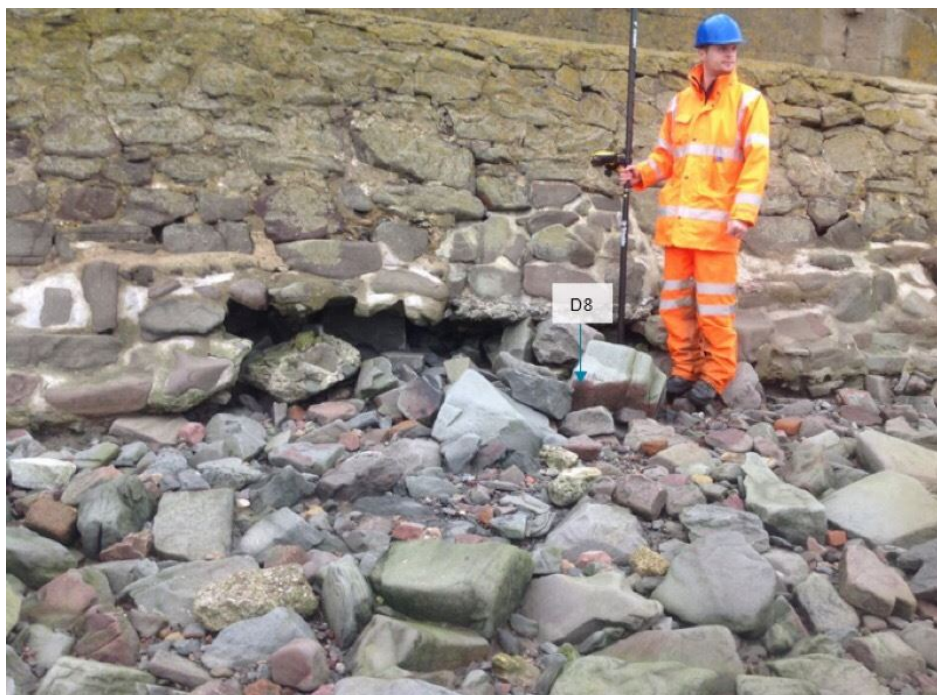
| Defect Ref No. | Defect Location (NGR) | Major Element | Minor Element | Photo Ref | Severity | Probability | Risk Score | Below MHWS | Defect Group | Defect Description | Recommendations | Defect Priority |
|---|---|---|---|---|---|---|---|---|---|---|---|---|
| D7 | 350819, 187396 BSW 13.0952 | Wall | Wall section | 24, 41, 69, 105 | 2 | 4 | 8 | N/A | Missing blockwork | Large top area open. Collapse of lower section of wall. Between the 2020 and 2021 inspections, larger voids have been repaired, but small voids are still present. | Small voids to be filled and monitor the effectiveness of the concrete repair. | 14 |

**Section A**  
**Wall section**  
**Defect Ref: D7**  
**Description:** Large top area open. Collapse of lower section of wall. Between the 2020 and 2021 inspections, larger voids have been repaired, but small voids are still present.  
**Photo number: 24**

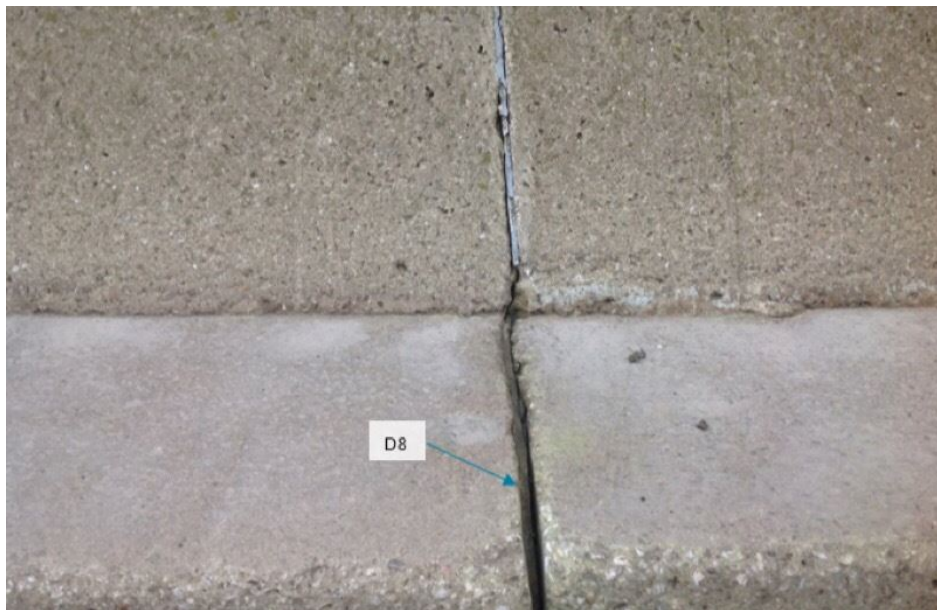
**Photo number: 25**

**Description:** Loss of sealant between wall panels. No change between 2020 and 2021 inspections.

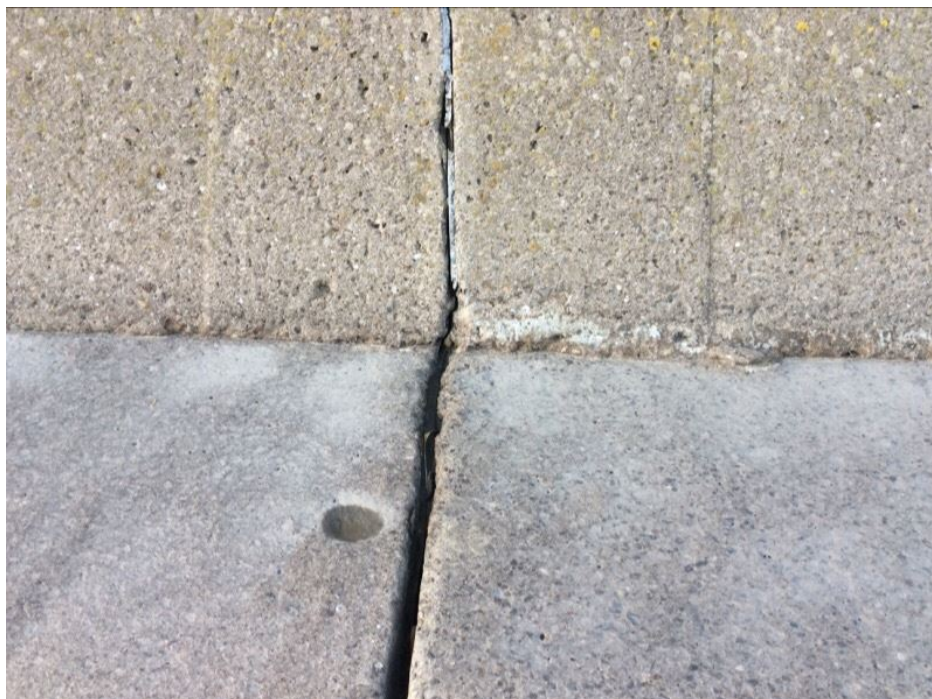
**Section A**  
**Wall section**  
**Defect Ref: D8**  
**Description:** Loss of sealant between wall panels. No change between 2020 and 2021 inspections.  
**Photo number: 42**

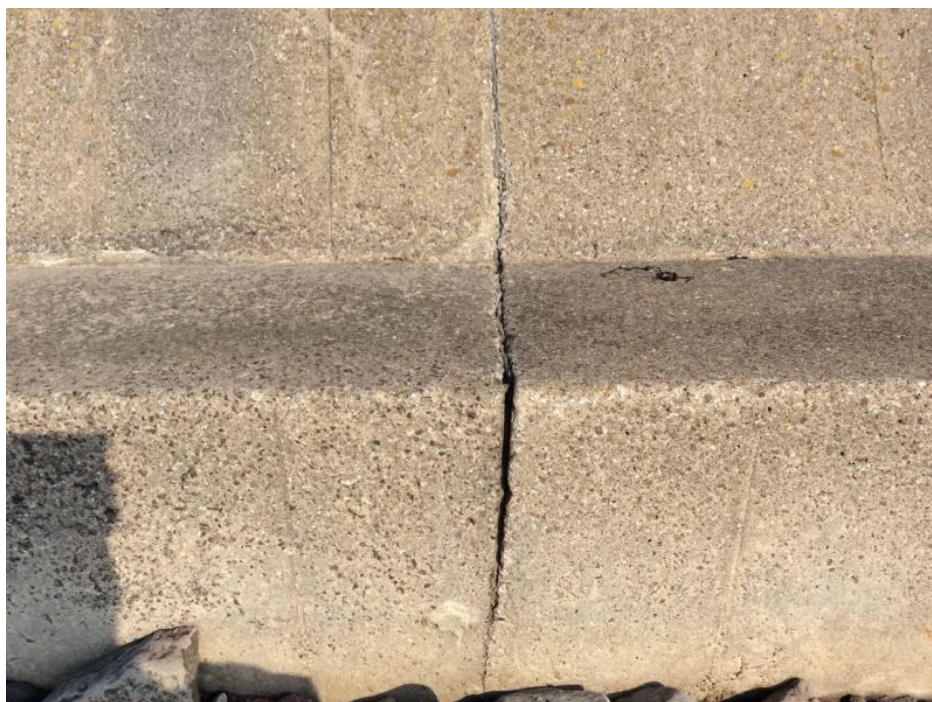
**Section A**  
**Wall section**  
**Defect Ref: D8**  
**Description:** Loss of sealant between wall panels. No change between 2020 and 2021 inspections.  
**Photo number: 71**

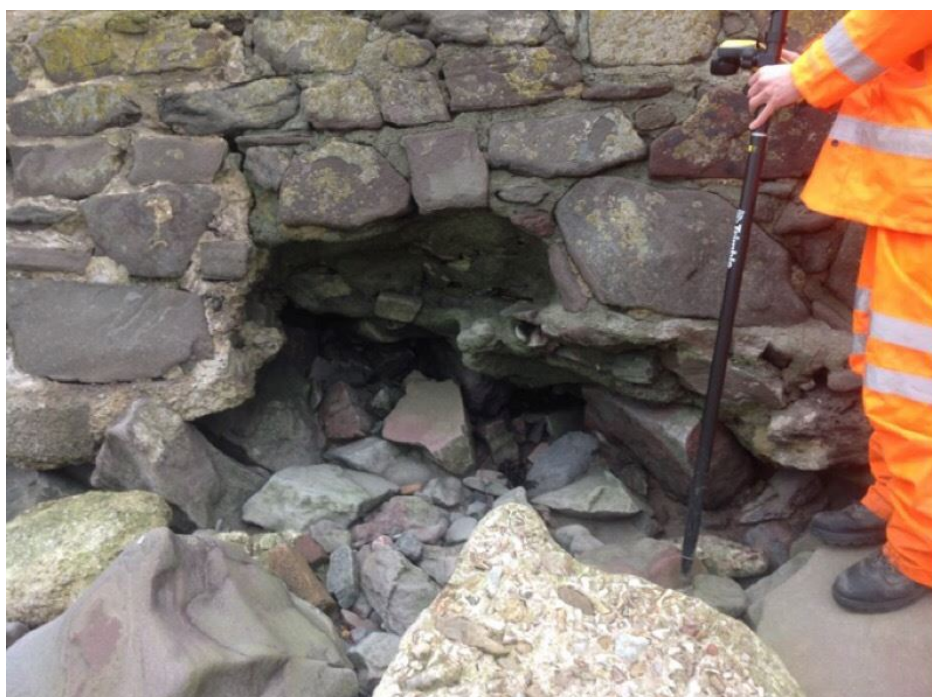
**Section A**  
**Wall section**  
**Defect Ref: D9**  
**Description:** The undermined section leading to the collapse of the lower section of the wall. No change between 2020 and 2021 inspections.  
**Photo number: 51**

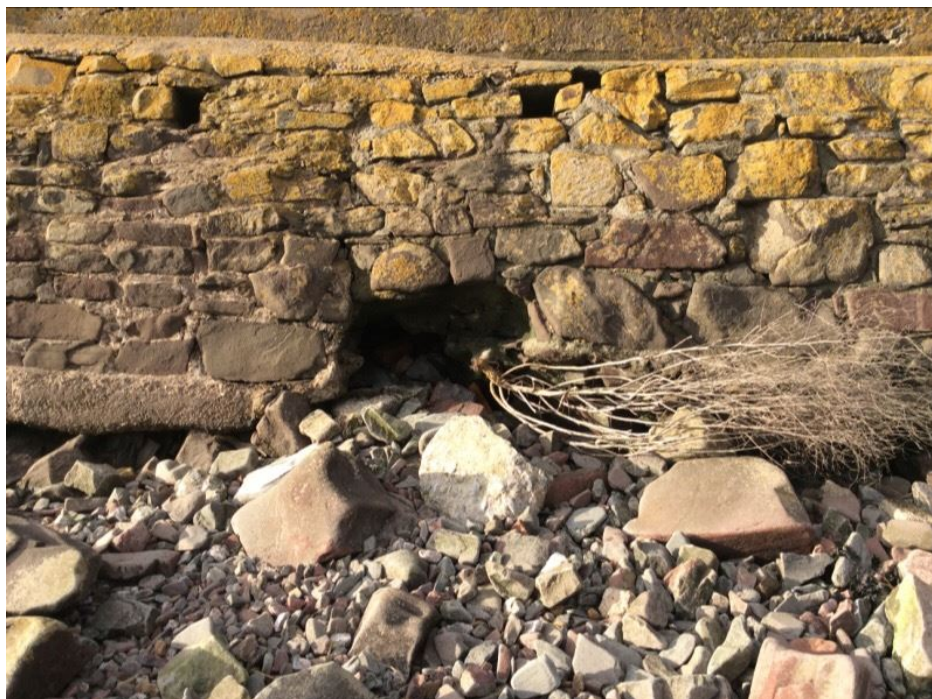
**Section A**  
**Wall section**  
**Defect Ref: D9**  
**Description:** The undermined section leading to the collapse of the lower section of the wall. No change between 2020 and 2021 inspections.  
**Photo number: 74**

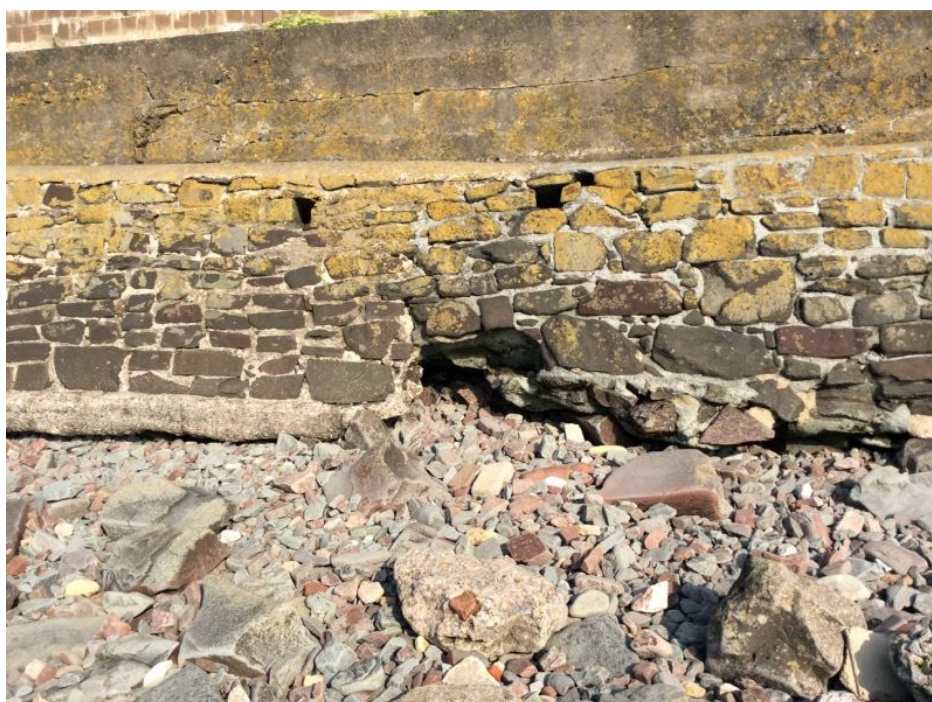
**Photo number: 27**

Localised collapse of the lower wall. During the 2021 inspection the defect was found to be in worse condition.

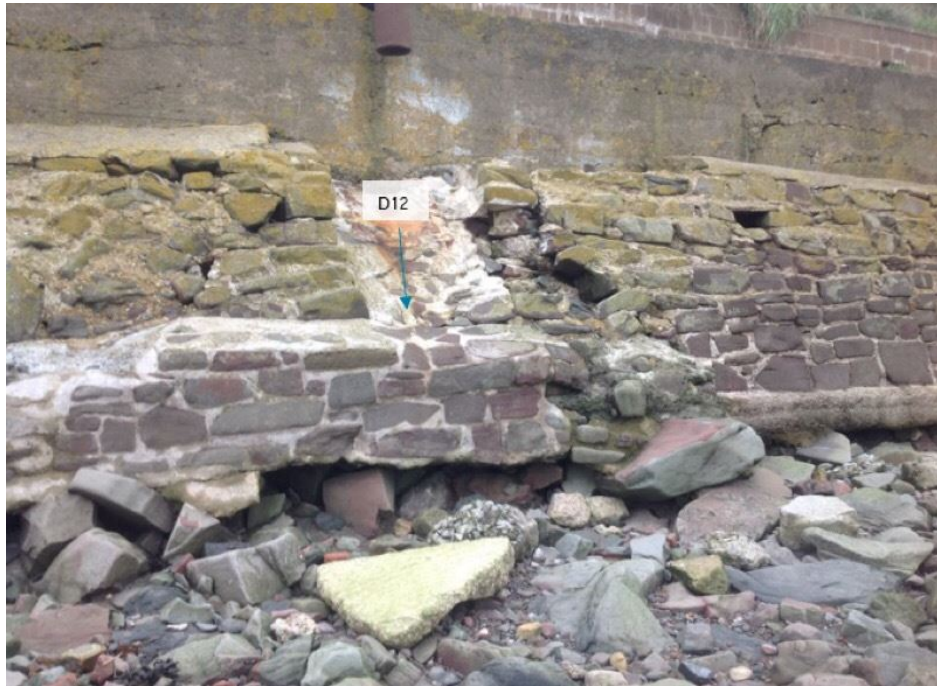
Localised collapse of the lower wall. During the 2021 inspection the defect was found to be in worse condition.

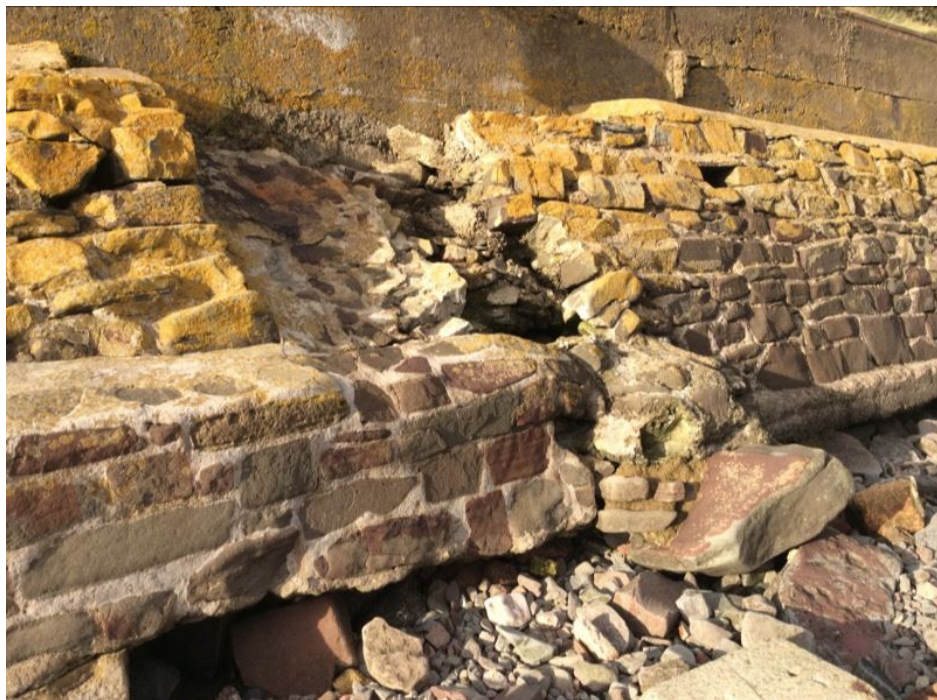
Localised collapse of the lower wall. During the 2021 inspection the defect was found to be in worse condition.

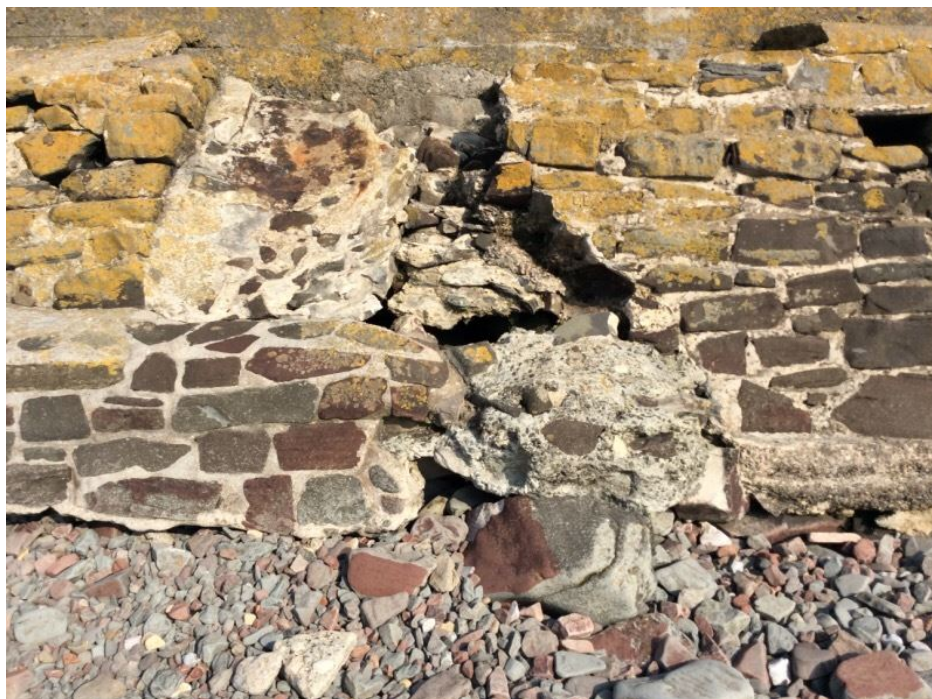
Localised collapse of the lower wall. During the 2021 inspection the defect was found to be in worse condition.

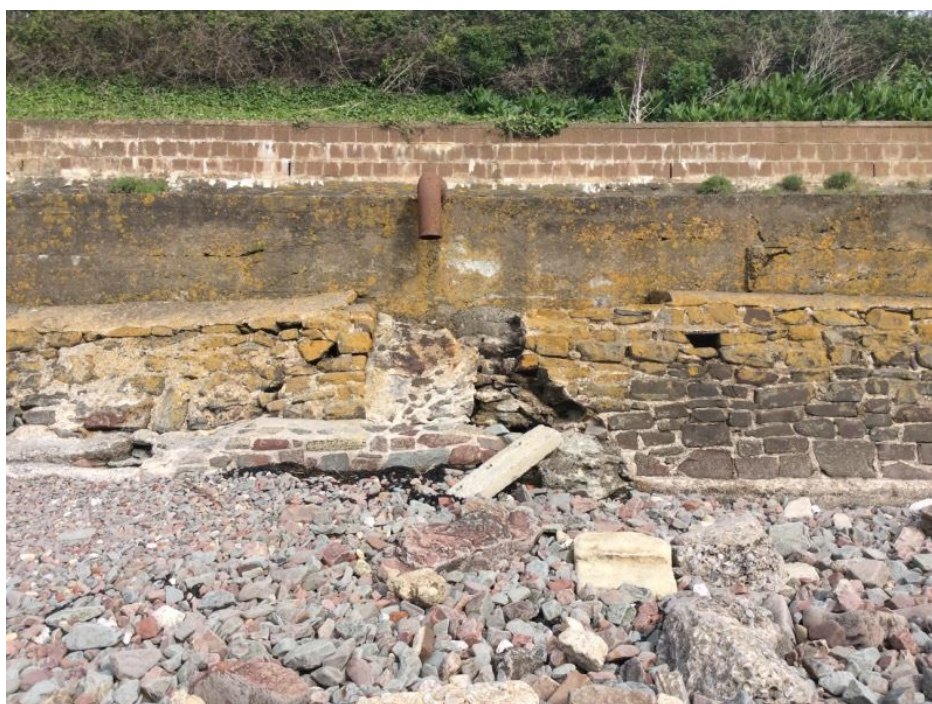
**Section A**  
**Wall section**  
**Defect Ref: D11**  
**Description:** Loss of fill through open joints leading to hollow structure behind. No change between 2020 and 2021 inspections.  
**Photo number: 28**

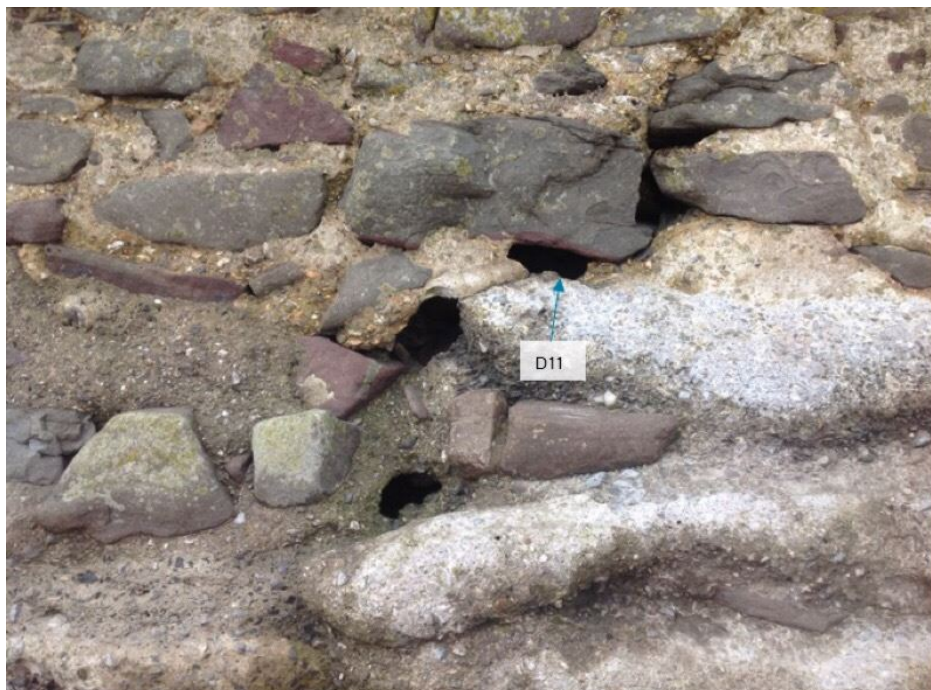
**Section A**  
**Wall section**  
**Defect Ref: D11**  
**Description:** Loss of fill through open joints leading to hollow structure behind. No change between 2020 and 2021 inspections.  
**Photo number: 54**

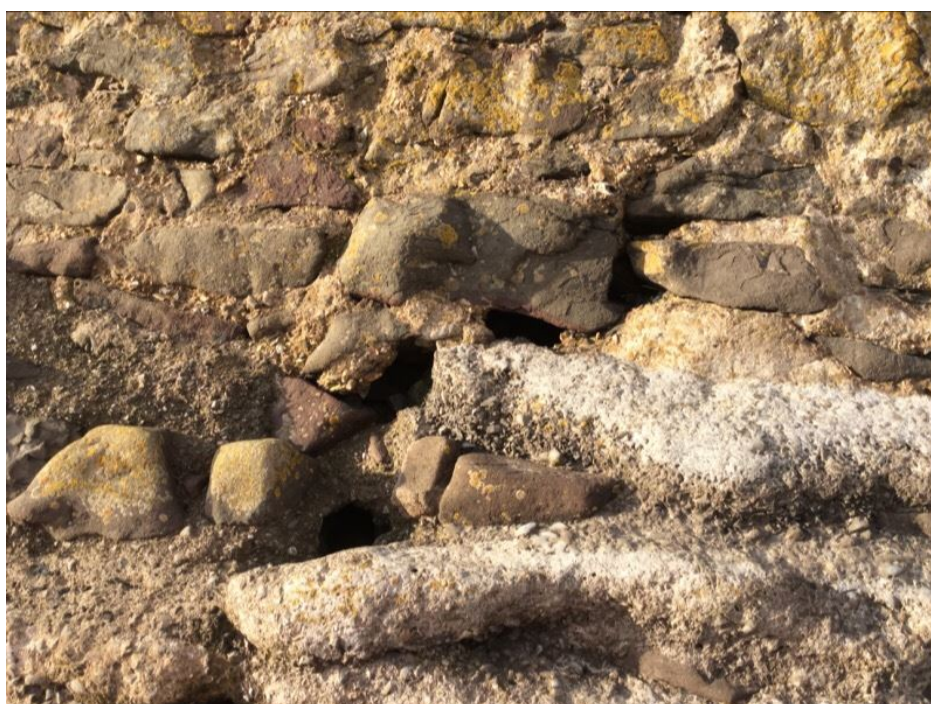
**Section A**  
**Wall section**  
**Defect Ref: D11**  
**Description:** Loss of fill through open joints leading to hollow structure behind. No change between 2020 and 2021 inspections.  
**Photo number: 76**

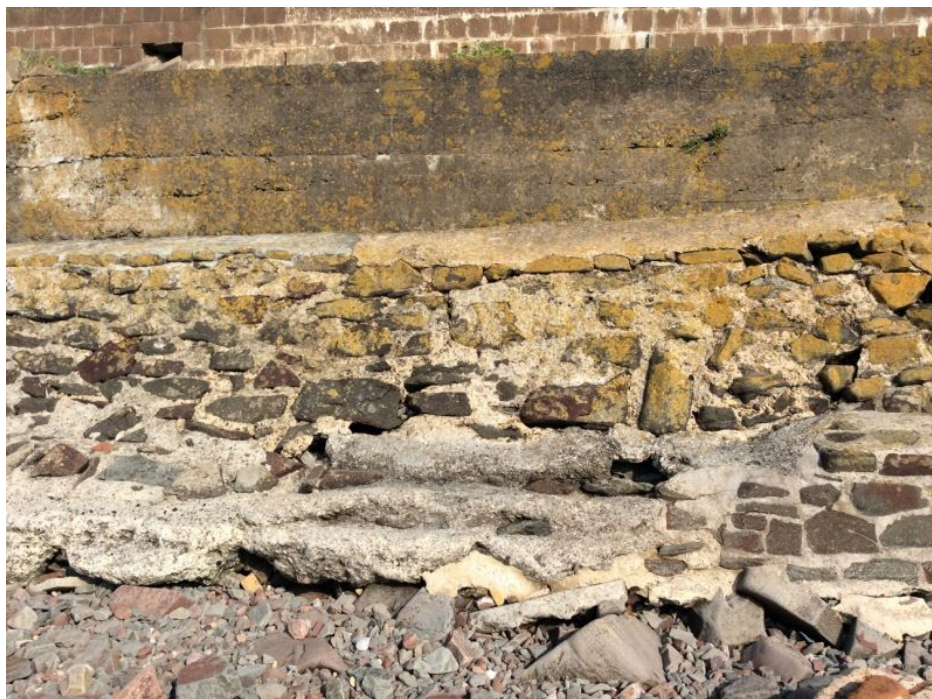
**Section A**  
**Wall section**  
**Defect Ref: D11**  
**Description:** Loss of fill through open joints leading to hollow structure behind. No change between 2020 and 2021 inspections.  
**Photo number: 111**

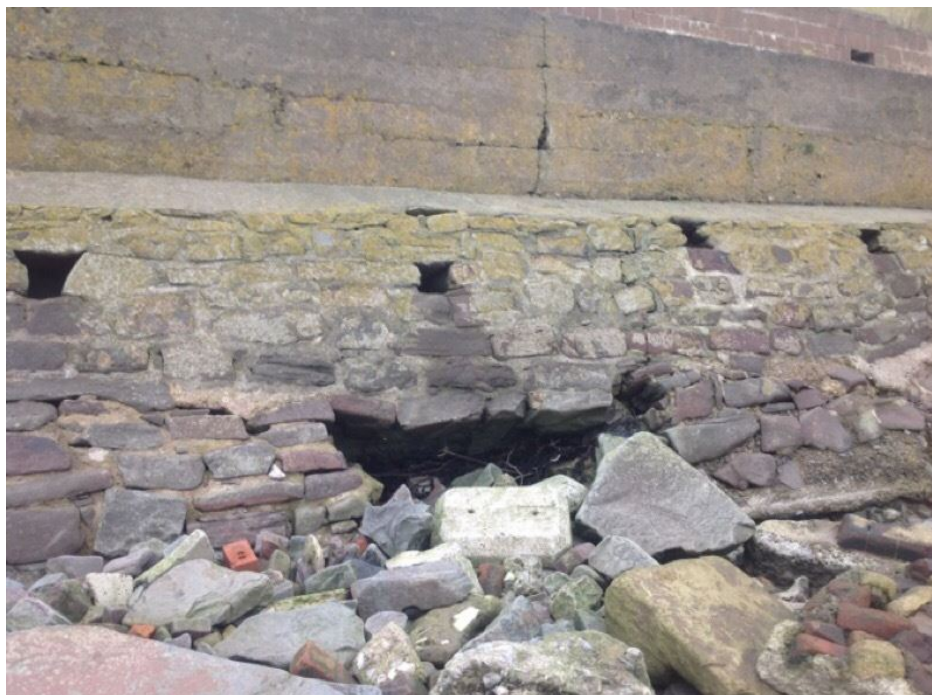
**Section A**  
**Wall section**  
**Defect Ref: D12**  
**Description:**  
Collapse of the lower  
section of the wall.  
Less evident during  
the 2021 inspection  
as cobbles have been  
placed/moved under  
the toe.  
**Photo number: 57**

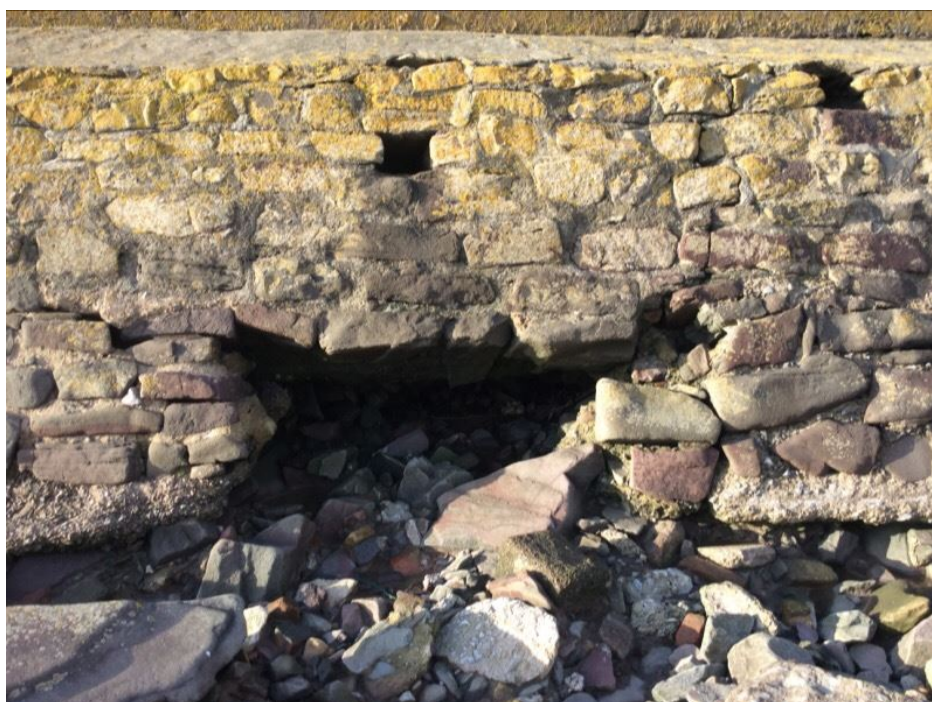
**Section A**  
**Wall section**  
**Defect Ref: D12**  
**Description:**  
Collapse of the lower  
section of the wall.  
Less evident during  
the 2021 inspection  
as cobbles have been  
placed/moved under  
the toe.  
**Photo number: 29**

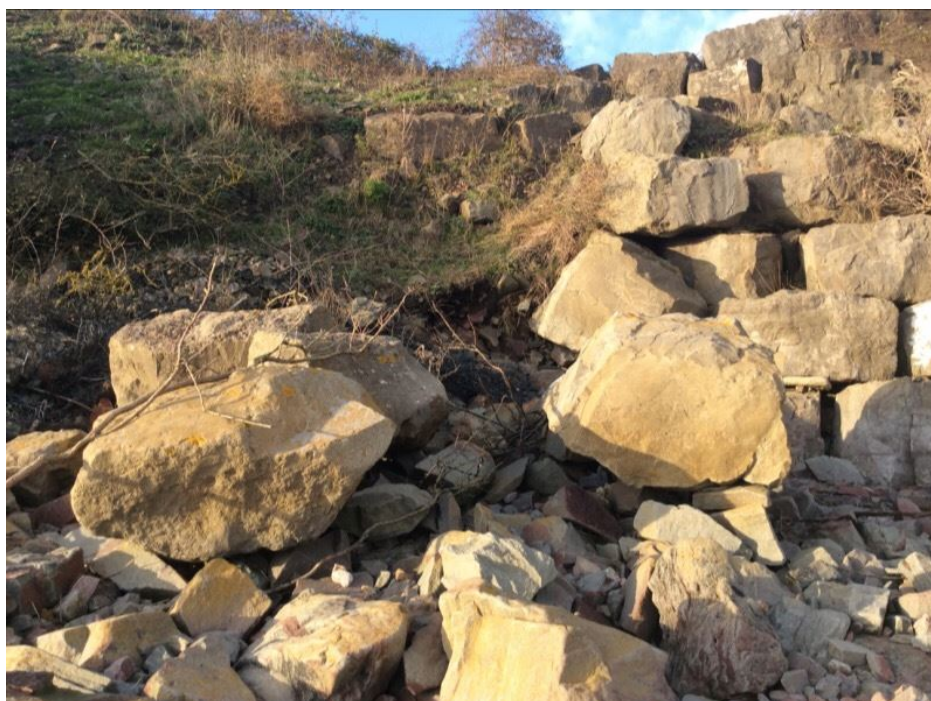
**Section A**  
**Wall section**  
**Defect Ref: D13**  
**Description:**  
Expelled rocks from  
block retaining  
structure protecting  
the tie in. No change  
between 2020 and  
2021 inspections.  
**Photo number: 62**
