| Location Plan: | | Sudbrook Wall | |
| | | Structure Reference: | <b>13 50</b> |

# COASTAL ASSET CONDITION SURVEY REPORT

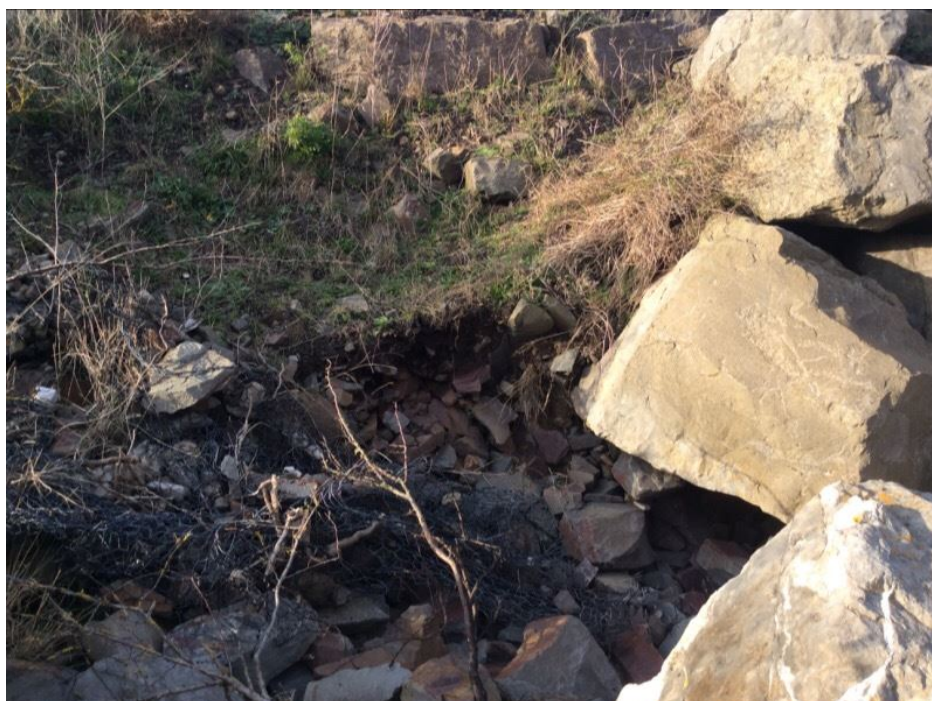
**Section A**  
**Wall section**  
**Defect Ref: D14**  
**Description:**  
Outflanking erosion  
initiating failure of the  
tie in. Slightly  
increased in severity  
as further erosion  
was noted in 2021.  
**Photo number: 63**

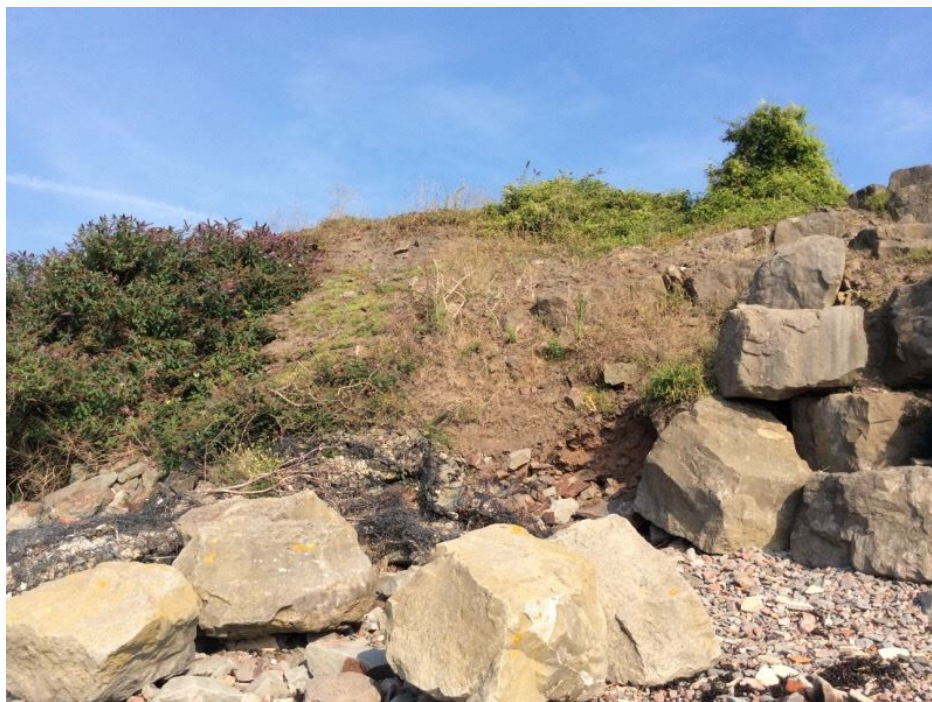
Outflanking erosion initiating failure of the tie in. Slightly increased in severity as further erosion was noted in 2021.

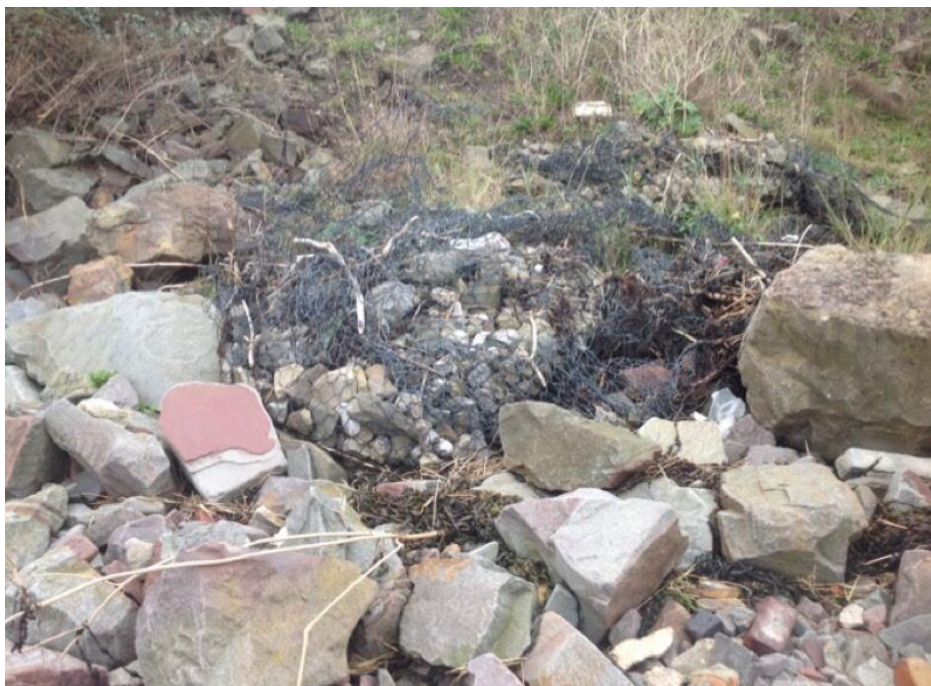
**Section A**  
**Wall section**  
**Defect Ref: D15**  
**Description:** Failed gabions no longer providing any defence function. No change between 2020 and 2021 inspections.  
**Photo number: 32**

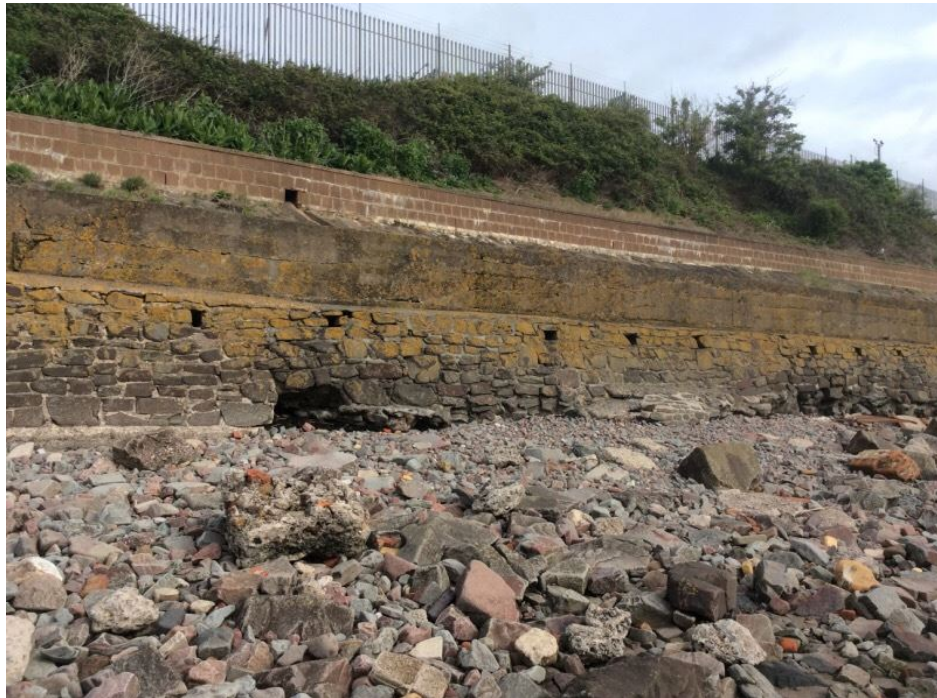
**Section A**  
**Wall section**  
**Defect Ref: D16**  
**Description:**  
Undermining of wall  
toe. No change  
between 2020 and  
2021 inspections.  
**Photo number: 109**

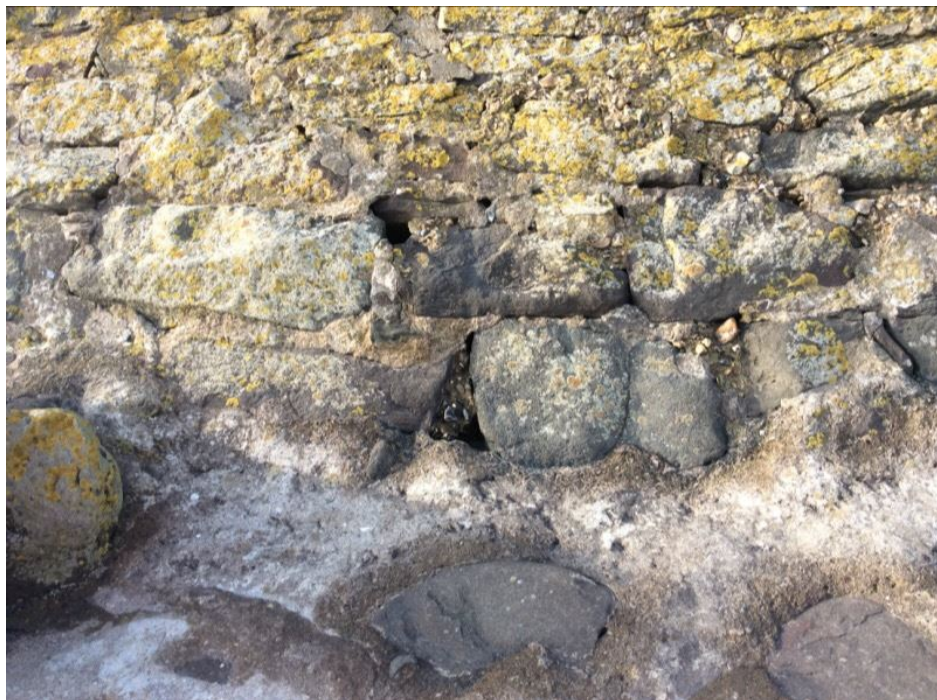
**Section A**  
**Wall section**  
**Defect Ref: D17**  
**Description:** Loss of  
fill through open  
joints. No change  
between 2020 and  
2021 inspections.  
**Photo number: 39**

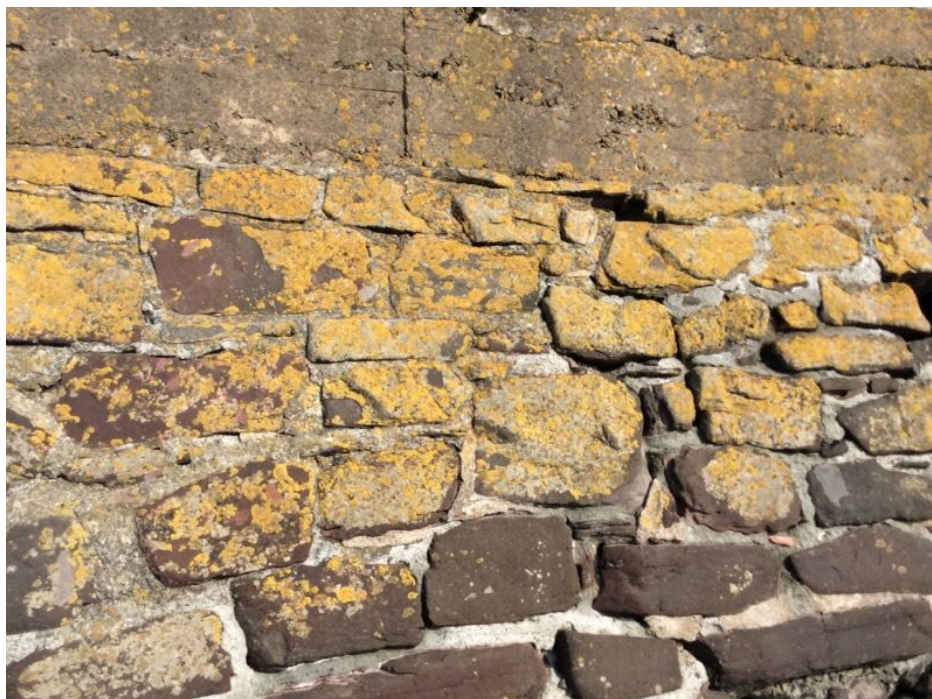
**Section A**  
**Wall section**  
**Defect Ref: D17**  
**Description:** Loss of  
fill through open  
joints. No change  
between 2020 and  
2021 inspections.  
**Photo number: 85**

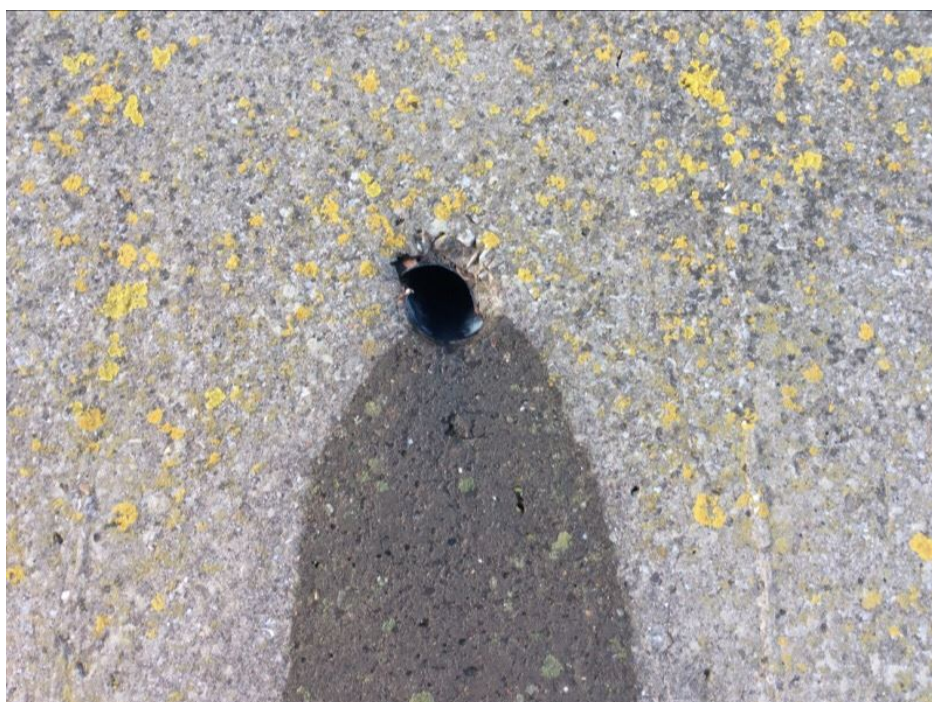
**Section A**  
**Wall section**  
**Defect Ref: D18**  
**Description:**  
Damage to drainage  
pipes, although likely  
a construction defect.  
No change between  
2020 and 2021  
inspections.  
**Photo number: 43**

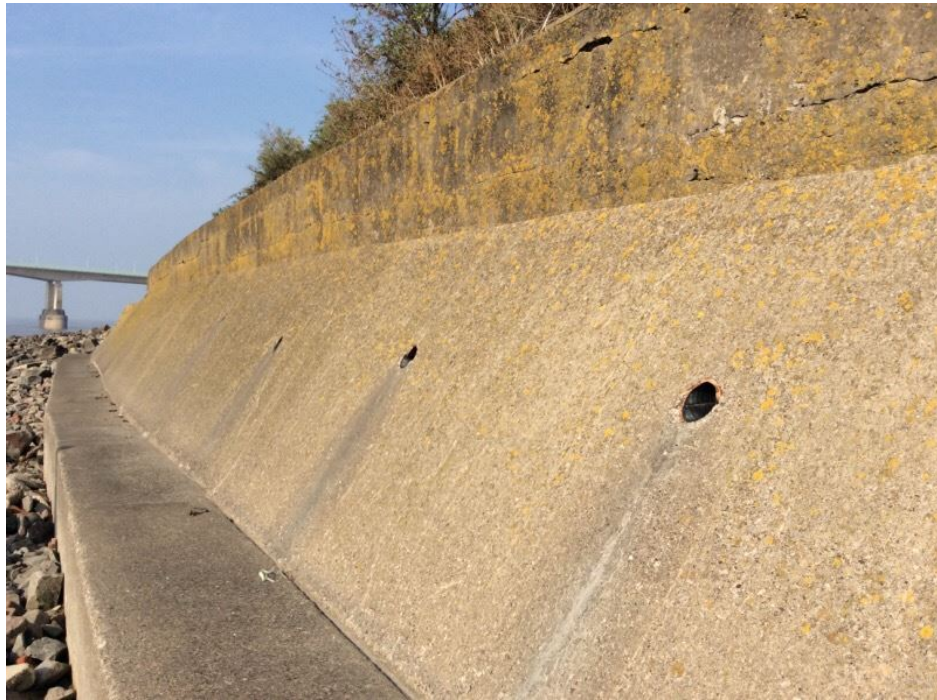
Damage to drainage pipes, although likely a construction defect. No change between 2020 and 2021 inspections.

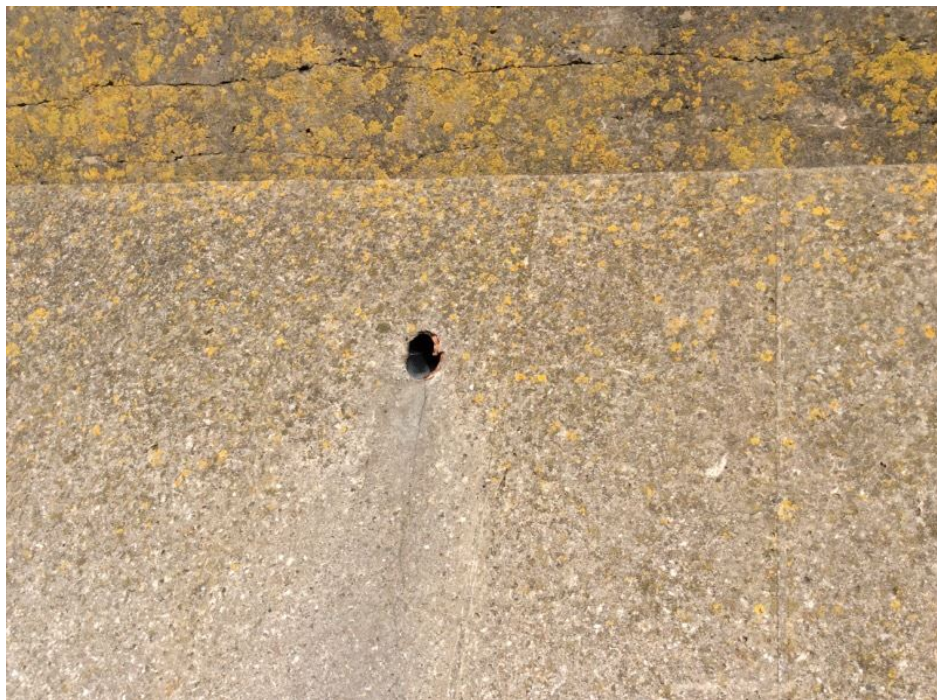
Damage to drainage pipes, although likely a construction defect. No change between 2020 and 2021 inspections.

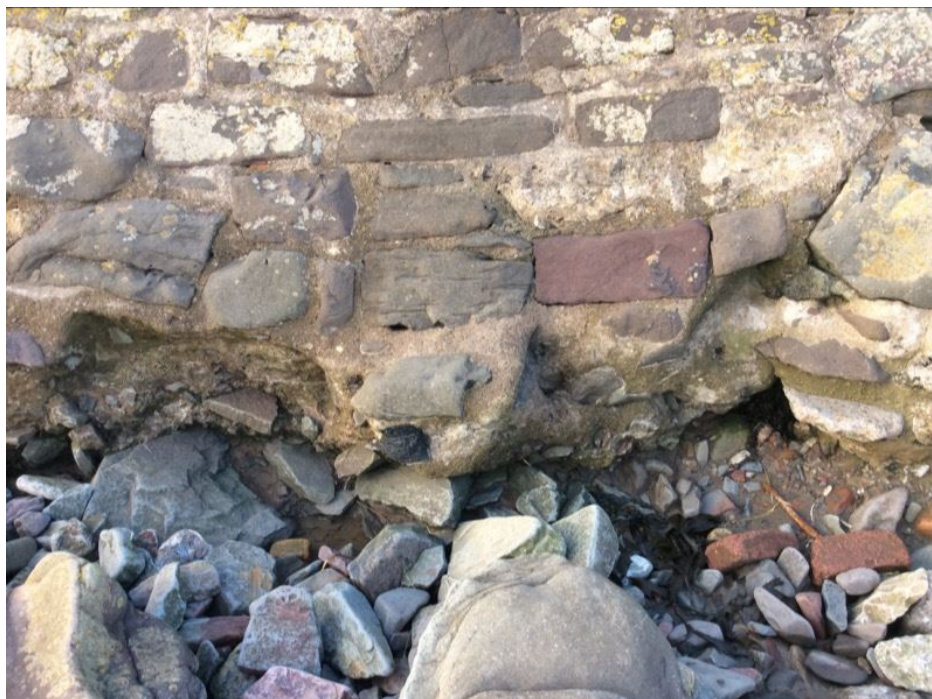
**Section A**  
**Wall section**  
**Defect Ref: D19**  
**Description:**  
Undermining and  
scour of wall toe. No  
change between  
2020 and 2021  
inspections.  
**Photo number: 45**

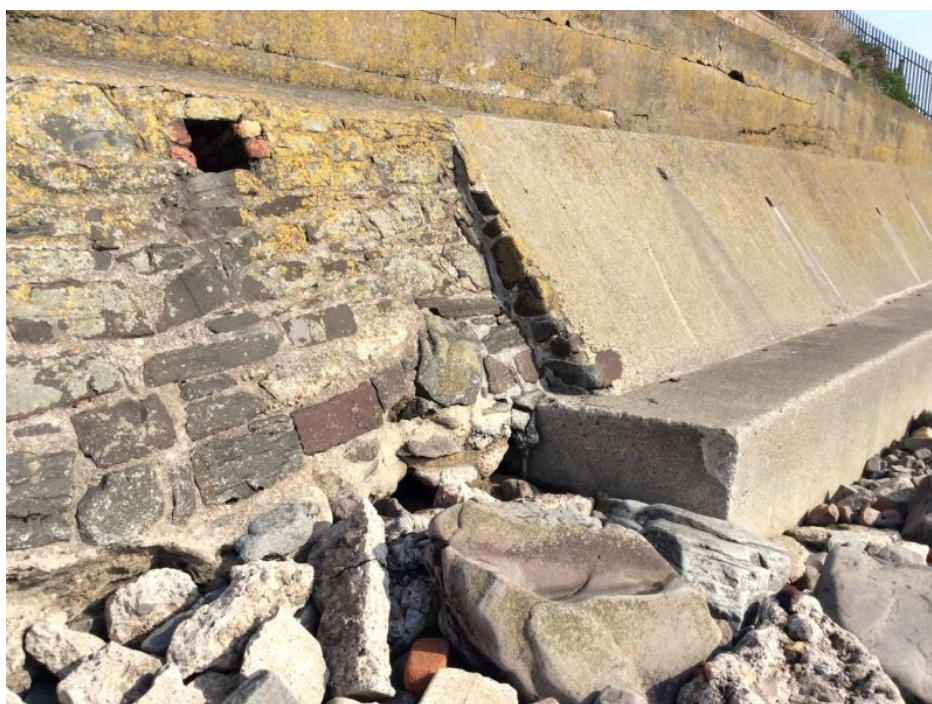
**Section A**  
**Wall section**  
**Defect Ref: D19**  
**Description:**  
Undermining and  
scour of wall toe. No  
change between  
2020 and 2021  
inspections.  
**Photo number: 86**

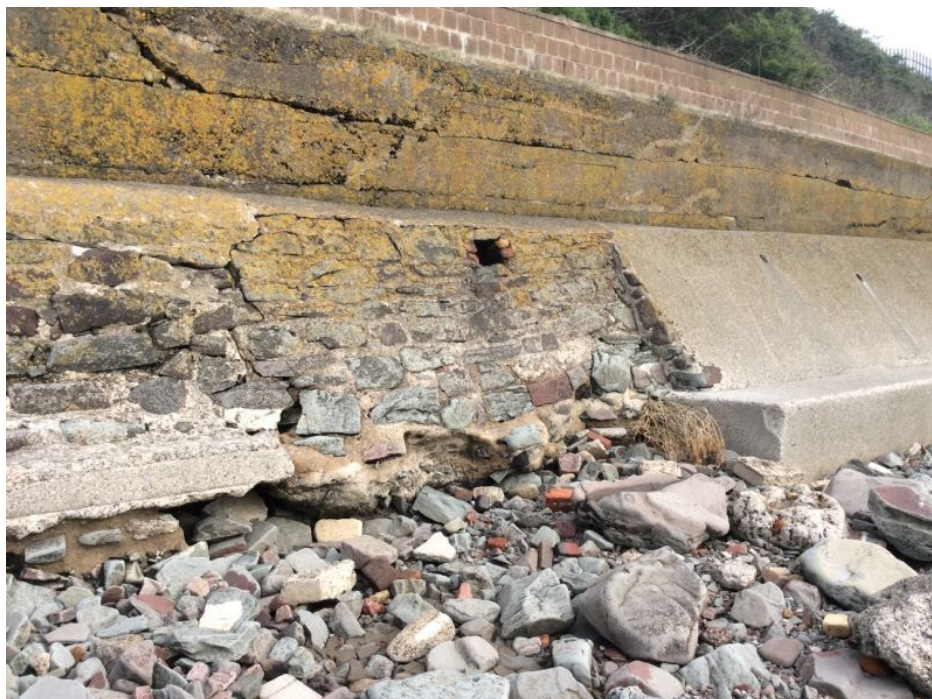
**Section A**  
**Wall section**  
**Defect Ref: D19**  
**Description:**  
Undermining and  
scour of wall toe. No  
change between  
2020 and 2021  
inspections.  
**Photo number: 114**

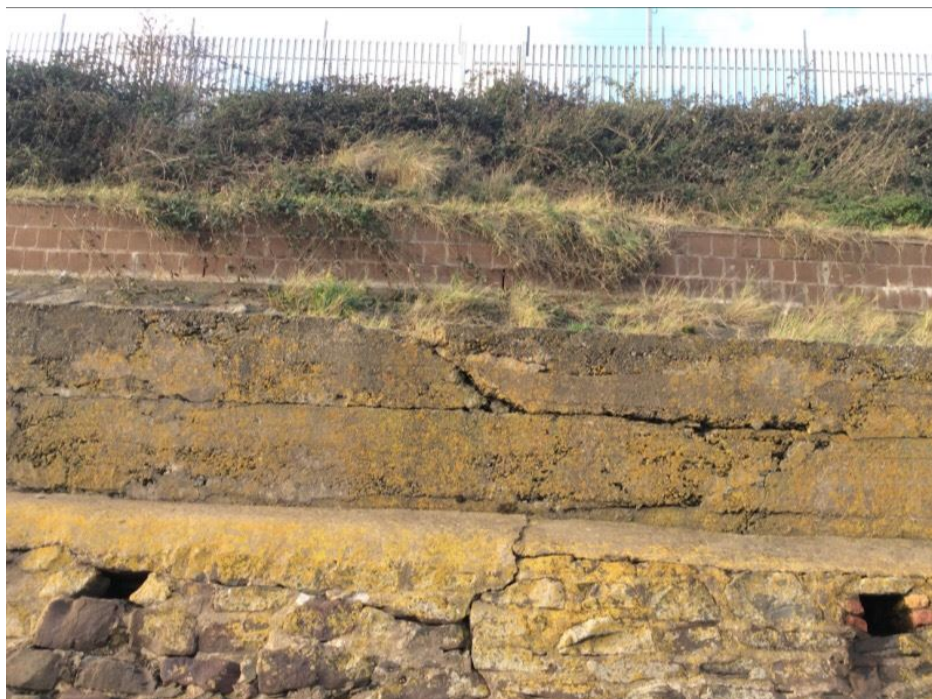
**Section A**  
**Wall section**  
**Defect Ref: D21**  
**Description:** Spalling concrete and localised section loss with possible reinforcement steel exposed. No change between 2020 and 2021 inspections.  
**Photo number: 47**

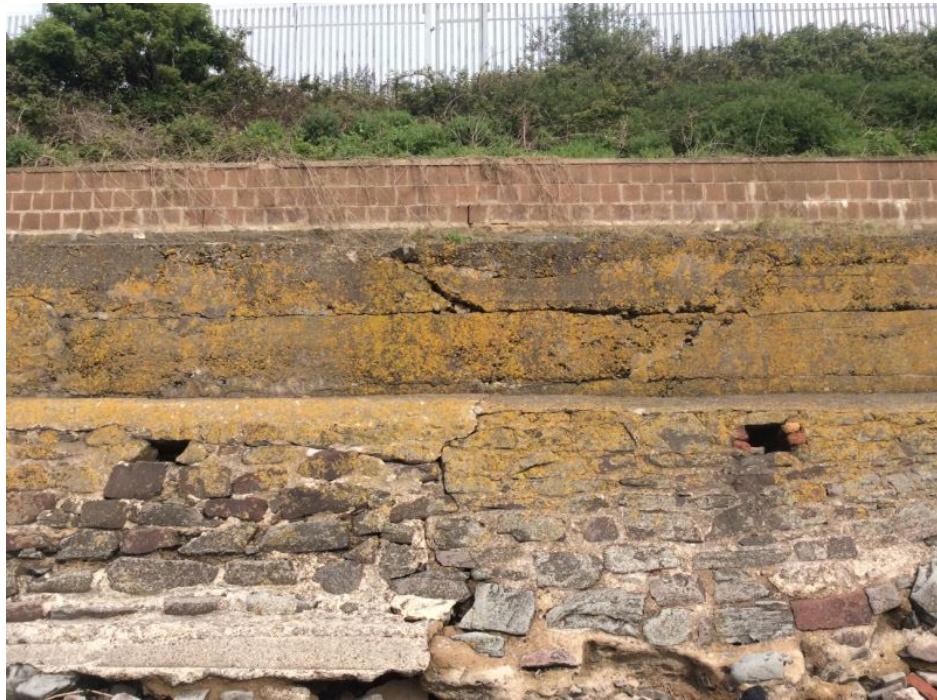
**Section A**  
**Wall section**  
**Defect Ref: D21**  
**Description:** Spalling concrete and localised section loss with possible reinforcement steel exposed. No change between 2020 and 2021 inspections.  
**Photo number: 117**

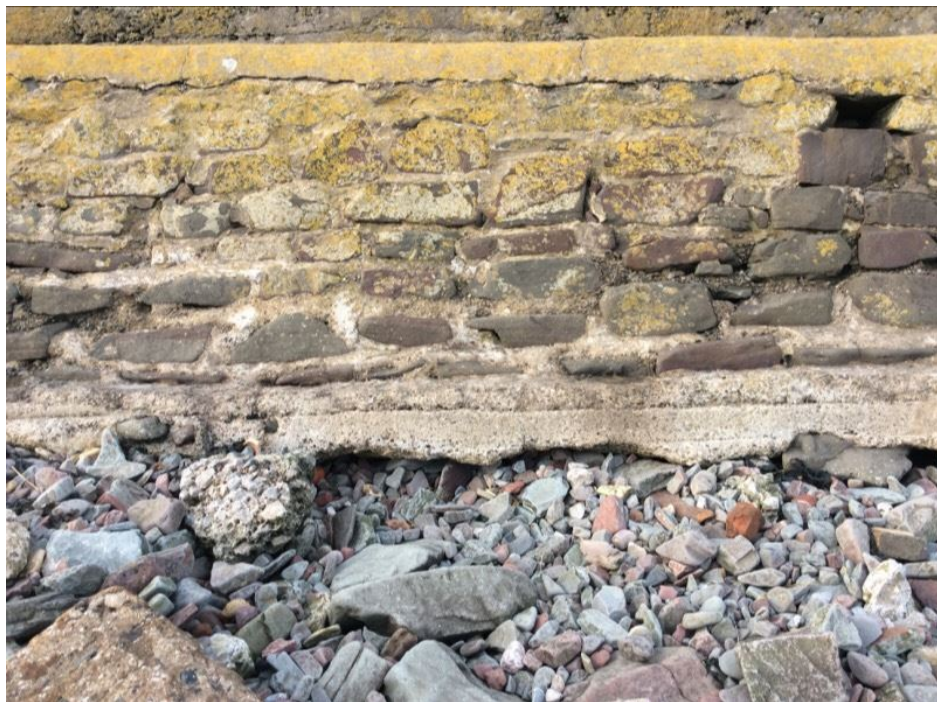
**Section A**  
**Wall section**  
**Defect Ref: D22**  
**Description:** Undermining of wall toe. No change between 2020 and 2021 inspections.  
**Photo number: 48**

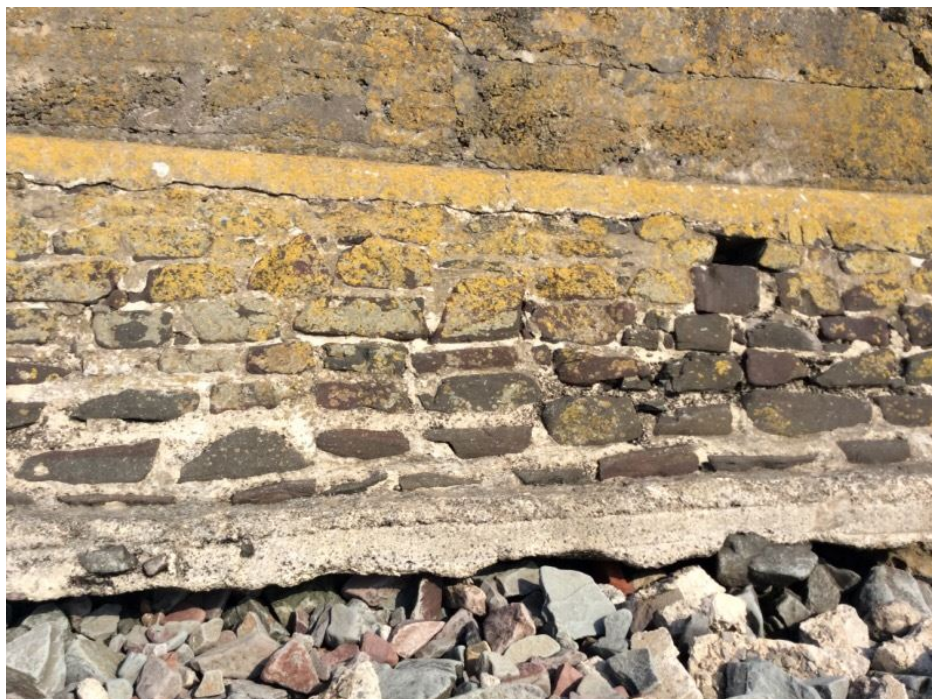
**Section A**  
**Wall section**  
**Defect Ref: D22**  
**Description:**  
Undermining of wall  
toe. No change  
between 2020 and  
2021 inspections.  
**Photo number: 89**

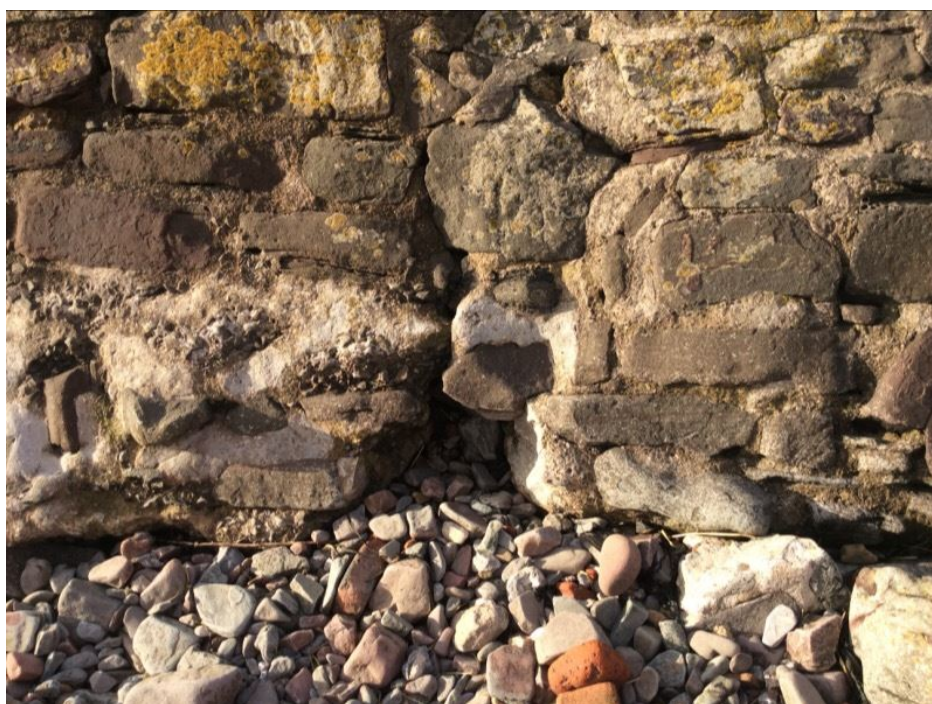
**Section A**  
**Wall section**  
**Defect Ref: D23**  
**Description:** Missing  
block work in the  
lower wall. No change  
between 2020 and  
2021 inspections.  
**Photo number: 49**

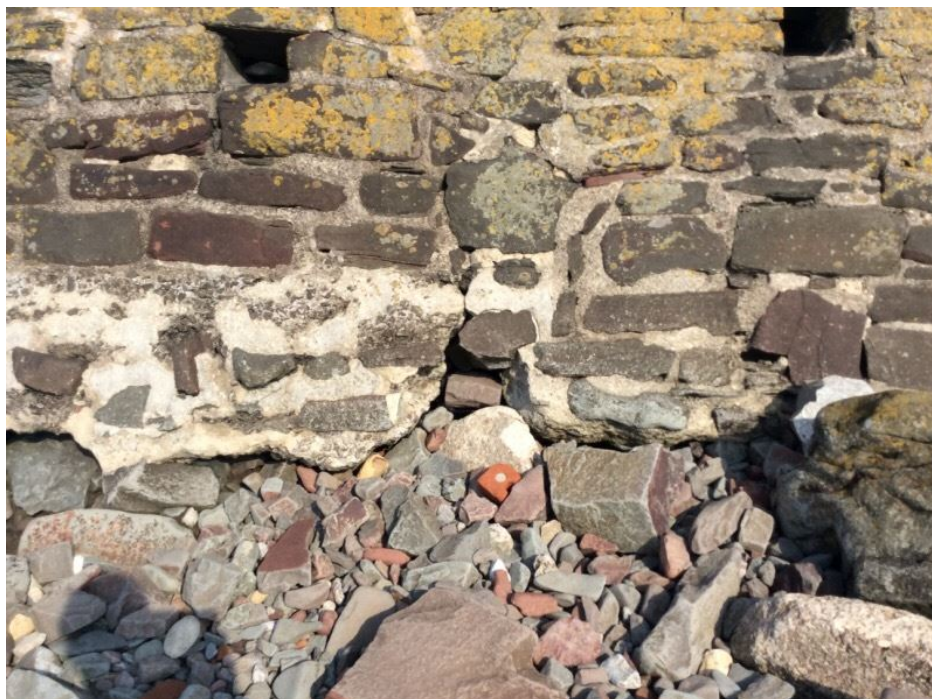
**Section A**  
**Wall section**  
**Defect Ref: D23**  
**Description:** Missing block work in the lower wall. No change between 2020 and 2021 inspections.  
**Photo number: 90**

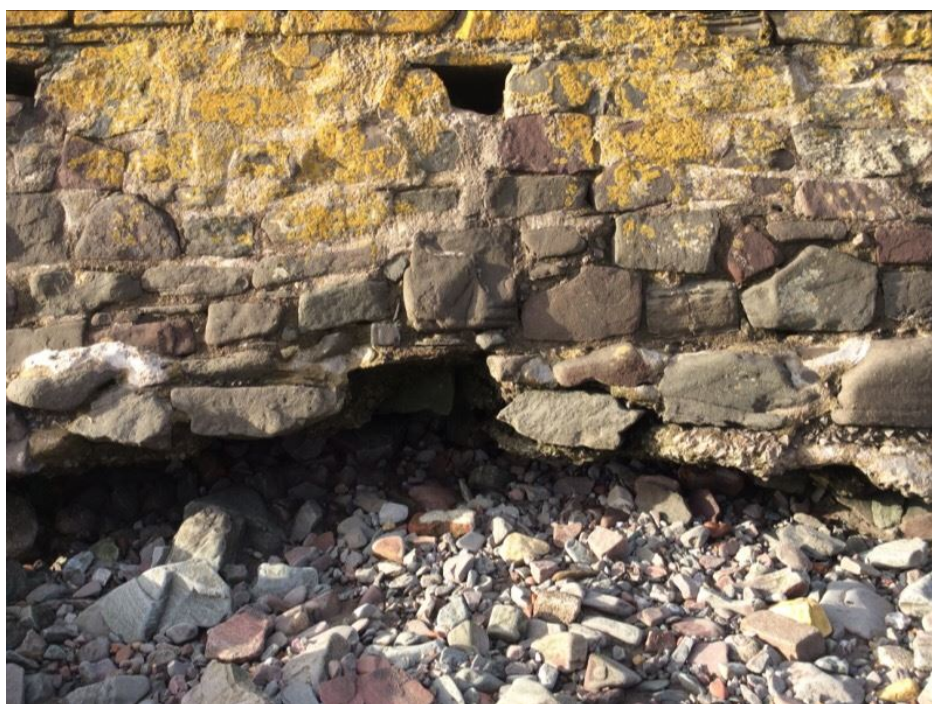
**Section A**  
**Wall section**  
**Defect Ref: D24**  
**Description:** Extensive undermining of wall toe along the length of the defence. No change between 2020 and 2021 inspections.  
**Photo number: 50**

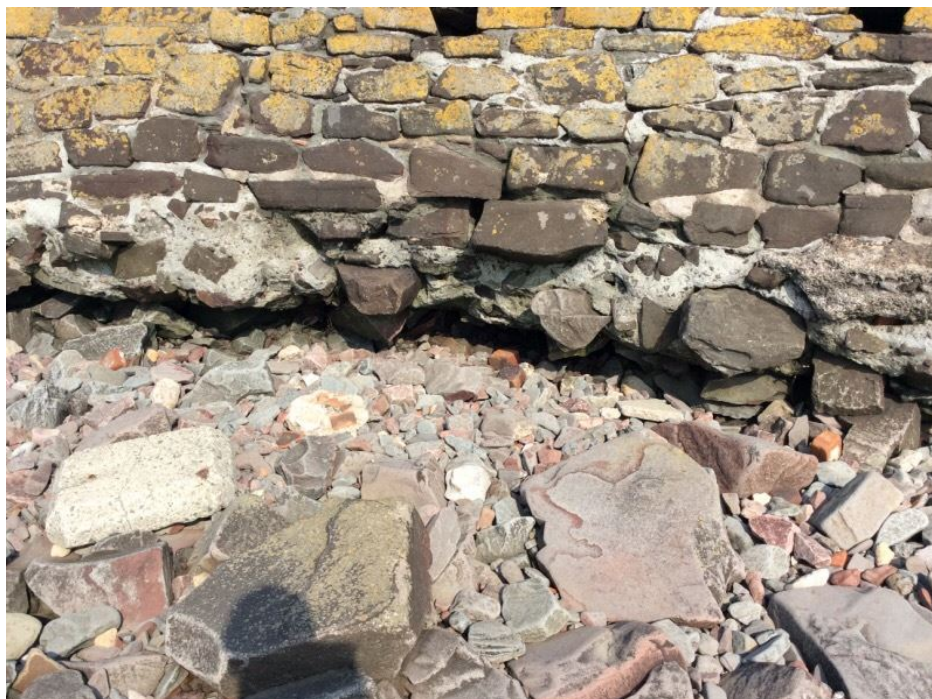
**Section A**  
**Wall section**  
**Defect Ref: D24**  
**Description:**  
Extensive  
undermining of wall  
toe along the length  
of the defence. No  
change between  
2020 and 2021  
inspections.  
**Photo number: 91**

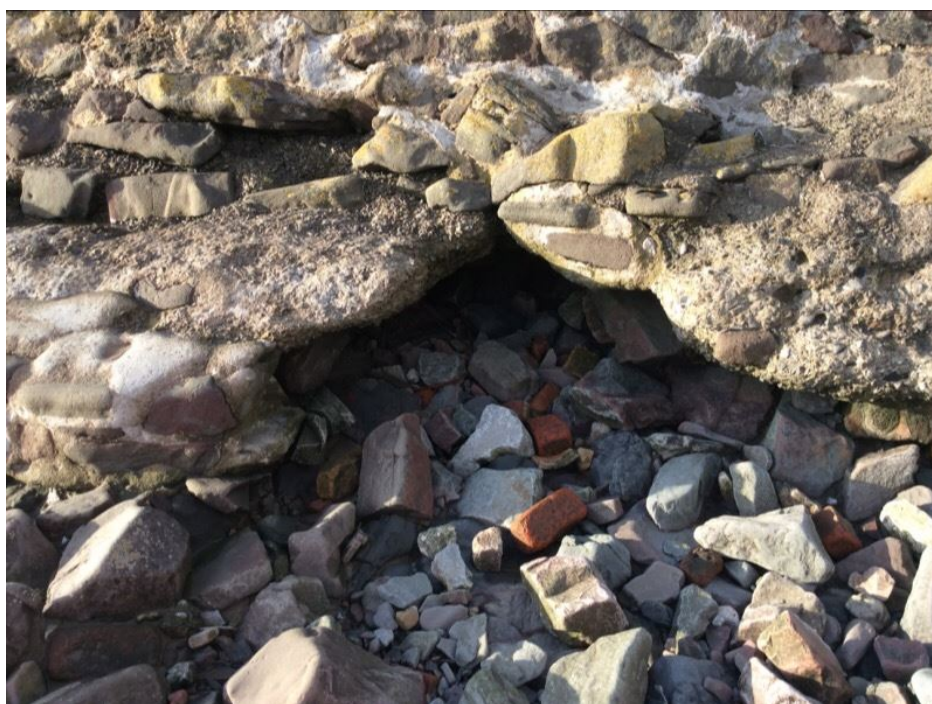
**Section A**  
**Wall section**  
**Defect Ref: D25**  
**Description:**  
Undermining of wall  
toe. No change  
between 2020 and  
2021 inspections.  
**Photo number: 55**

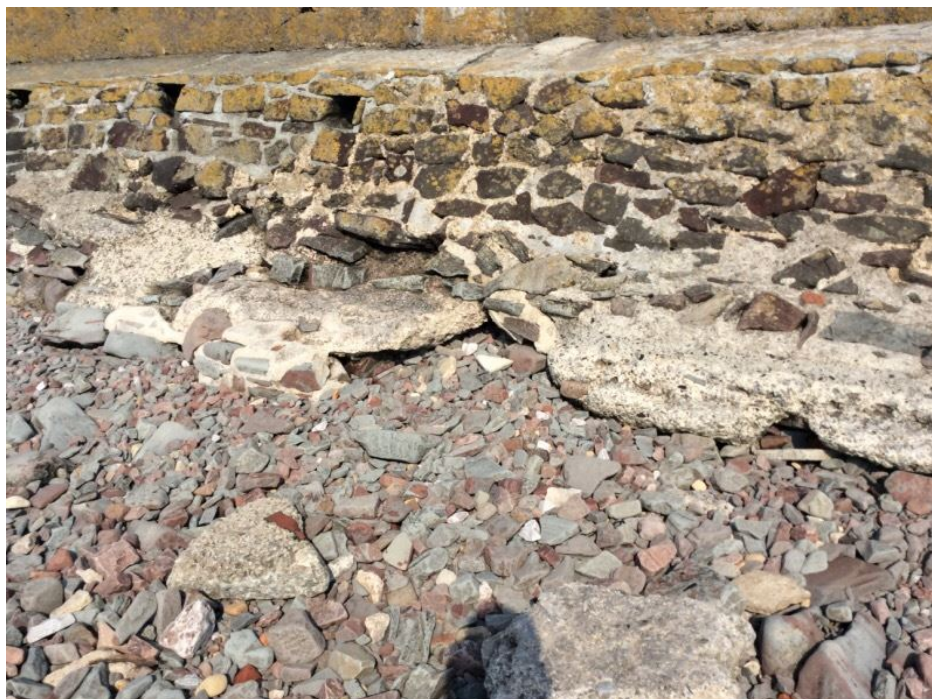
**Section A**  
**Wall section**  
**Defect Ref: D25**  
**Description:**  
Undermining of wall toe. No change between 2020 and 2021 inspections.  
**Photo number: 92**

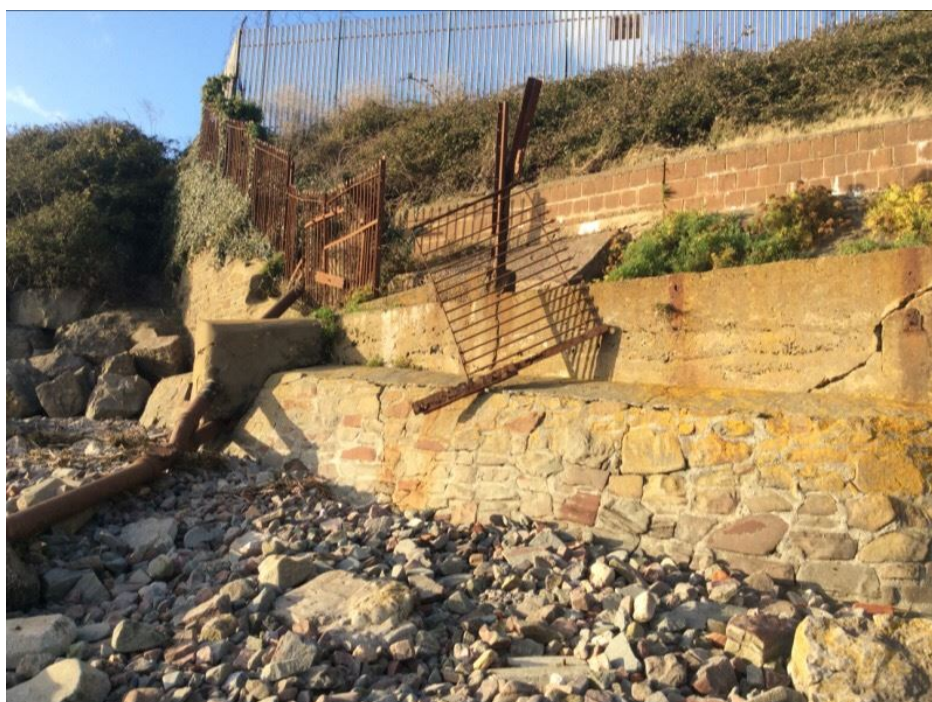
**Section A**  
**Wall section**  
**Defect Ref: D26**  
**Description:**  
Collapsed safety fence. No change between 2020 and 2021 inspections, but the collapsed panel fence has likely been removed from the site.  
**Photo number: 58**

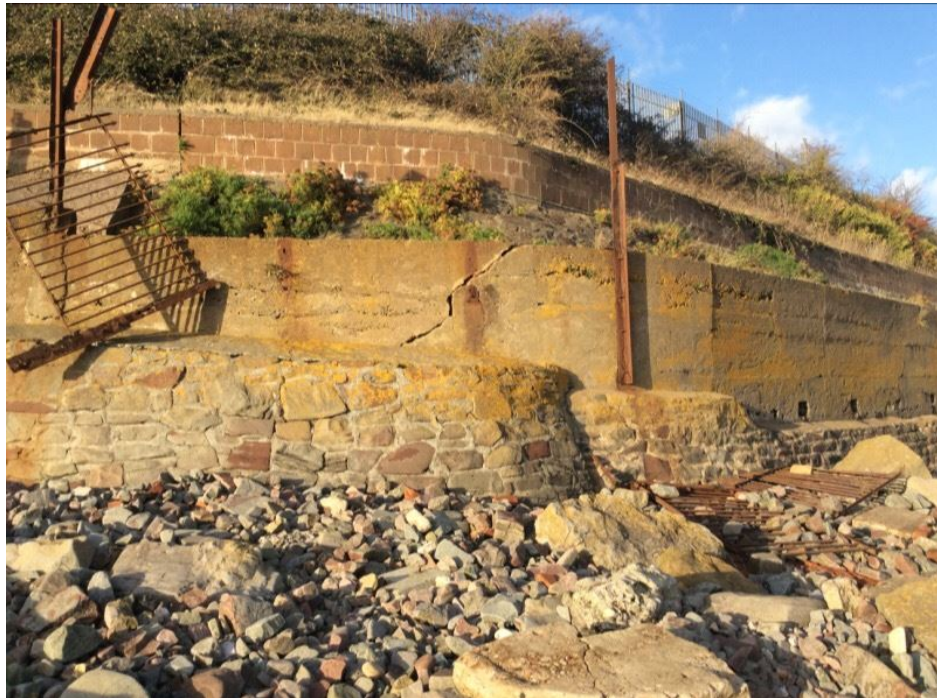
**Section A**  
**Wall section**  
**Defect Ref: D27**  
**Description:** Vertical fracture in-wall indicates possible subsidence. No change between 2020 and 2021 inspections.  
**Photo number: 59**

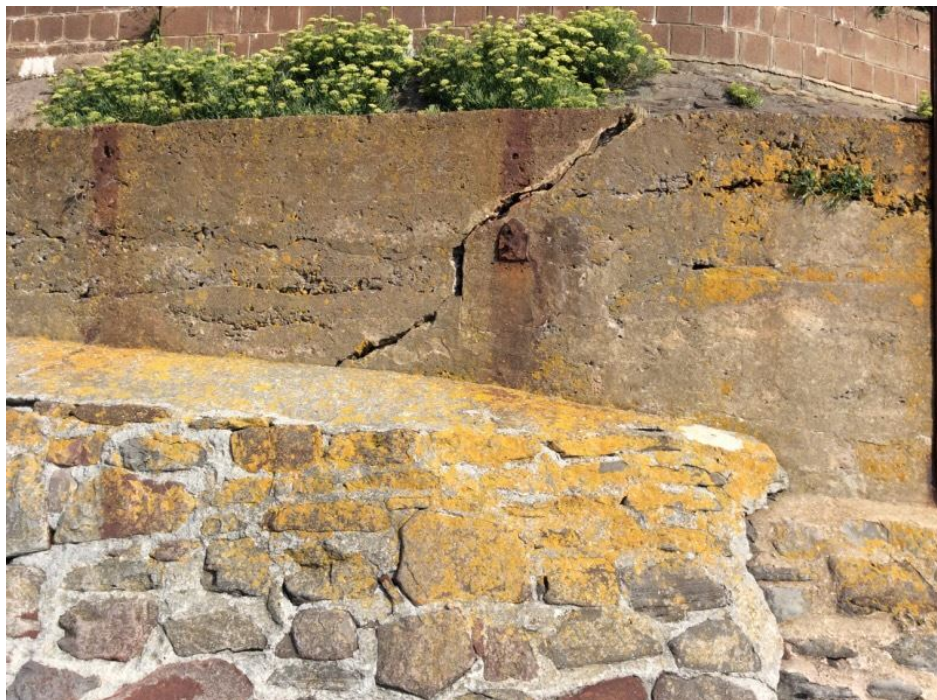
**Section A**  
**Wall section**  
**Defect Ref: D27**  
**Description:** Vertical fracture in-wall indicates possible subsidence. No change between 2020 and 2021 inspections.  
**Photo number: 94**

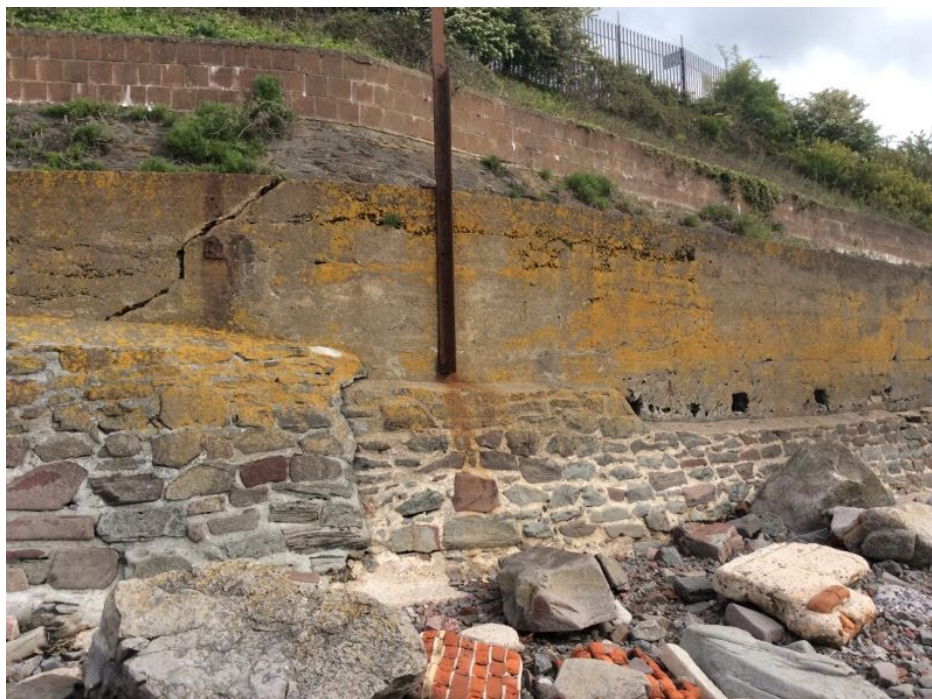
**Section A**  
**Wall section**  
**Defect Ref: D27**  
**Description:** Vertical fracture in-wall indicates possible subsidence. No change between 2020 and 2021 inspections.  
**Photo number: 120**

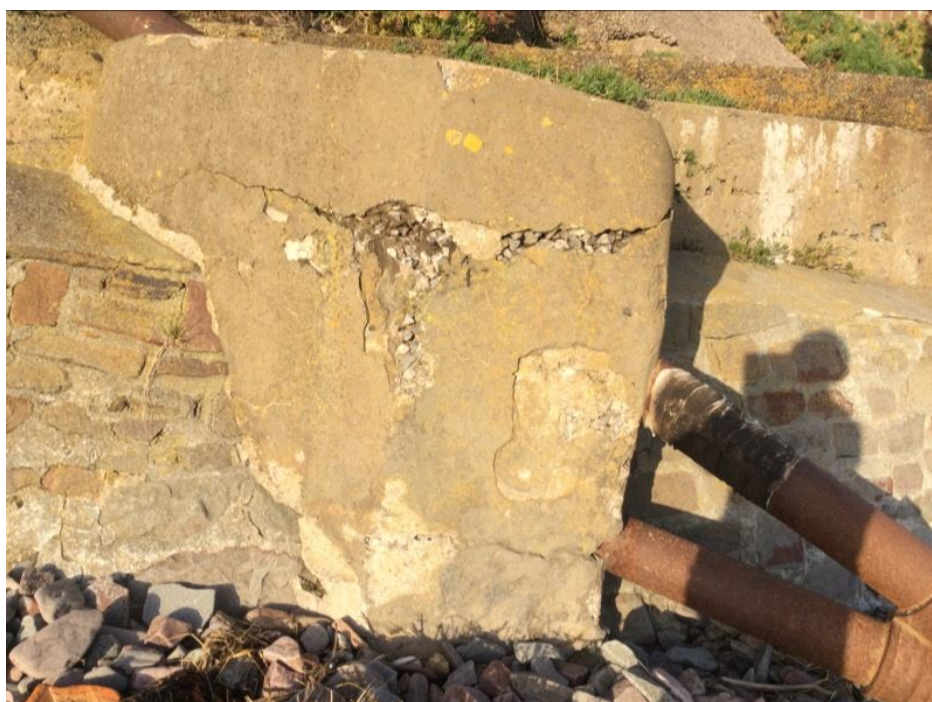
**Section A**  
**Wall section**  
**Defect Ref: D28**  
**Description:** Damage to drainage pipe concrete encasement (delamination and horizontal fracturing). No change between 2020 and 2021 inspections.  
**Photo number: 60**

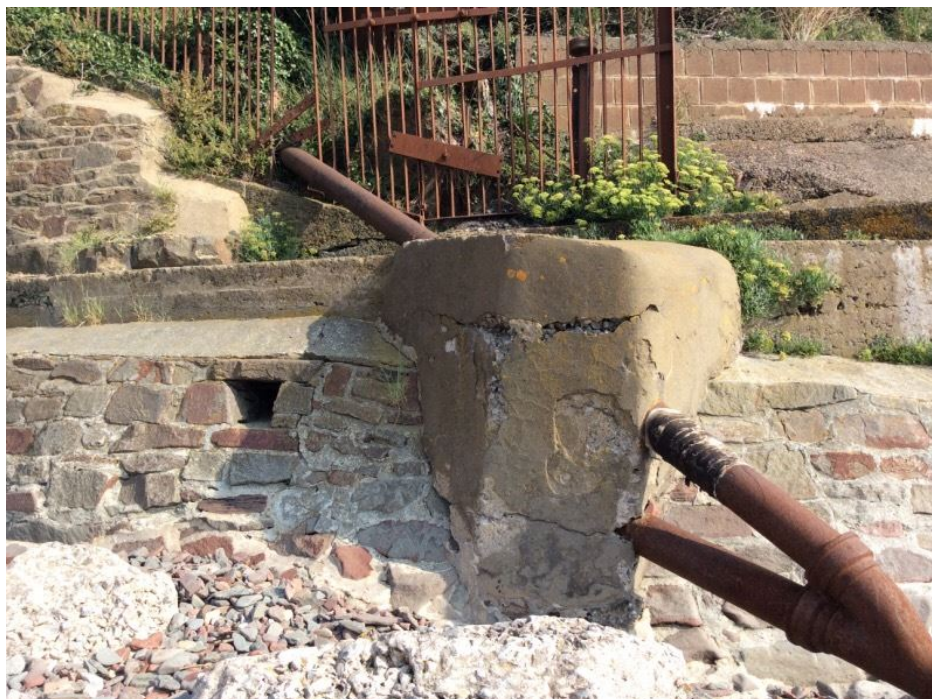
**Section A**  
**Wall section**  
**Defect Ref: D28**  
**Description:**  
Damage to drainage  
pipe concrete  
encasement  
(delamination and  
horizontal fracturing).  
No change between  
2020 and 2021  
inspections.  
**Photo number: 95**

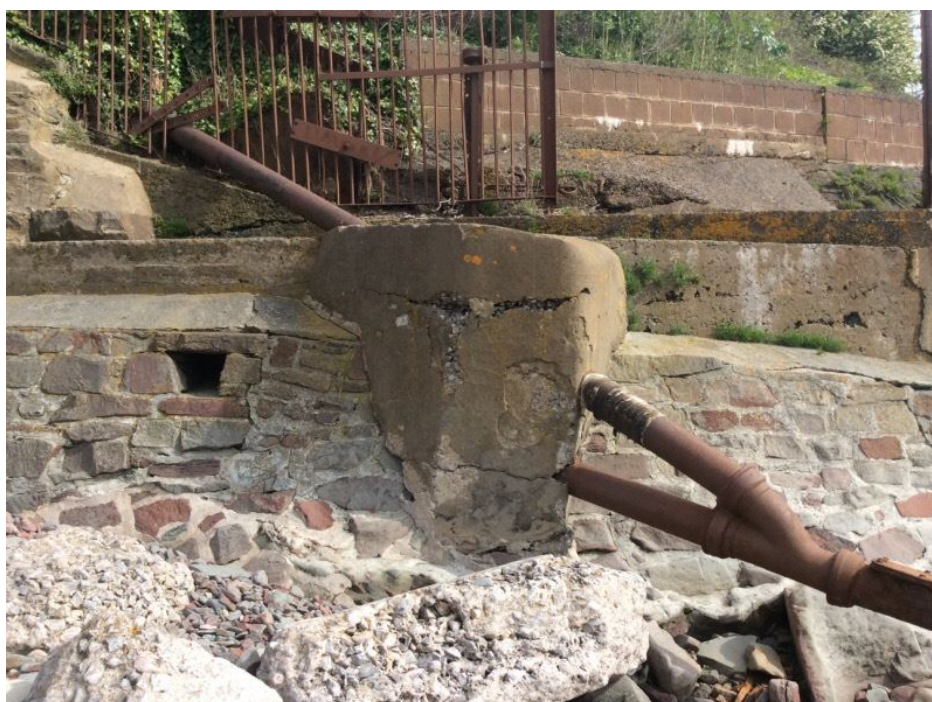
**Section A**  
**Wall section**  
**Defect Ref: D28**  
**Description:**  
Damage to drainage  
pipe concrete  
encasement  
(delamination and  
horizontal fracturing).  
No change between  
2020 and 2021  
inspections.  
**Photo number: 123**

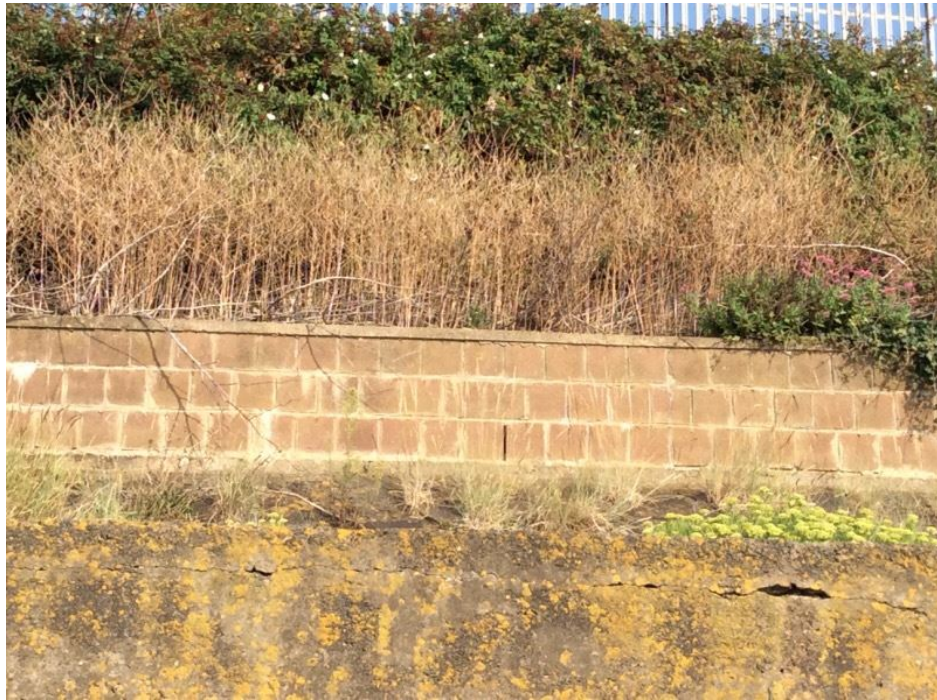
**Section A**  
**Parapet/Capping**  
**Defect Ref: D29**  
**Description:** Vertical missing mortar. No change between 2020 and 2021 inspections.  
**Photo number: 73**

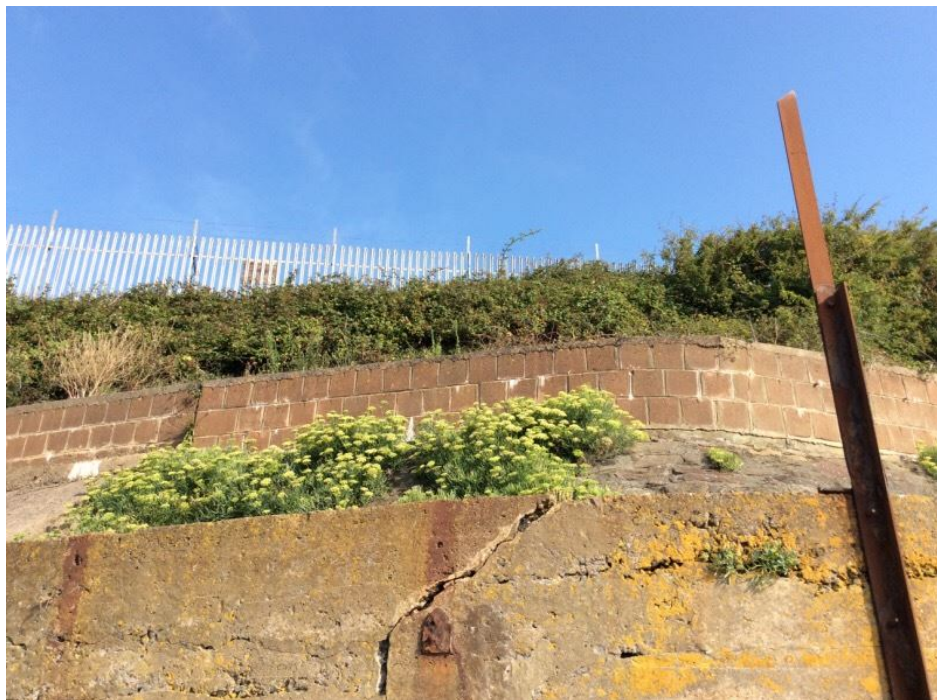
**Section A**  
**Parapet/Capping**  
**Defect Ref: D30**  
**Description:** Vegetation growth on pitching below top masonry wall and cracking on the wall. No change between 2020 and 2021 inspections.  
**Photo number: 80**

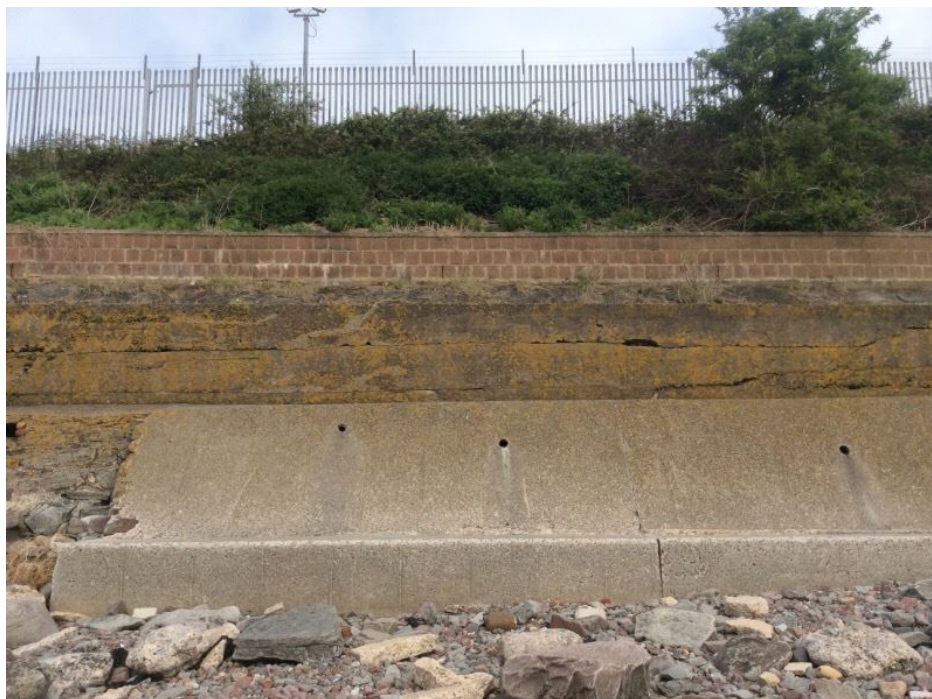
**Defect Ref: D30**

Vegetation growth on pitching below top masonry wall and cracking on the wall. No change between 2020 and 2021 inspections.
