| Location Plan: | | Sudbrook Wall | |
| | | Structure Reference: | <b>13 50</b> |

# COASTAL ASSET CONDITION SURVEY REPORT

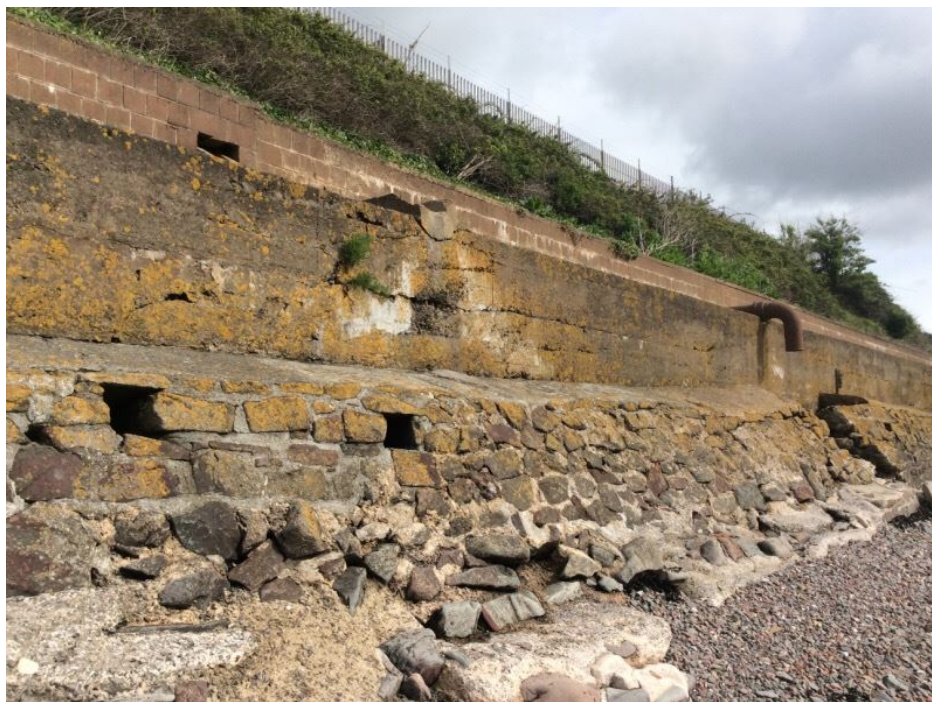
**Section A**  
**Wall section**  
**Defect Ref: D31**  
**Description:** Minor vegetation growth on vertical concrete wall. No change between 2020 and 2021 inspections.  
**Photo number: 119**

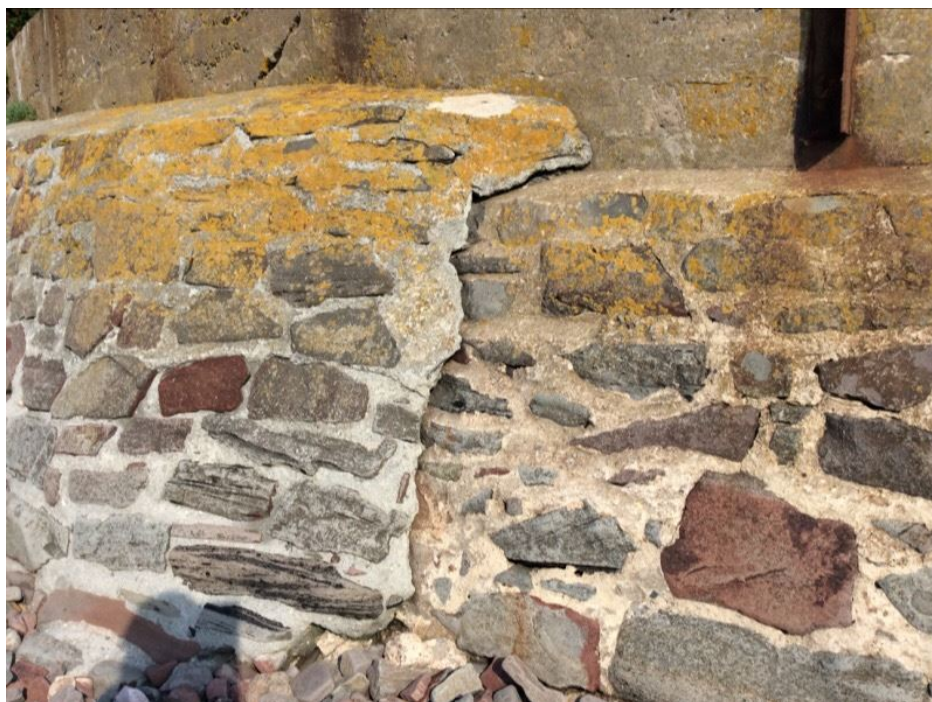
**Section A**  
**Wall section**  
**Defect Ref: D32**  
**Description:** Void in tie in between masonry wall extents. No change between 2020 and 2021 inspections.  
**Photo number: 79**

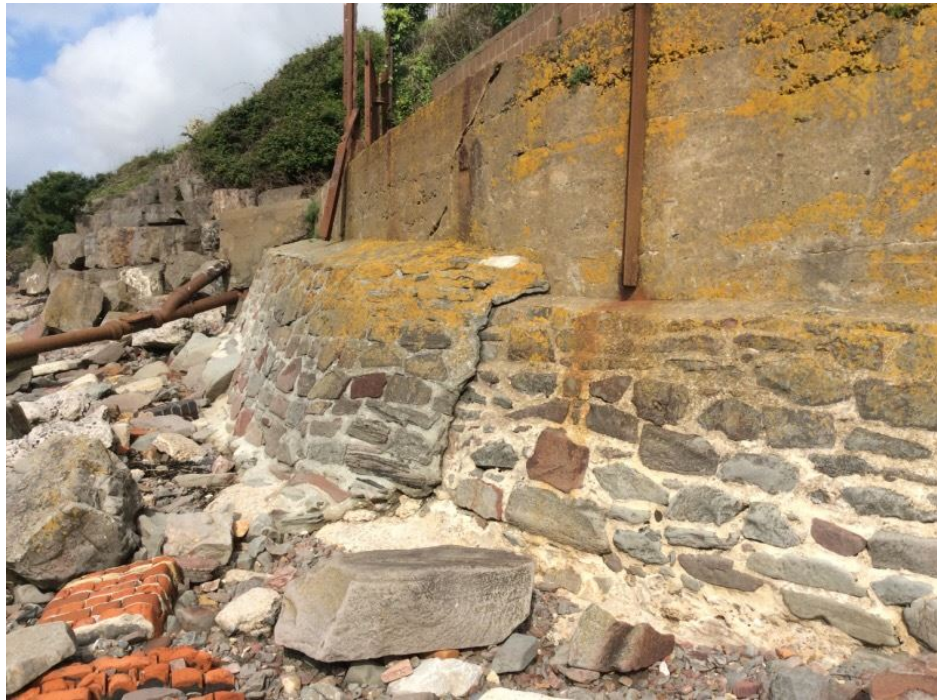
**Section A**  
**Wall section**  
**Defect Ref: D32**  
**Description:** Void in tie in between masonry wall extents. No change between 2020 and 2021 inspections.  
**Photo number: 121**

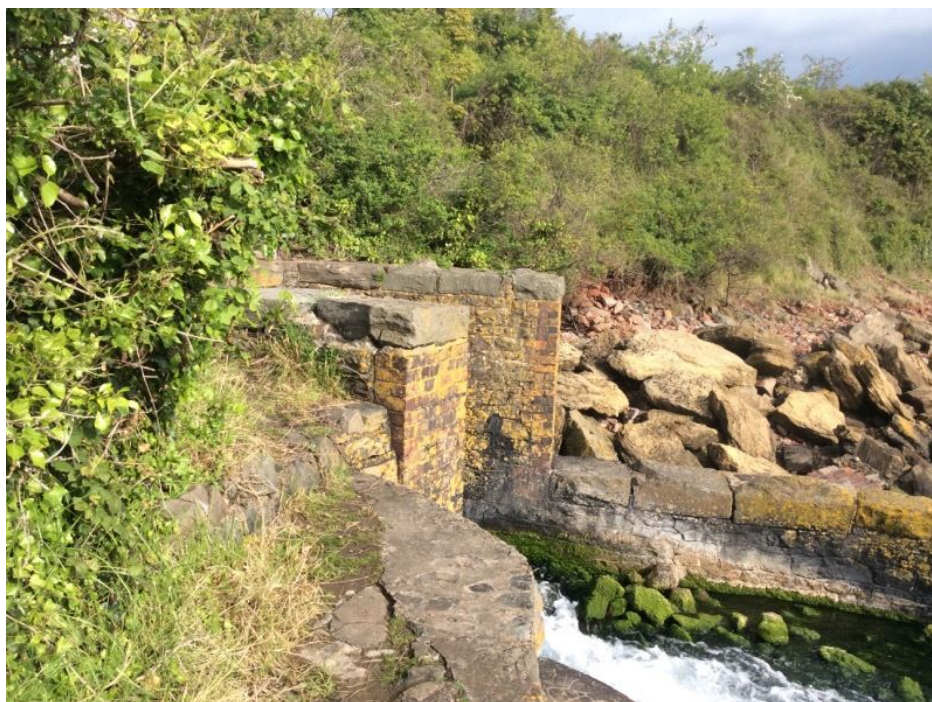
**Section B**  
**Downstream**  
**Headwall**  
**Defect Ref: D35**  
**Description:** Horizontal fracture of masonry wall (high wall). No change between 2020 and 2021 inspections.  
**Photo number: 98**

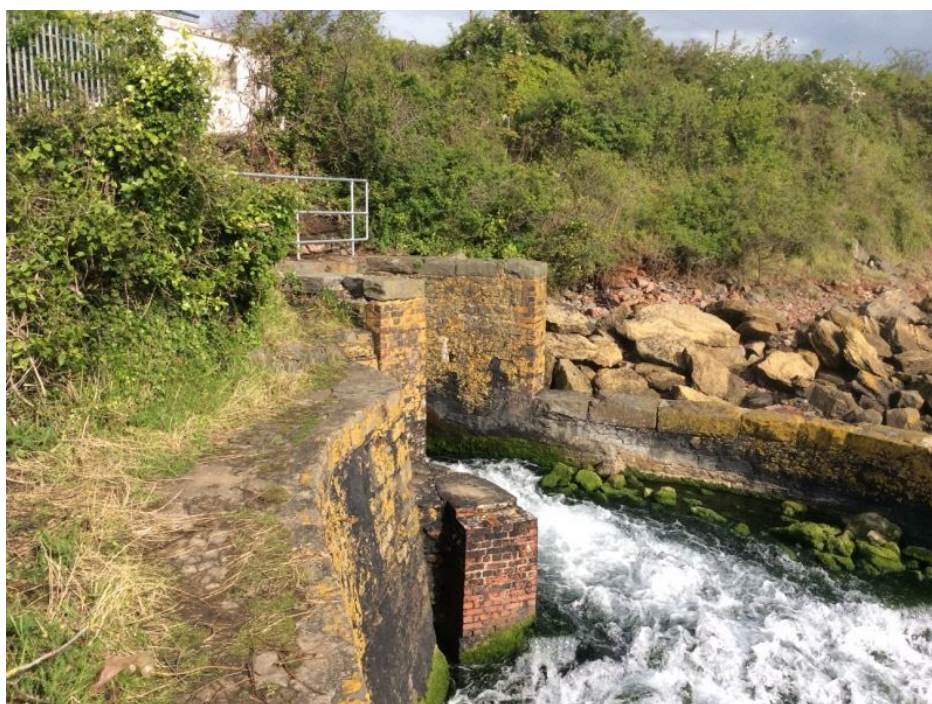
**Defect Ref: D37**

**Description:** Missing masonry brick.
