| Location Plan: | | Pwll Sea Wall | |
| | | Structure Reference: | 226 21.5 |

# COASTAL ASSET CONDITION SURVEY REPORT

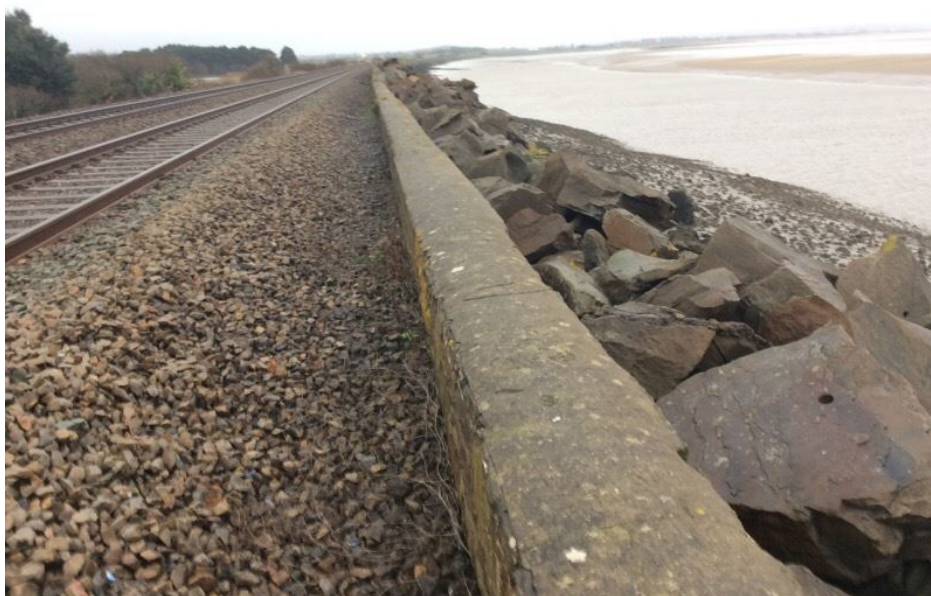
**Section A**  
**Capping Wall**  
**Photo number: 35**

| Minor Elements | Photo No. | Attributes and General Notes | Condition Grade | Weighting (1-9) | Overall (CG x W) |
|---|---|---|---|---|---|
| Capping Wall | 35, 36, 37, 41, 42, 46 | Masonry ((brick displacement, loss of mortar, lowering of crest, cracking).). | 3 | 4 | 12 |

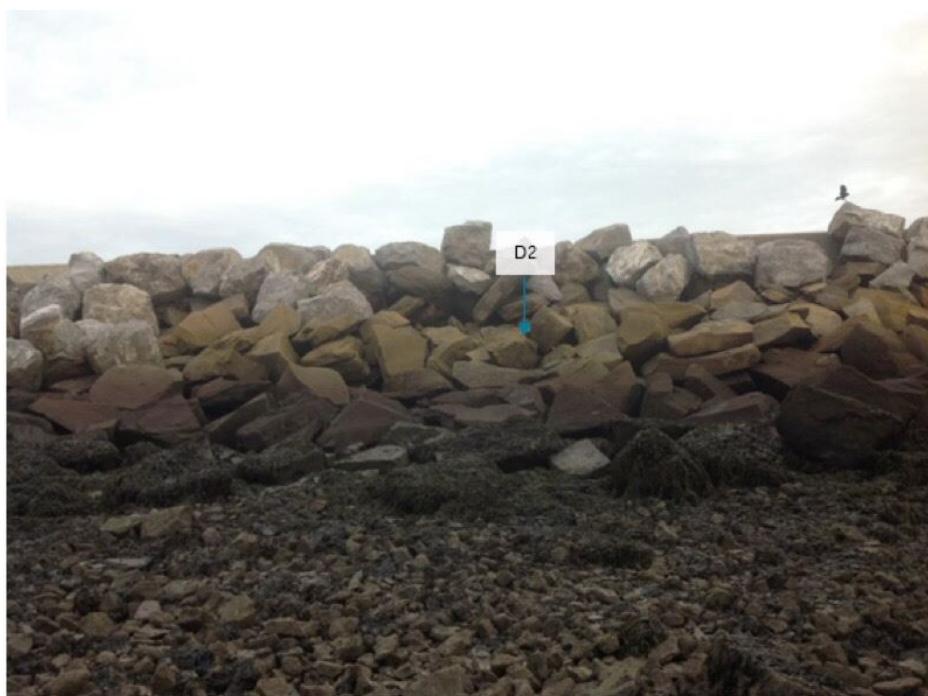
**Photo number: 47**

Undersized rock armour likely to be unstable and provide inadequate protection during storm events. There has been no change between the 2019 and 2020 inspections.

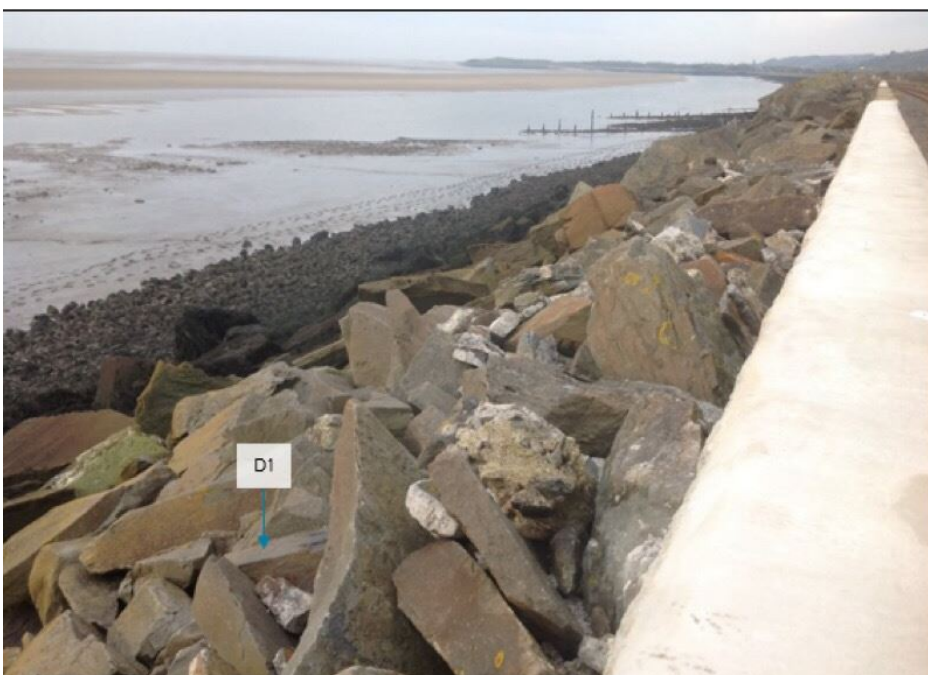
**Photo number: 48**

Undersized rock armour likely to be unstable and provide inadequate protection during storm events. There has been no change between the 2019 and 2020 inspections.

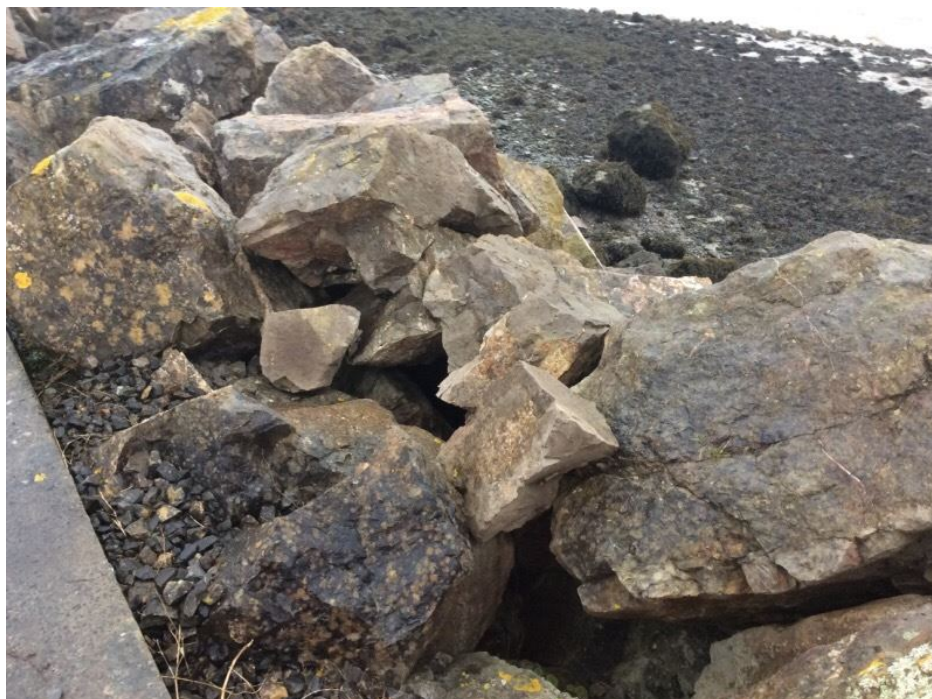
Undersized rock armour likely to be unstable and provide inadequate protection during storm events. There has been no change between the 2019 and 2020 inspections.

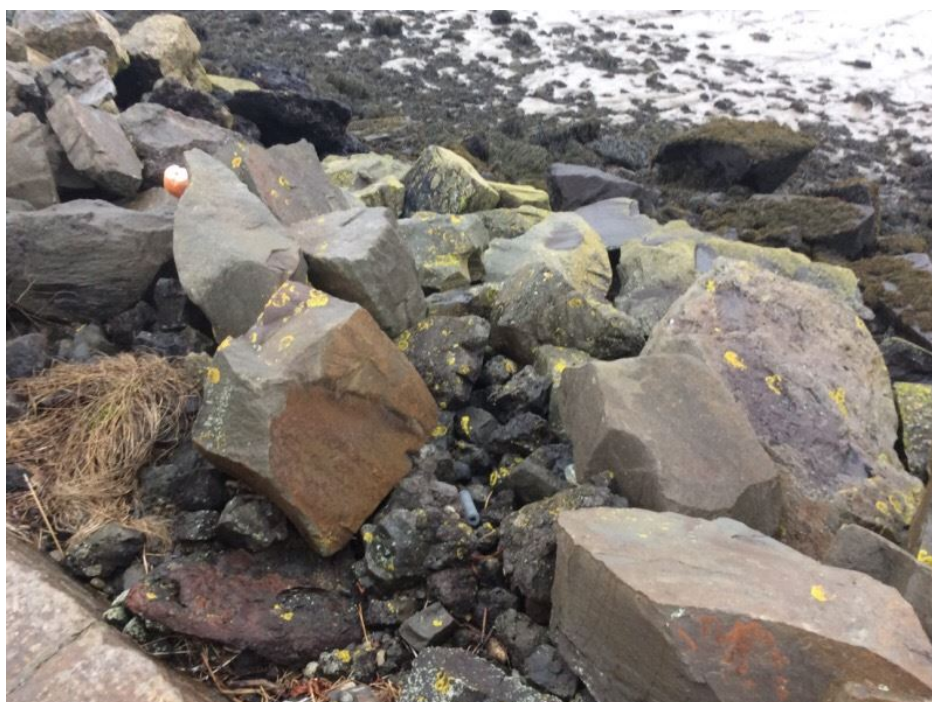
Undersized rock armour likely to be unstable and provide inadequate protection during storm events. There has been no change between the 2019 and 2020 inspections.

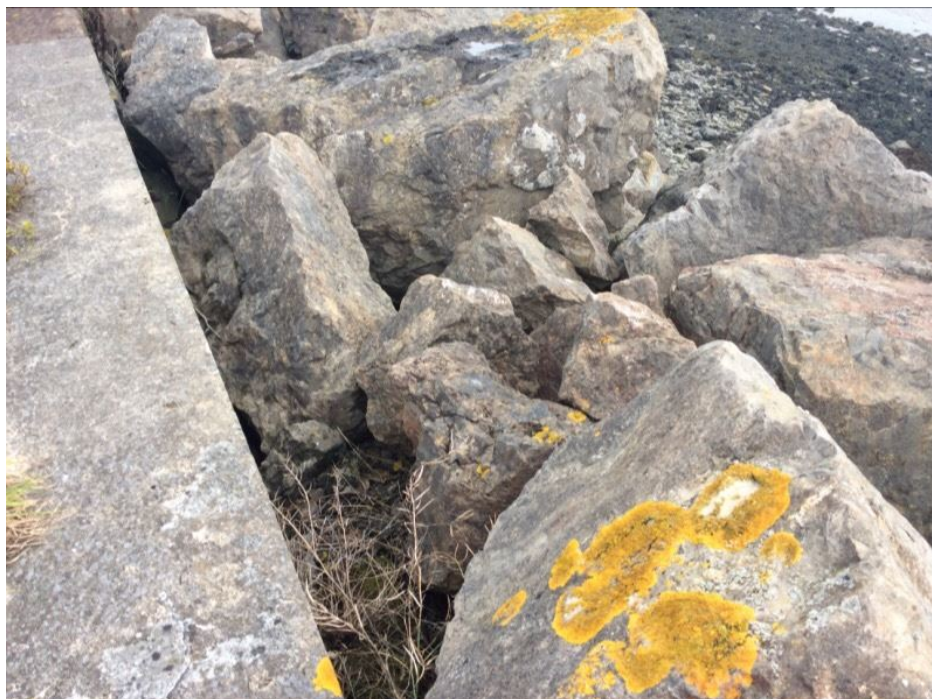
Undersized rock armour likely to be unstable and provide inadequate protection during storm events. There has been no change between the 2019 and 2020 inspections.

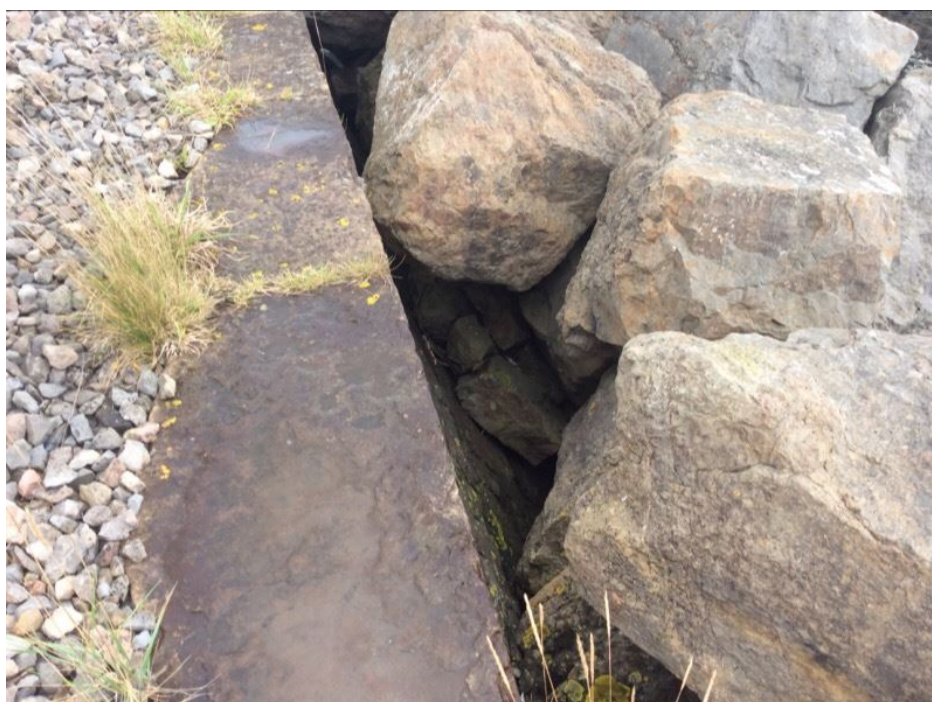
Undersized rock armour likely to be unstable and provide inadequate protection during storm events. There has been no change between the 2019 and 2020 inspections.

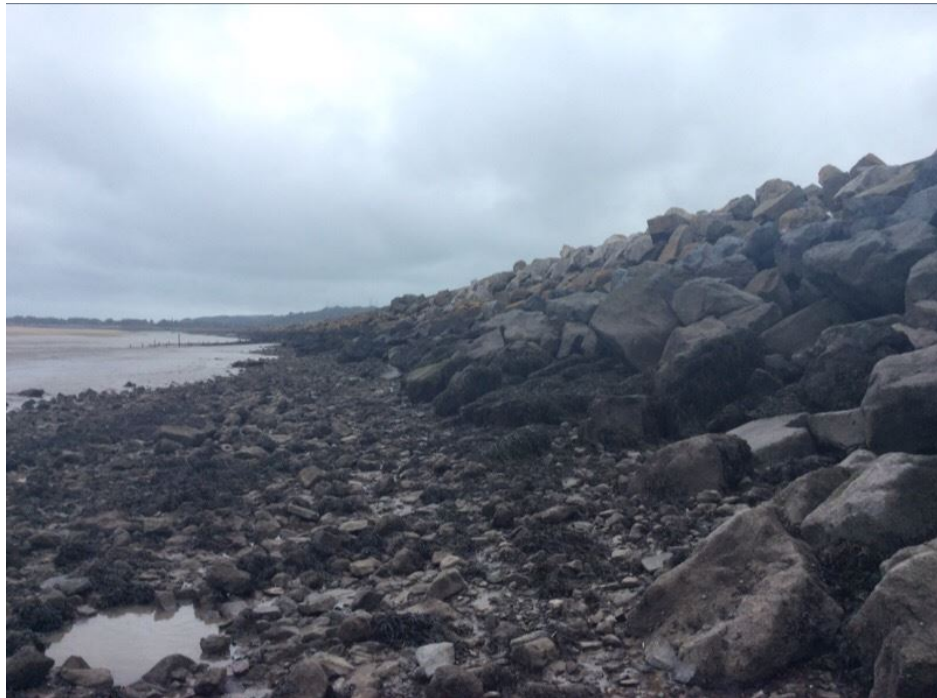
Undersized rock armour likely to be unstable and provide inadequate protection during storm events. There has been no change between the 2019 and 2020 inspections.

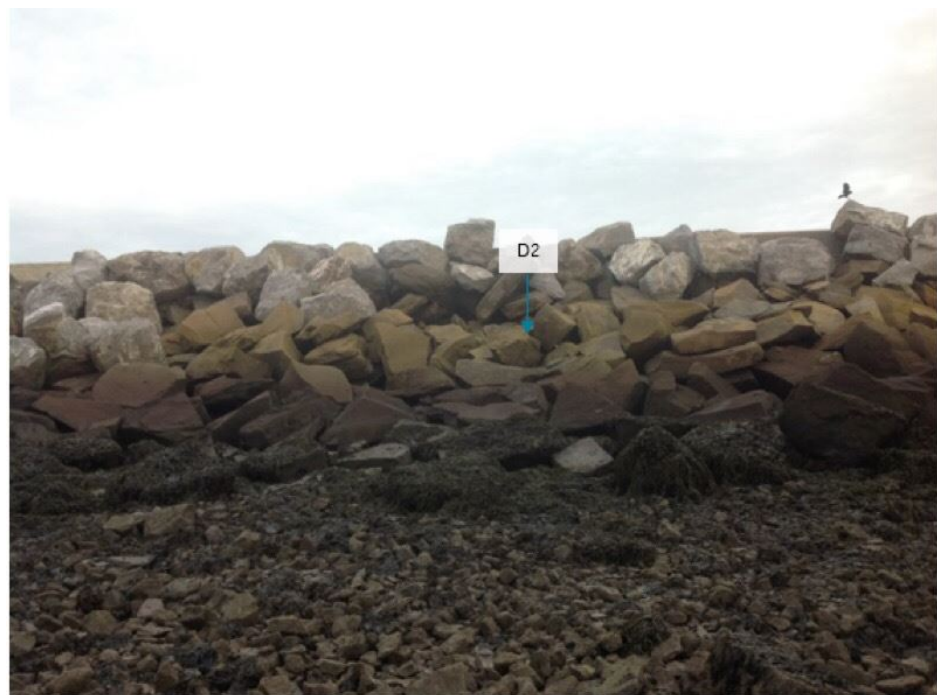
**Photo number: 49**

The hollow in the rock armour creates a localised weakness, compromising the stability of the embankment. No change between 2019 and 2020 inspections.

| Defect Ref No. | Works Category | Recommendations | Recommended Closure Date | Latest Status |
|---|---|---|---|---|
| D2 | Brickwork/Stone Repairs | Reshape rock armour embankment, replace and add additional armour if necessary. | | Active Defect (Approved) |

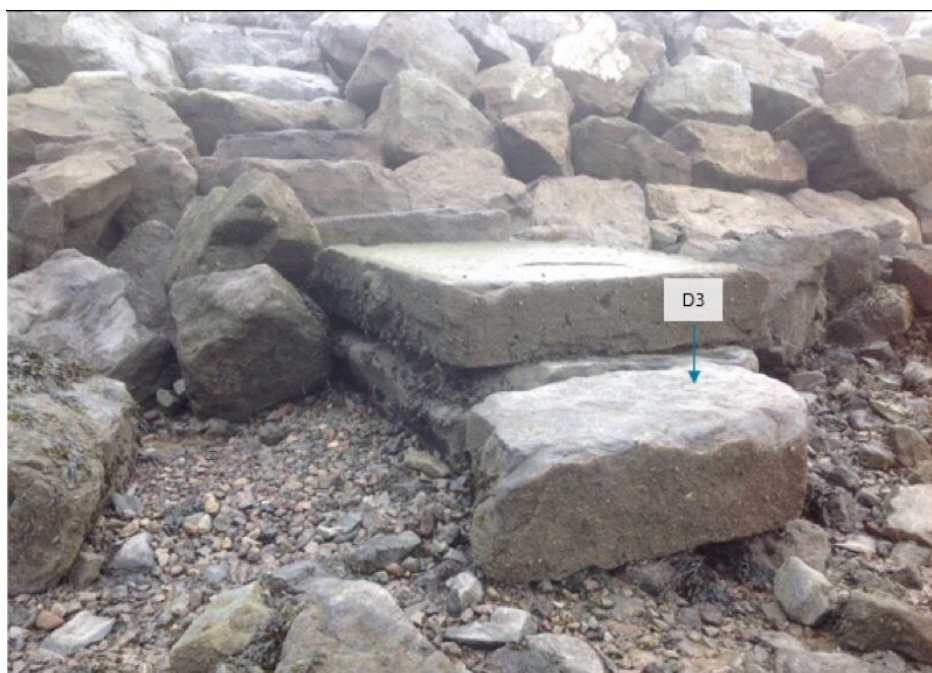
**Photo number: 50**

**Description:** Algae covered steps providing slipping hazard. No change between 2019 and 2020 inspections.

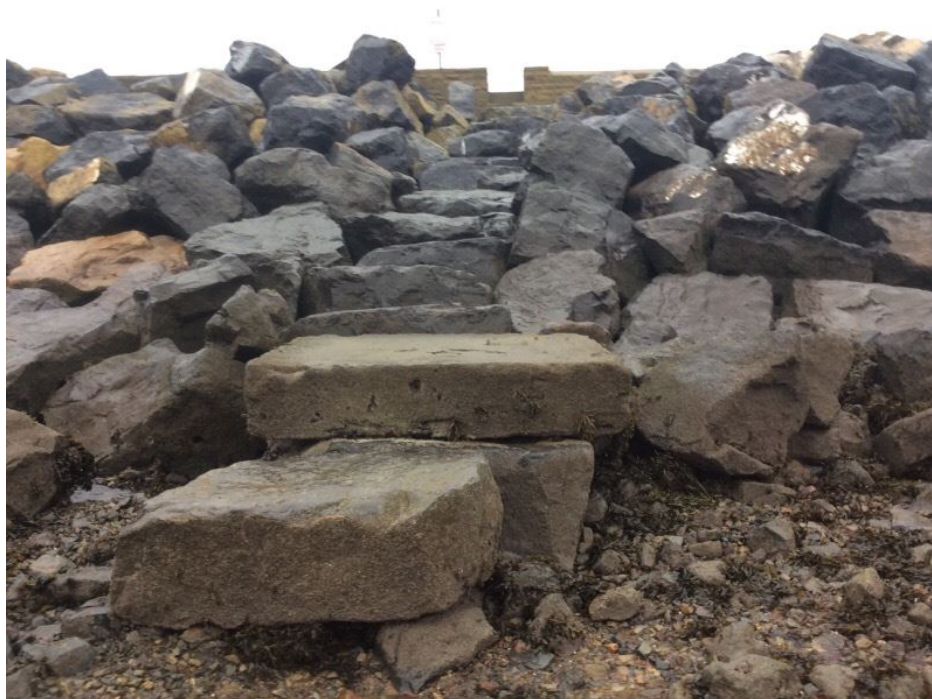
**Section A**  
**Embankment**  
**Armour**  
**Defect Ref: D3**  
**Description:** Algae covered steps providing slipping hazard. No change between 2019 and 2020 inspections.  
**Photo number: 114**

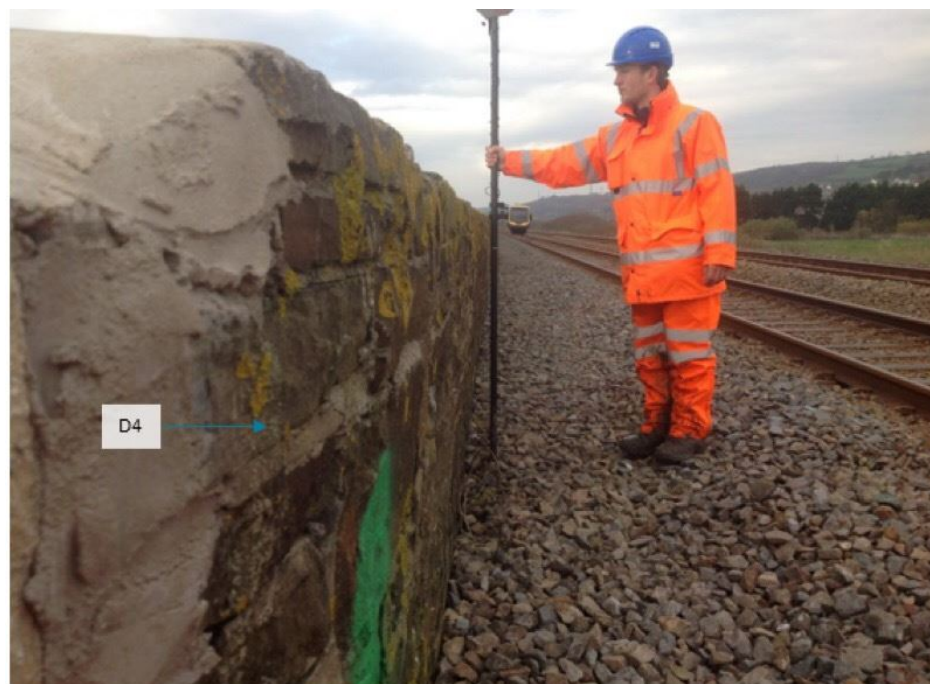
**Section A**  
**Capping Wall**  
**Defect Ref: D4**  
**Description:** Parapet wall is leaning towards the track. No change between the 2019 and 2020 inspections.  
**Photo number: 51**

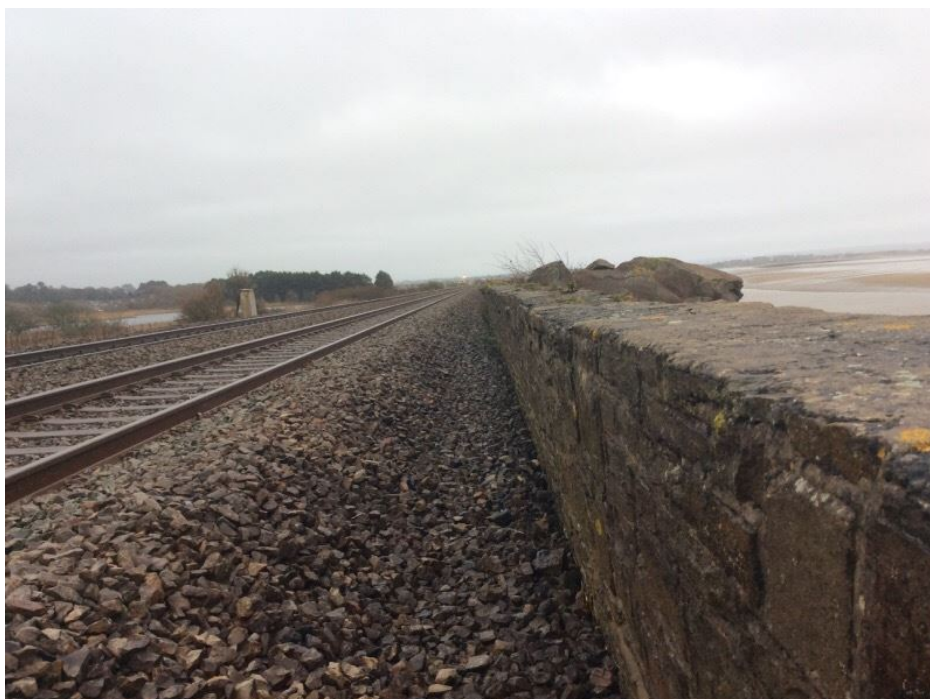
**Section A**  
**Capping Wall**  
**Defect Ref: D4**  
**Description:** Parapet wall is leaning towards the track. No change between the 2019 and 2020 inspections.  
**Photo number: 104**

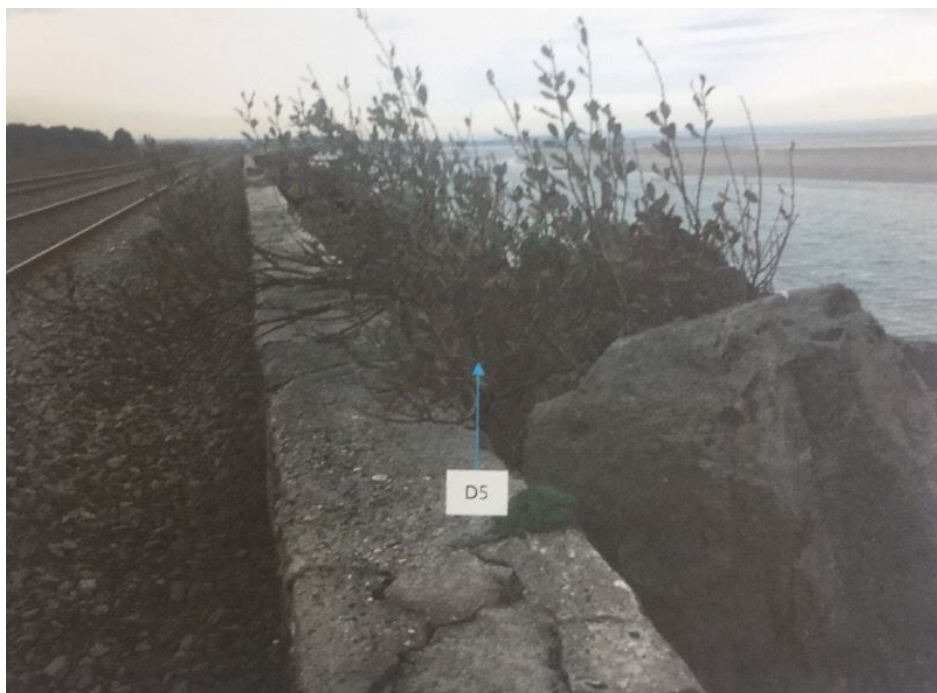
**Section A**  
**Capping Wall**  
**Defect Ref: D5**  
**Description:** Vegetation growth could weaken embankment armour and cause localised structural damage. Increased in severity between the 2019 and 2020 inspections as more vegetation and cracking in mortar was noted.  
**Photo number: 52**

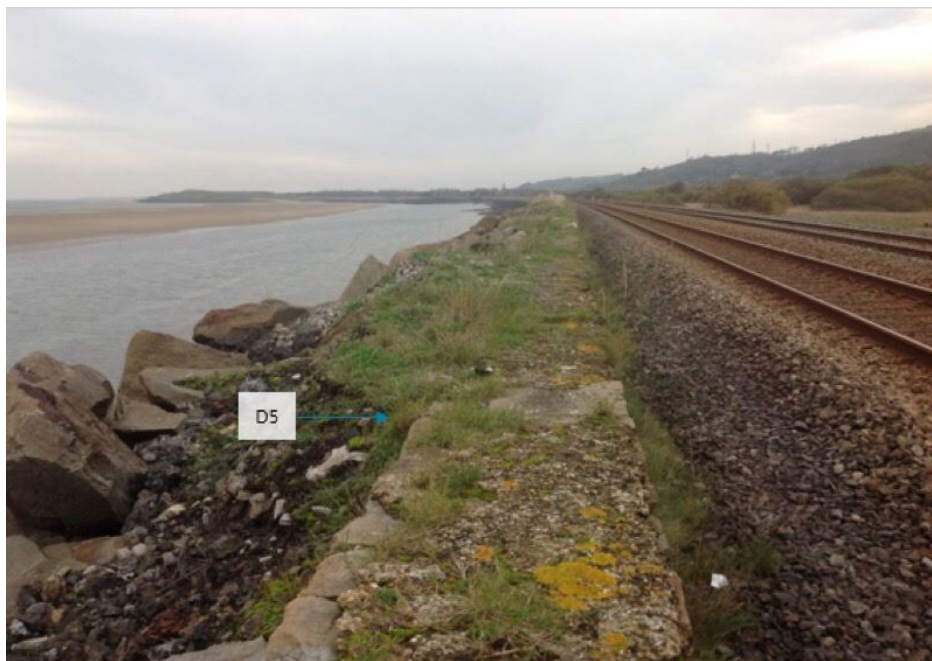
Photo number: 53

Vegetation growth could weaken embankment armour and cause localised structural damage. Increased in severity between the 2019 and 2020 inspections as more vegetation and cracking in mortar was noted.

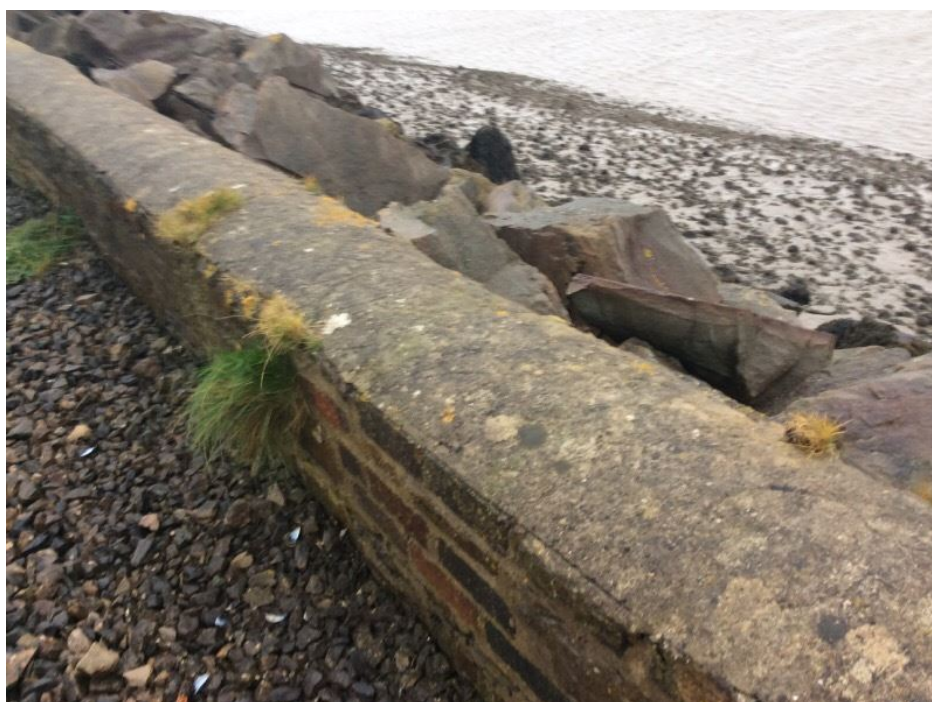
Vegetation growth could weaken embankment armour and cause localised structural damage. Increased in severity between the 2019 and 2020 inspections as more vegetation and cracking in mortar was noted.

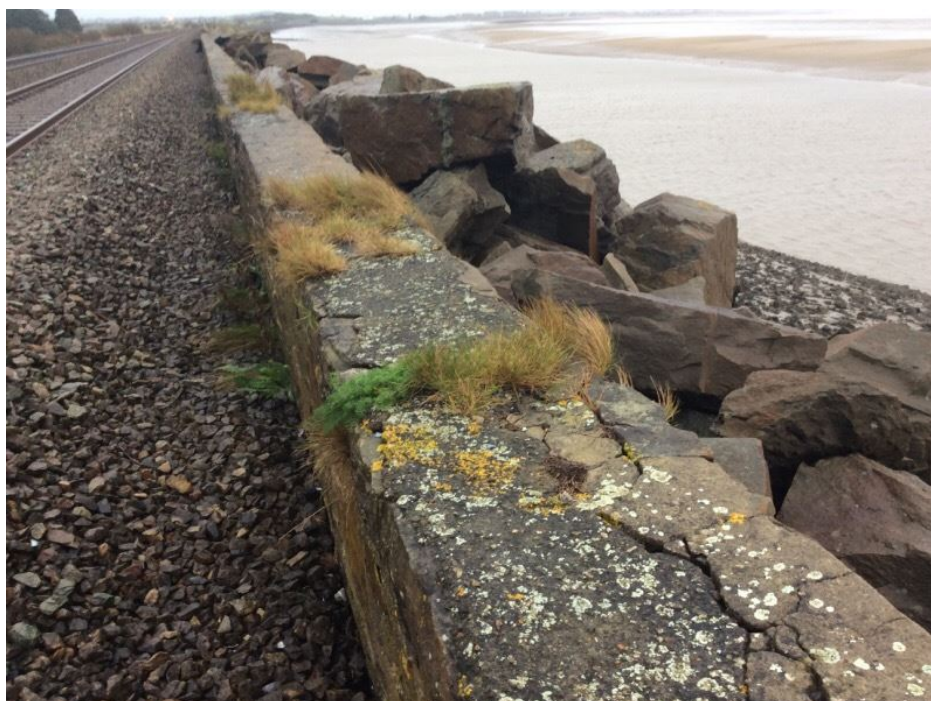
Vegetation growth could weaken embankment armour and cause localised structural damage. Increased in severity between the 2019 and 2020 inspections as more vegetation and cracking in mortar was noted.

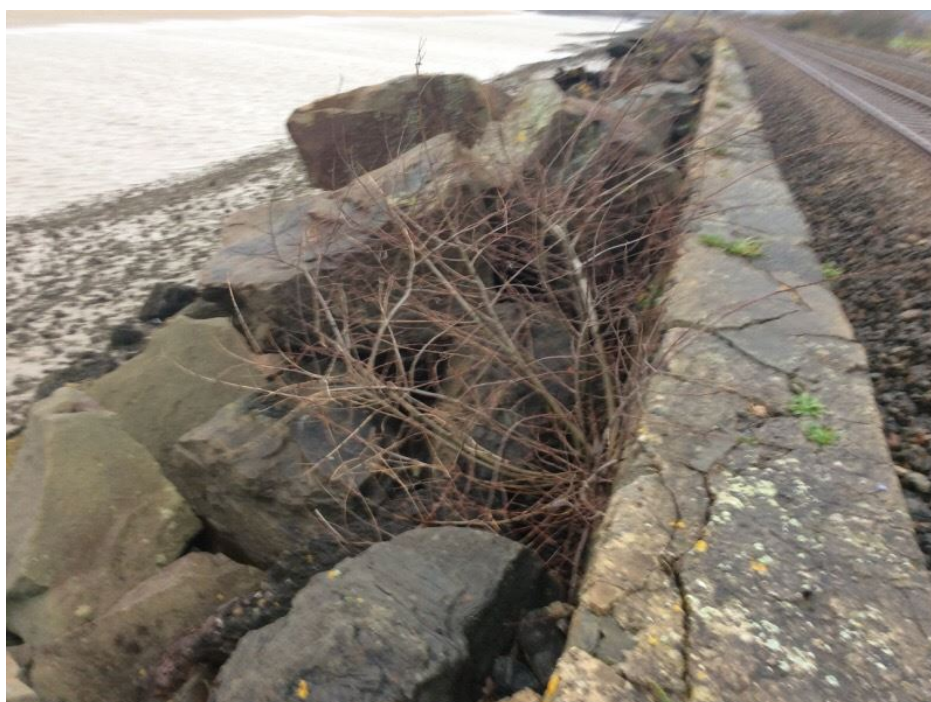
Vegetation growth could weaken embankment armour and cause localised structural damage. Increased in severity between the 2019 and 2020 inspections as more vegetation and cracking in mortar was noted.

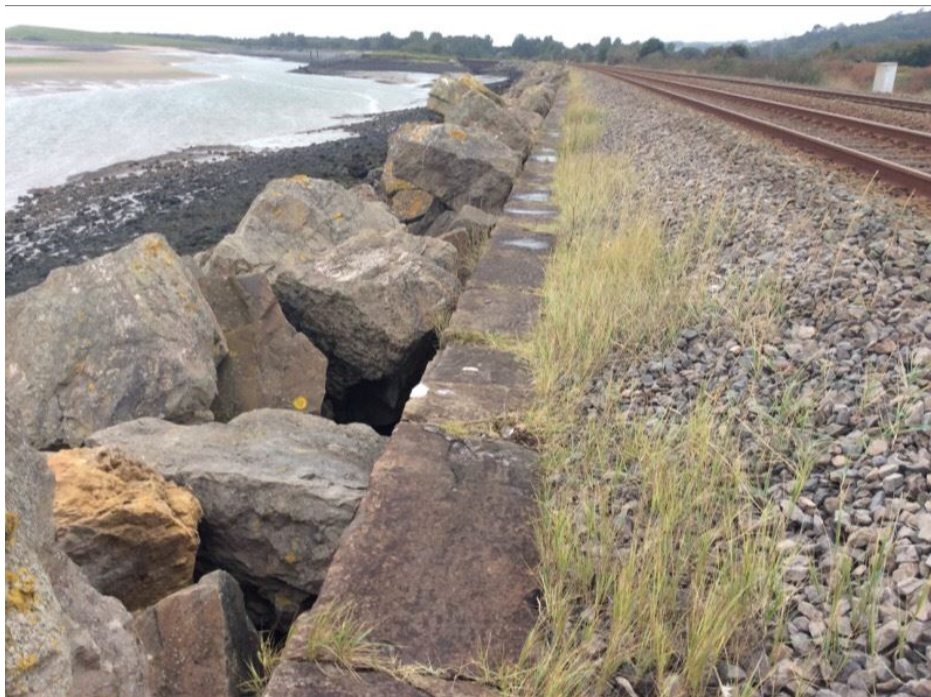
Vegetation growth could weaken embankment armour and cause localised structural damage. Increased in severity between the 2019 and 2020 inspections as more vegetation and cracking in mortar was noted.

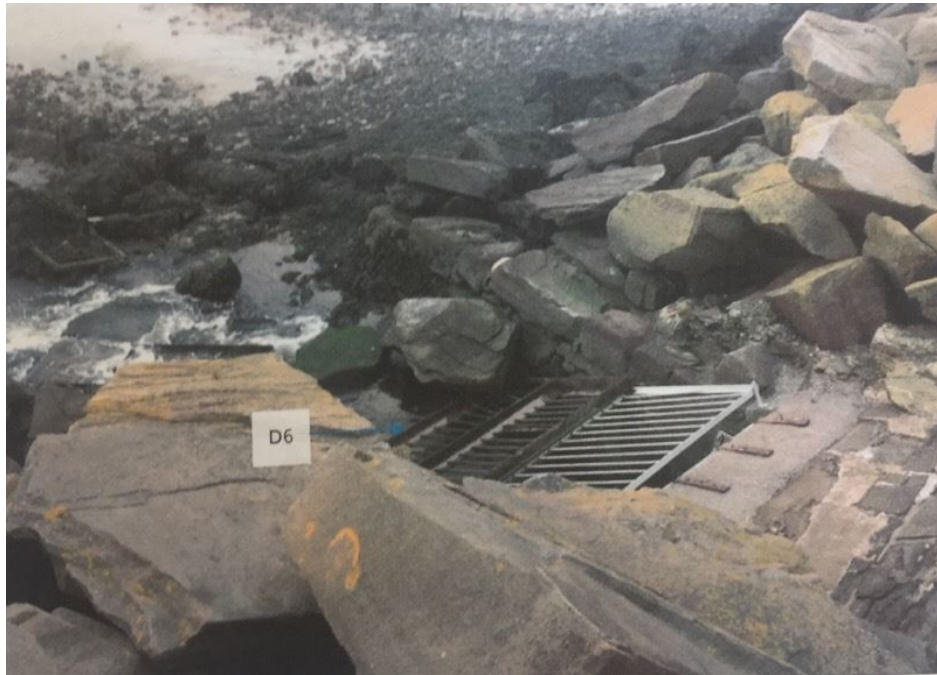
**Section A**  
**Capping Wall**  
**Defect Ref: D6**  
**Description:**  
Damaged and corroded trash screen. Both the lower and upper screens were found to be detached during the 2020 inspection.  
**Photo number: 54**

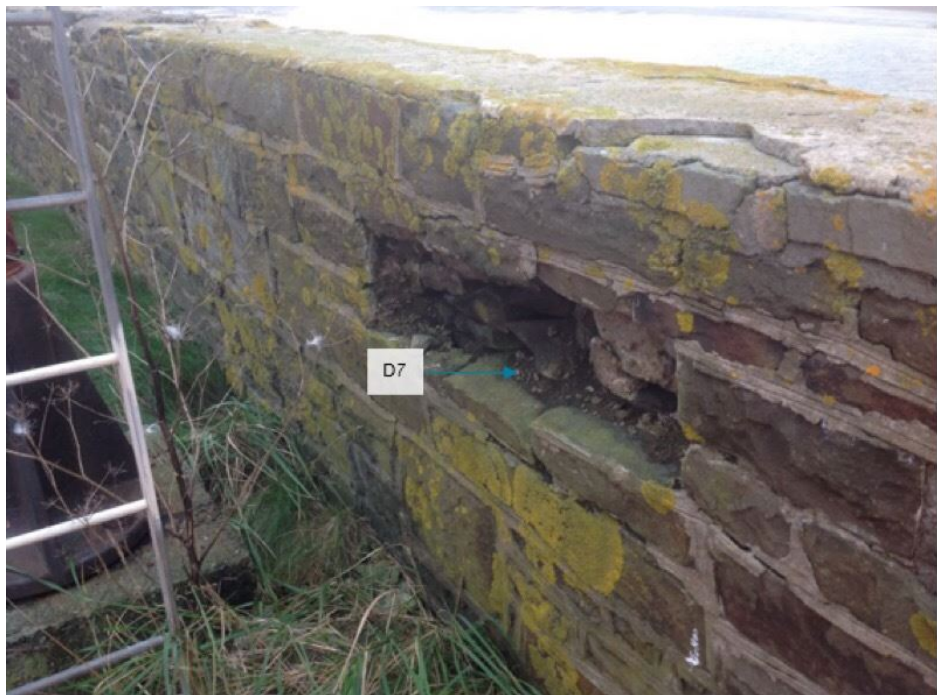
**Section A**  
**Capping Wall**  
**Defect Ref: D7**  
**Description:**  
Damaged parapet and capping. A section of the capping wall has been replaced between the 2019 and 2020 inspections. However, there are still missing blocks noted in the existing wall.  
**Photo number: 55**

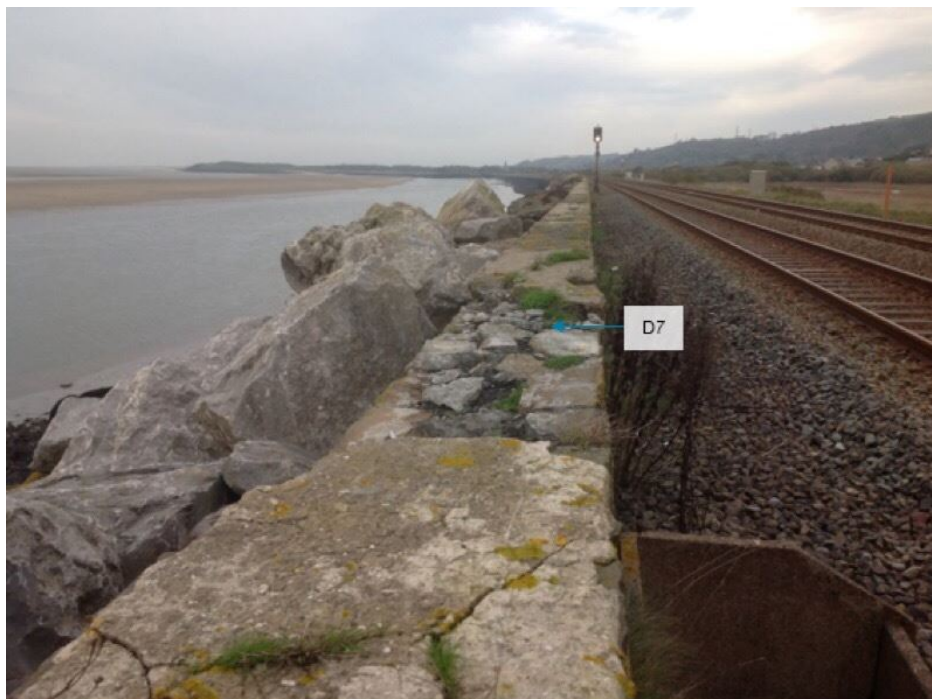
**Section A**  
**Capping Wall**  
**Defect Ref: D7**  
**Description:**  
Damaged parapet and capping. A section of the capping wall has been replaced between the 2019 and 2020 inspections. However, there are still missing blocks noted in the existing wall.  
**Photo number: 56**

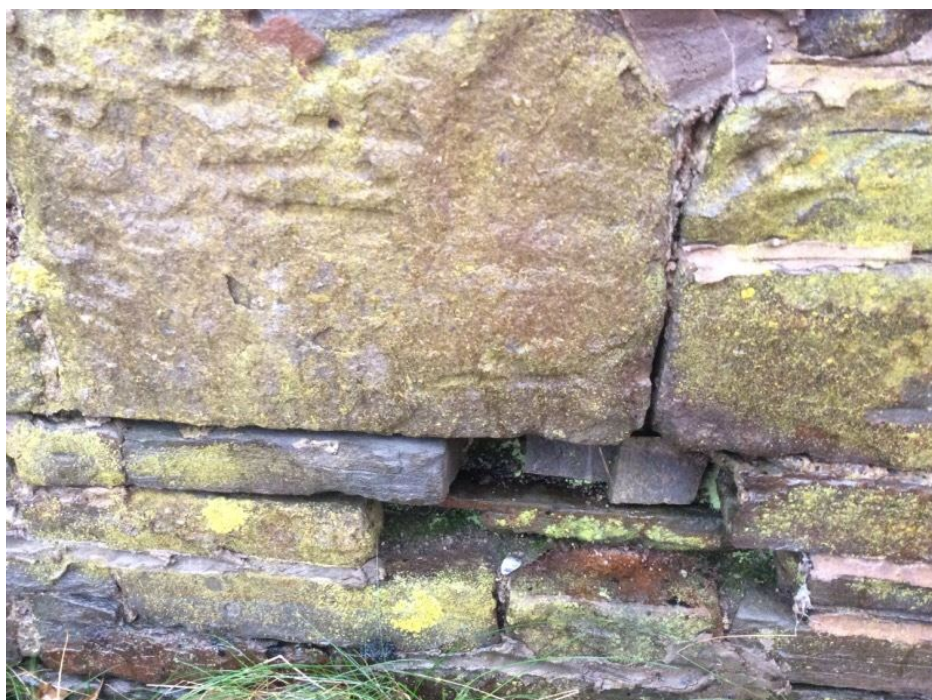
**Section A**  
**Capping Wall**  
**Defect Ref: D7**  
**Description:**  
Damaged parapet and capping. A section of the capping wall has been replaced between the 2019 and 2020 inspections. However, there are still missing blocks noted in the existing wall.  
**Photo number: 108**

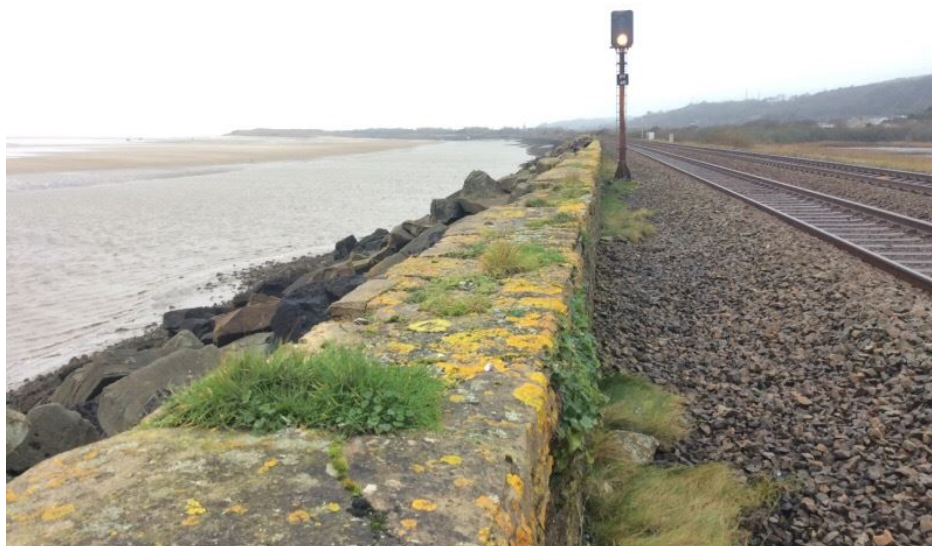
**Section A**  
**Capping Wall**  
**Defect Ref: D7**  
**Description:**  
Damaged parapet and capping. A section of the capping wall has been replaced between the 2019 and 2020 inspections. However, there are still missing blocks noted in the existing wall.  
**Photo number: 109**

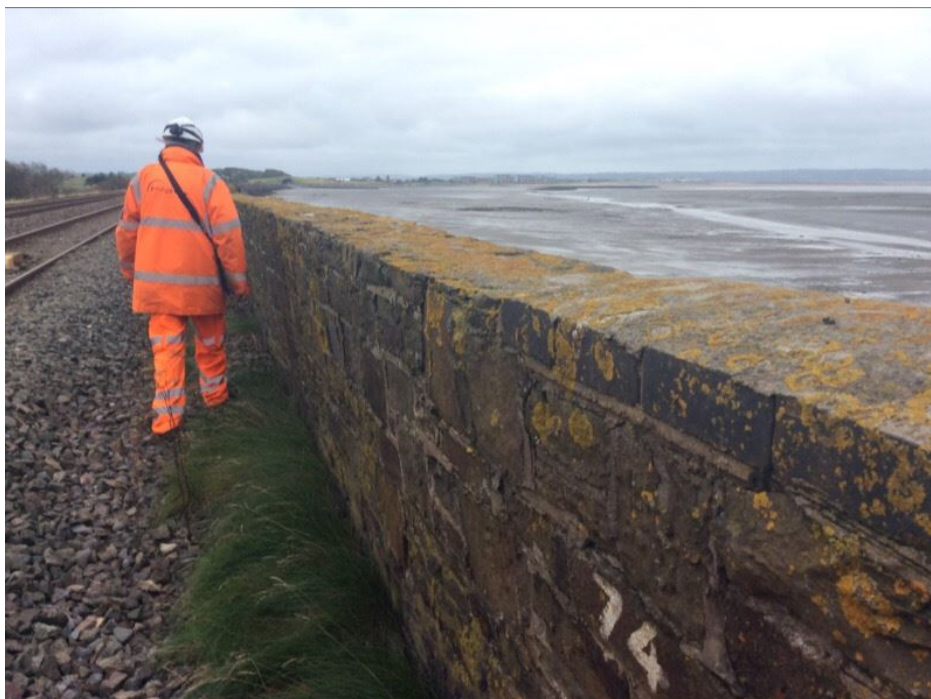
**Section A**  
**Capping Wall**  
**Defect Ref: D7**  
**Description:**  
Damaged parapet and capping. A section of the capping wall has been replaced between the 2019 and 2020 inspections. However, there are still missing blocks noted in the existing wall.  
**Photo number: 194**

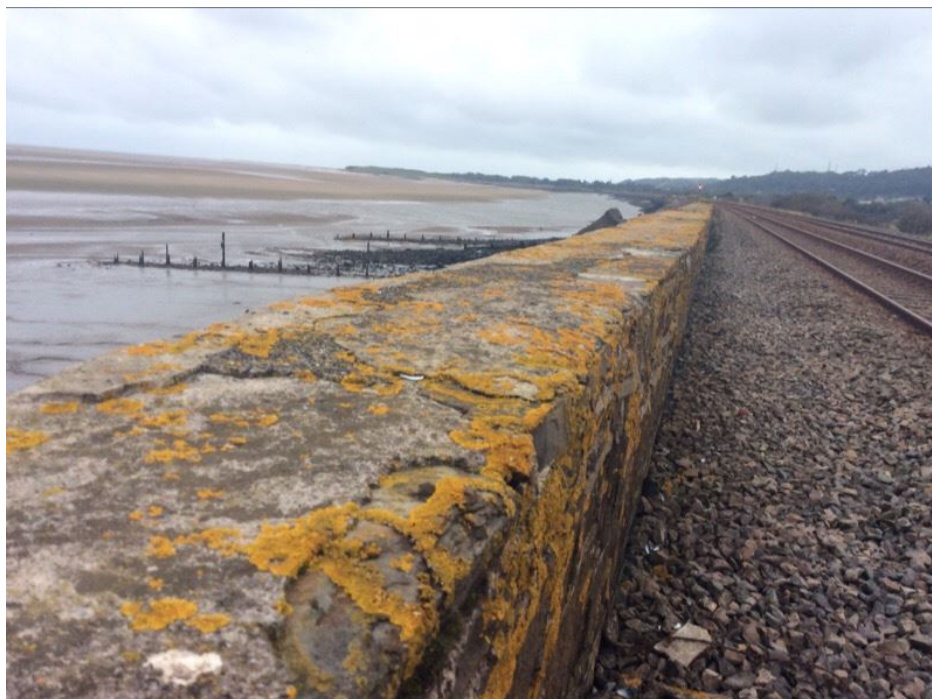
**Section A**  
**Capping Wall**  
**Defect Ref: D7**  
**Description:**  
Damaged parapet and capping. A section of the capping wall has been replaced between the 2019 and 2020 inspections. However, there are still missing blocks noted in the existing wall.  
**Photo number: 196**

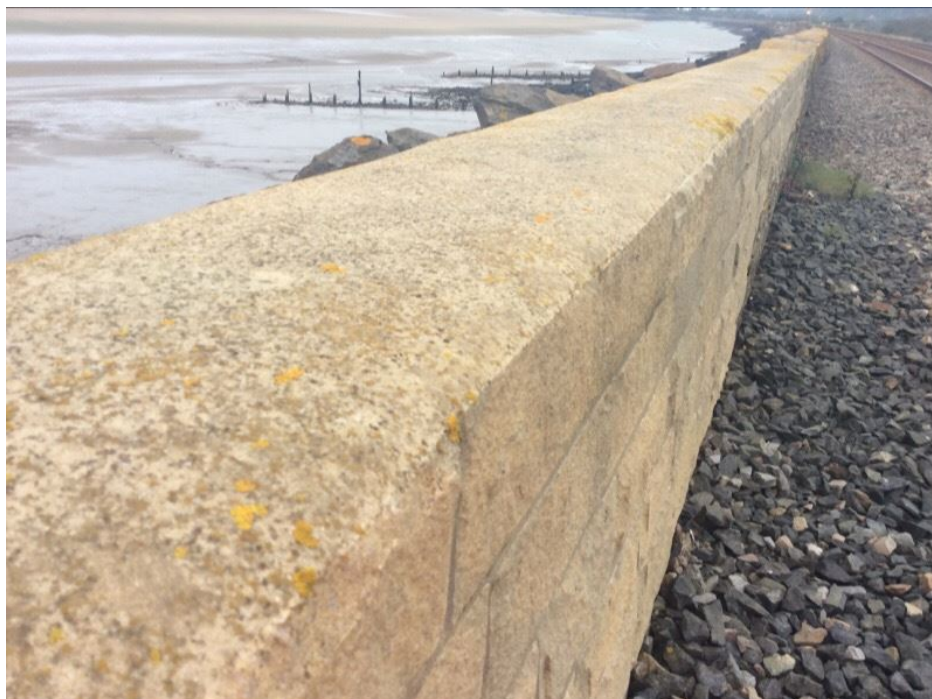
**Section A**  
**Capping Wall**  
**Defect Ref: D7**  
**Description:** Damaged parapet and capping. A section of the capping wall has been replaced between the 2019 and 2020 inspections. However, there are still missing blocks noted in the existing wall.  
**Photo number: 198**

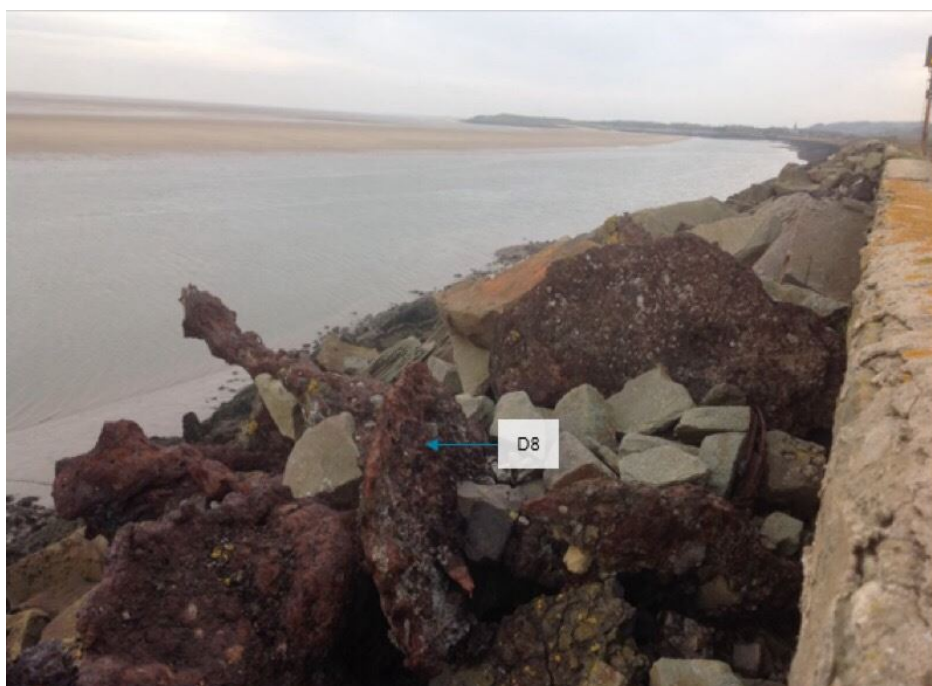
**Section A**  
**Embankment**  
**Armour**  
**Defect Ref: D8**  
**Description:** Lack of rock armour, and ineffective repair measures. No change between 2019 and 2020 inspections.  
**Photo number: 57**

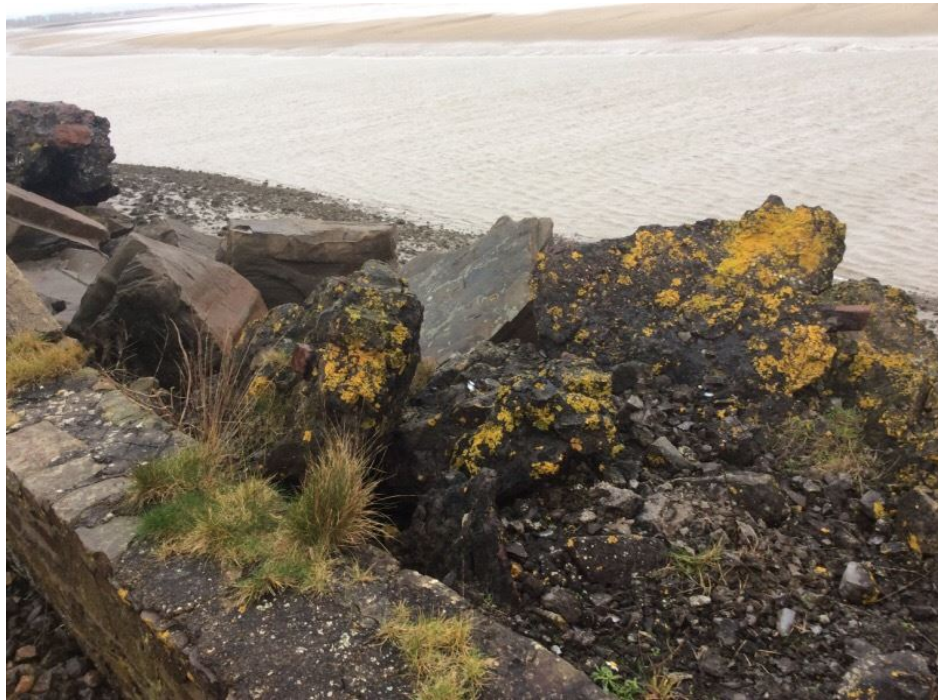
**Description:** Lack of rock armour, and ineffective repair measures. No change between 2019 and 2020 inspections.

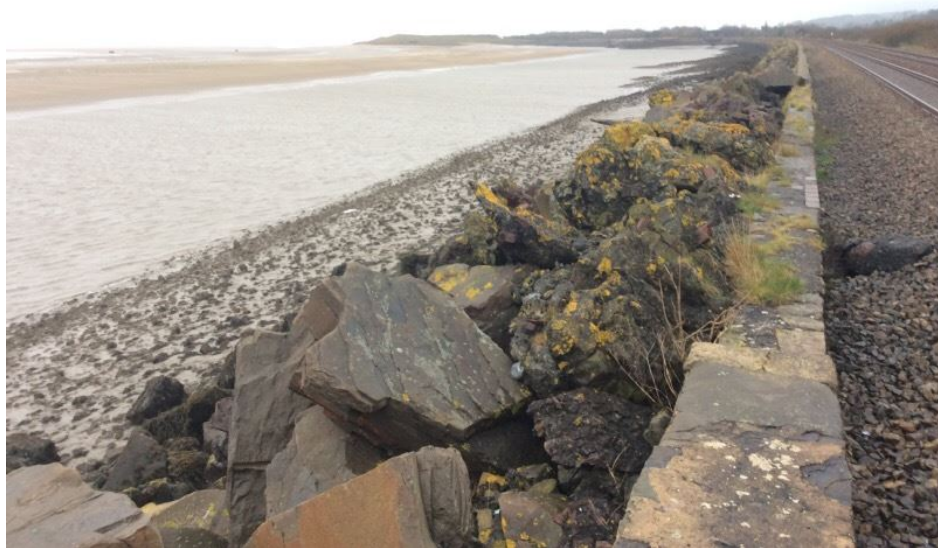
**Description:** Lack of rock armour, and ineffective repair measures. No change between 2019 and 2020 inspections.

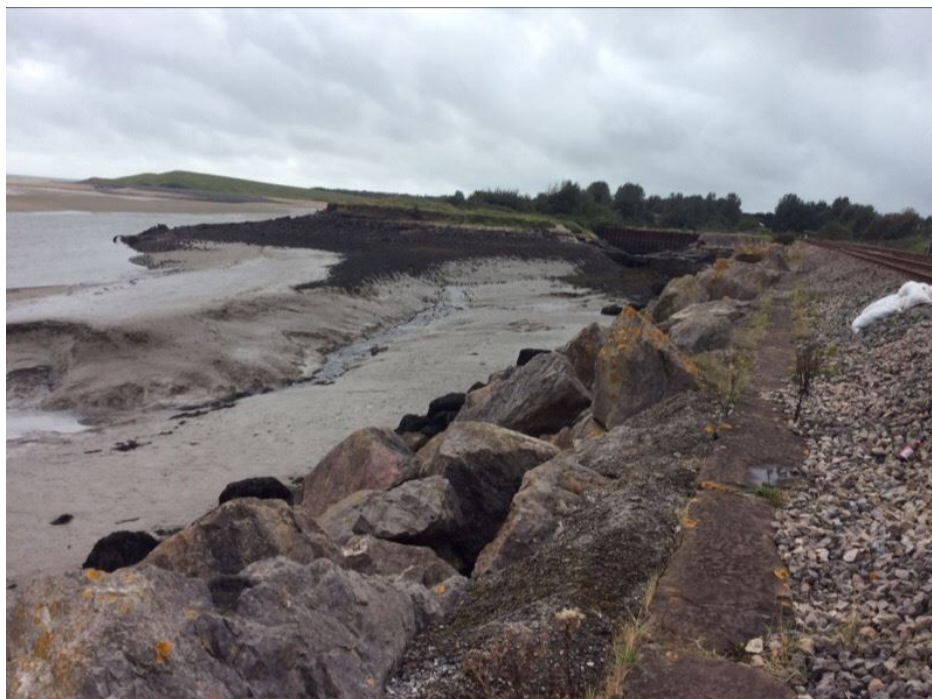
**Description:** Lack of rock armour, and ineffective repair measures. No change between 2019 and 2020 inspections.

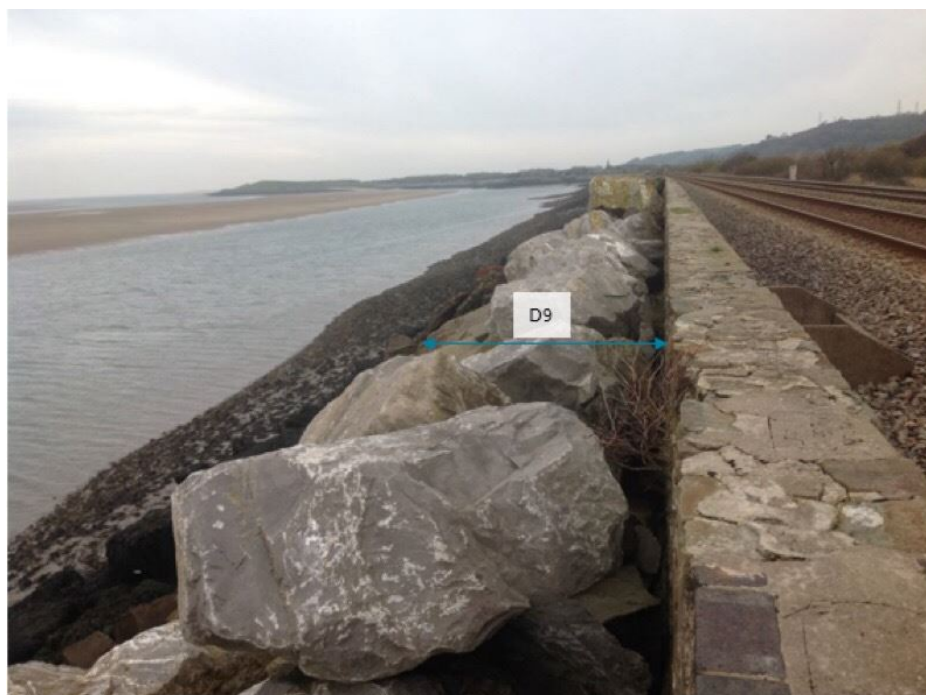
**Section A**  
**Embankment**  
**Armour**  
**Defect Ref: D9**  
**Description:** Lack of crest width on rock embankment, leading to instabilities in the defence. No change between 2019 and 2020 inspections.  
**Photo number: 58**

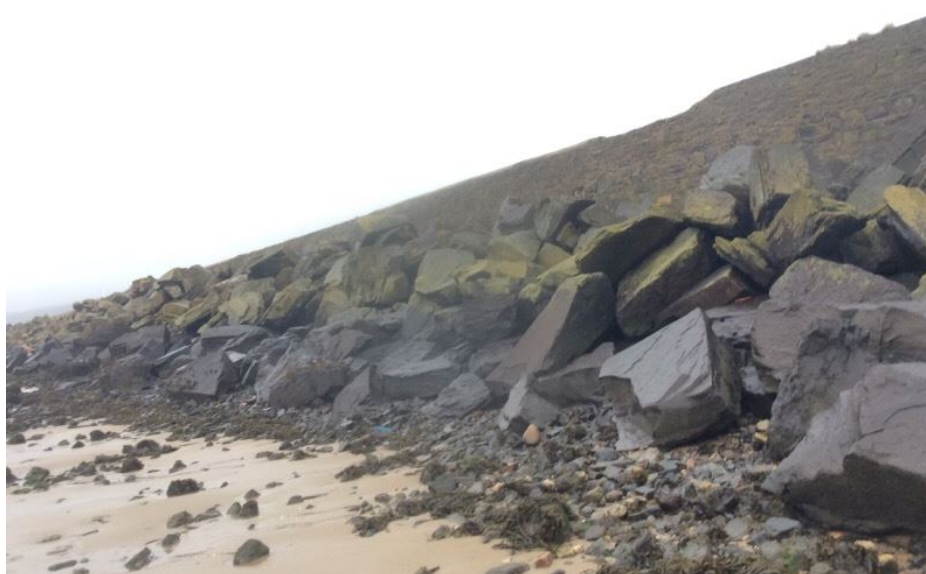
**Section A**  
**Embankment**  
**Armour**  
**Defect Ref: D9**  
**Description:** Lack of crest width on rock embankment, leading to instabilities in the defence. No change between 2019 and 2020 inspections.  
**Photo number: 123**
