| Location Plan: | | Pwll Sea Wall | |
| | | Structure Reference: | 226 21.5 |

# COASTAL ASSET CONDITION SURVEY REPORT

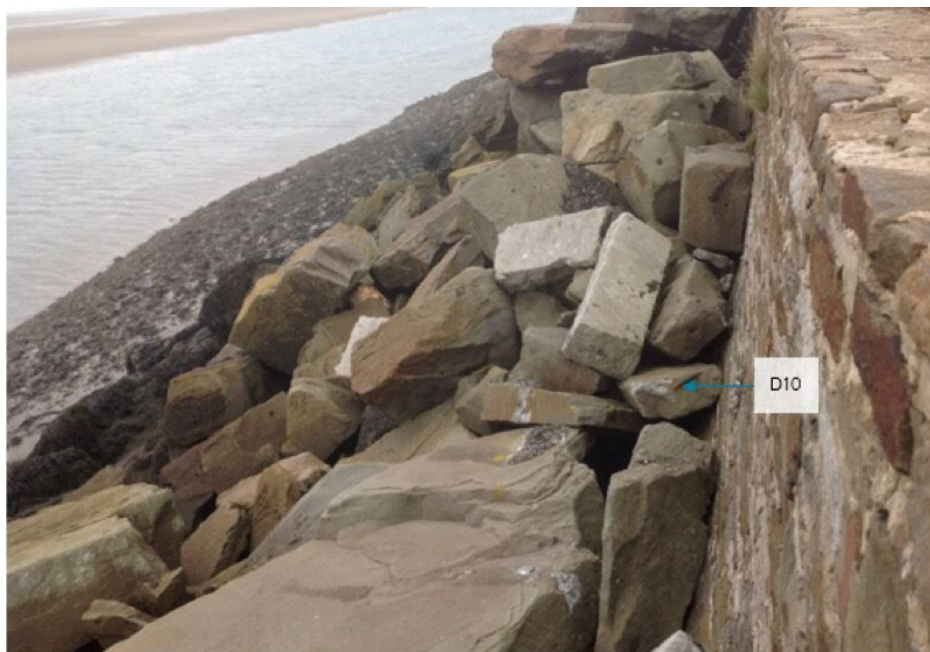
**Section A**  
**Embankment**  
**Armour**  
**Defect Ref: D10**  
**Description:** Isolated lack of rock armour. Masonry wall exposed to increased wave loading. No change between 2019 and 2020 inspections.  
**Photo number: 59**

| Defect Ref No. | Works Category | Recommendations | Recommended Closure Date | Latest Status |
|---|---|---|---|---|
| D10 | Brickwork/Stone Repairs | Place additional rock armour. | | Active Defect (Approved) |

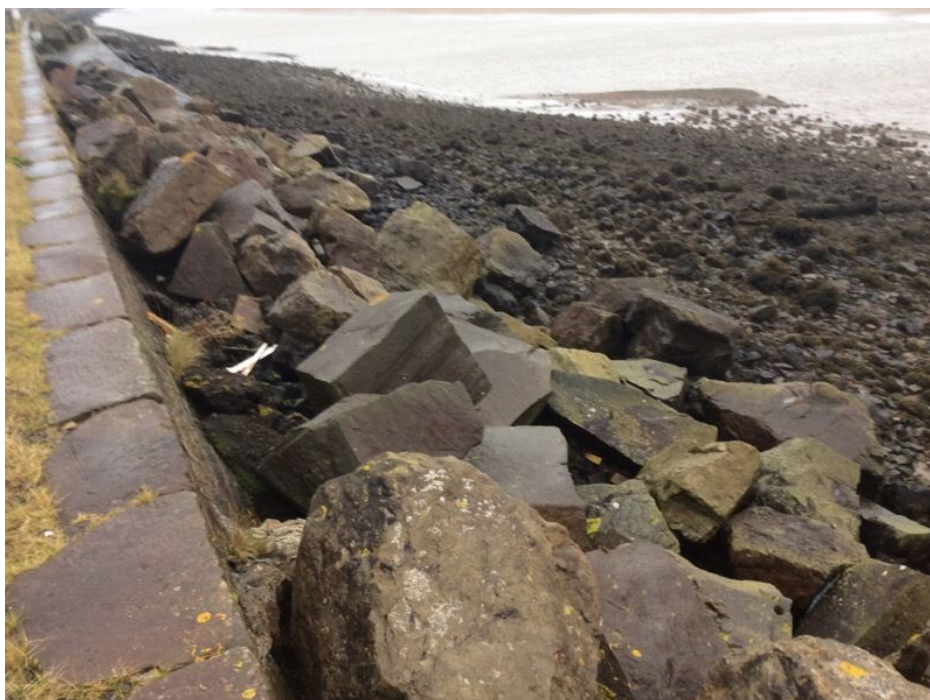
**Section A**  
**Embankment**  
**Armour**  
**Defect Ref: D10**  
**Description:** Isolated lack of rock armour. Masonry wall exposed to increased wave loading. No change between 2019 and 2020 inspections.  
**Photo number: 93**

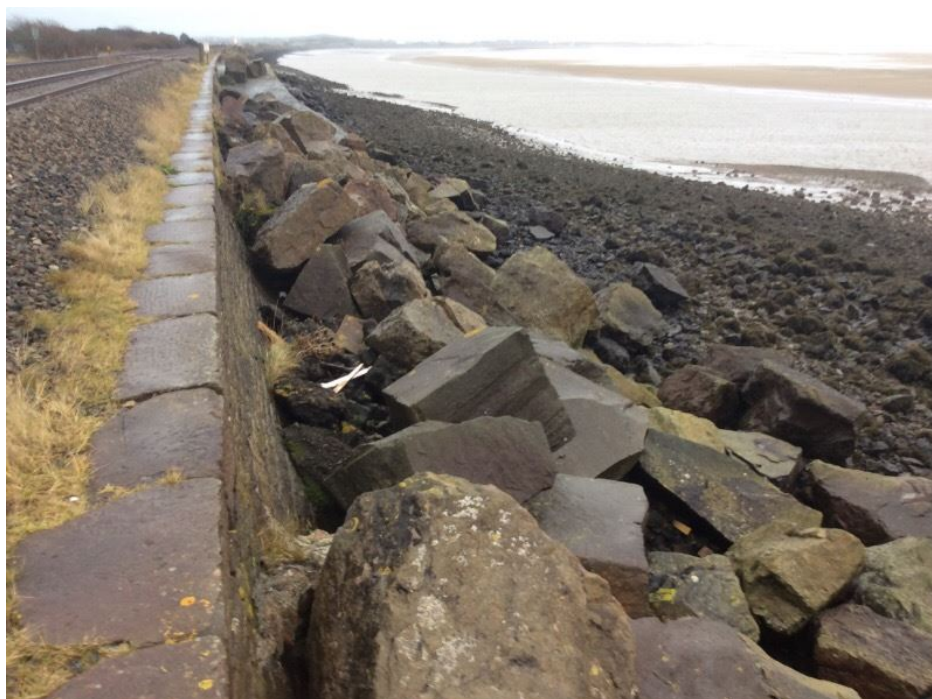
**Section A**  
**Embankment**  
**Armour**  
**Defect Ref: D10**  
**Description:** Isolated lack of rock armour. Masonry wall exposed to increased wave loading. No change between 2019 and 2020 inspections.  
**Photo number: 94**

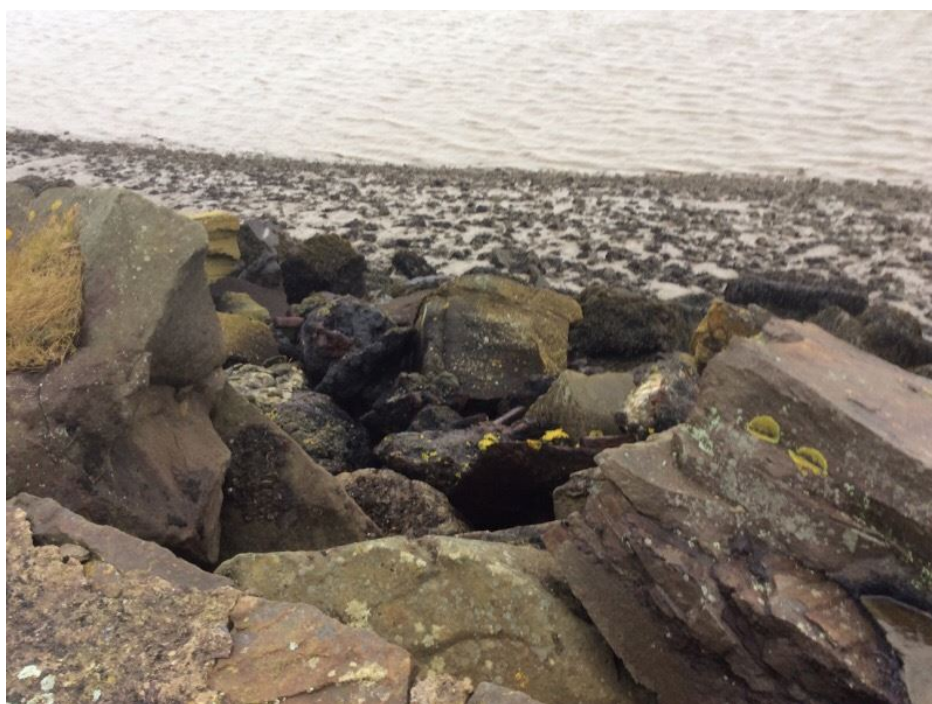
**Section A**  
**Embankment**  
**Armour**  
**Defect Ref: D10**  
**Description:** Isolated lack of rock armour. Masonry wall exposed to increased wave loading. No change between 2019 and 2020 inspections.  
**Photo number: 107**

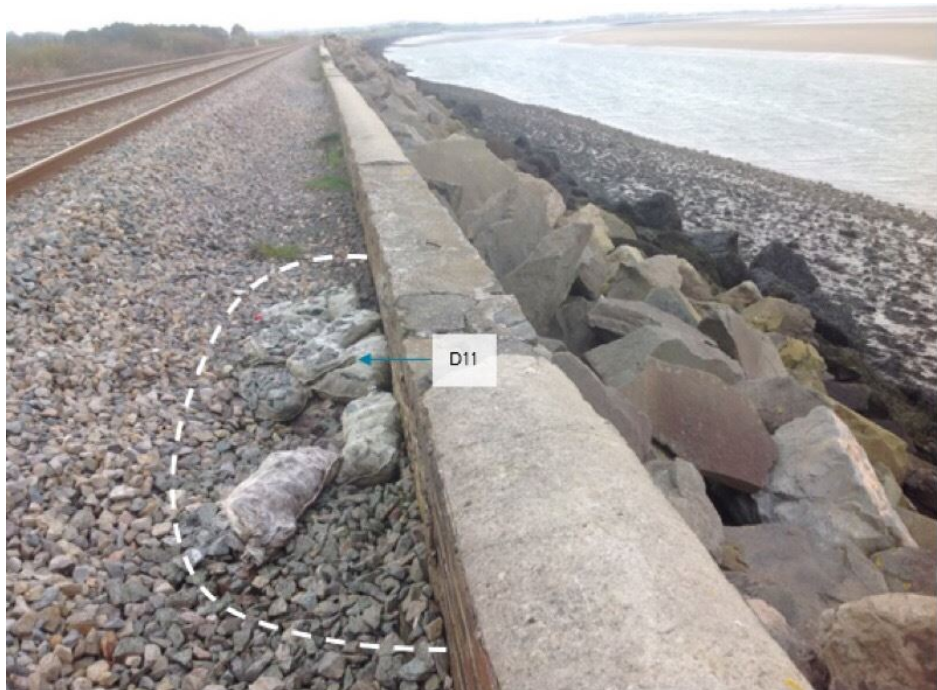
**Photo number: 60**

**Description:** Evidence of possible subsidence on the embankment crest. Indication of early stages of more severe failure mechanisms. No change between 2019 and 2020 inspections.

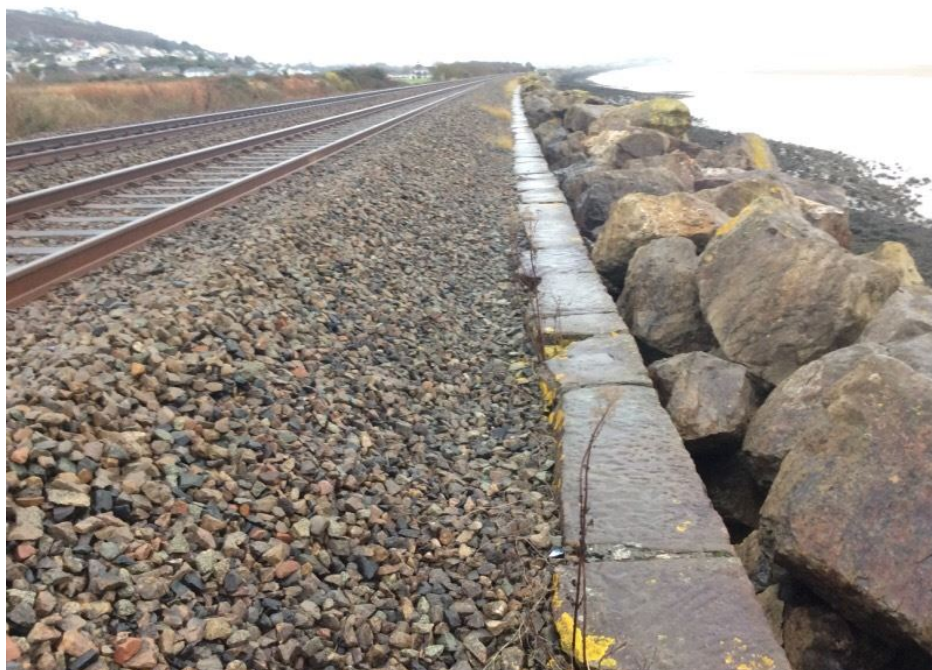
Evidence of possible subsidence on the embankment crest. Indication of early stages of more severe failure mechanisms. No change between 2019 and 2020 inspections.

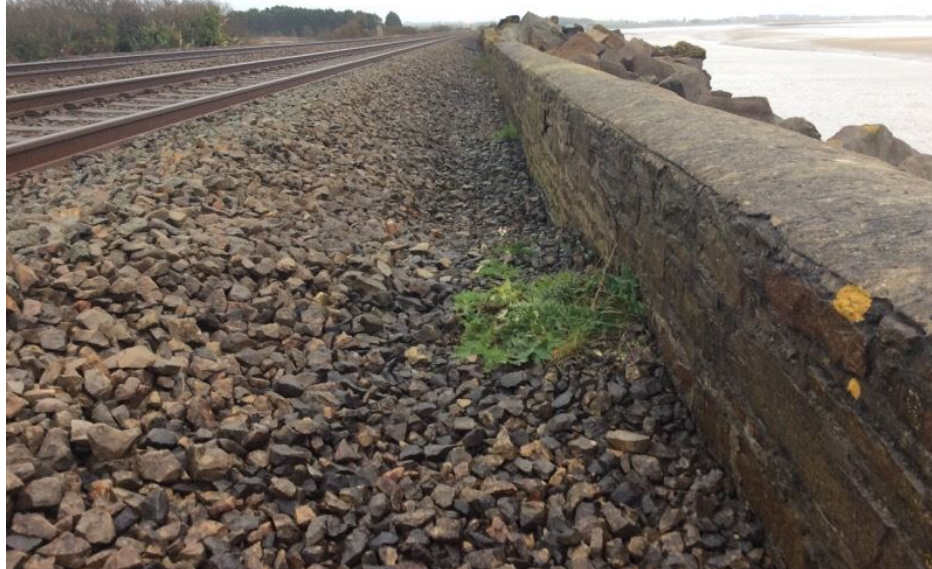
Evidence of possible subsidence on the embankment crest. Indication of early stages of more severe failure mechanisms. No change between 2019 and 2020 inspections.

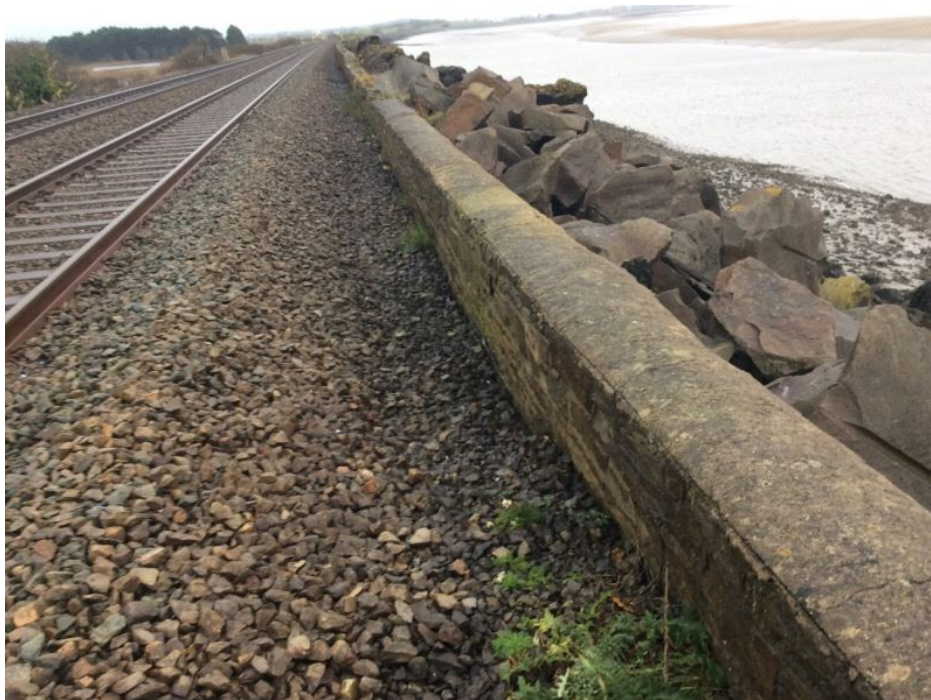
Evidence of possible subsidence on the embankment crest. Indication of early stages of more severe failure mechanisms. No change between 2019 and 2020 inspections.

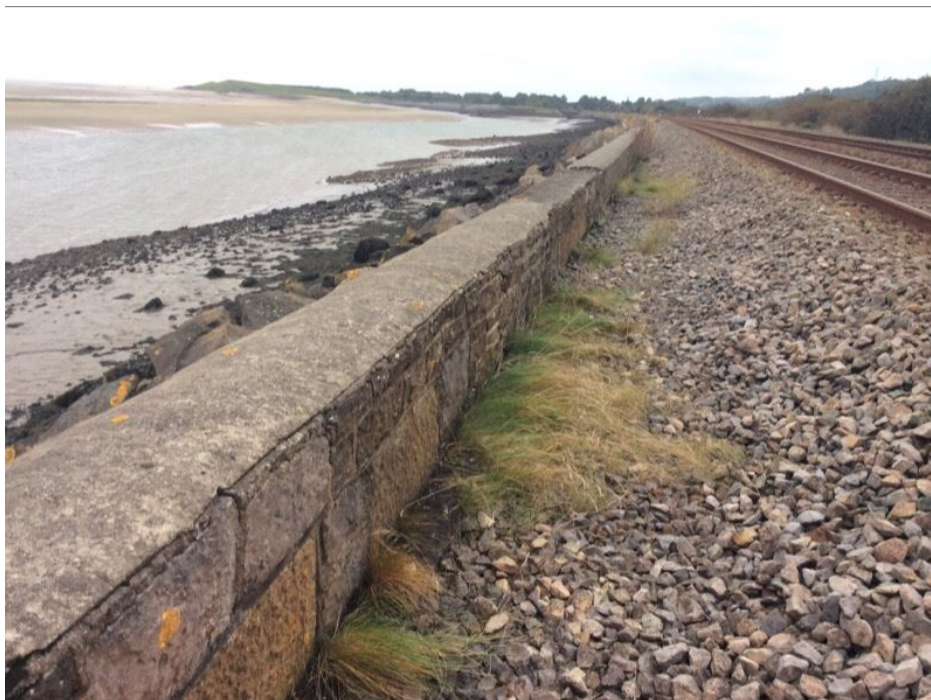
Evidence of possible subsidence on the embankment crest. Indication of early stages of more severe failure mechanisms. No change between 2019 and 2020 inspections.

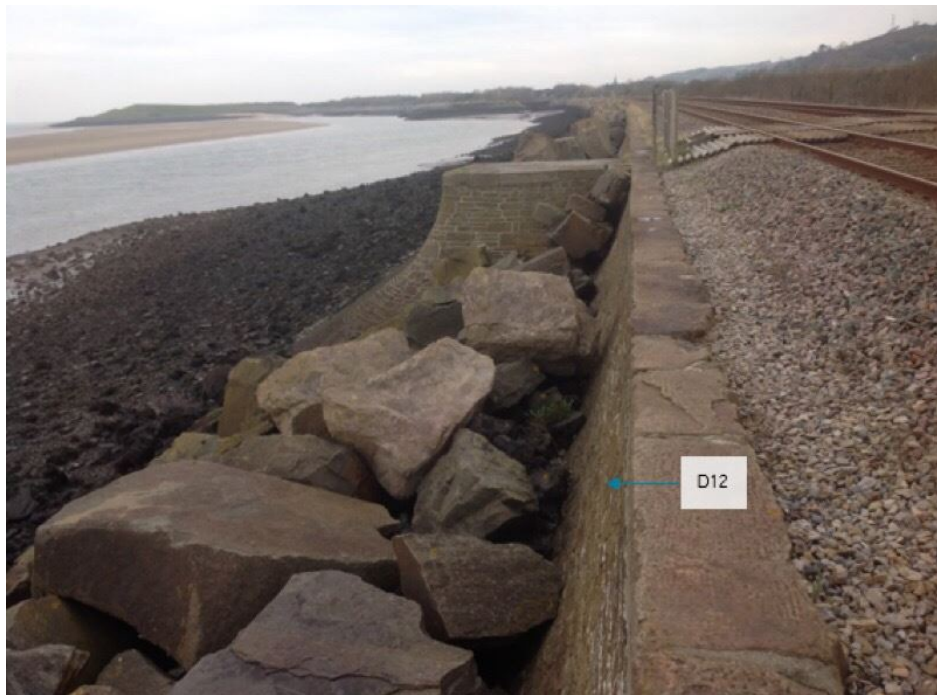
**Photo number: 61**

**Description:** Isolated lack of rock armour. Masonry wall exposed to increased wave loading. No change between 2019 and 2020 inspections.

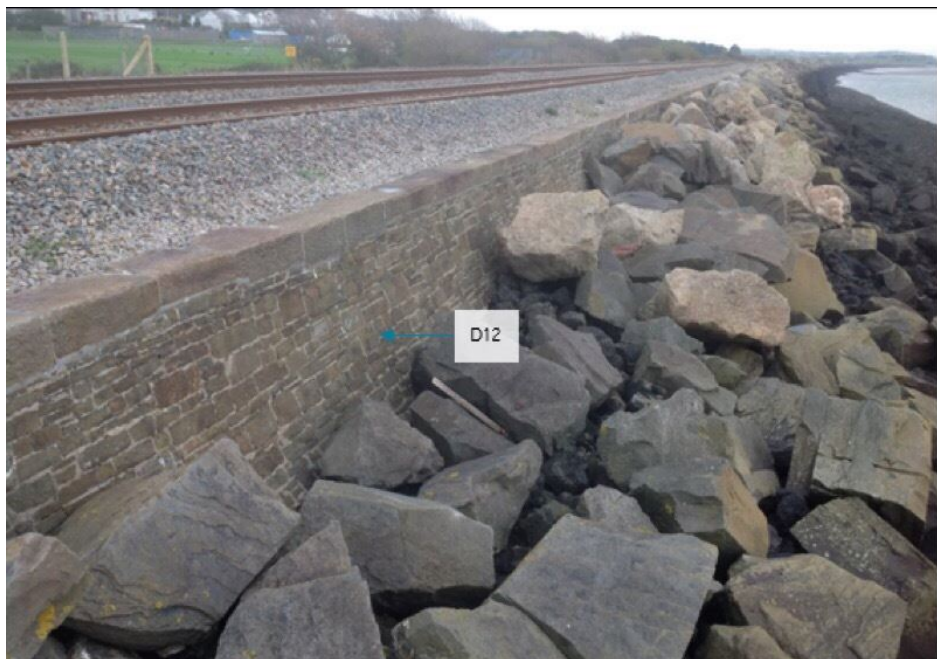
**Photo number: 62**

**Description:** Isolated lack of rock armour. Masonry wall exposed to increased wave loading. No change between 2019 and 2020 inspections.

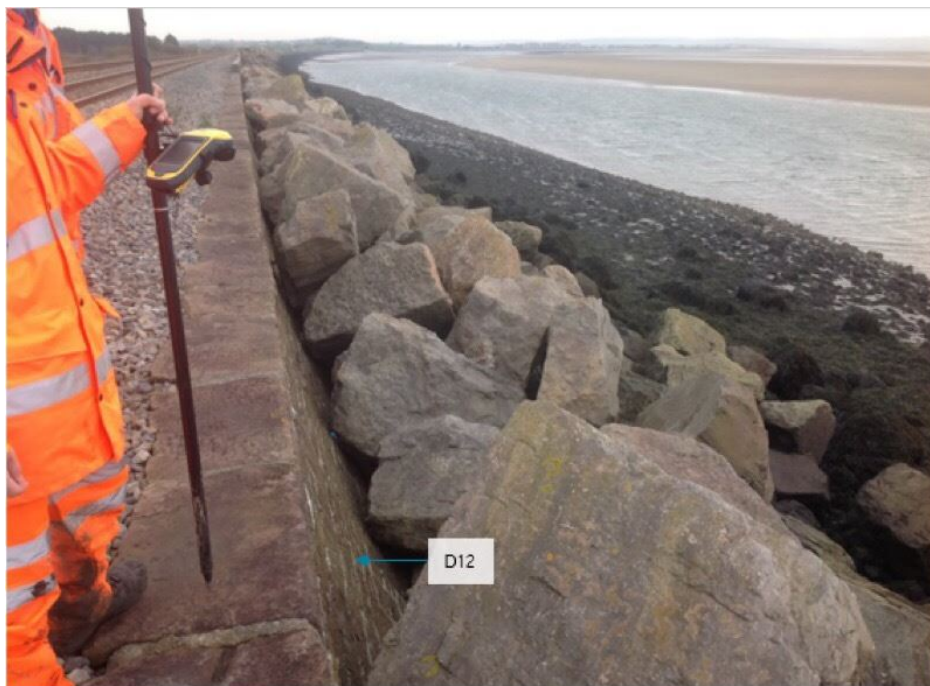
**Section A**  
**Embankment**  
**Armour**  
**Defect Ref: D12**  
**Description:** Isolated lack of rock armour. Masonry wall exposed to increased wave loading. No change between 2019 and 2020 inspections.  
**Photo number: 63**

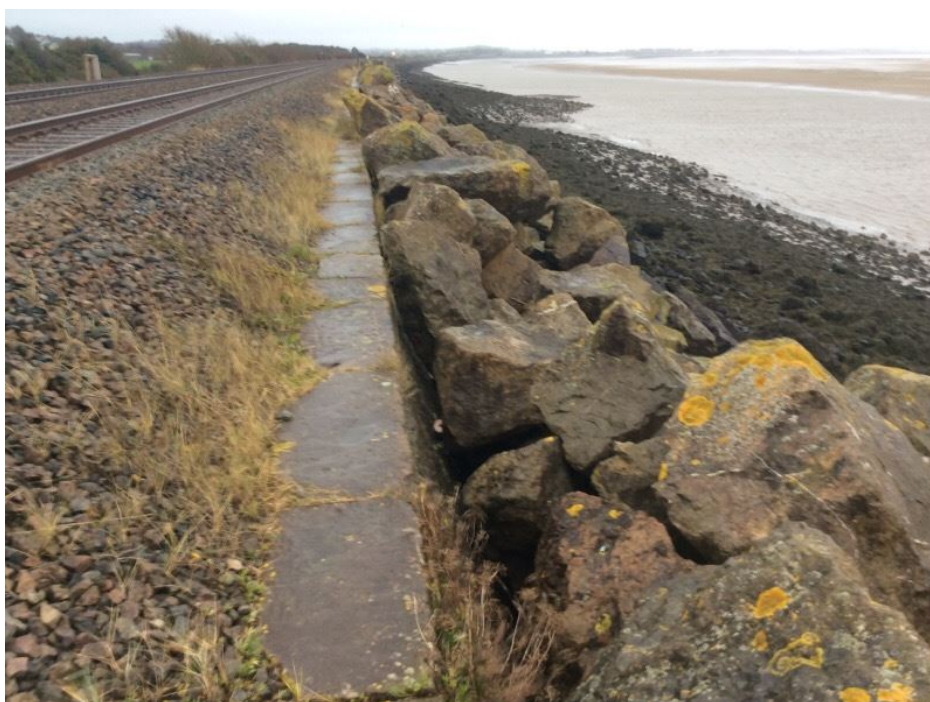
**Section A**  
**Embankment**  
**Armour**  
**Defect Ref: D12**  
**Description:** Isolated lack of rock armour. Masonry wall exposed to increased wave loading. No change between 2019 and 2020 inspections.  
**Photo number: 89**

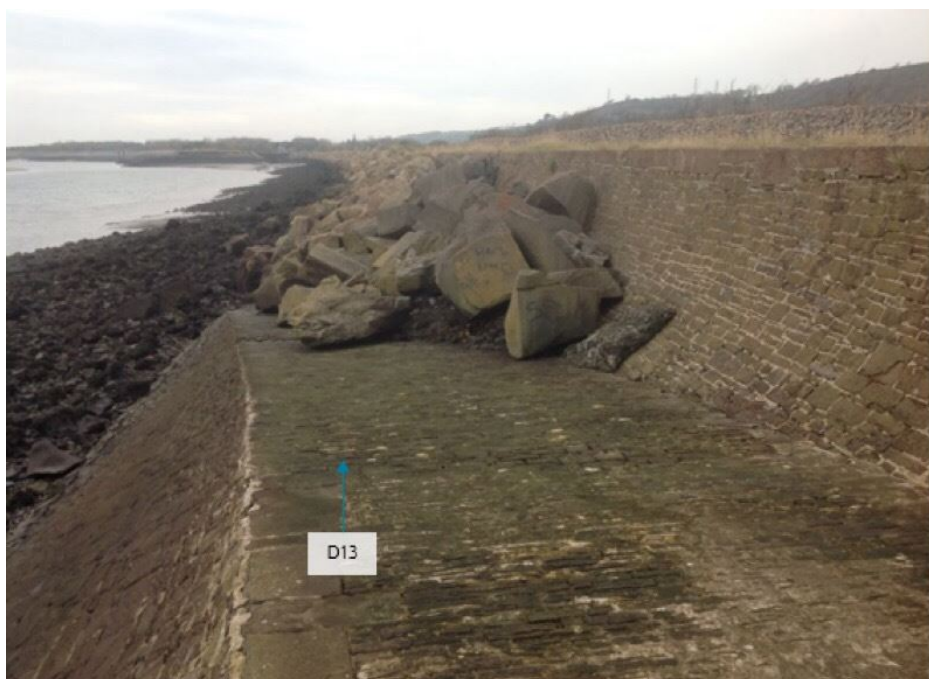
**Section A**  
**Embankment**  
**Armour**  
**Defect Ref: D13**  
**Description:** Algae covered access ramp providing slipping hazard. This defect has been addressed between 2019 and 2020 inspections.  
**Photo number: 64**

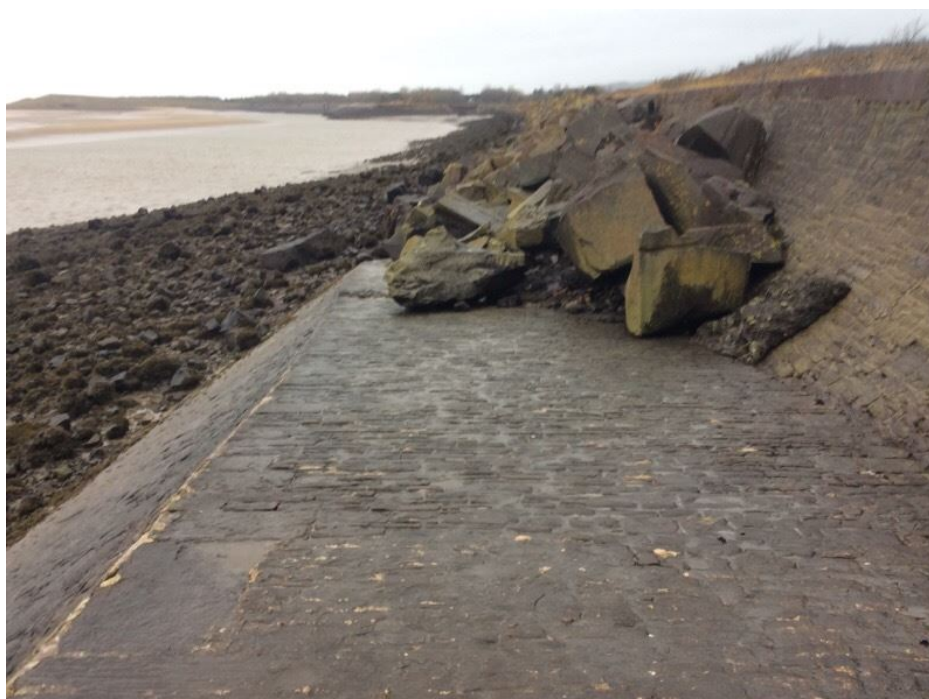
**Section A**  
**Embankment**  
**Armour**  
**Defect Ref: D13**  
**Description:** Algae covered access ramp providing slipping hazard. This defect has been addressed between 2019 and 2020 inspections.  
**Photo number: 95**

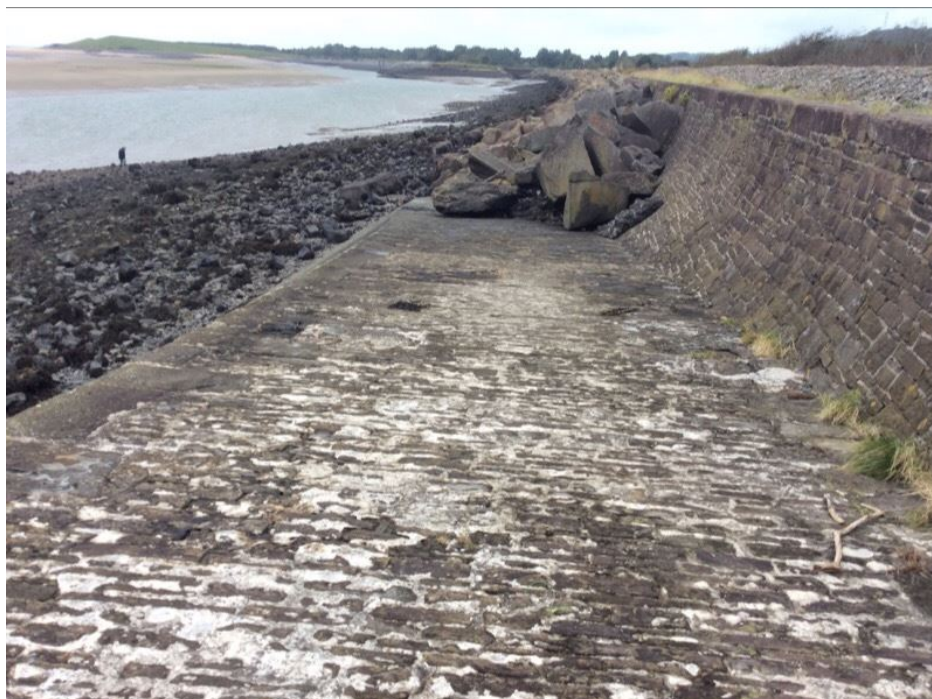
**Description:** Algae covered access ramp providing slipping hazard. This defect has been addressed between 2019 and 2020 inspections.

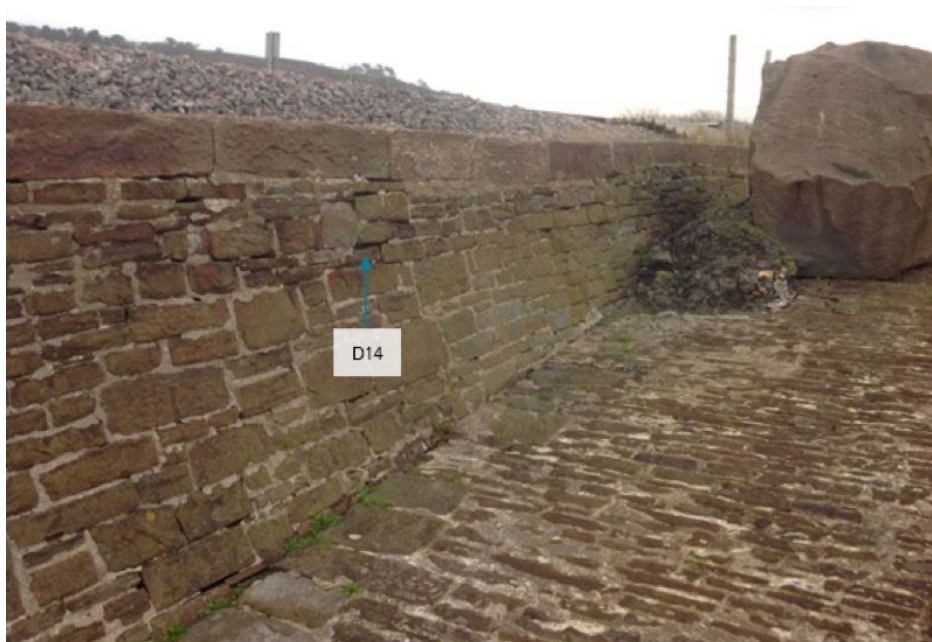
**Photo number: 65**

**Description:** Open joints, if left unrepaired further deterioration of the wall is expected. No change between 2019 and 2020 inspections.

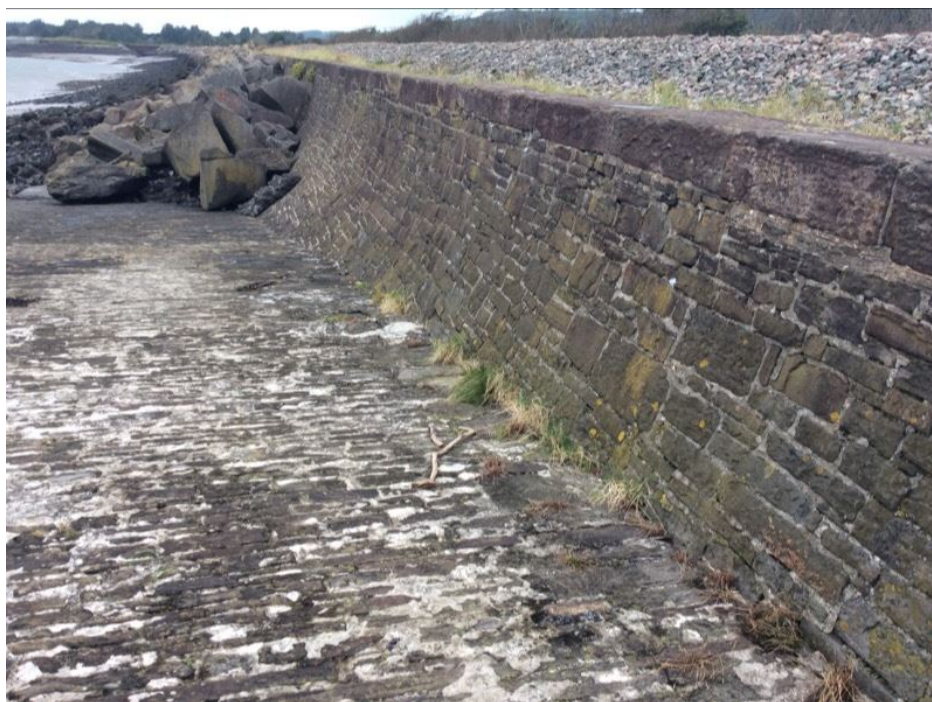
**Section A**  
**Capping Wall**  
**Defect Ref: D14**  
**Description:** Open joints, if left unrepaired further deterioration of the wall is expected. No change between 2019 and 2020 inspections.  
**Photo number: 170**

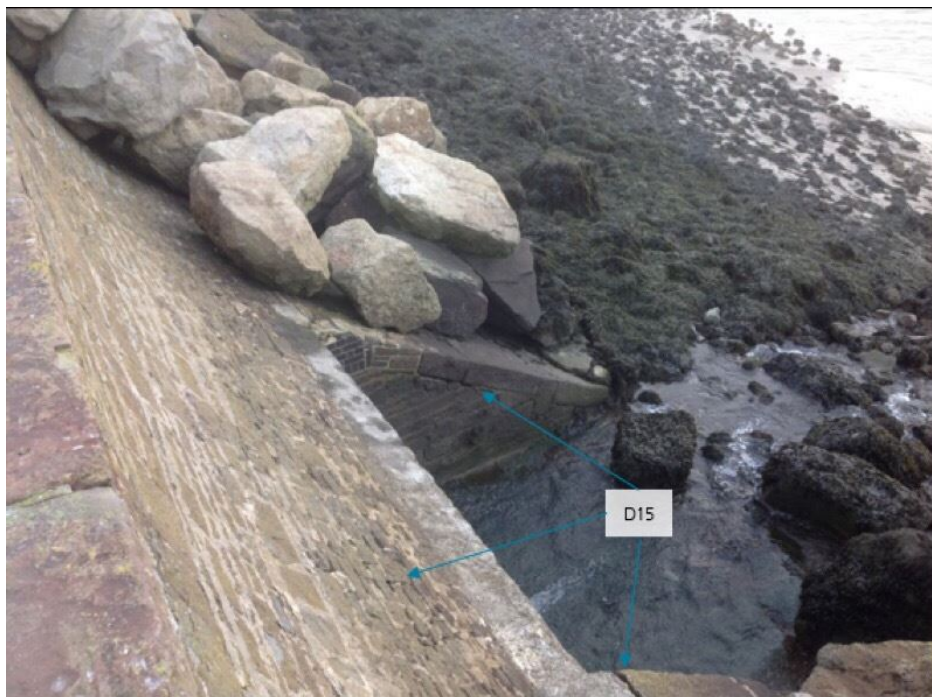
**Photo number: 66**

**Description:** Open joints, if left unrepaired further deterioration of the wall is expected. Between 2014 and 2020 this defect has been repaired.

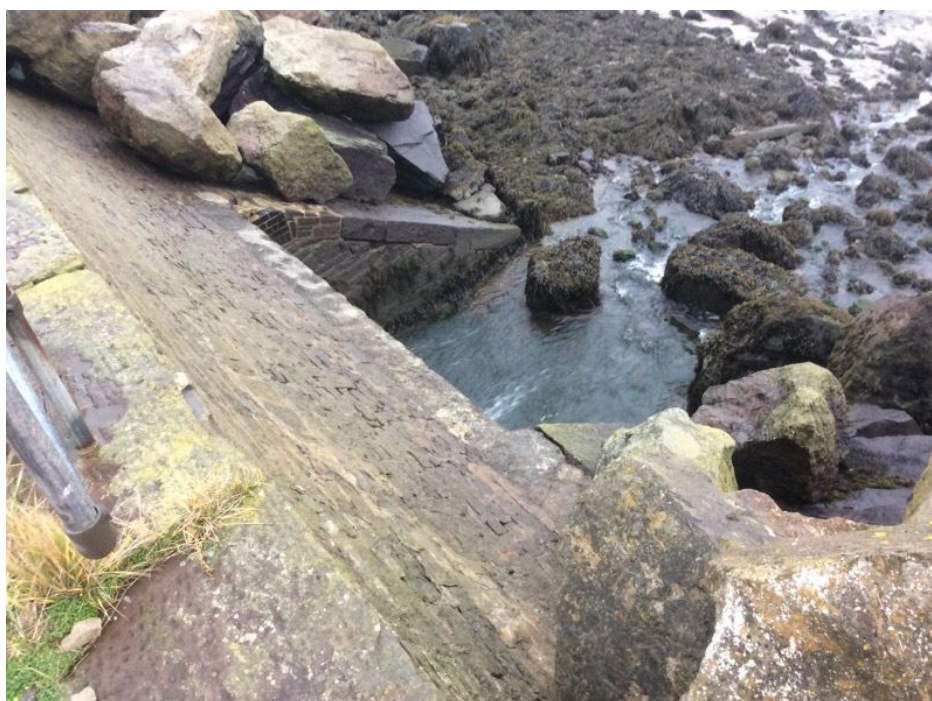
**Description:** Open joints, if left unrepaired further deterioration of the wall is expected. Between 2014 and 2020 this defect has been repaired.

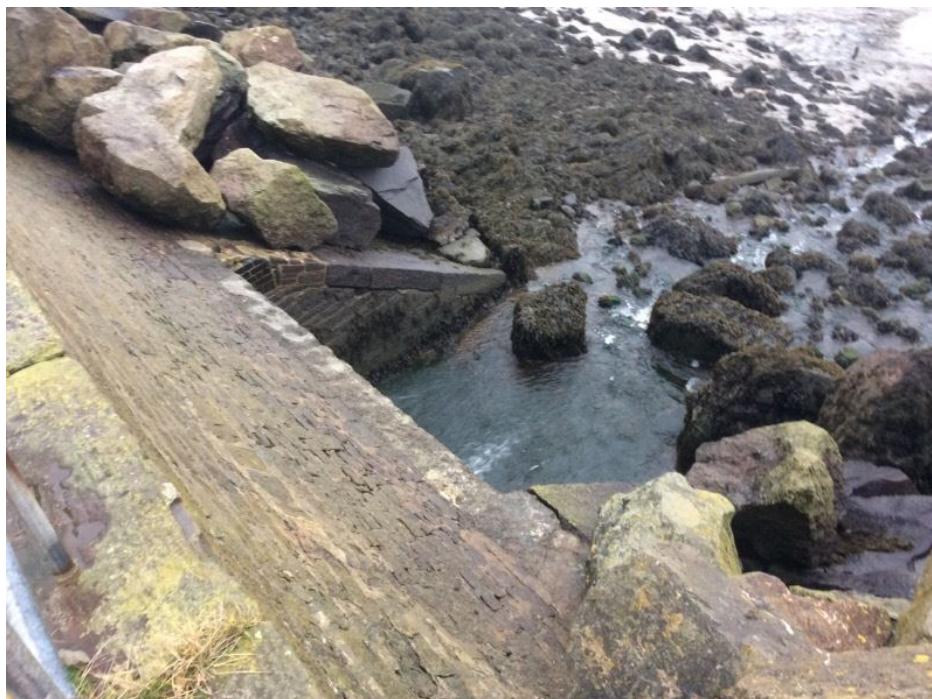
**Description:** Open joints, if left unrepaired further deterioration of the wall is expected. Between 2014 and 2020 this defect has been repaired.

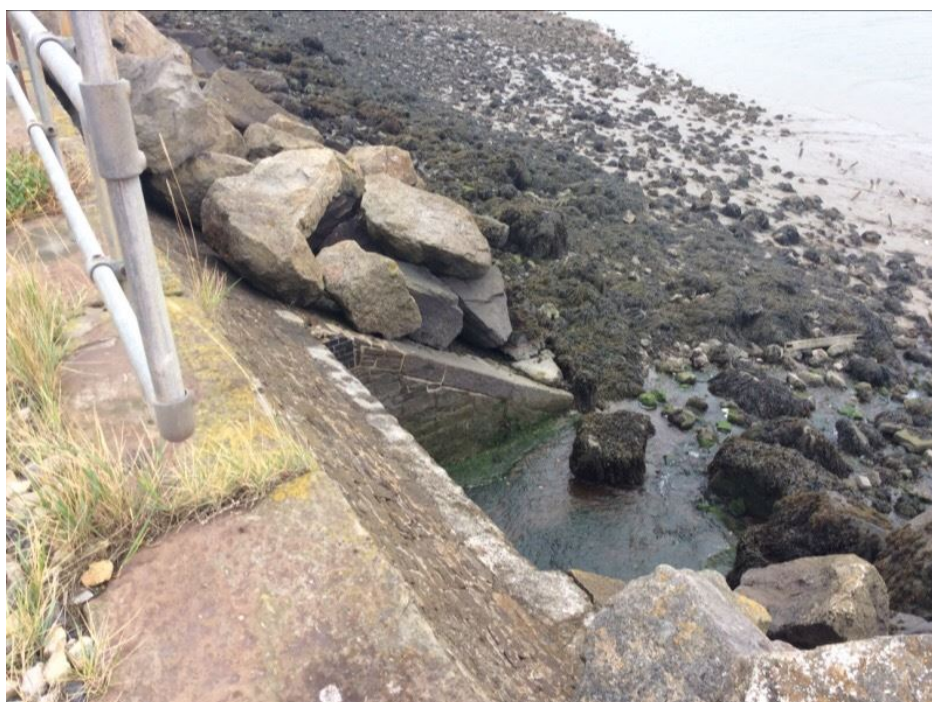
**Description:** Open joints, if left unrepaired further deterioration of the wall is expected. Between 2014 and 2020 this defect has been repaired.

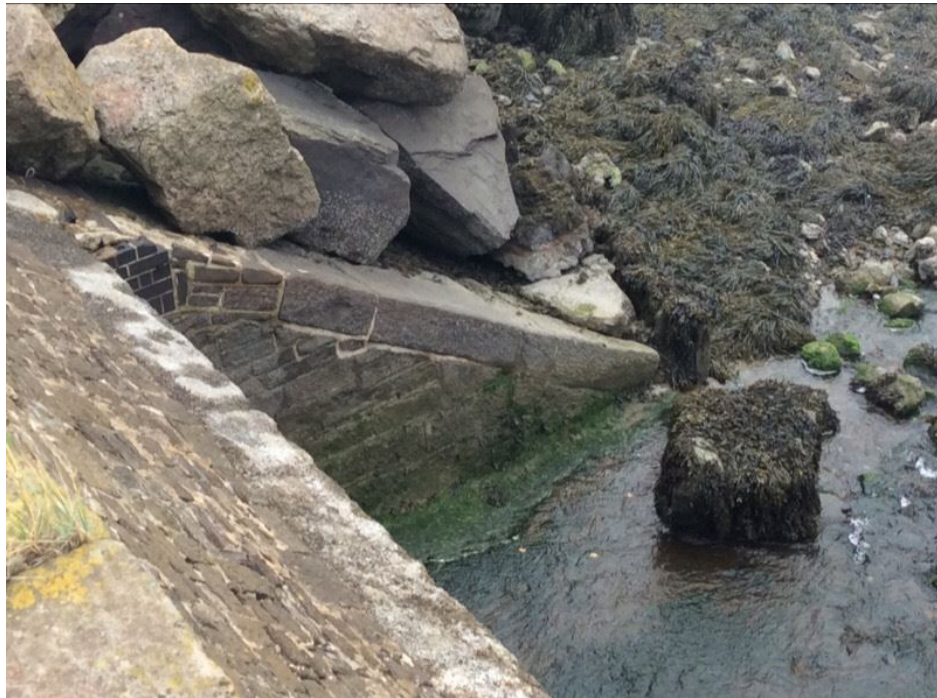
**Description:** Open joints, if left unrepaired further deterioration of the wall is expected. Between 2014 and 2020 this defect has been repaired.

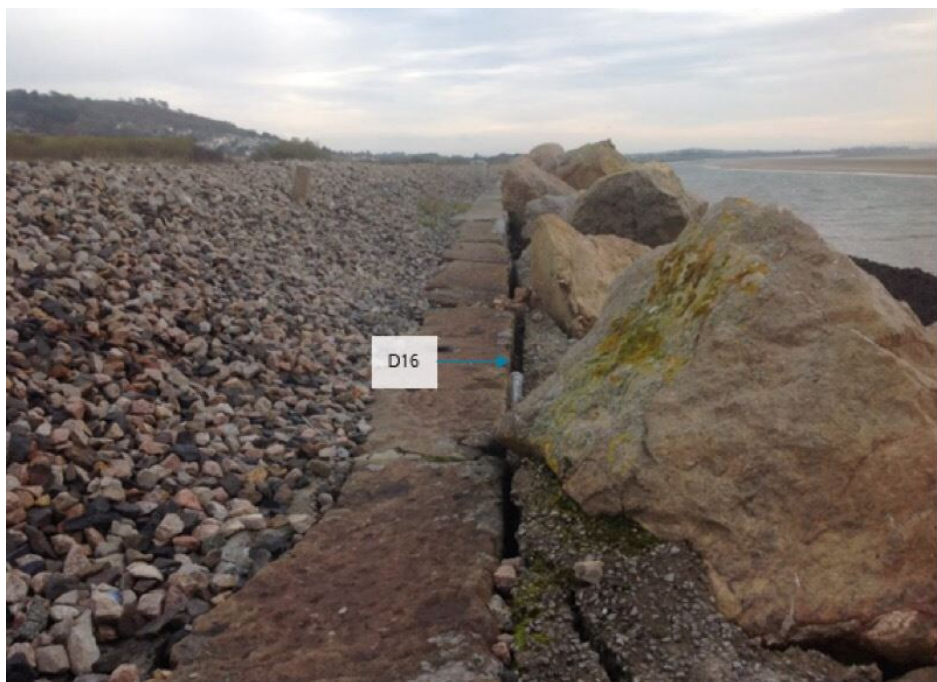
**Photo number: 67**

**Description:** Signs of possible subsidence on the embankment armour. Indication of early stages of more severe failure mechanisms. No change between 2019 and 2020 inspections.

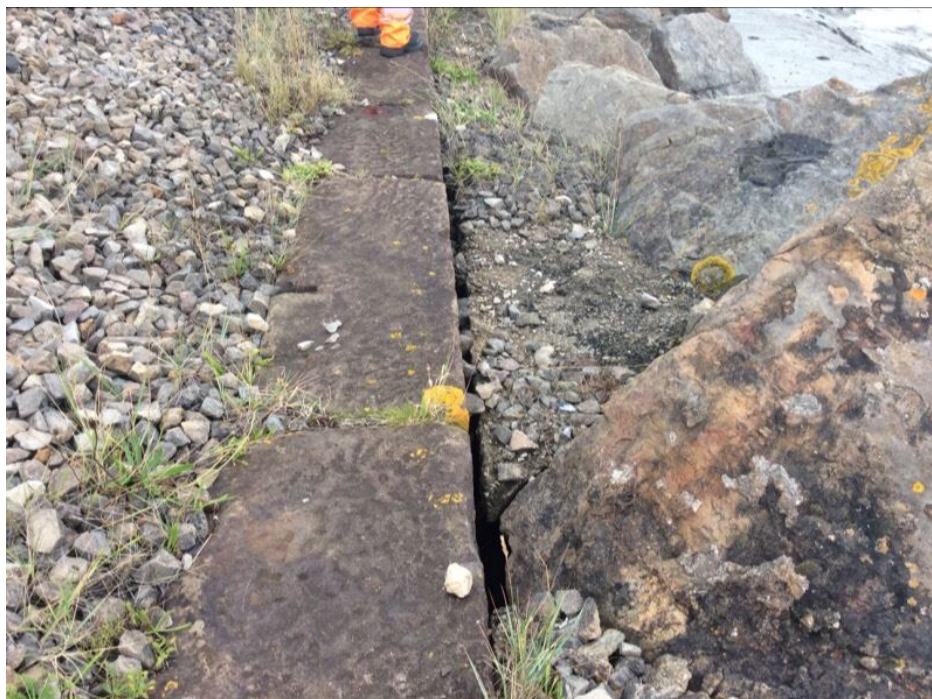
**Description:** Signs of possible subsidence on the embankment armour. Indication of early stages of more severe failure mechanisms. No change between 2019 and 2020 inspections.

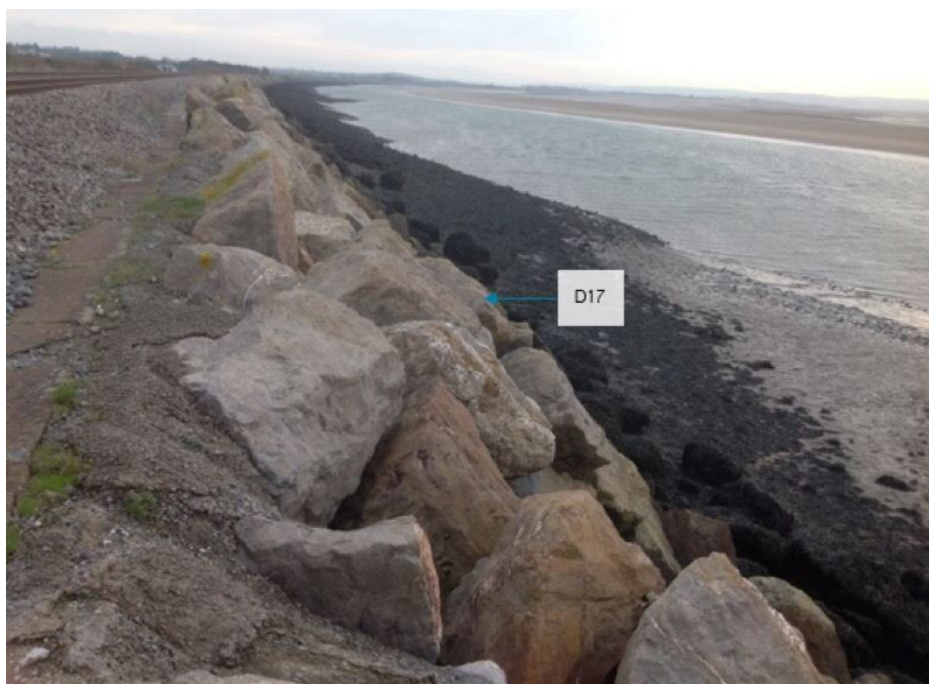
**Section A**  
**Embankment**  
**Armour**  
**Defect Ref: D17**  
**Description:**  
Embankment slope  
too steep by design  
standards. No change  
between 2019 and  
2020 inspections.  
**Photo number: 68**

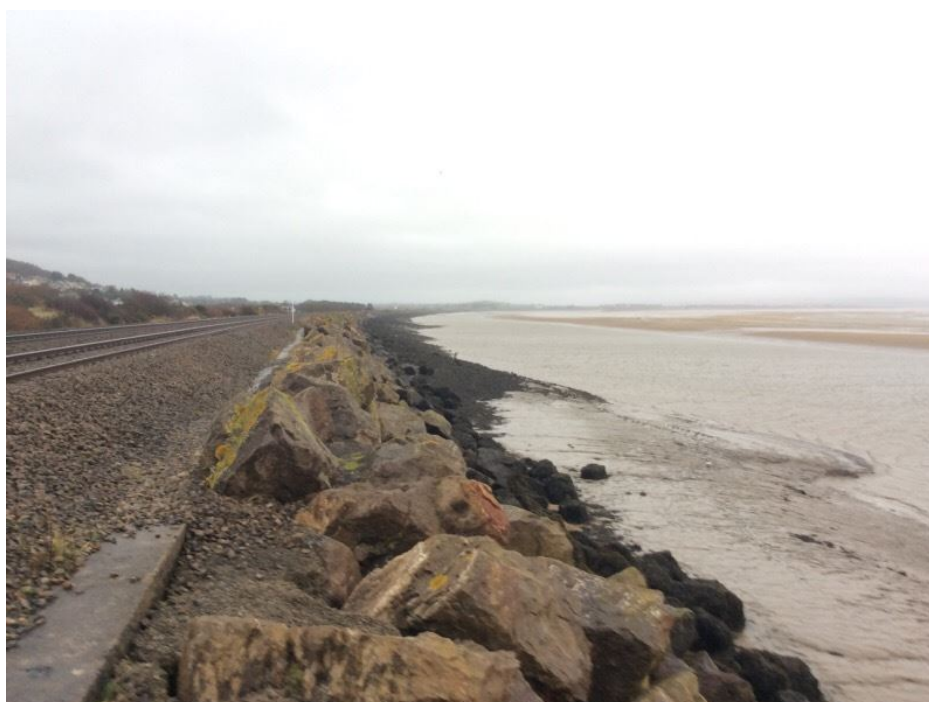
**Section A**  
**Embankment**  
**Armour**  
**Defect Ref: D17**  
**Description:**  
Embankment slope  
too steep by design  
standards. No change  
between 2019 and  
2020 inspections.  
**Photo number: 80**

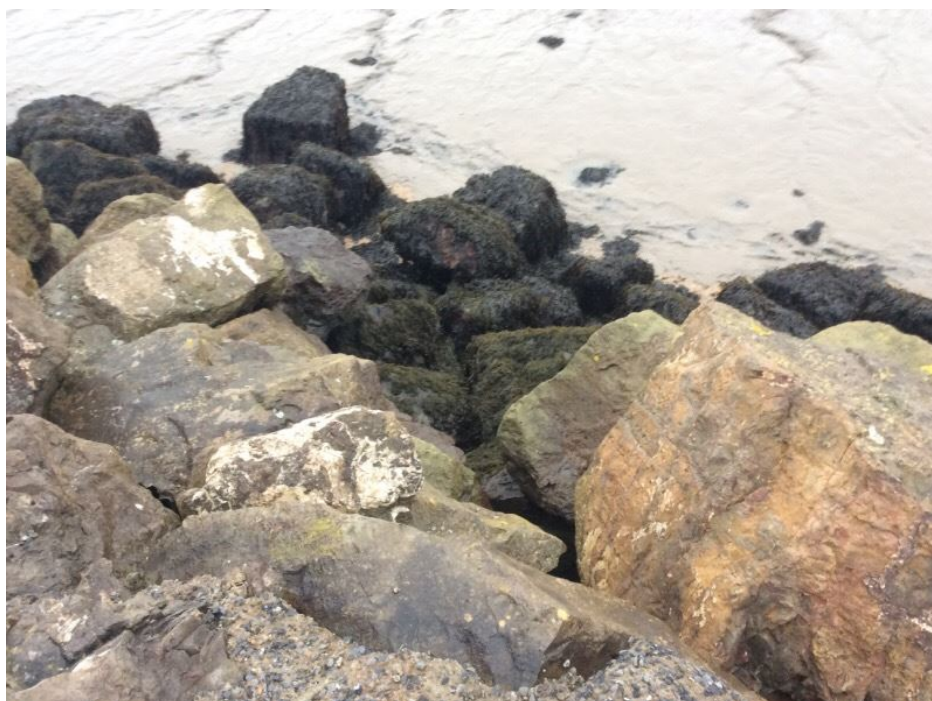
**Section A**  
**Embankment**  
**Armour**  
**Defect Ref: D17**  
**Description:**  
Embankment slope  
too steep by design  
standards. No change  
between 2019 and  
2020 inspections.  
**Photo number: 81**

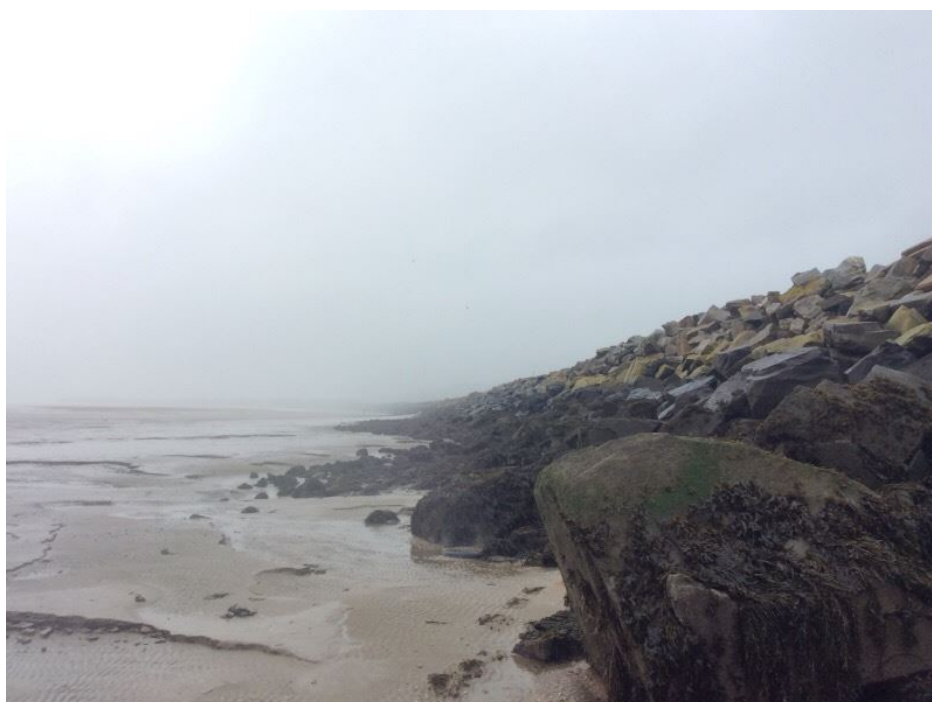
**Section A**  
**Embankment**  
**Armour**  
**Defect Ref: D17**  
**Description:**  
Embankment slope  
too steep by design  
standards. No change  
between 2019 and  
2020 inspections.  
**Photo number: 117**

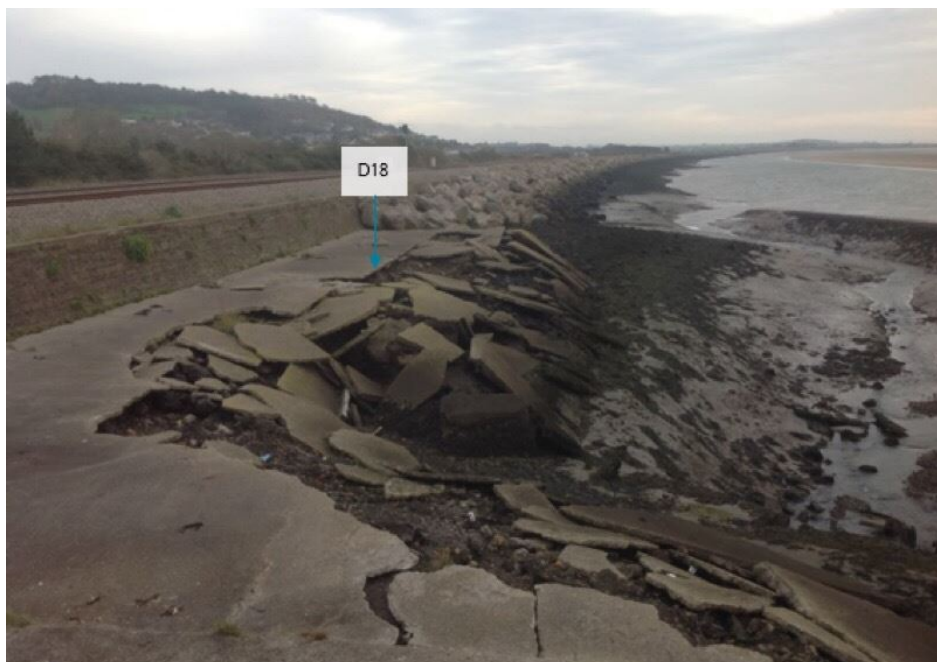
**Photo number: 69**

**Description:** Very poor condition of defence tie-in. Slightly increased in severity as the defect has further deteriorated between the 2019 and 2020 inspections.

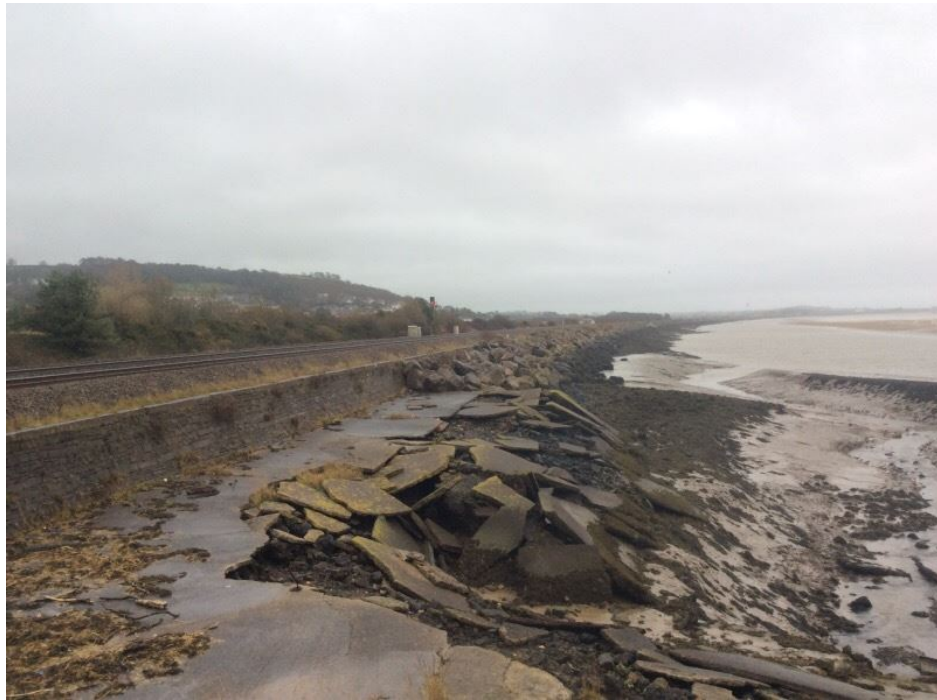
**Description:** Very poor condition of defence tie-in. Slightly increased in severity as the defect has further deteriorated between the 2019 and 2020 inspections.

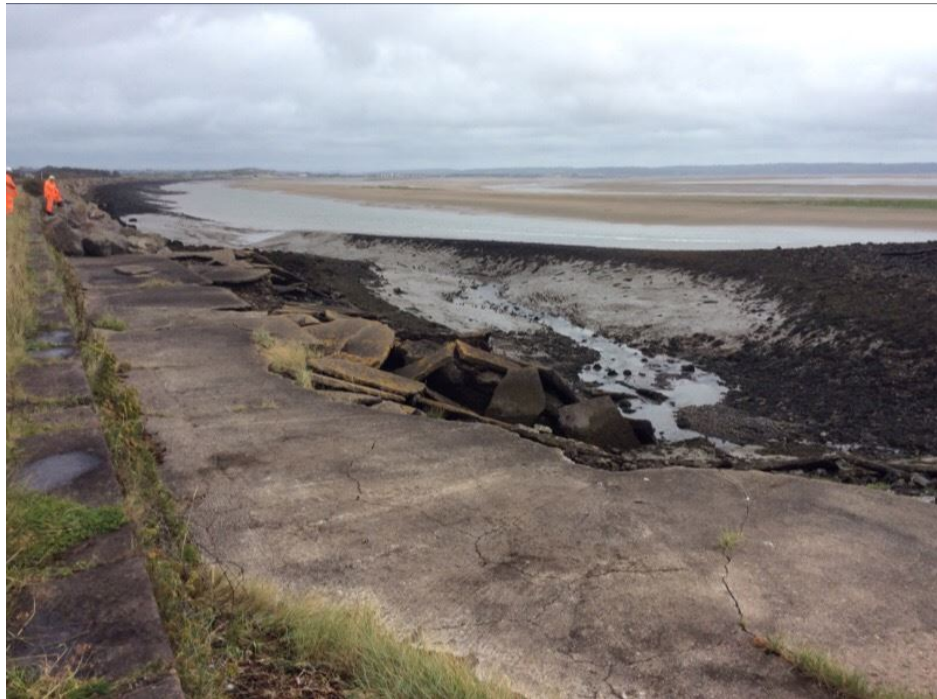
**Description:** Very poor condition of defence tie-in. Slightly increased in severity as the defect has further deteriorated between the 2019 and 2020 inspections.

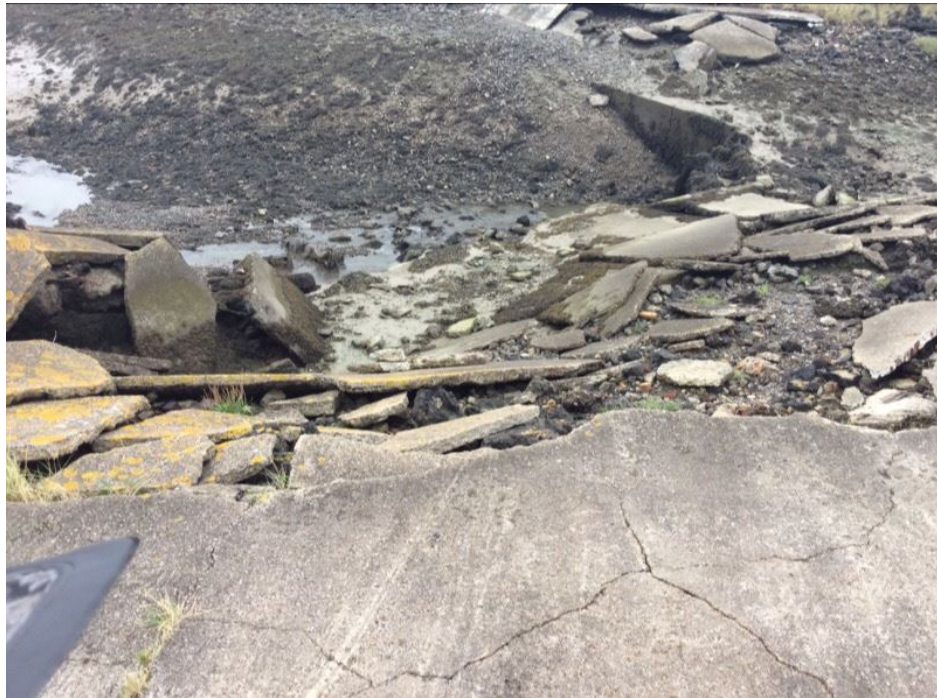
**Description:** Very poor condition of defence tie-in. Slightly increased in severity as the defect has further deteriorated between the 2019 and 2020 inspections.
