| Location Plan: | | Pwll Sea Wall | |
| | | Structure Reference: | 226 21.5 |

# COASTAL ASSET CONDITION SURVEY REPORT

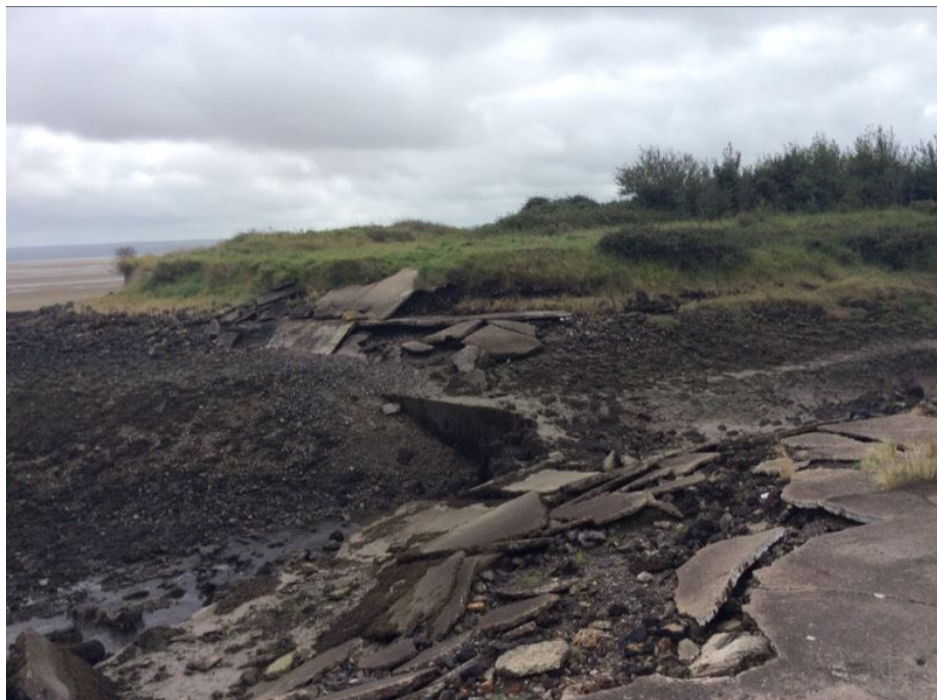
**Description:** Very poor condition of defence tie-in. Slightly increased in severity as the defect has further deteriorated between the 2019 and 2020 inspections.

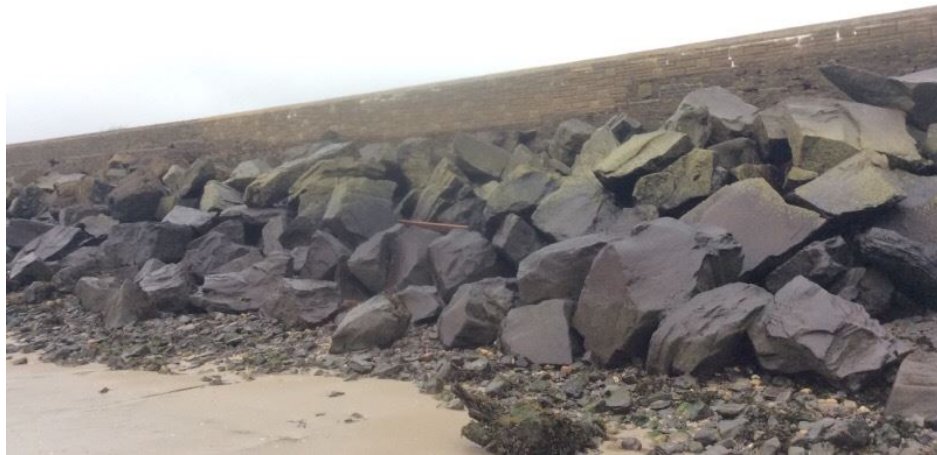
**Description:** Failed  
parapet wall sections.  
This defect has been  
repaired between  
2014 and 2019.

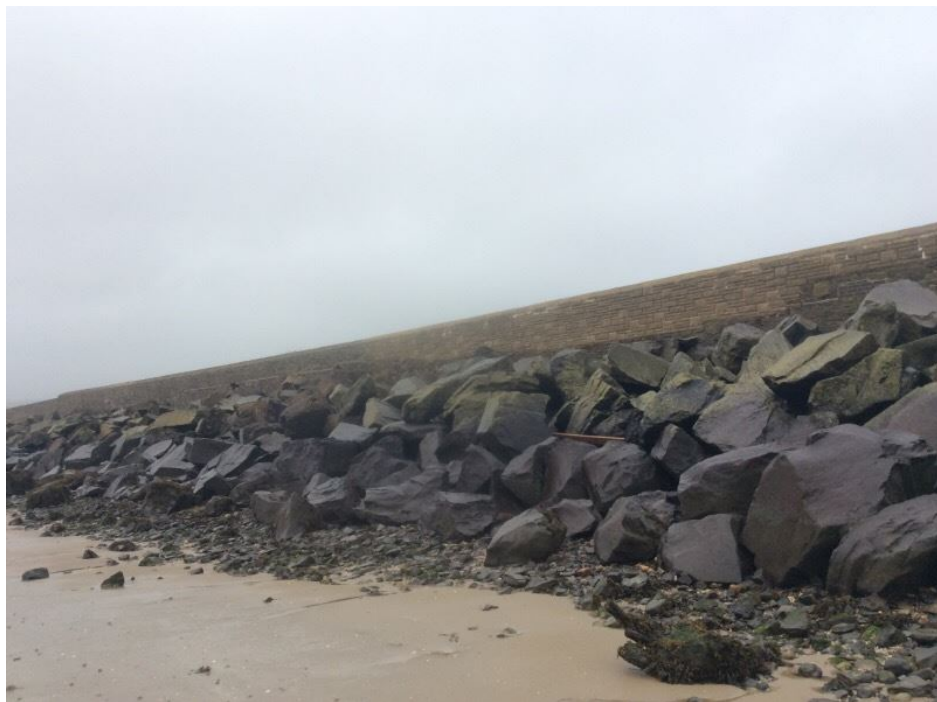
**Section A  
Embankment  
Armour**

**Defect Ref: D19**

**Description:** Failed  
parapet wall sections.  
This defect has been  
repaired between  
2014 and 2019.

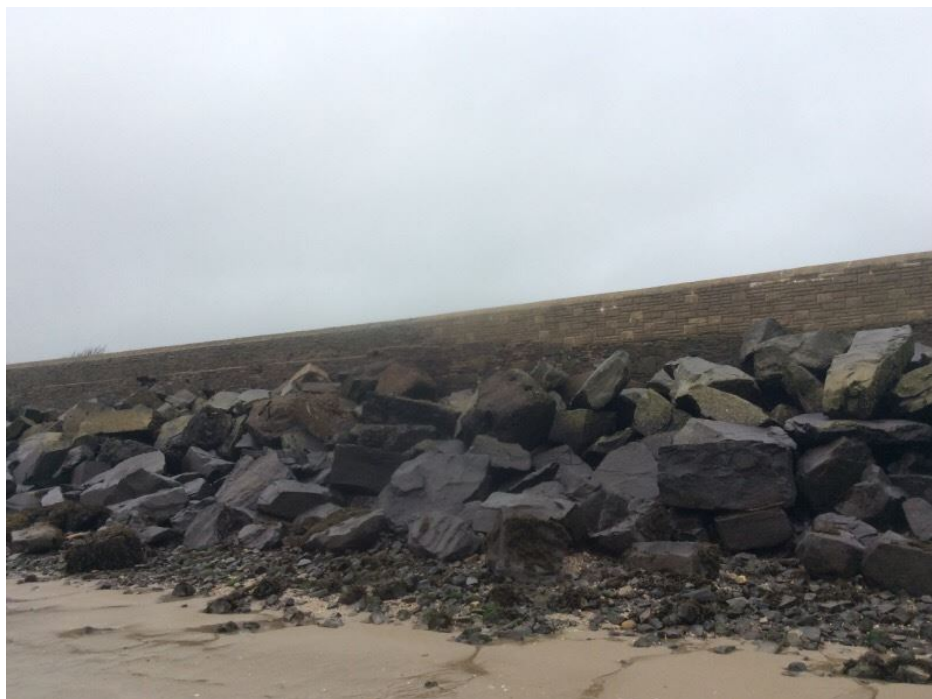
**Section A  
Embankment  
Armour**

**Defect Ref: D19**

**Description:** Failed  
parapet wall sections.  
This defect has been  
repaired between  
2014 and 2019.

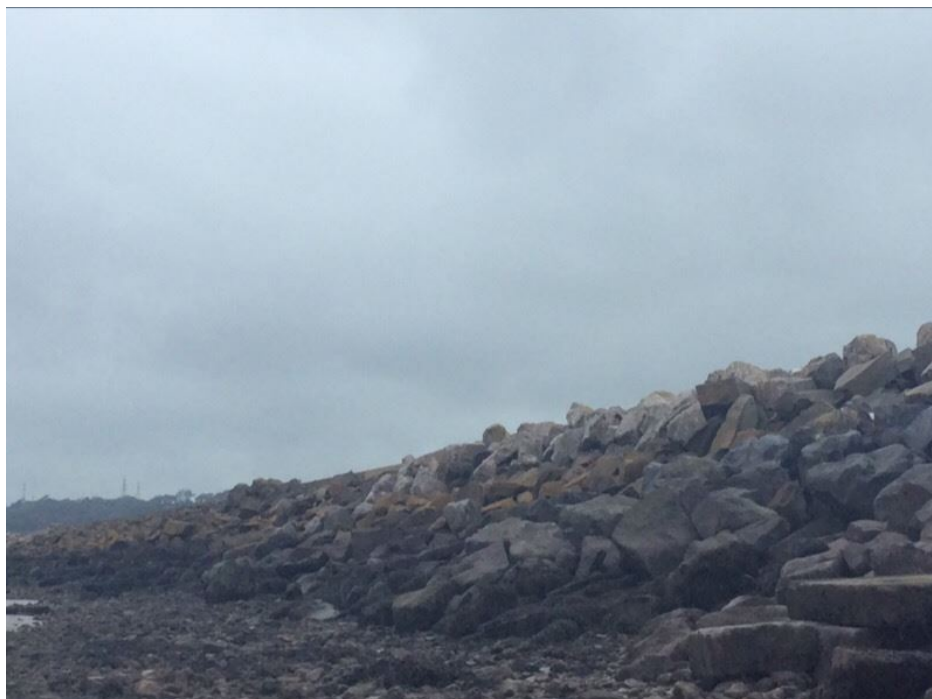
**Section A**  
**Embankment**  
**Armour**  
**Defect Ref: D19**  
**Description:** Failed  
parapet wall sections.  
This defect has been  
repaired between  
2014 and 2019.  
**Photo number: 202**

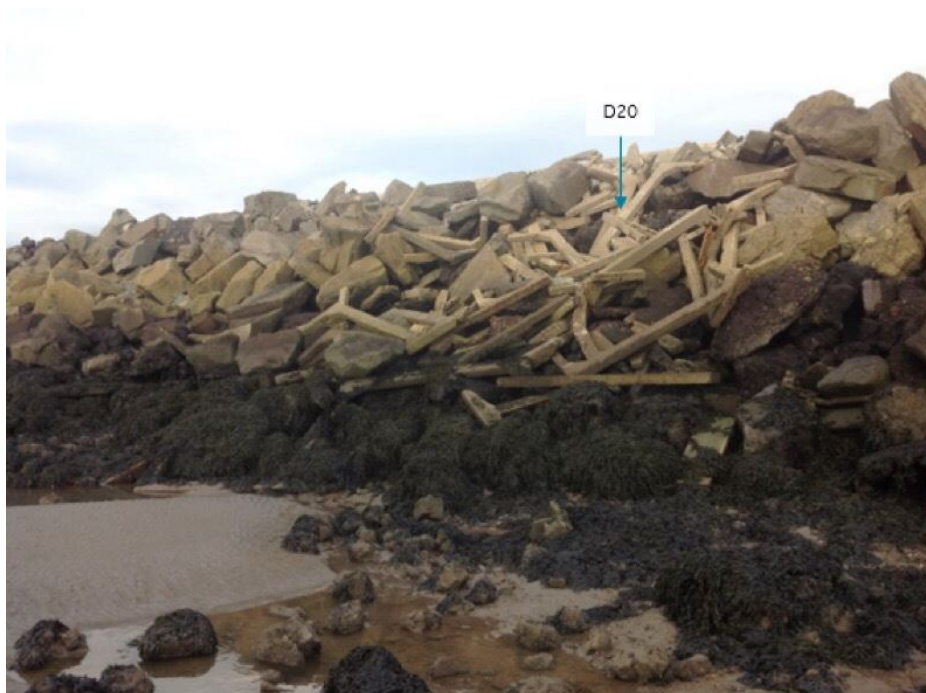
**Section A**  
**Embankment**  
**Armour**  
**Defect Ref: D20**  
**Description:** Non-  
standard and  
ineffective armour  
units. No change  
between 2019 and  
2020 inspections.  
**Photo number: 70**

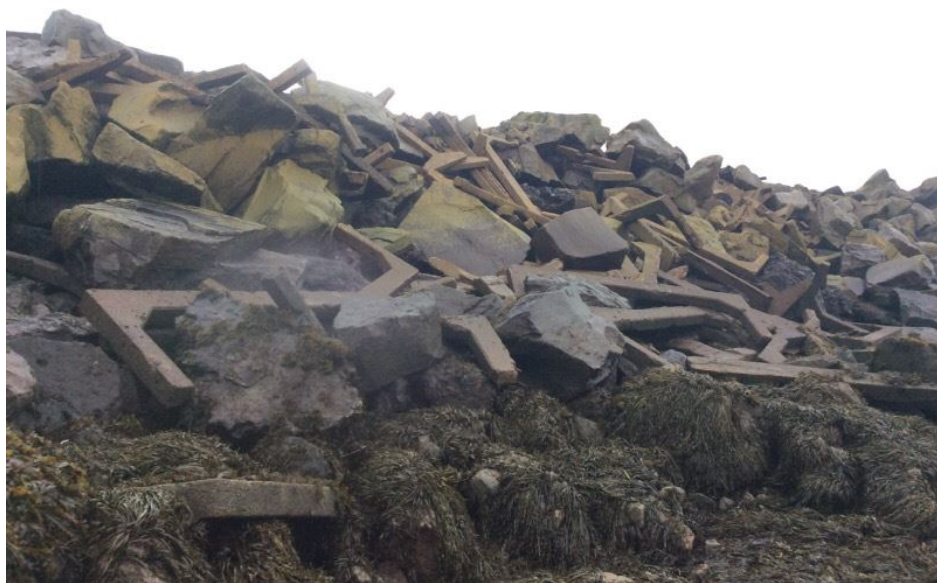
**Section A**  
**Embankment**  
**Armour**  
**Defect Ref: D20**  
**Description:** Non-standard and ineffective armour units. No change between 2019 and 2020 inspections.  
**Photo number: 116**

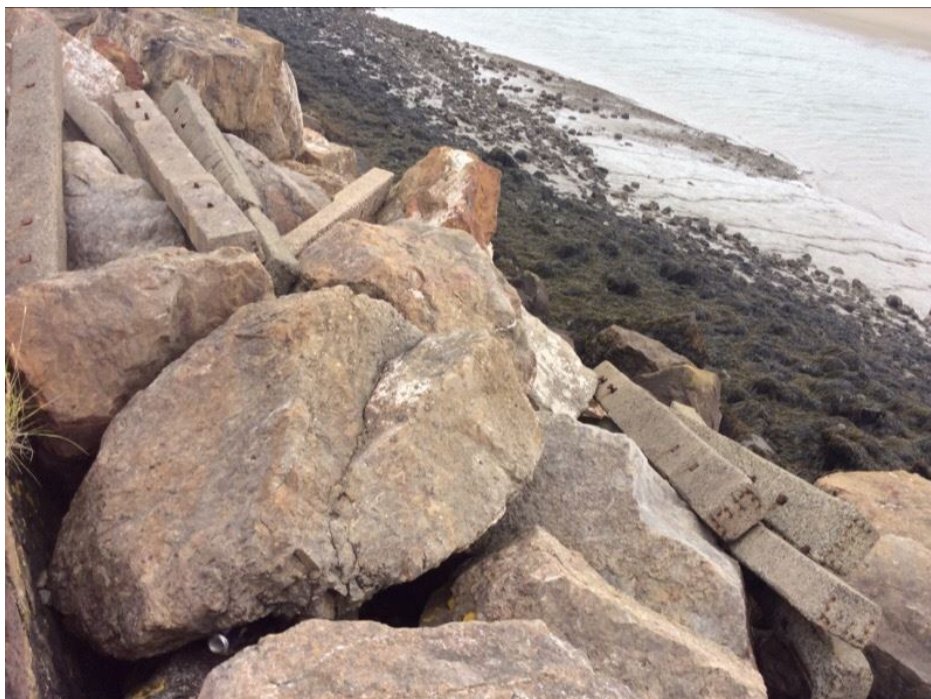
**Section A**  
**Embankment**  
**Armour**  
**Defect Ref: D20**  
**Description:** Non-standard and ineffective armour units. No change between 2019 and 2020 inspections.  
**Photo number: 159**

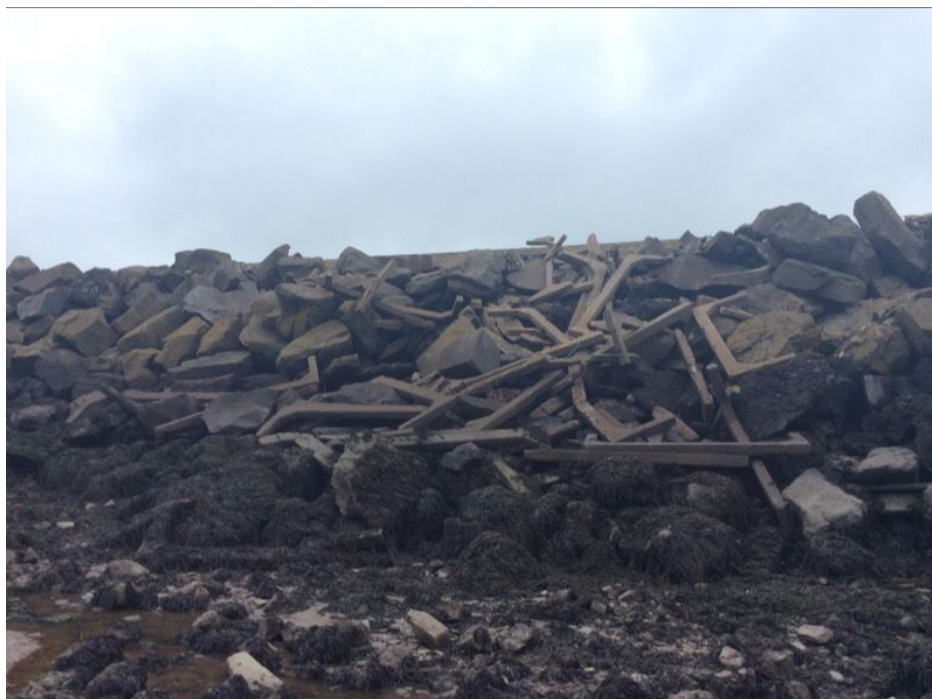
**Section A  
Embankment  
Armour  
Defect Ref: D20  
Description:** Non-  
standard and  
ineffective armour  
units. No change  
between 2019 and  
2020 inspections.  
**Photo number: 203**

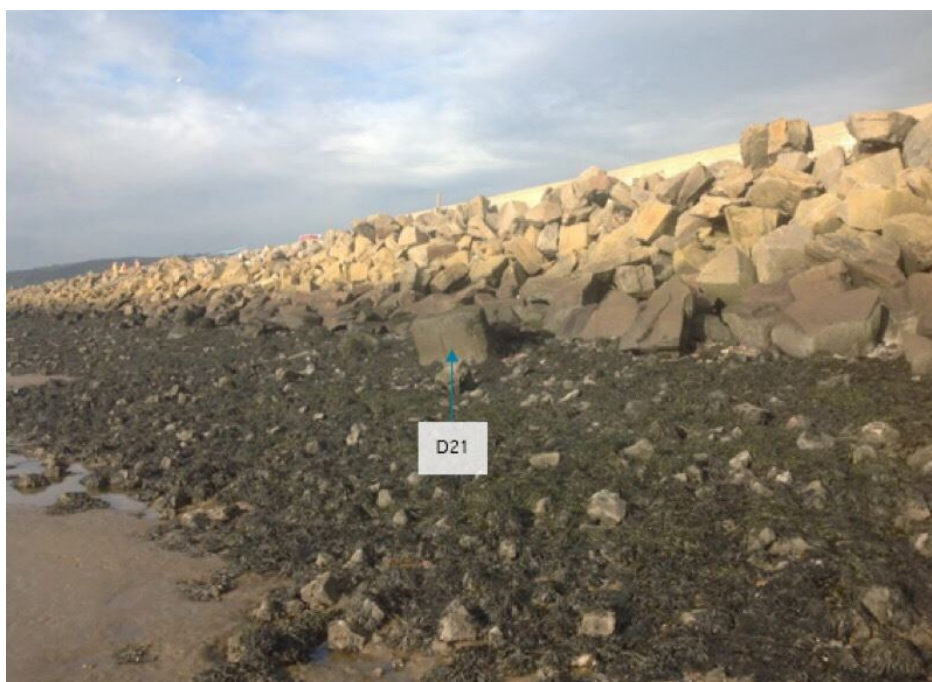
**Section A  
Embankment  
Armour  
Defect Ref: D21  
Description:** Expelled  
rock armour units. No change  
between 2019 and  
2020 inspections.  
**Photo number: 71**

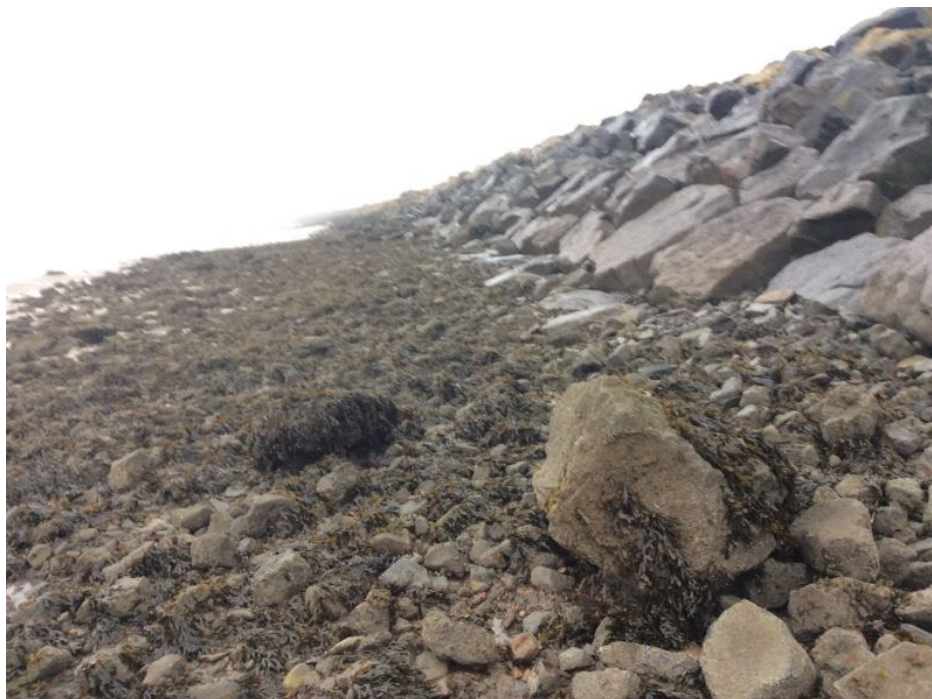
**Section A**  
**Embankment**  
**Armour**  
**Defect Ref: D21**  
**Description:**  
Expelled rock armour  
units. No change  
between 2019 and  
2020 inspections.  
**Photo number: 115**

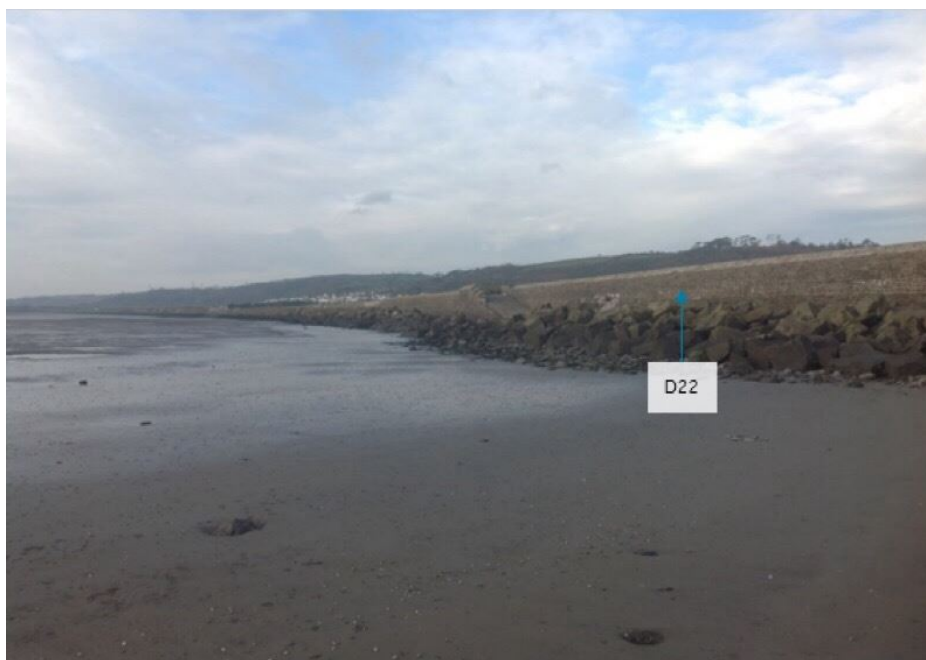
**Section A**  
**Embankment**  
**Armour**  
**Defect Ref: D22**  
**Description:**  
Exposed wall section.  
No change between  
2019 and 2020  
inspections.  
**Photo number: 73**

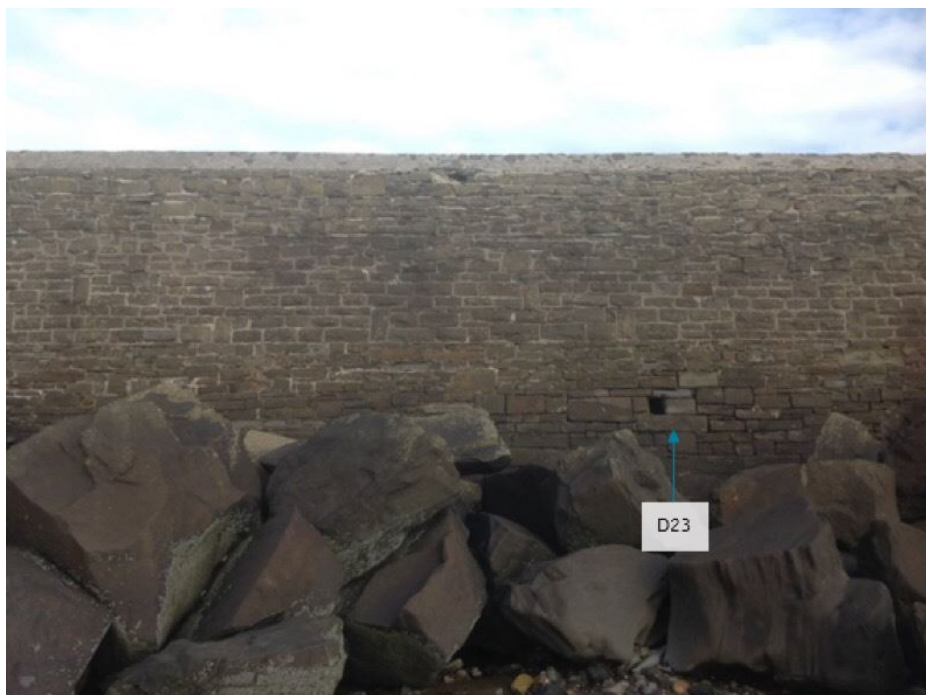
**Section A**  
**Capping Wall**  
**Defect Ref: D23**  
**Description:** Open joints, if left unrepaired further deterioration of the wall is expected. This defect has been repaired between the 2014 and 2020 inspections. However, multiple repointing repairs were found to be broken in 2020.  
**Photo number: 74**

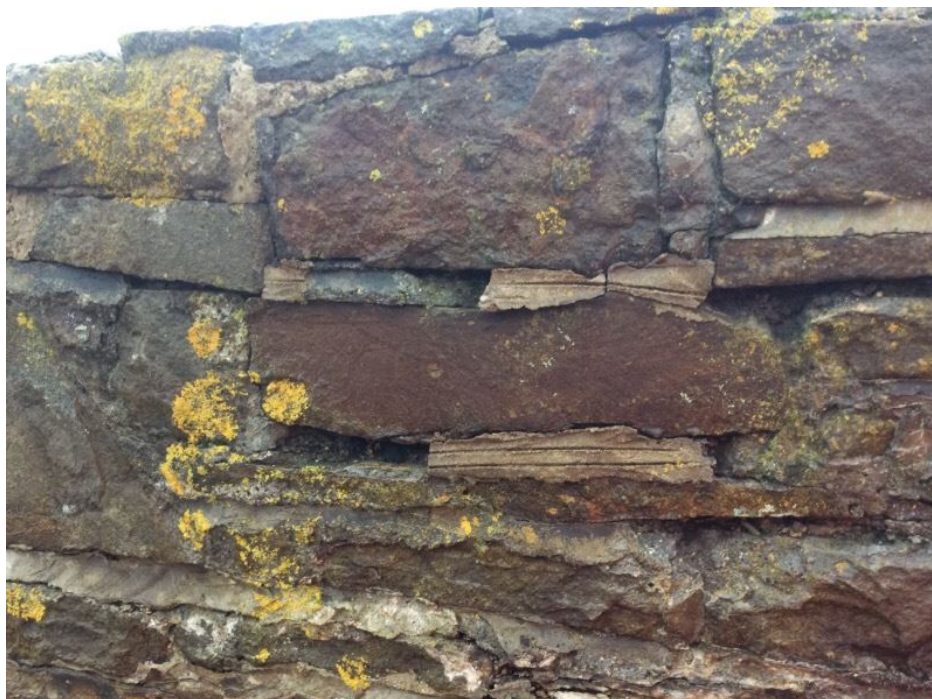
**Section A**  
**Capping Wall**  
**Defect Ref: D23**  
**Description:** Open joints, if left unrepaired further deterioration of the wall is expected. This defect has been repaired between the 2014 and 2020 inspections. However, multiple repointing repairs were found to be broken in 2020.  
**Photo number: 111**

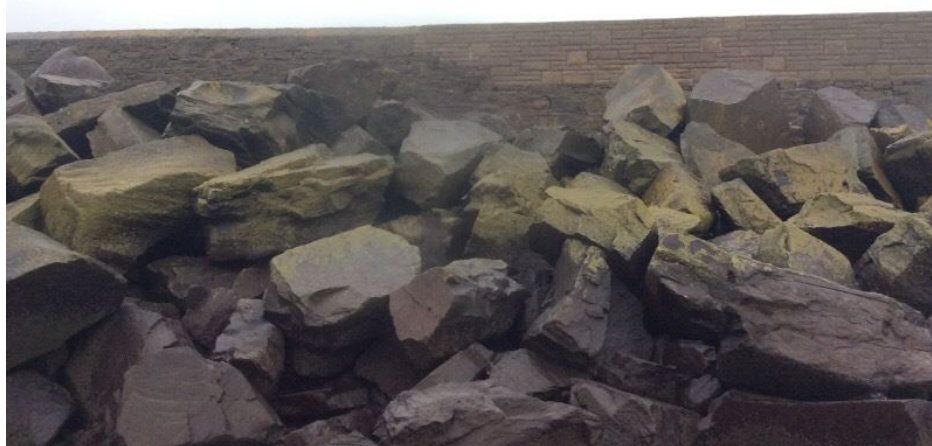
**Section A**  
**Capping Wall**  
**Defect Ref: D23**  
**Description:** Open joints, if left unrepaired further deterioration of the wall is expected. This defect has been repaired between the 2014 and 2020 inspections. However, multiple repointing repairs were found to be broken in 2020.  
**Photo number: 124**

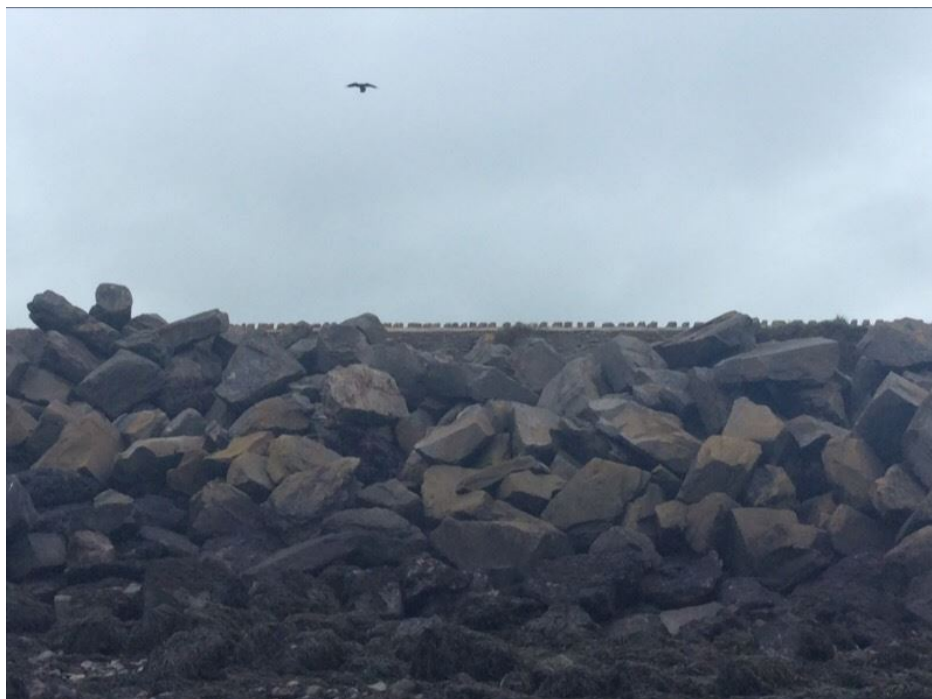
**Section A**  
**Capping Wall**  
**Defect Ref: D23**  
**Description:** Open joints, if left unrepaired further deterioration of the wall is expected. This defect has been repaired between the 2014 and 2020 inspections. However, multiple repointing repairs were found to be broken in 2020.  
**Photo number: 204**

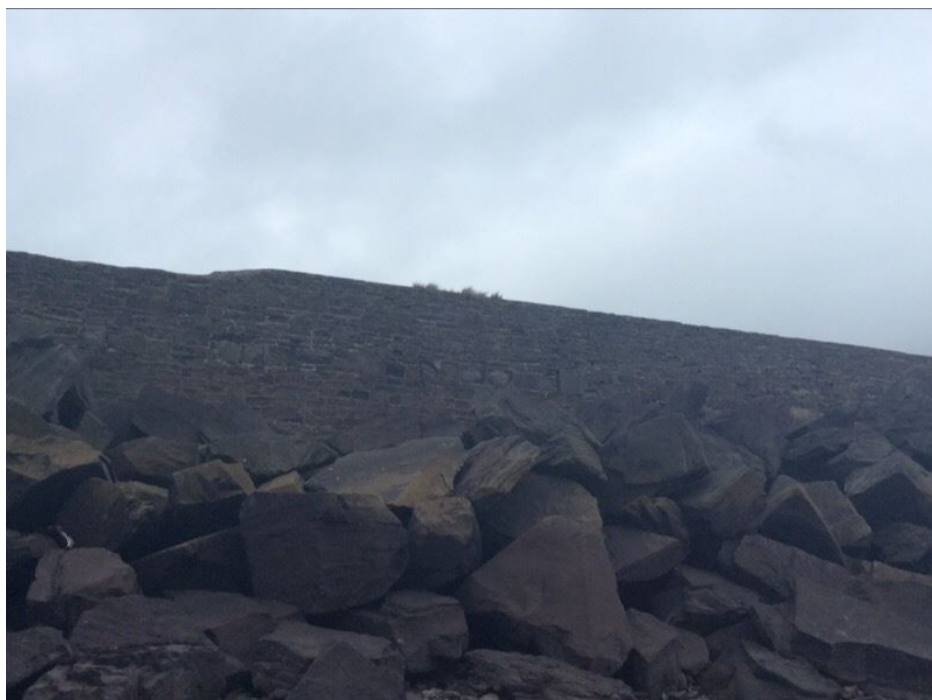
**Section A**  
**Capping Wall**  
**Defect Ref: D23**  
**Description:** Open joints, if left unrepaired further deterioration of the wall is expected. This defect has been repaired between the 2014 and 2020 inspections. However, multiple repointing repairs were found to be broken in 2020.  
**Photo number: 206**

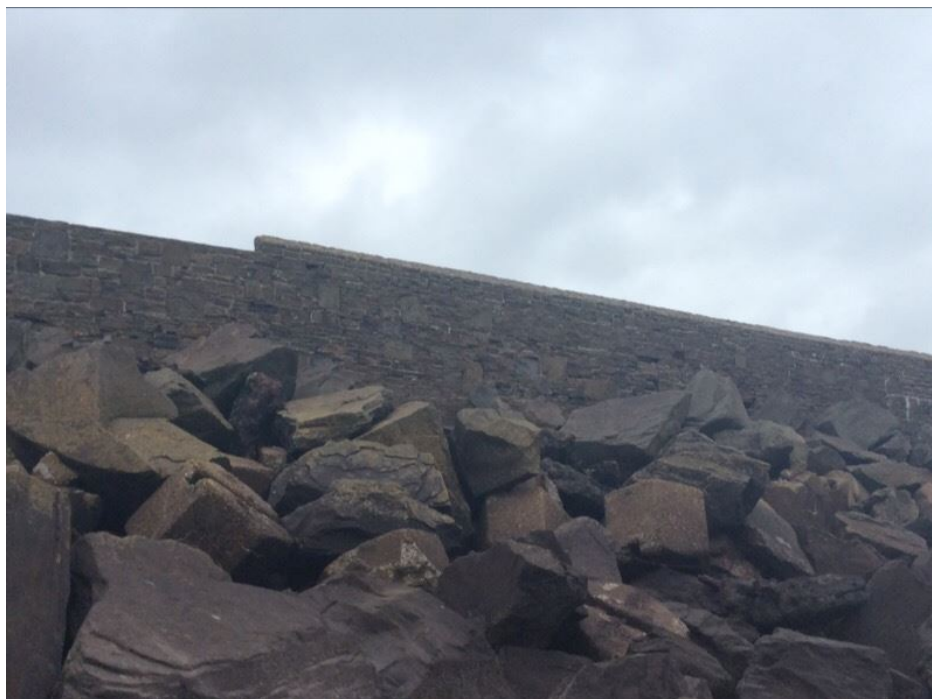
**Section A**  
**Capping Wall**  
**Defect Ref: D23**  
**Description:** Open joints, if left unrepaired further deterioration of the wall is expected. This defect has been repaired between the 2014 and 2020 inspections. However, multiple repointing repairs were found to be broken in 2020.  
**Photo number: 207**

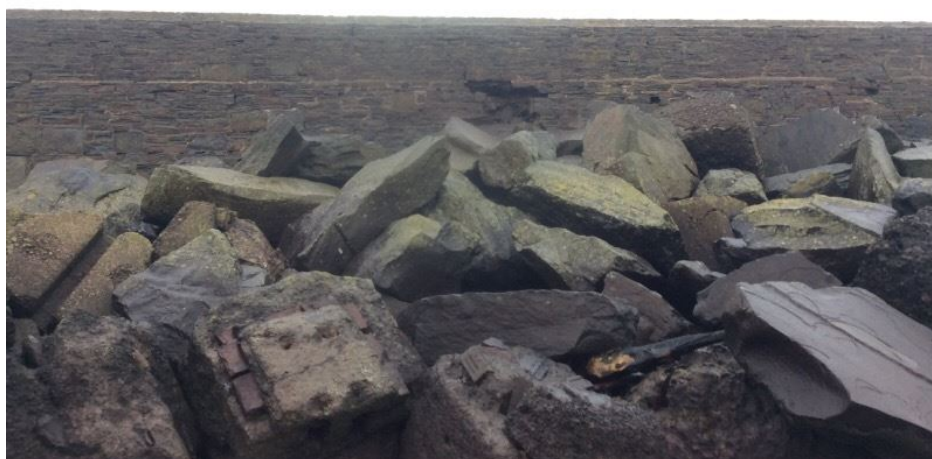
**Section A**  
**Capping Wall**  
**Defect Ref: D24**  
**Description:** Severe damage to wall. Between the 2019 and 2020 inspections, the defect has been repaired.  
**Photo number: 125**

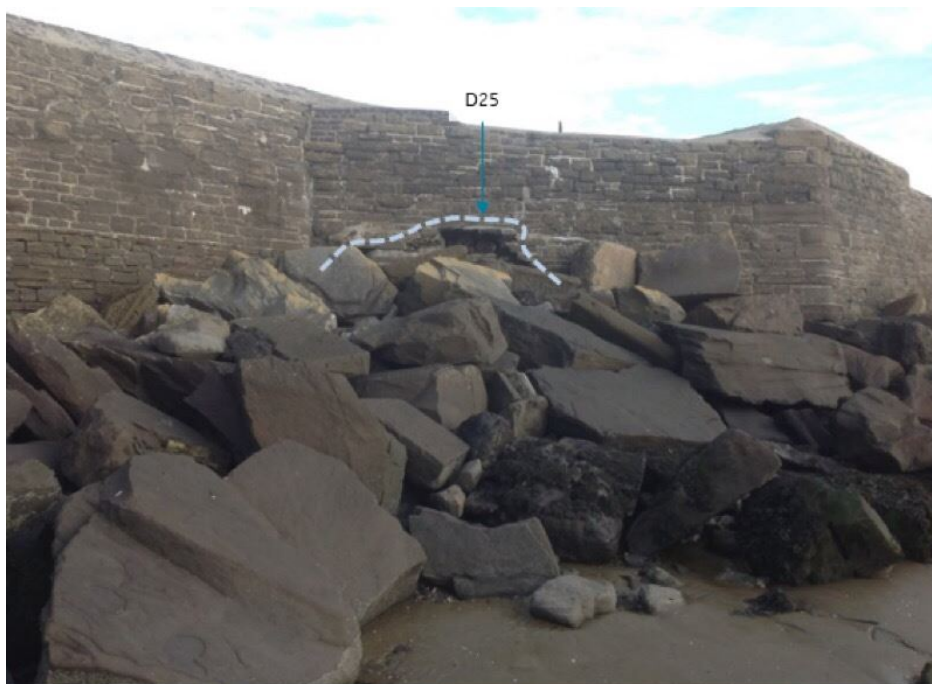
**Section A**  
**Capping Wall**  
**Defect Ref: D25**  
**Description:** This defect has been crudely repaired between 2014 and 2020 inspections with concrete sandbags. The repair is failing.  
**Photo number: 77**

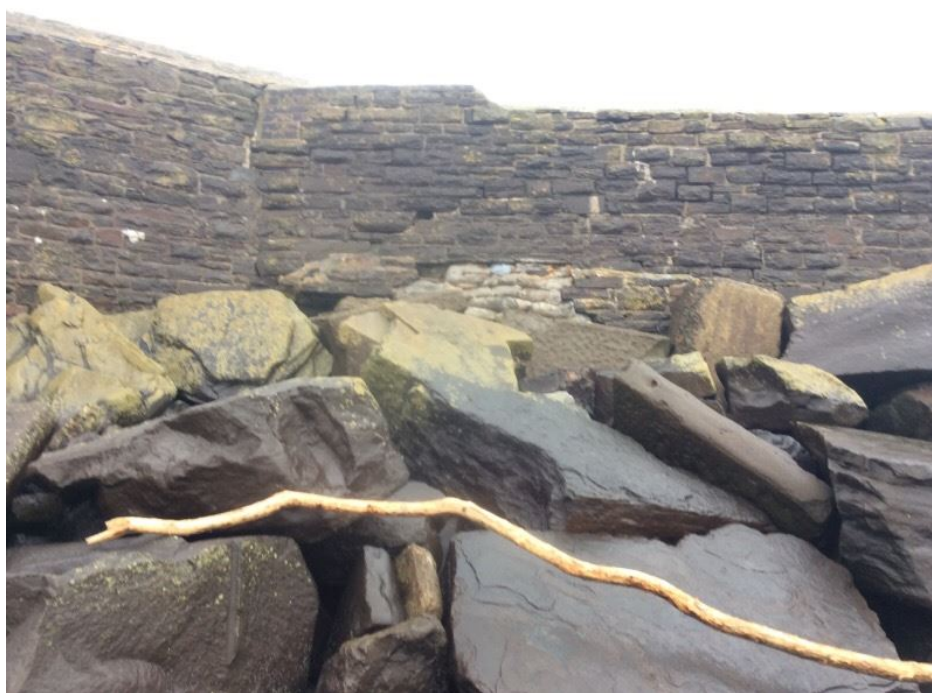
**Section A**  
**Capping Wall**  
**Defect Ref: D25**  
**Description:** This defect has been crudely repaired between 2014 and 2020 inspections with concrete sandbags. The repair is failing.  
**Photo number: 127**

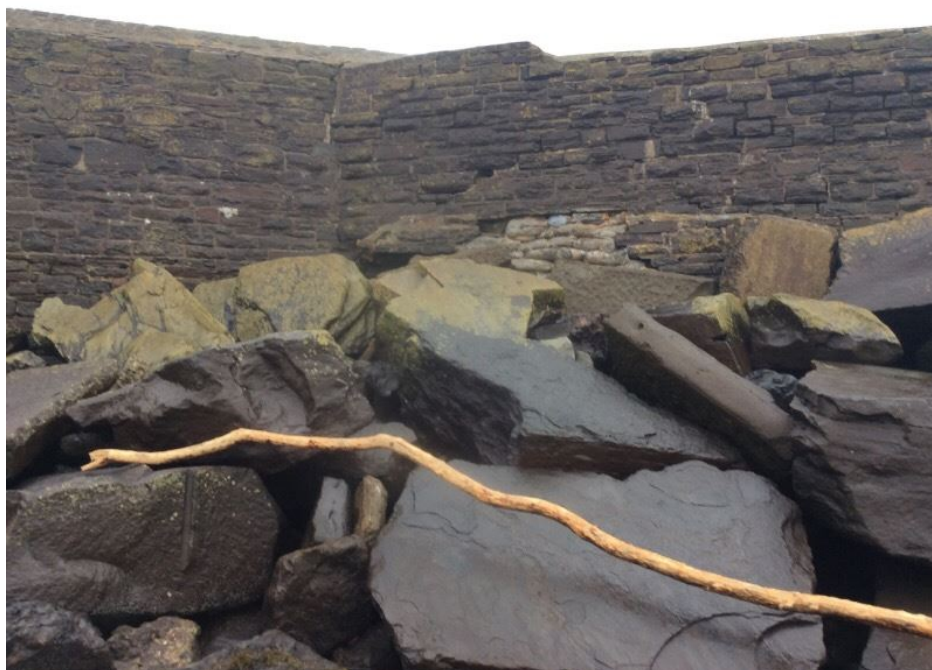
**Section A**  
**Capping Wall**  
**Defect Ref: D25**  
**Description:** This defect has been crudely repaired between 2014 and 2020 inspections with concrete sandbags. The repair is failing.  
**Photo number: 128**

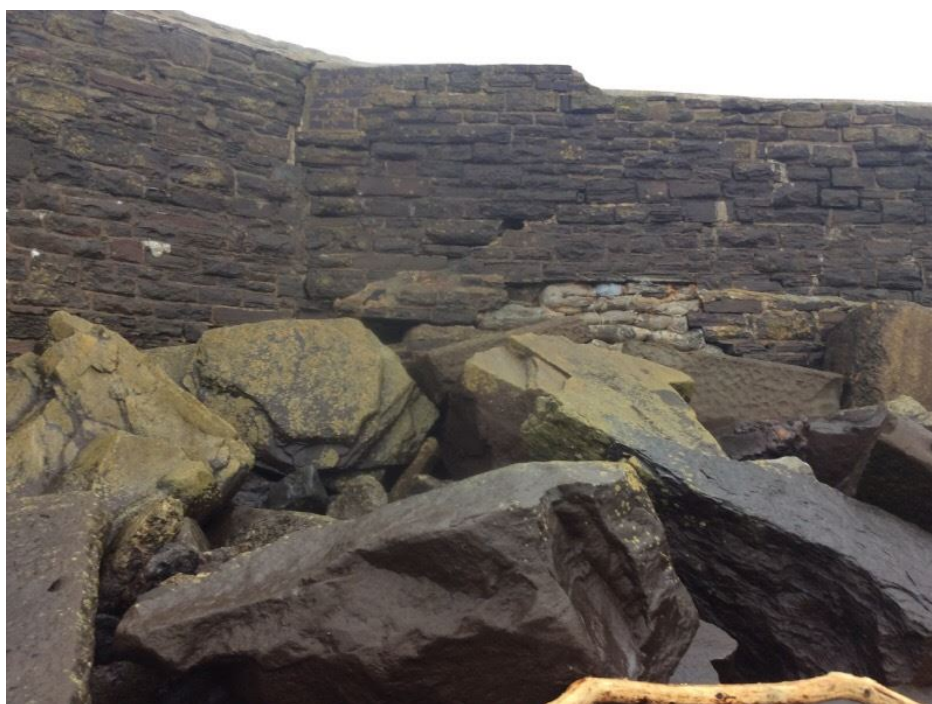
**Section A**  
**Capping Wall**  
**Defect Ref: D25**  
**Description:** This defect has been crudely repaired between 2014 and 2020 inspections with concrete sandbags. The repair is failing.  
**Photo number: 129**

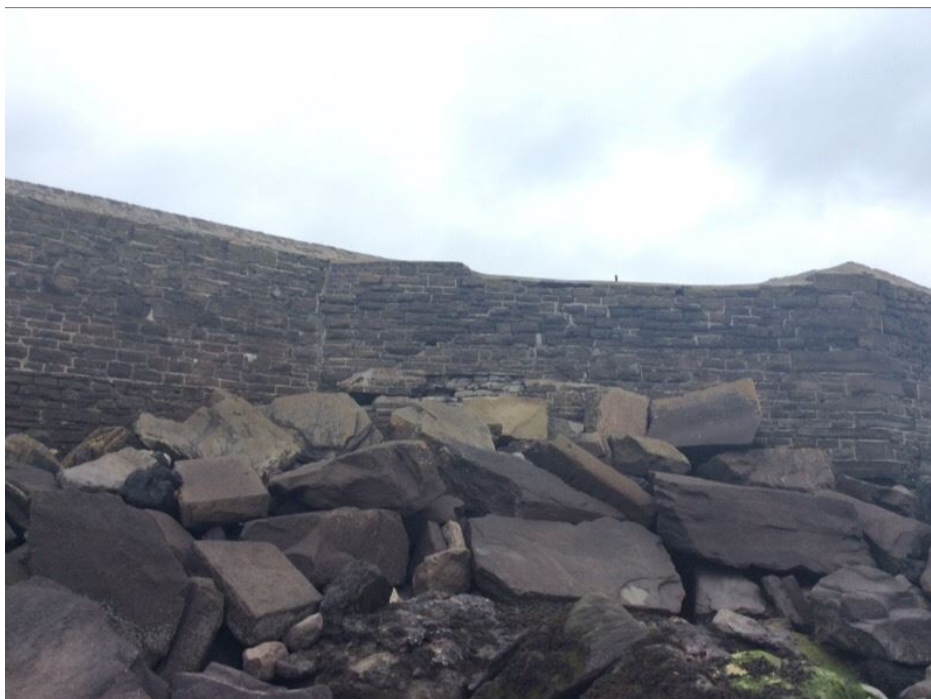
**Defect Ref: D25**

**Description:** This defect has been crudely repaired between 2014 and 2020 inspections with concrete sandbags. The repair is failing.

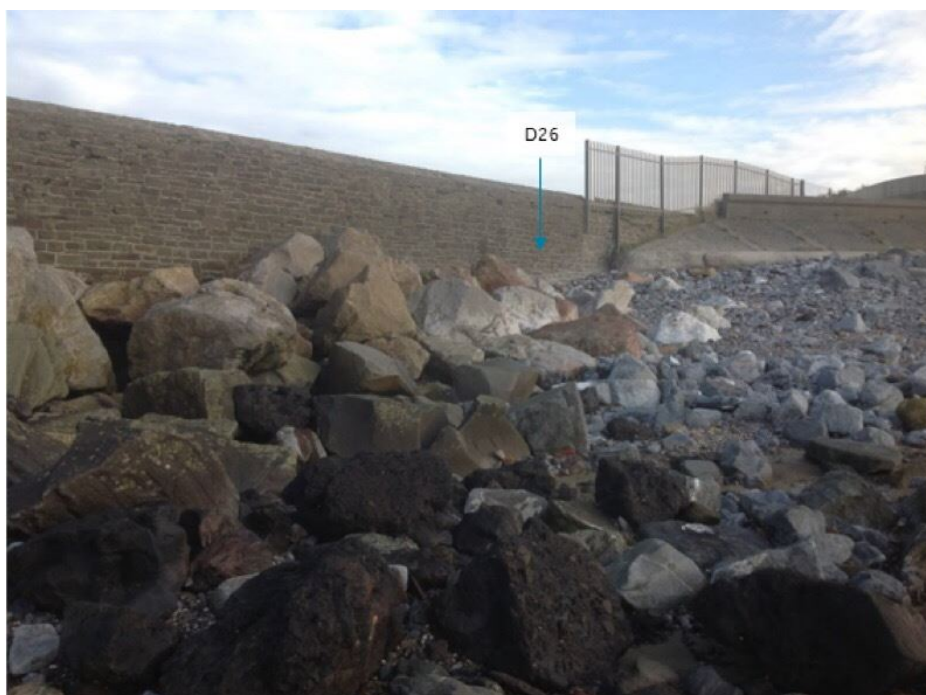
**Photo number: 78**

**Defect Ref: D26**

**Description:** Poor defence tie-in. Increased in severity between the 2014 and 2019 inspections, with additional damage to the capping wall. The capping wall has been repaired between the 2019 and 2020 inspections, but there is still a loss of grouting areas.

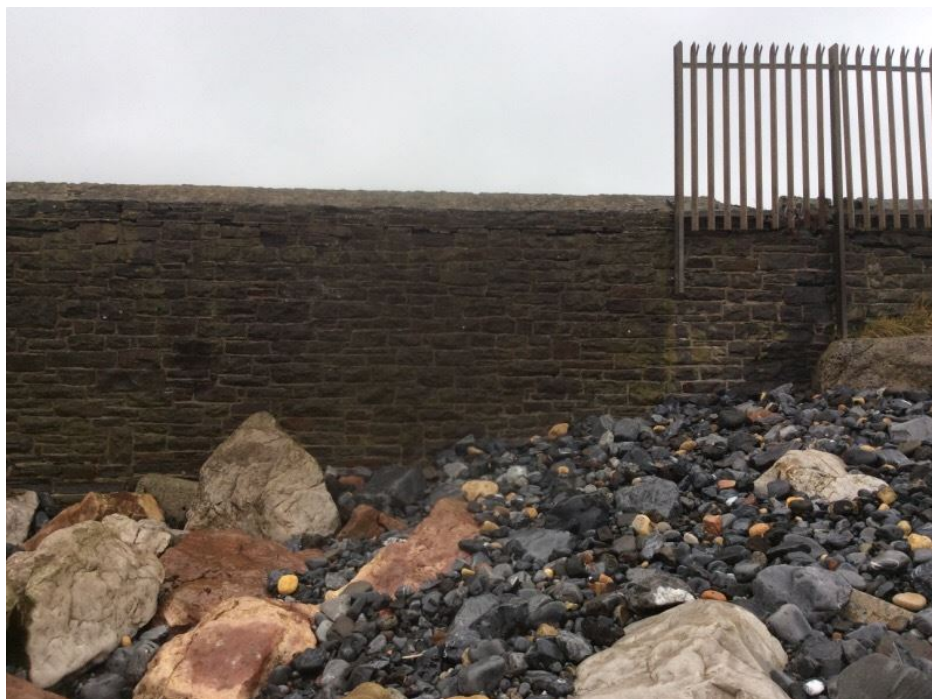
**Section A**  
**Capping Wall**  
**Defect Ref: D26**  
**Description:** Poor defence tie-in. Increased in severity between the 2014 and 2019 inspections, with additional damage to the capping wall. The capping wall has been repaired between the 2019 and 2020 inspections, but there is still a loss of grouting areas.  
**Photo number: 134**

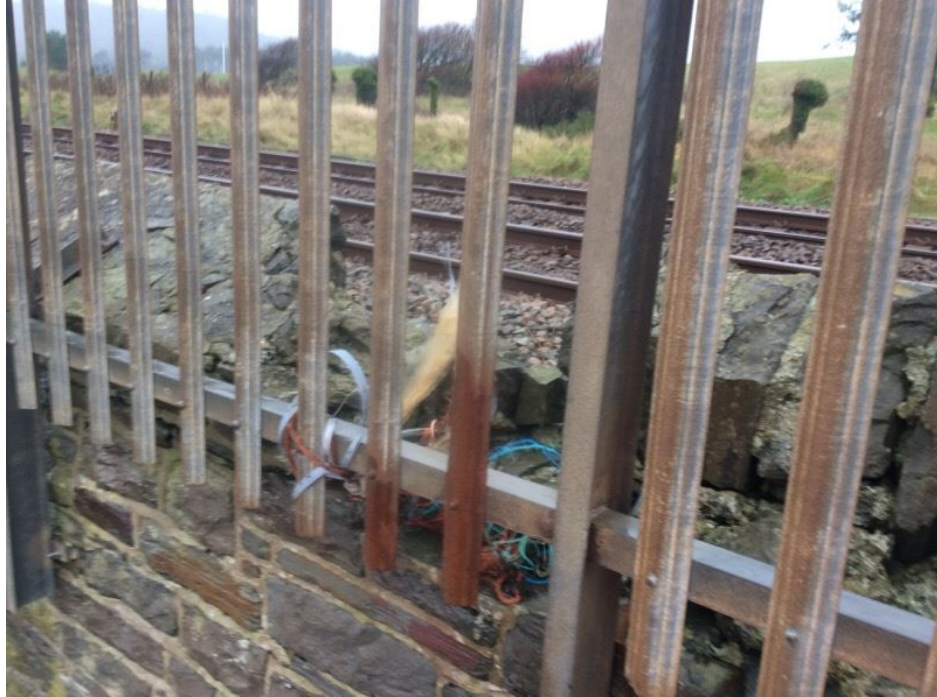
**Section A**  
**Capping Wall**  
**Defect Ref: D26**  
**Description:** Poor defence tie-in. Increased in severity between the 2014 and 2019 inspections, with additional damage to the capping wall. The capping wall has been repaired between the 2019 and 2020 inspections, but there is still a loss of grouting areas.  
**Photo number: 136**

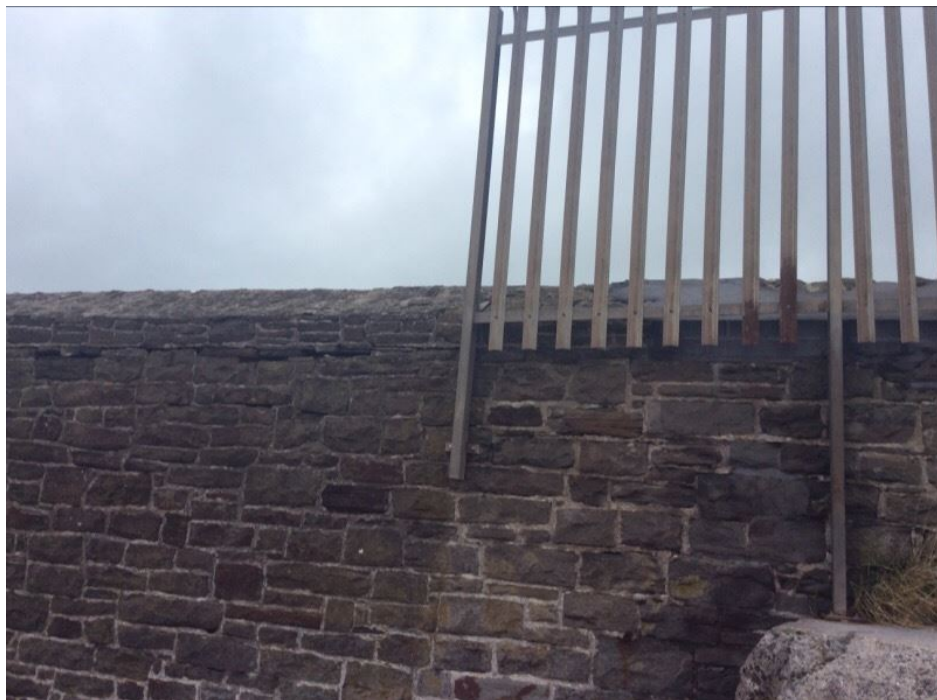
**Section A**  
**Capping Wall**  
**Defect Ref: D26**  
**Description:** Poor defence tie-in. Increased in severity between the 2014 and 2019 inspections, with additional damage to the capping wall. The capping wall has been repaired between the 2019 and 2020 inspections, but there is still a loss of grouting areas.  
**Photo number: 211**

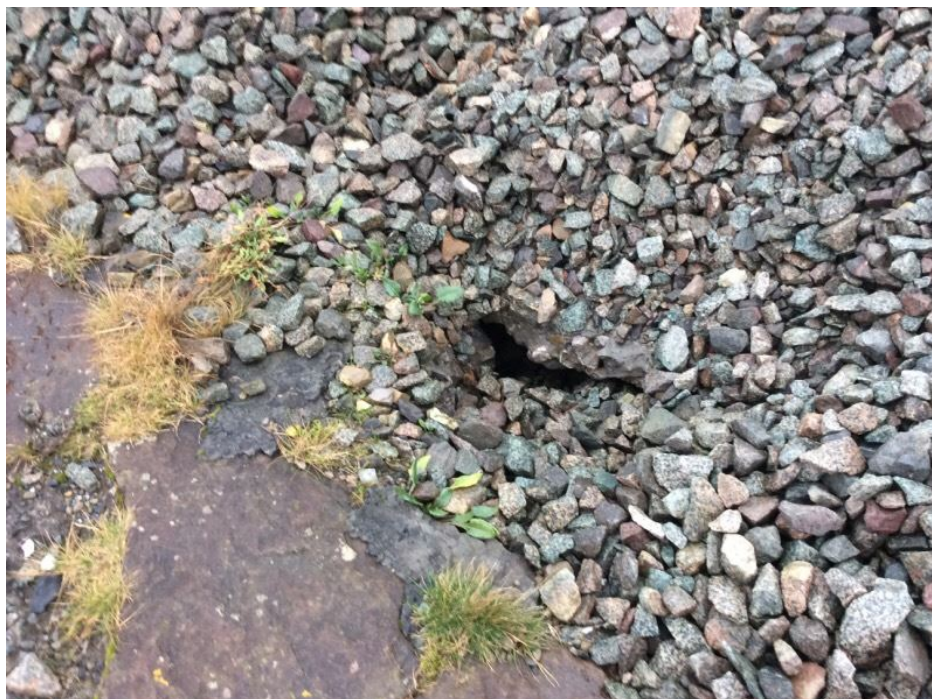
**Defect Ref: D27**

**Description:** Minor subsidence and undermining of ballast, but no evidence of failure on sea wall. No change between the 2019 and 2020 inspections.

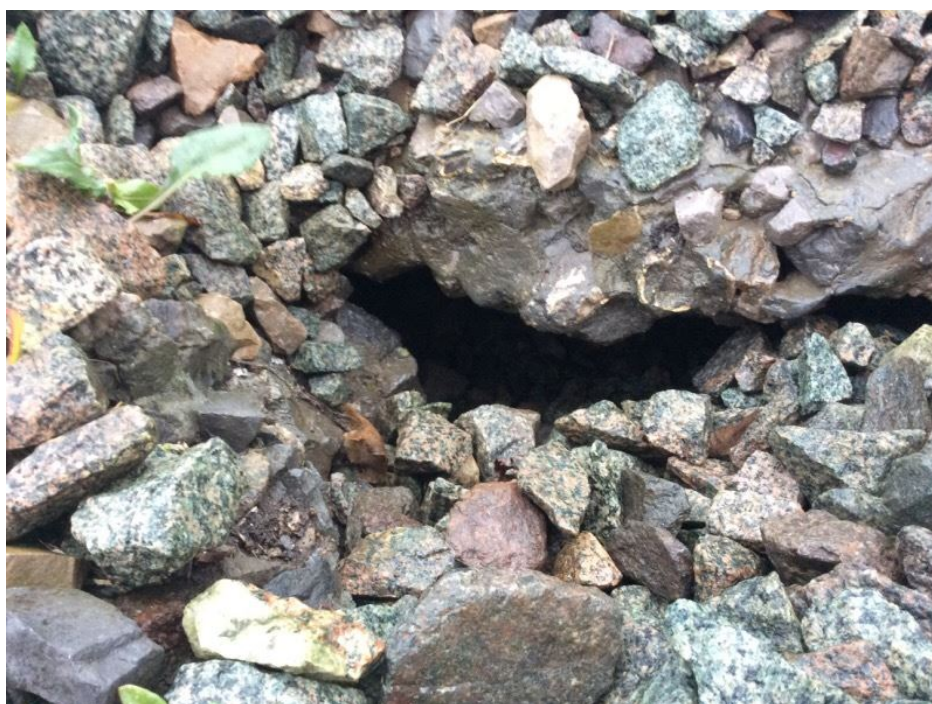
**Defect Ref: D27**

**Description:** Minor subsidence and undermining of ballast, but no evidence of failure on sea wall. No change between the 2019 and 2020 inspections.

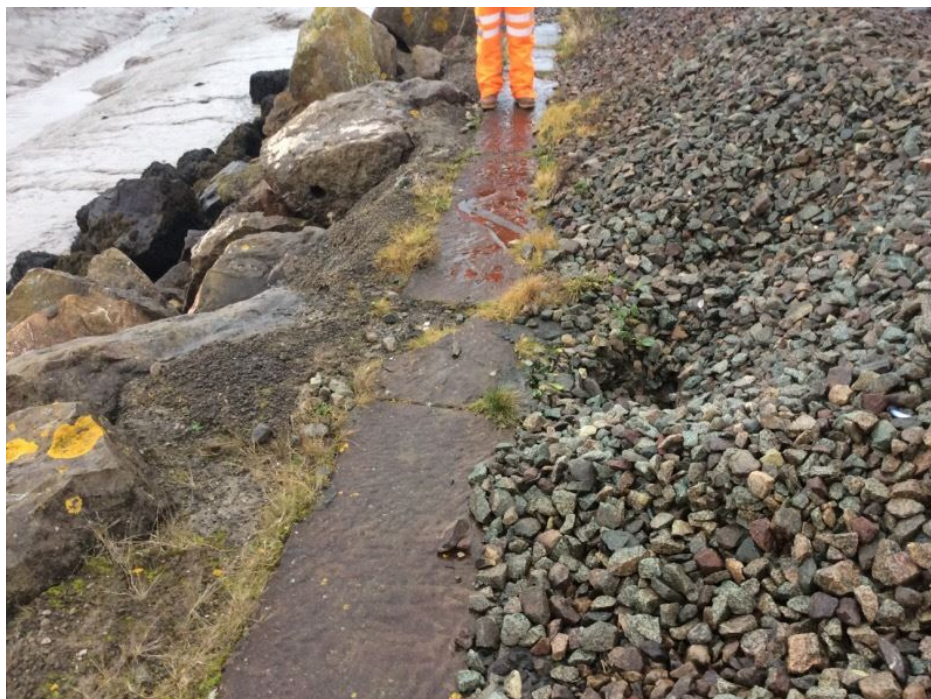
**Defect Ref: D27**

**Description:** Minor subsidence and undermining of ballast, but no evidence of failure on sea wall. No change between the 2019 and 2020 inspections.

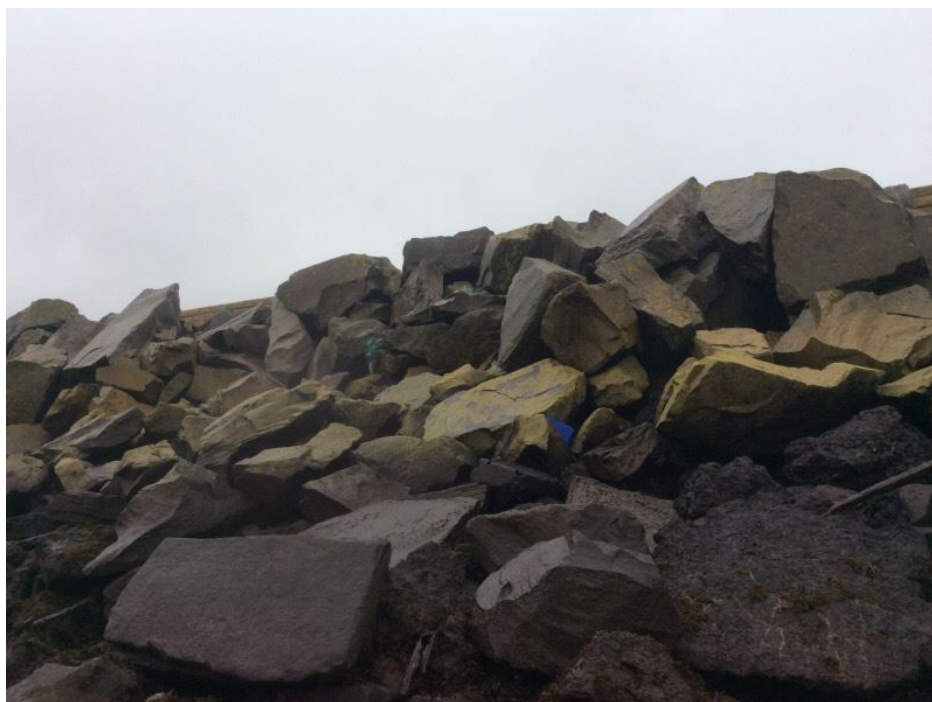
**Section A**  
**Embankment**  
**Armour**  
**Defect Ref: D28**  
**Description:** Poor interlocking between rock armour units. There has been no change between the 2019 and 2020 inspections.  
**Photo number: 119**

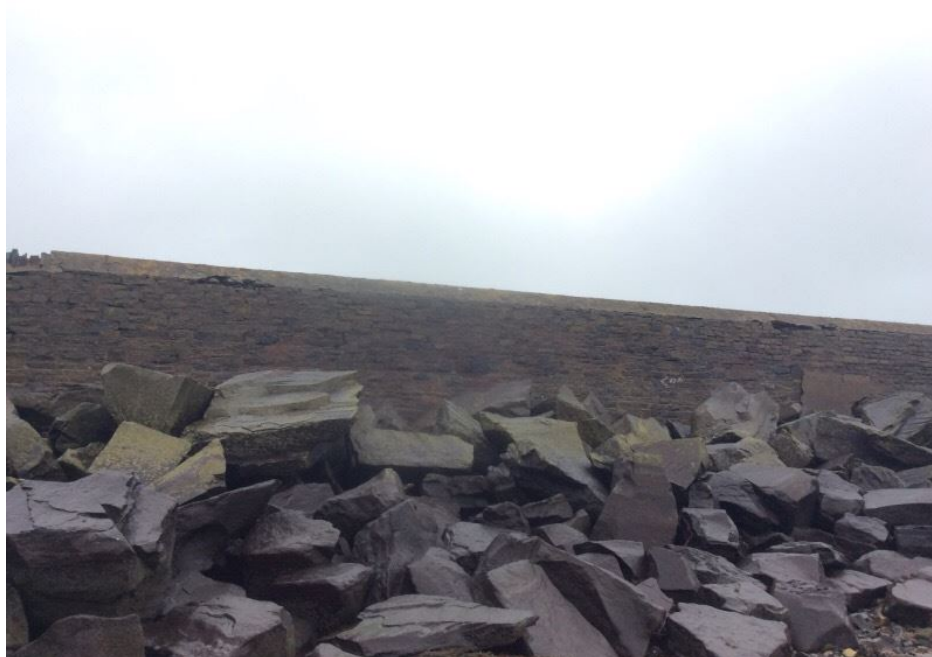
**Defect Ref: D29**

**Description:** Open joints and missing blockwork at the capping wall. No change between the 2019 and 2020 inspections.
