| Location Plan: | | Pwll Sea Wall | |
| | | Structure Reference: | 226 21.5 |

# COASTAL ASSET CONDITION SURVEY REPORT

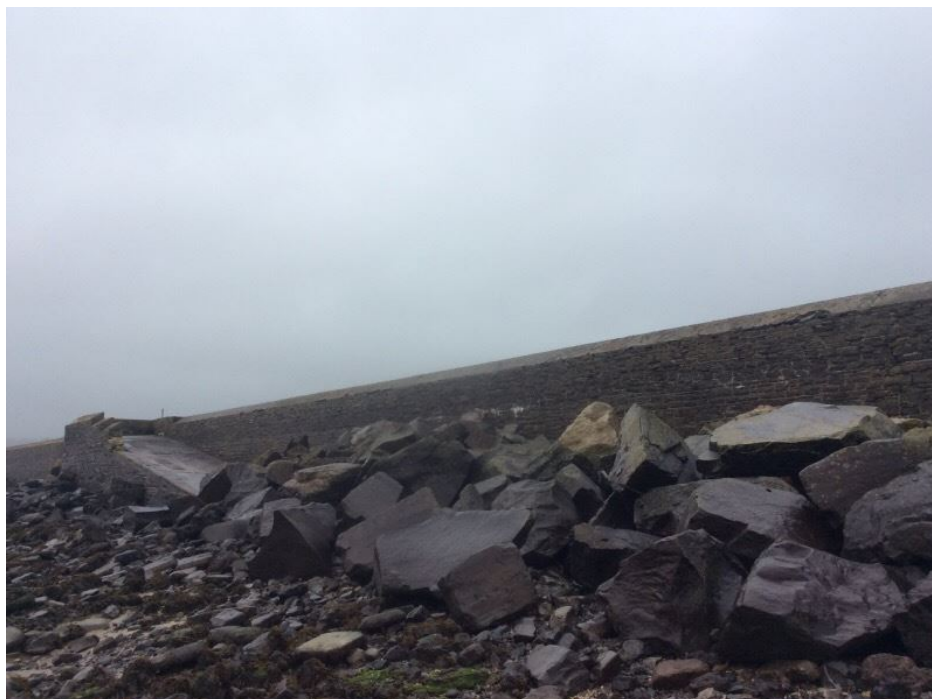
**Section A**  
**Capping Wall**  
**Defect Ref: D29**  
**Description:** Open joints and missing blockwork at the capping wall. No change between the 2019 and 2020 inspections.  
**Photo number: 130**

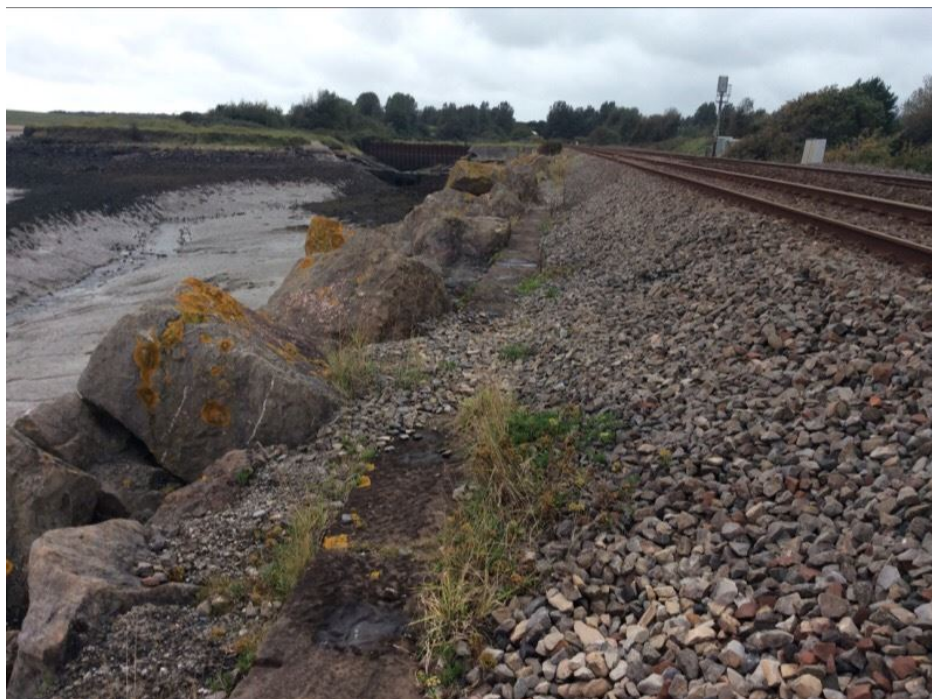
**Section A**  
**Embankment**  
**Armour**  
**Defect Ref: D30**  
**Description:** Wash  
out of ballast  
**Photo number: 143**

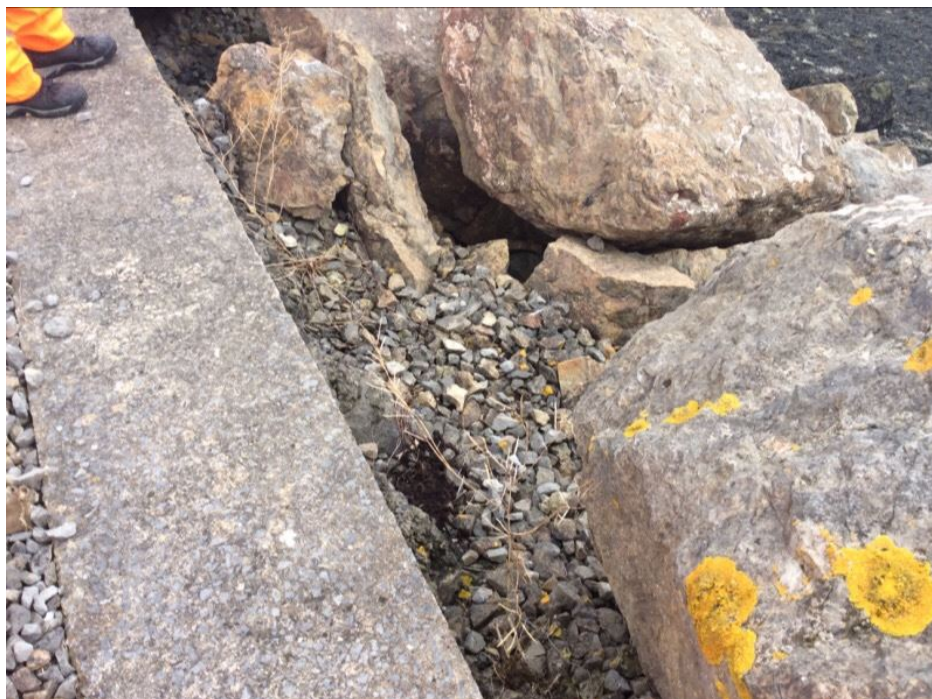
**Section A**  
**Embankment**  
**Armour**  
**Defect Ref: D31**  
**Description:** Voids in rock armour being filled with expelled ballast.  
**Photo number: 147**

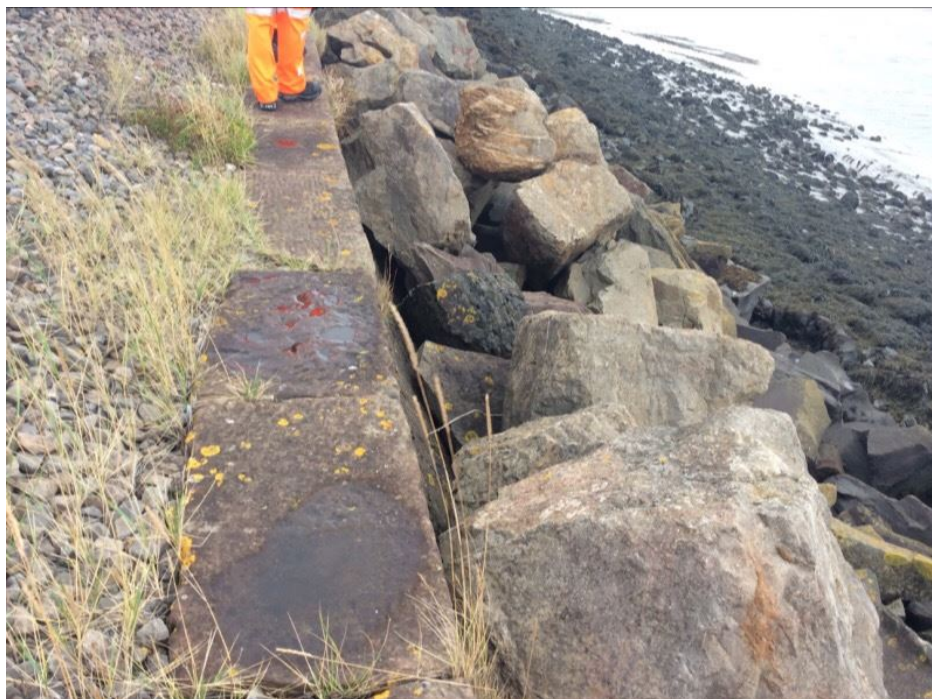
**Section A**  
**Embankment**  
**Armour**  
**Defect Ref: D32**  
**Description:** Large gaps between rock armour and crest of masonry wall.  
**Photo number: 162**

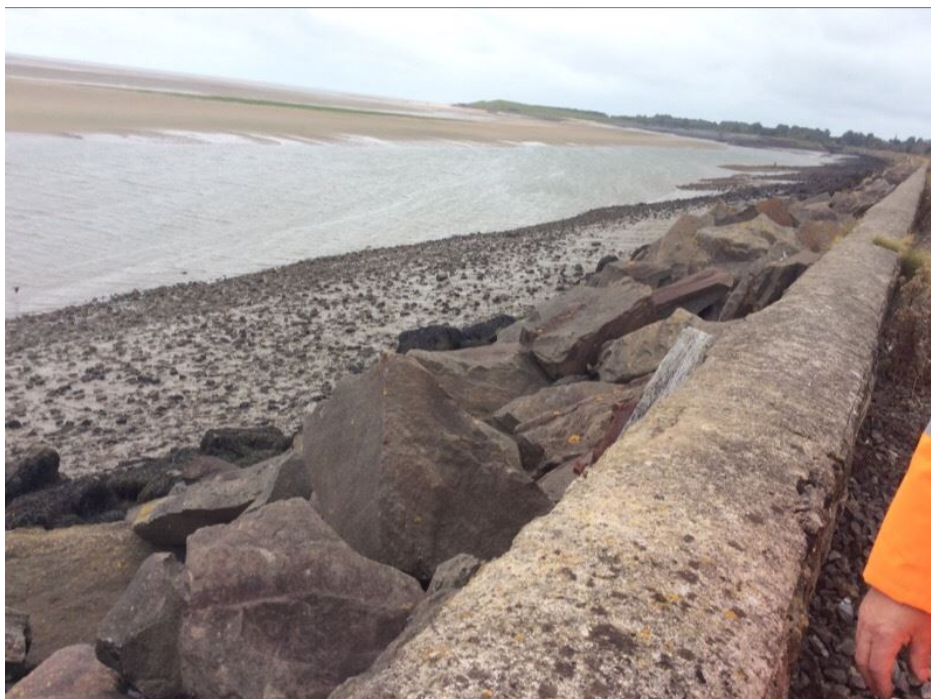
**Section A**  
**Embankment**  
**Armour**  
**Defect Ref: D32**  
**Description:** Large gaps between rock armour and crest of masonry wall.  
**Photo number: 176**

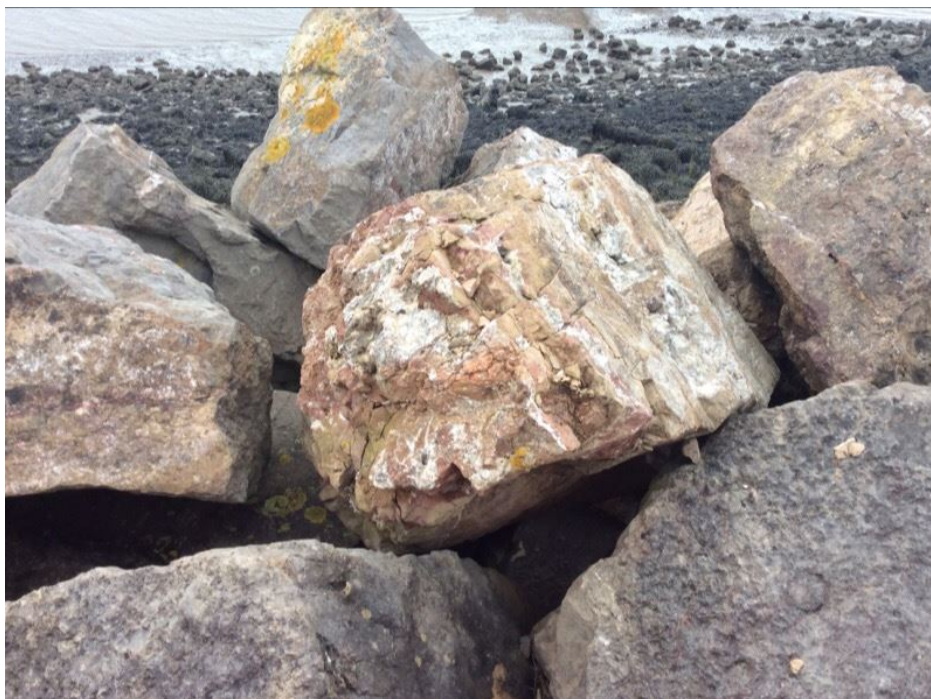
**Section A**  
**Embankment**  
**Armour**  
**Defect Ref: D33**  
**Description:**  
Fracturing in rocks.  
**Photo number: 158**

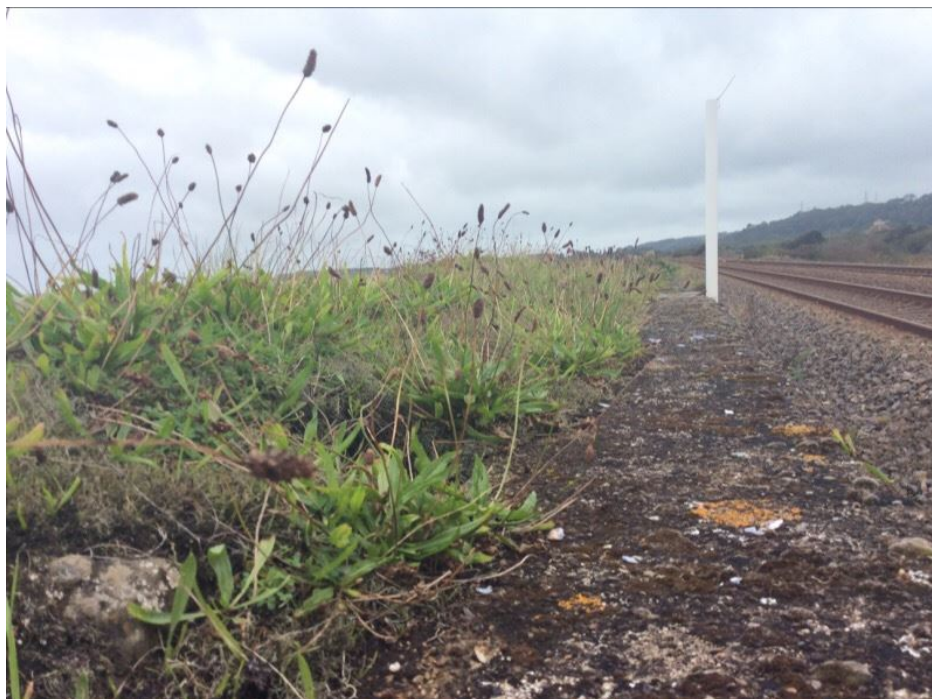
**Section A**  
**Capping Wall**  
**Defect Ref: D37**  
**Description:** Voids in  
crest approx.  
300x300mm  
**Photo number: 185**

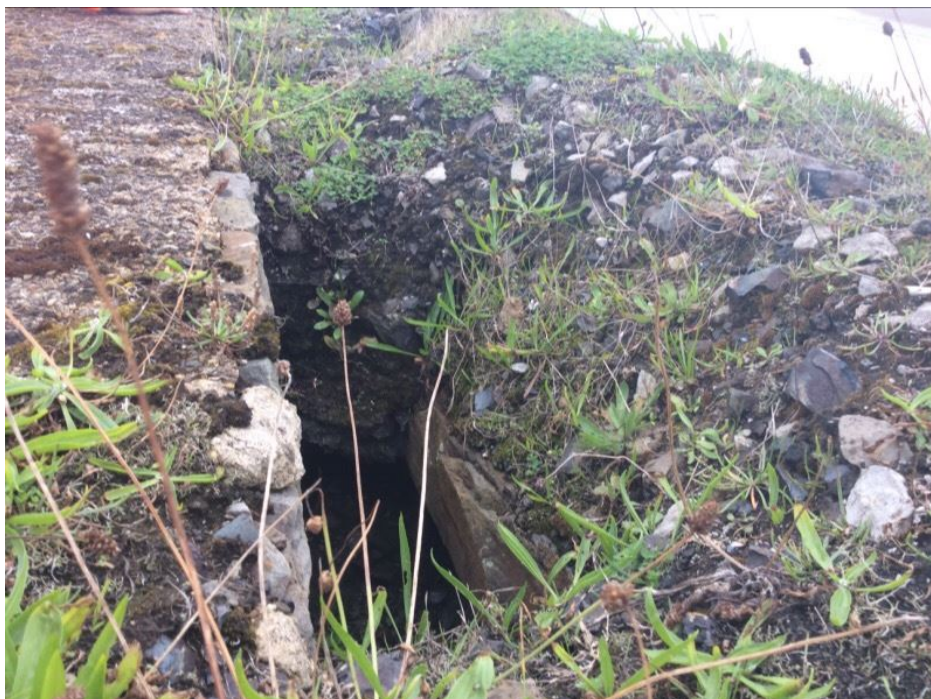
**Section A**  
**Capping Wall**  
**Defect Ref: D37**  
**Description:** Voids in  
crest approx.  
300x300mm  
**Photo number: 187**

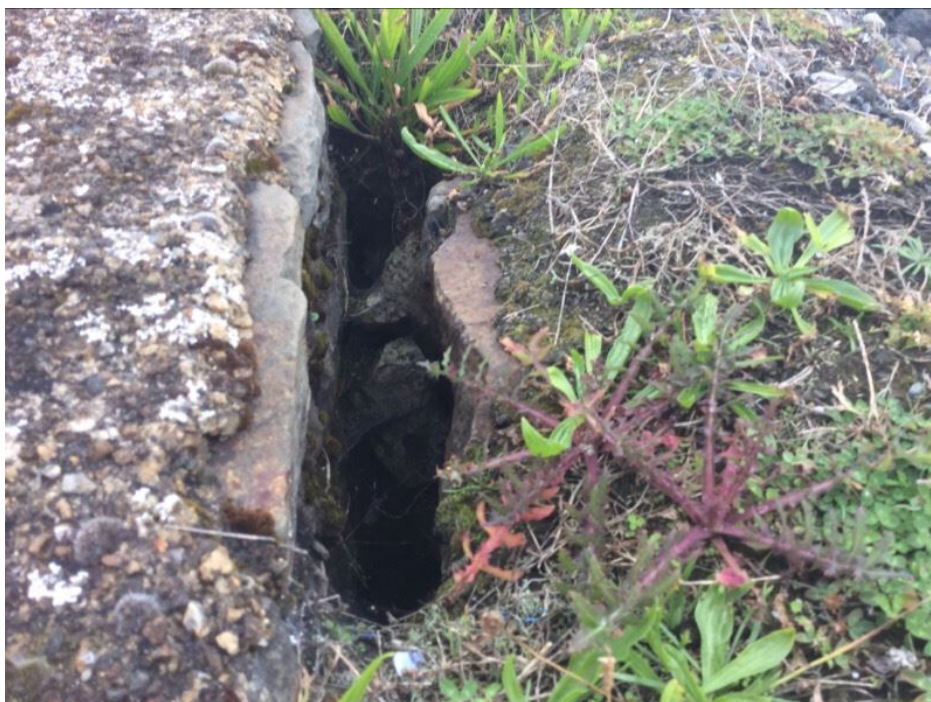
**Section A**  
**Capping Wall**  
**Defect Ref: D37**  
**Description:** Voids in  
crest approx.  
300x300mm  
**Photo number: 188**

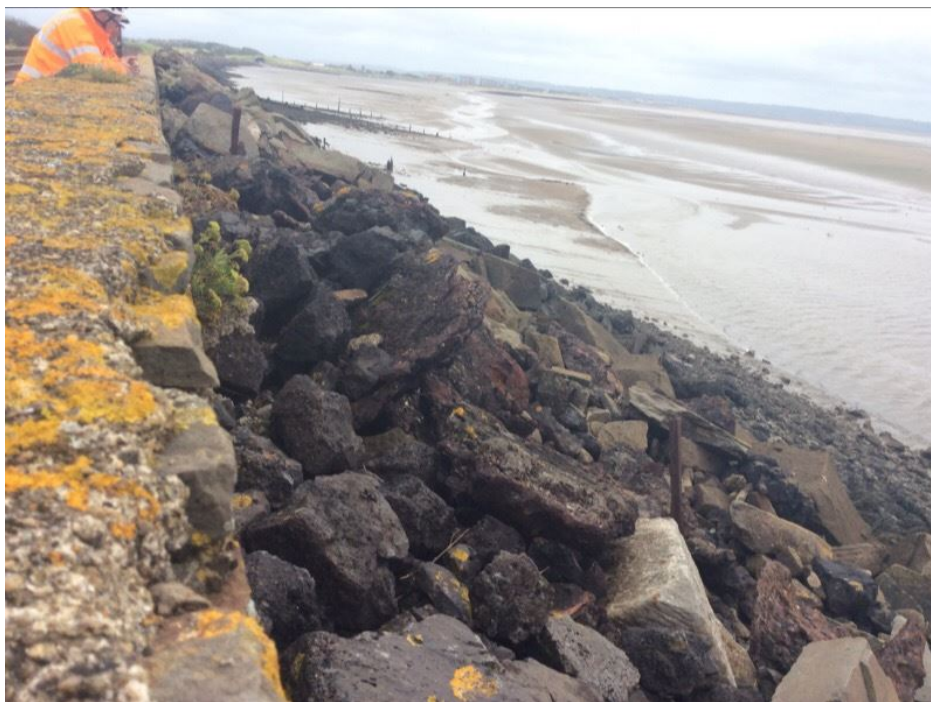
**Section A**  
**Embankment**  
**Armour**  
**Defect Ref: D38**  
**Description:**  
Dumped blast furnace  
slag.  
**Photo number: 189**

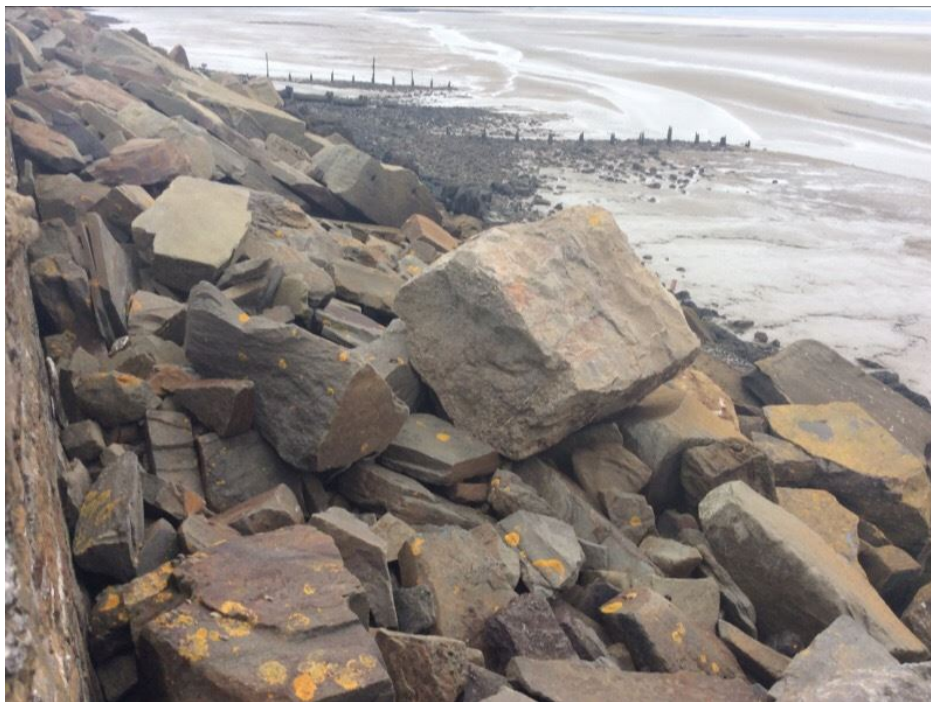
**Section A**  
**Embankment**  
**Armour**  
**Defect Ref: D38**  
**Description:**  
Dumped blast furnace  
slag.  
**Photo number: 191**

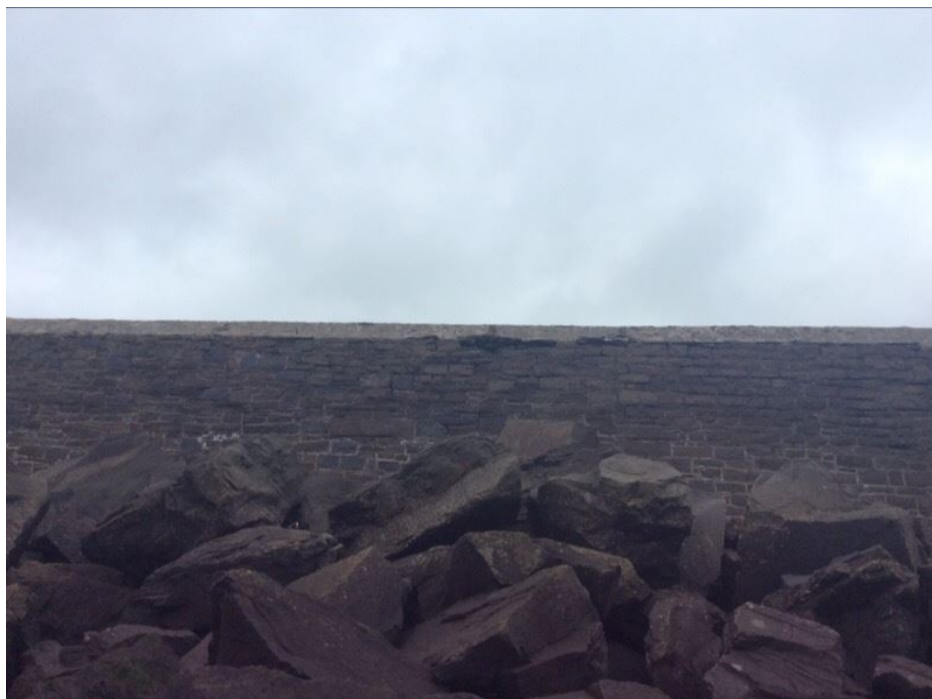
**Section A**  
**Capping Wall**  
**Defect Ref: D39**  
**Description:** Loss of  
grout between coping  
and wall.  
**Photo number: 209**
