Site Condition Report for Surrender Application EPR/XP3131VK/V002

Deeside Power Station

Deeside Power (UK) Limited

Report No. CRM 343 004 PE R 003

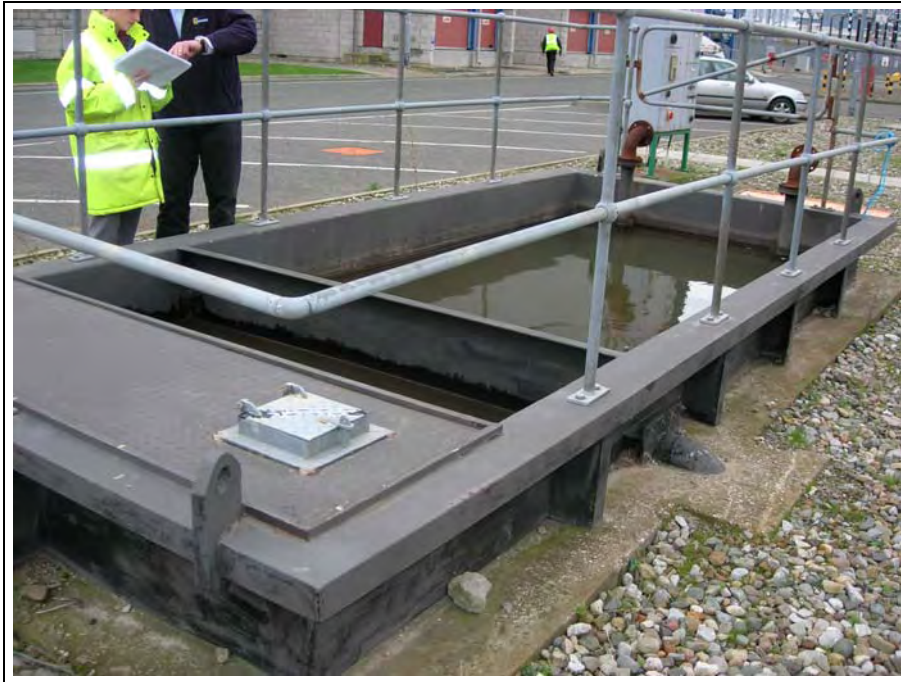
Photo 1: Skimovex interceptor.

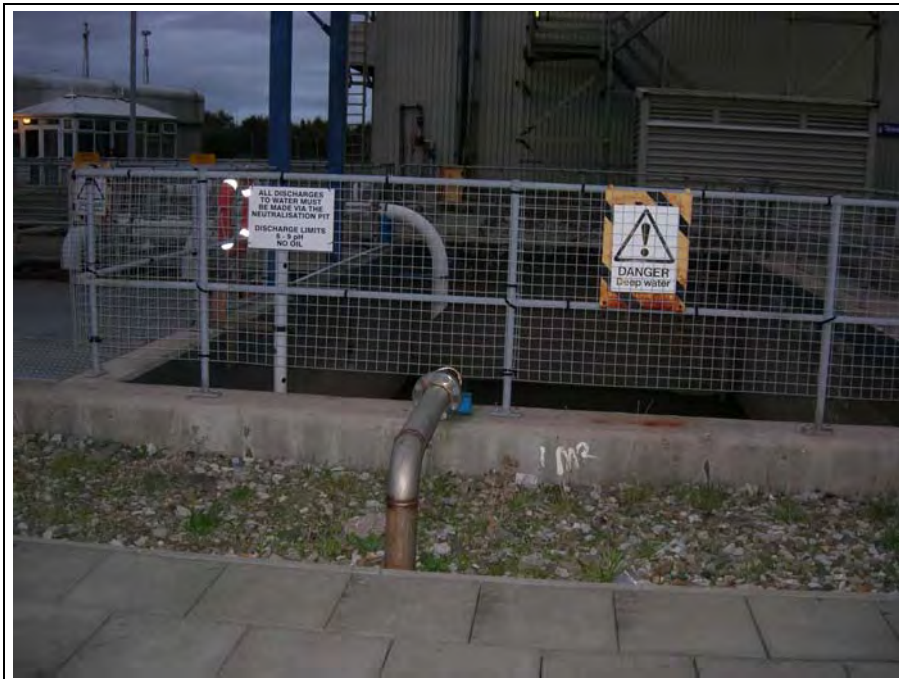
Photo 2: Wastewater pit.

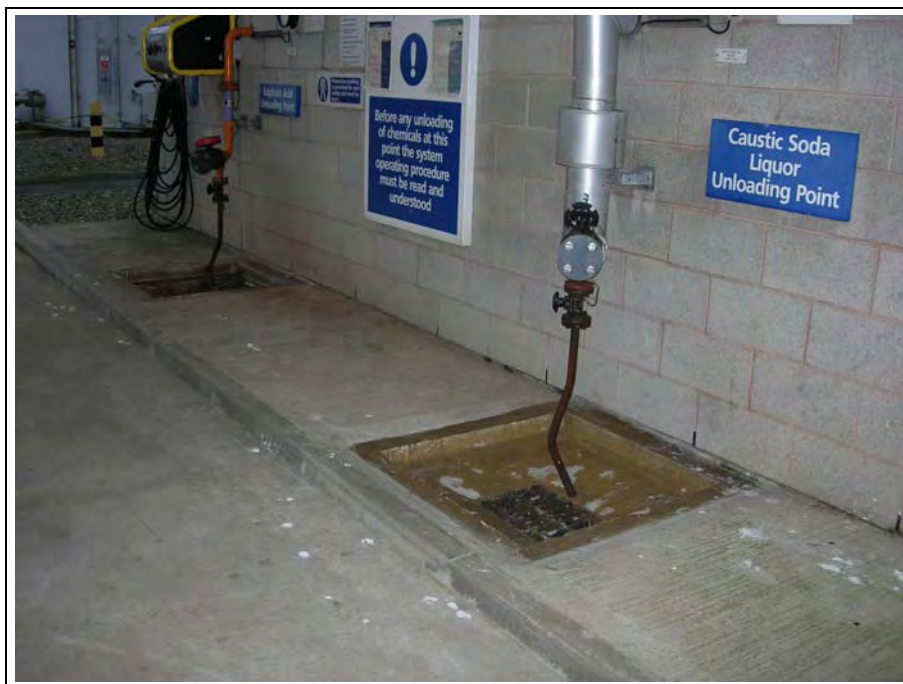
Photo 3: External fill point for sulphuric acid and caustic soda, sited on external wall of water treatment plant.

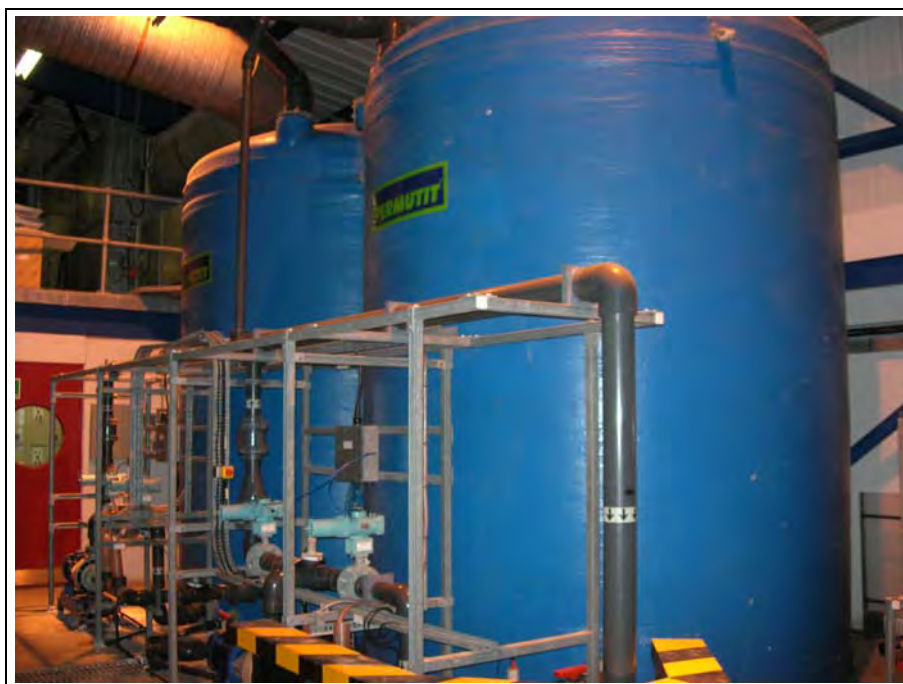
Photo 4: Internal sulphuric acid and sodium hydroxide storage tanks within the water treatment plant

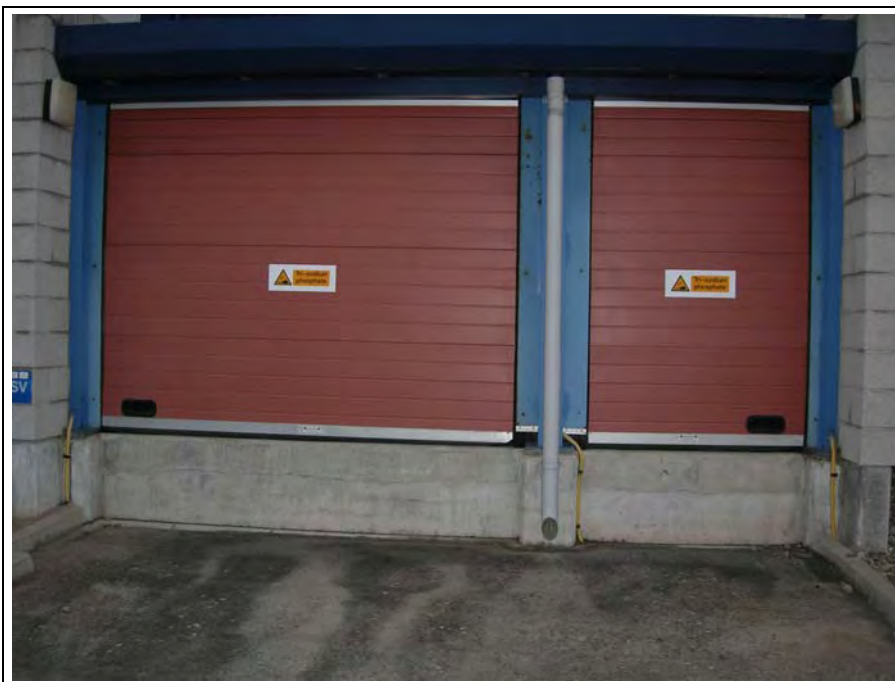
Photo 5: Tri-sodium phosphate unloading area adjacent to internal storage area.

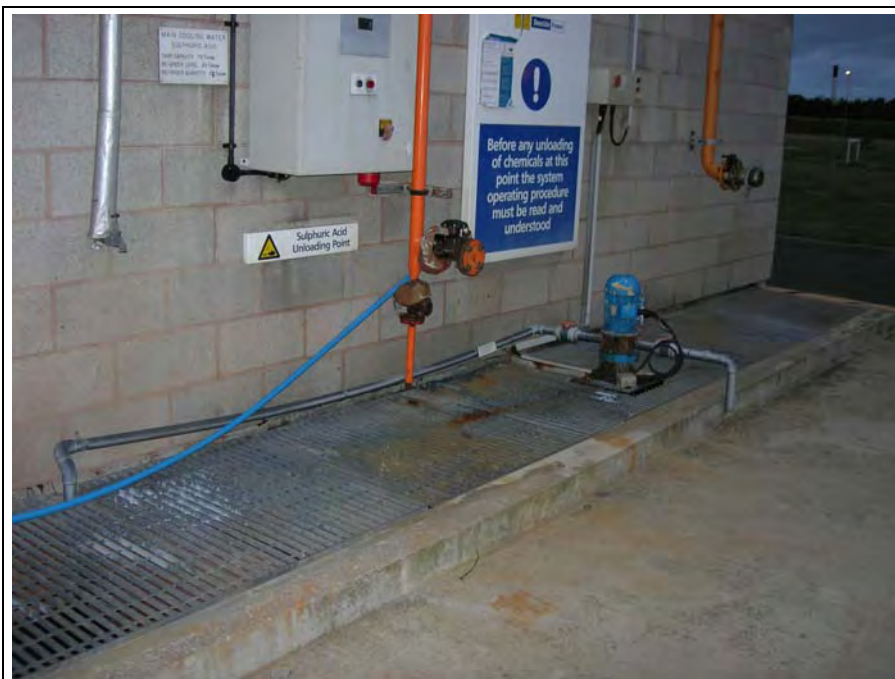
Photo 6: Contained sulphuric acid unloading area.

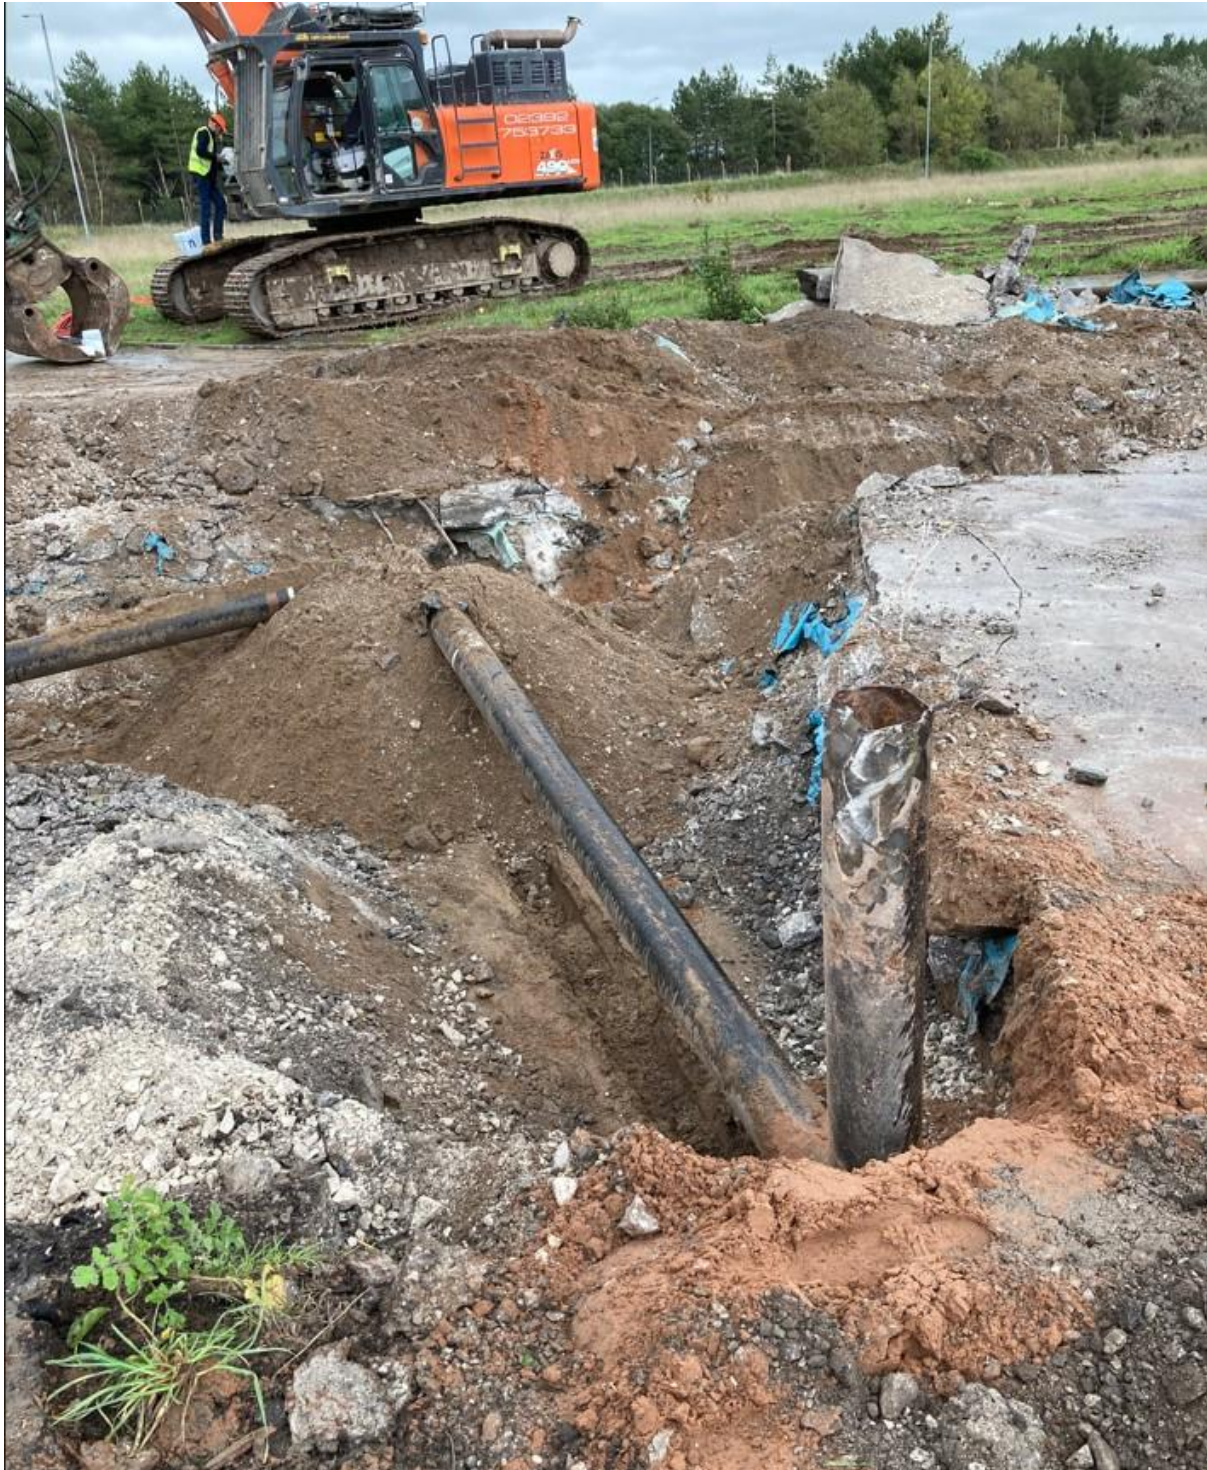
Filling Lines Exposed

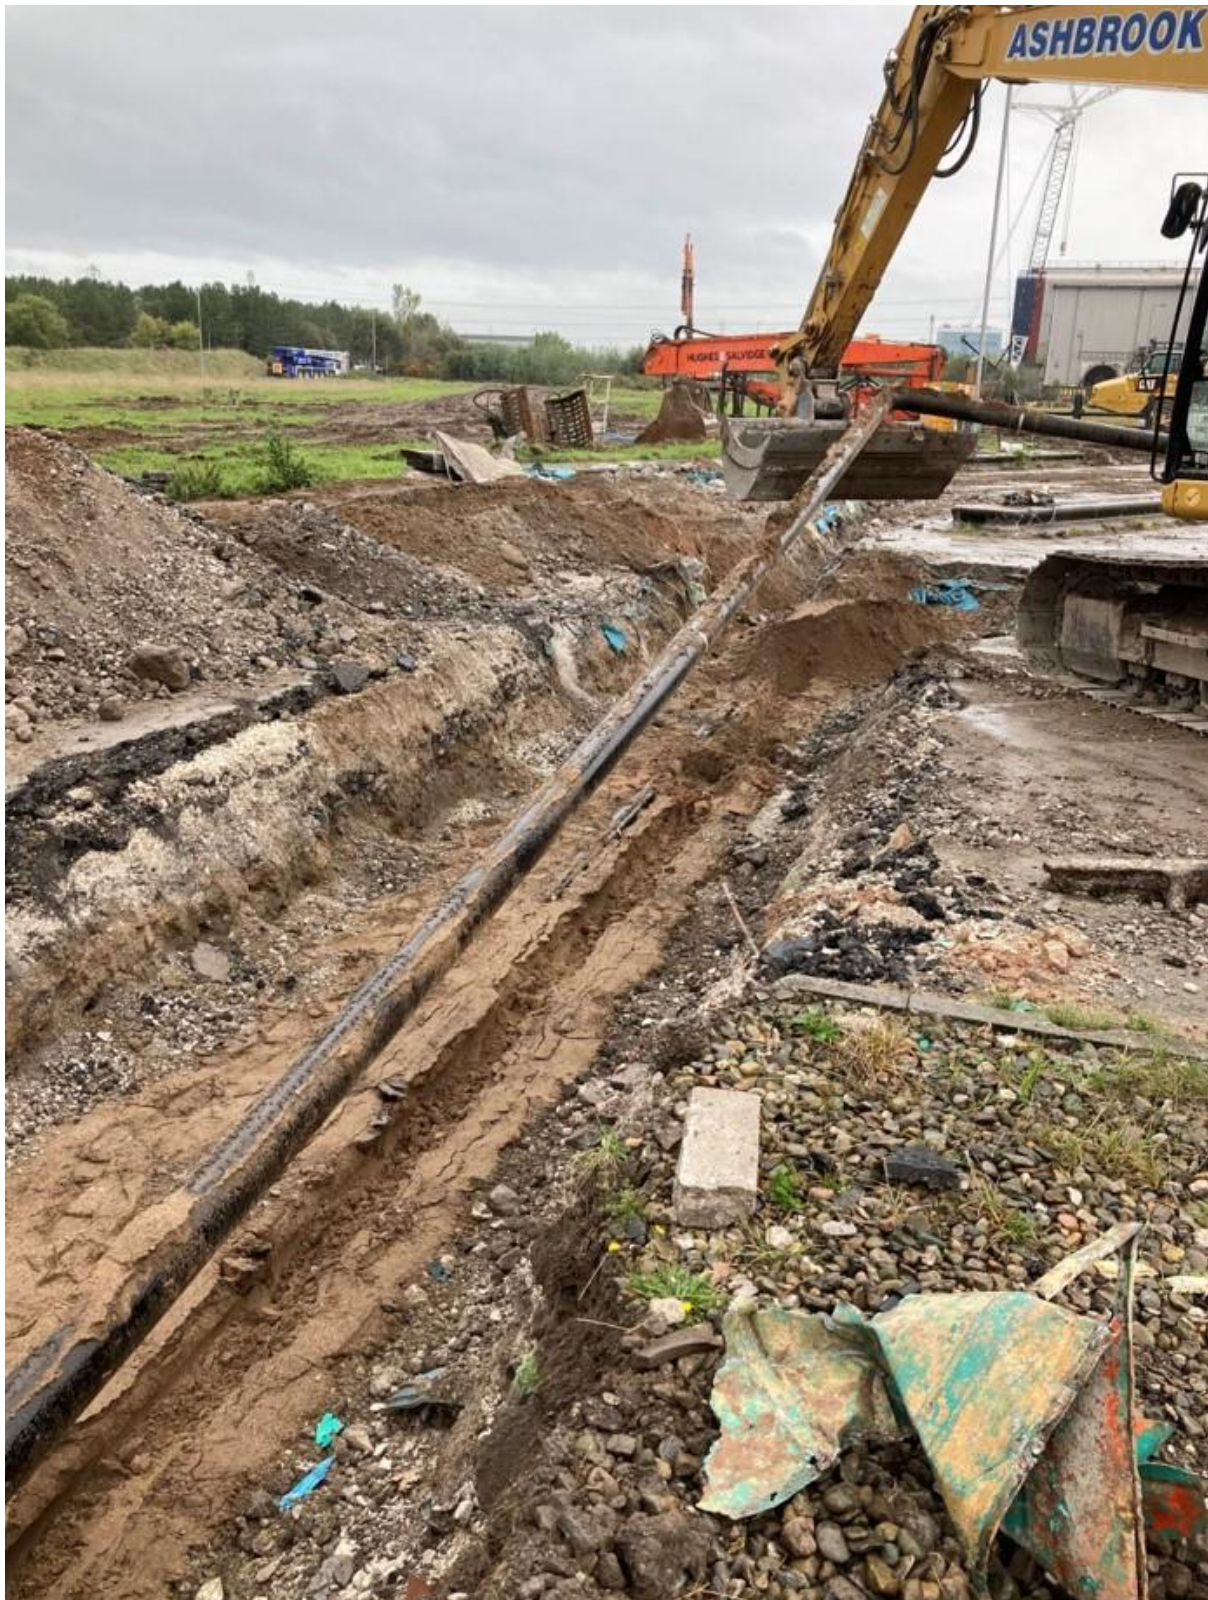
Filling Lines Being Removed

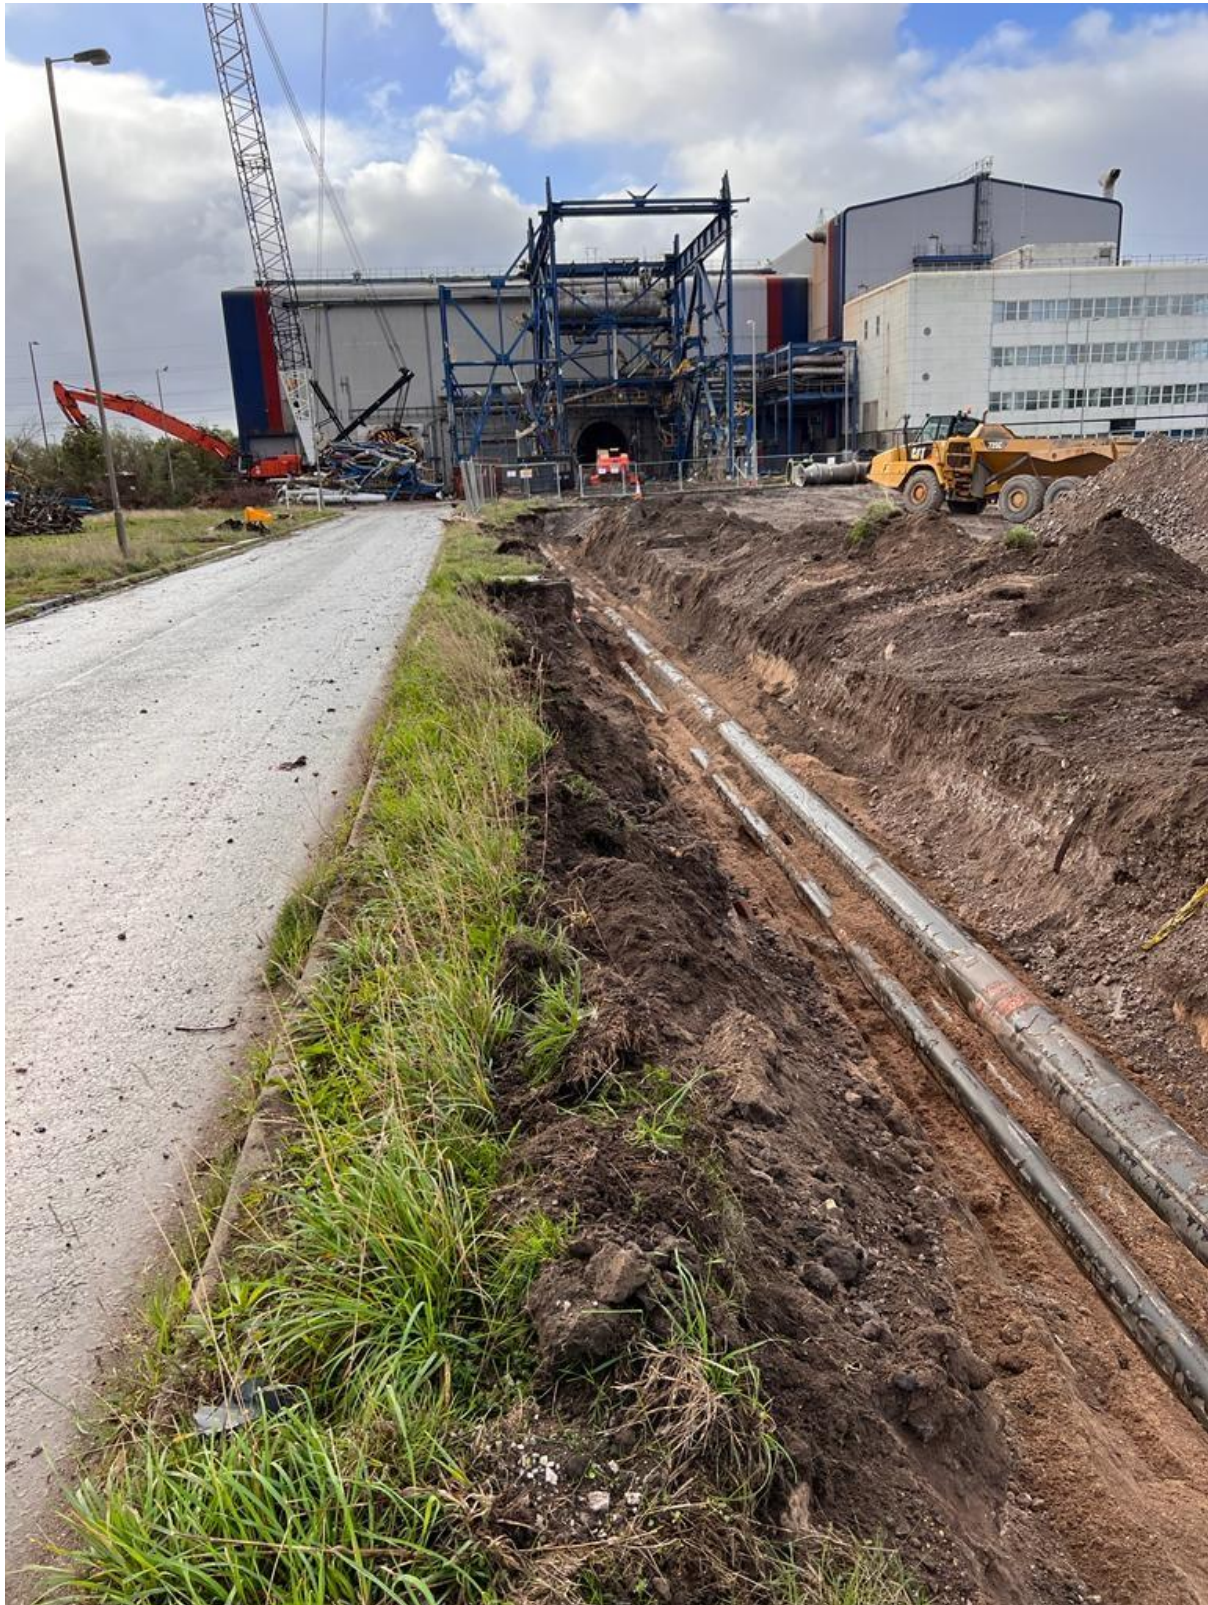
Gas and Fuel Lines Exposed

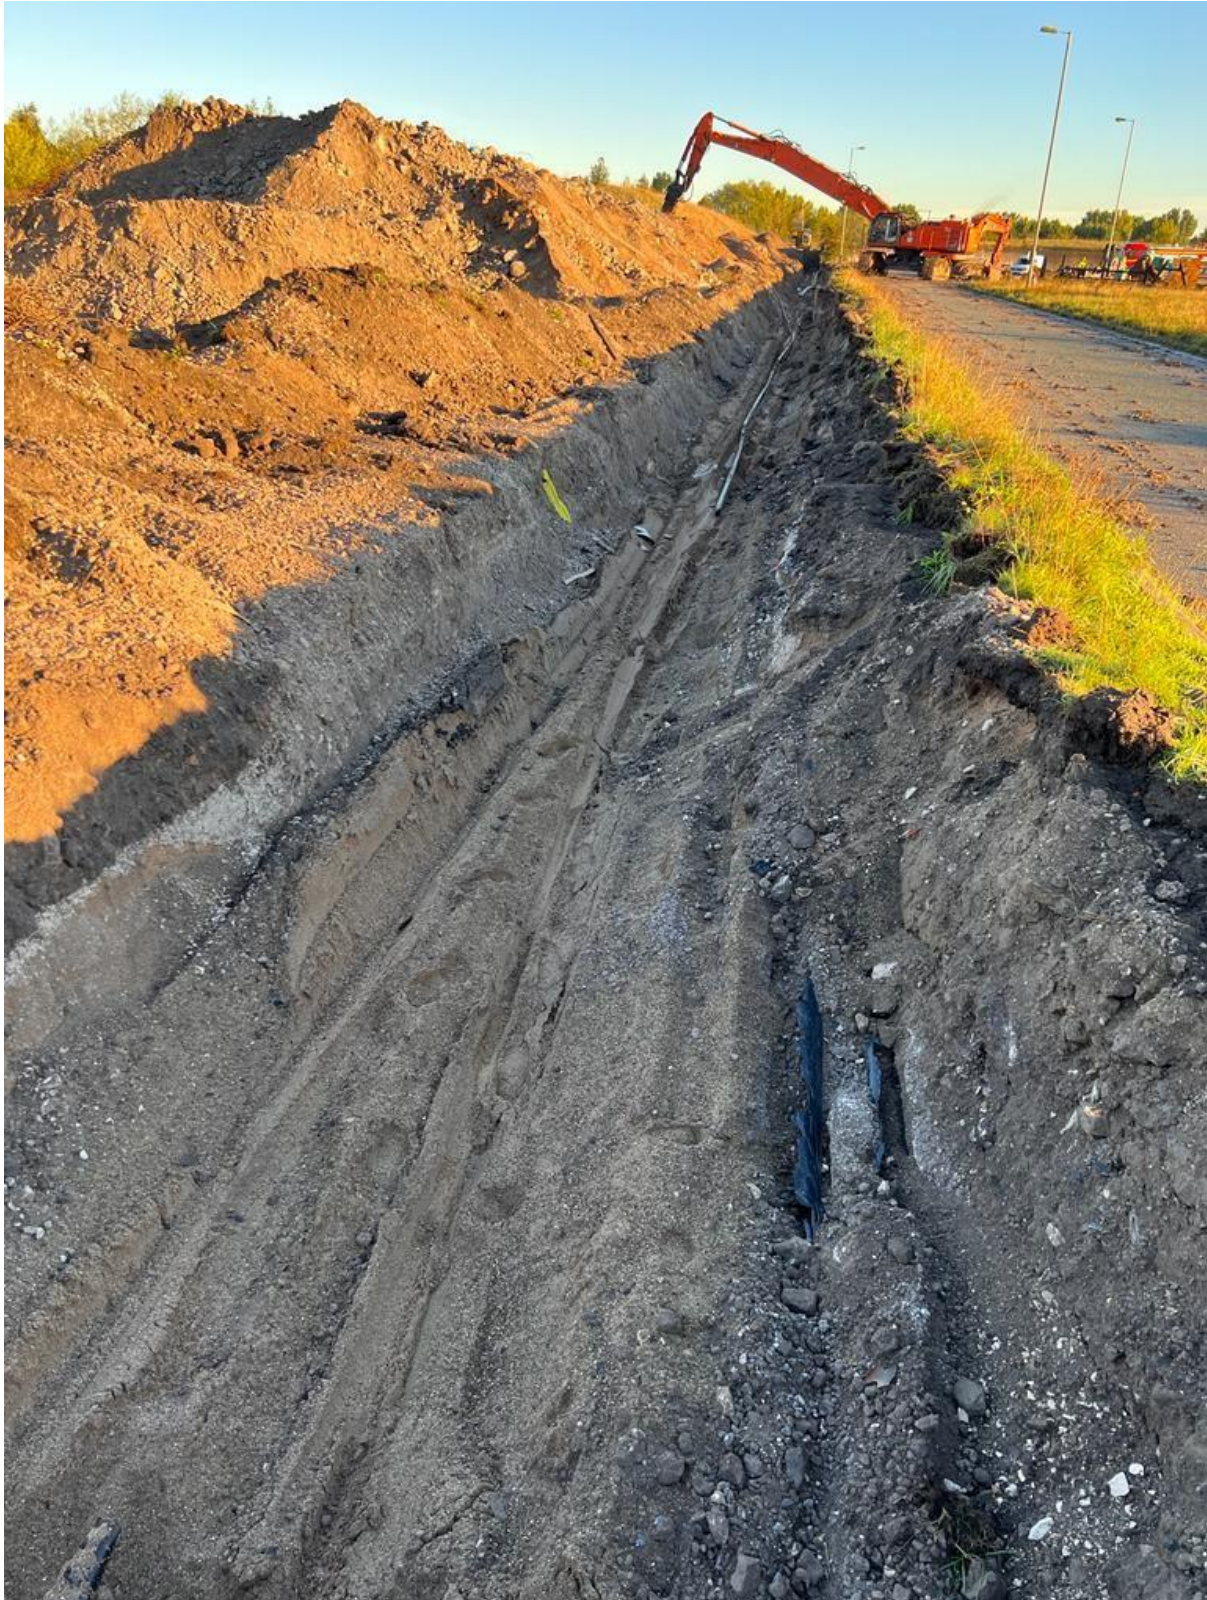
Gas and Fuel Lines Being Removed

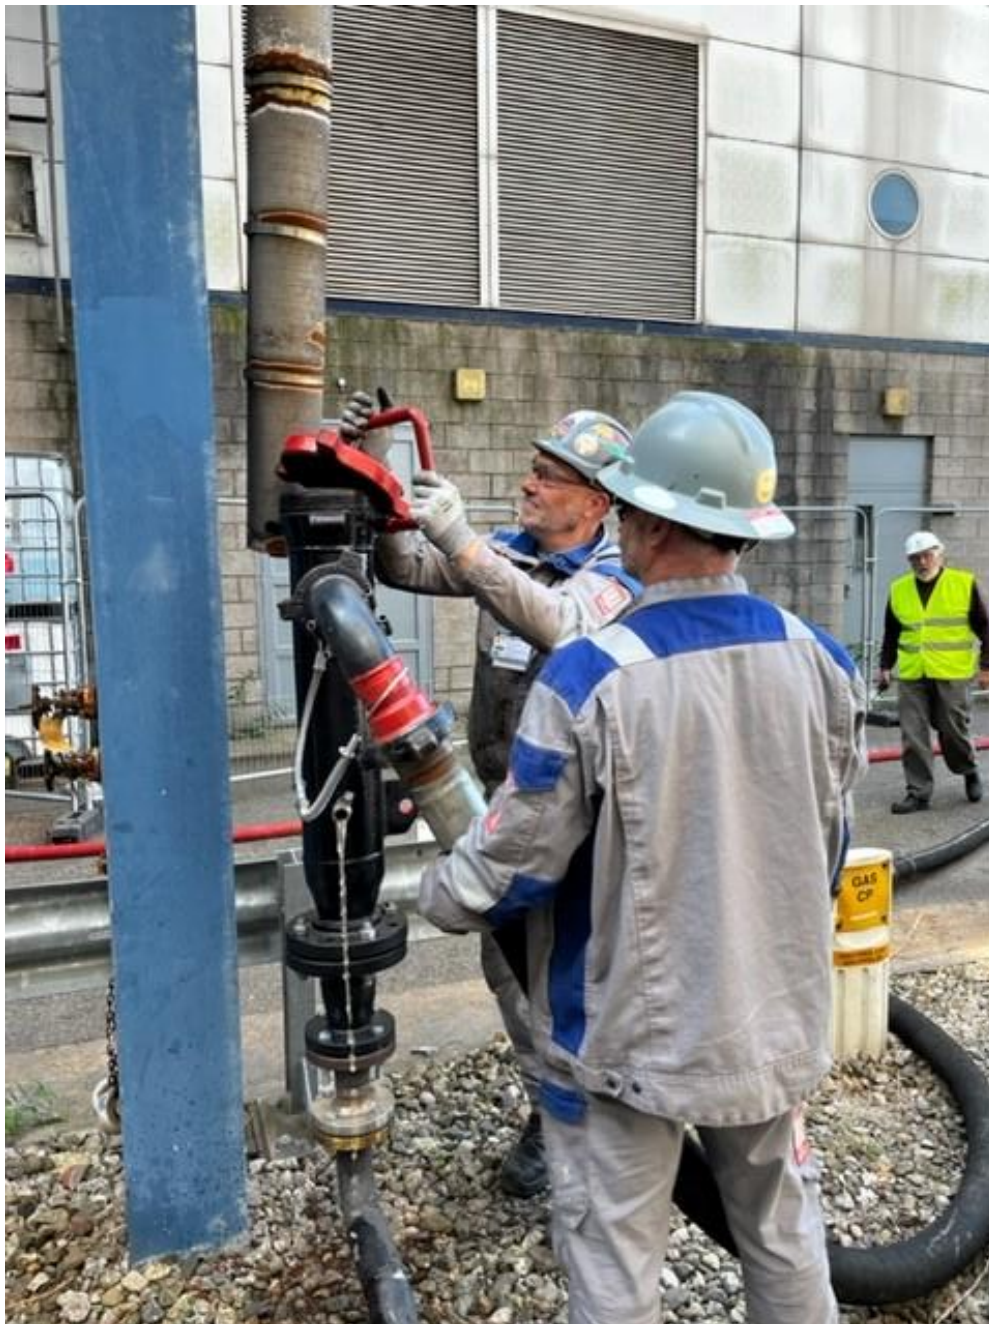
Cokebusters removing the diesel from the pipelines.

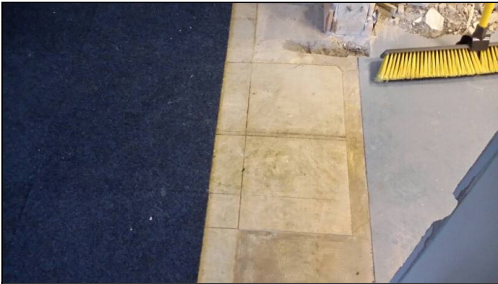
Survey Date:	Lead Surveyor	Survey Type	Floor	Analysis
	15 Feb 2021 to 18 Feb 2021	Adam Yates	Demolition Survey	Ground Floor	No Asbestos Detected
	Building	Room	Item	Quantity	
	Zone 1 - Resources Building	Office G/03	vinyl tile subfloor covering	48m ²	
	Sample No (S,SP,P,As)	Product Type	Surface Treatment	Condition	Accessibility
	JW004054 (S)	N/A	N/A	N/A	N/A
	Material Risk Score				
Recommended action		No further action required			
Surveyor comments		N/A

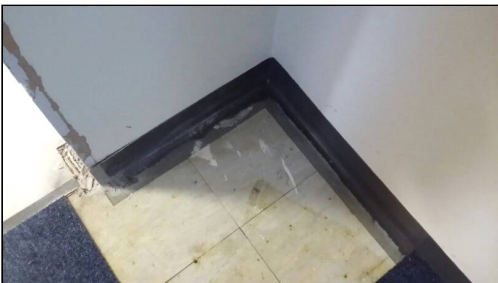
Survey Date:	Lead Surveyor	Survey Type	Floor	Analysis
	15 Feb 2021 to 18 Feb 2021	Adam Yates	Demolition Survey	Ground Floor	No Asbestos Detected
	Building	Room	Item	Quantity	
	Zone 1 - Resources Building	Office G/04	vinyl tile subfloor covering	30m ²	
	Sample No (S,SP,P,As)	Product Type	Surface Treatment	Condition	Accessibility
	As JW004054 (SP)	N/A	N/A	N/A	N/A
	Material Risk Score				
Recommended action		No further action required			
Surveyor comments		N/A

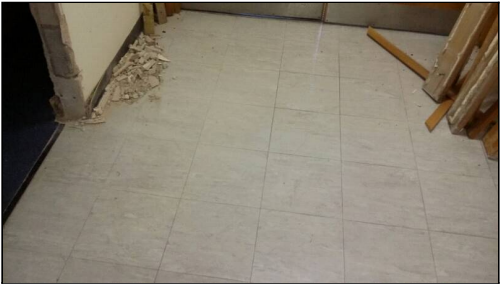
Survey Date:	Lead Surveyor	Survey Type	Floor	Analysis
	15 Feb 2021 to 18 Feb 2021	Adam Yates	Demolition Survey	Ground Floor	No Asbestos Detected
	Building	Room	Item	Quantity	
	Zone 1 - Resources Building	Circulation G/06	vinyl tile floor covering	24m ²	
	Sample No (S,SP,P,As)	Product Type	Surface Treatment	Condition	Accessibility
	As JW004054 (SP)	N/A	N/A	N/A	N/A
	Material Risk Score				
Recommended action		No further action required			
Surveyor comments		N/A

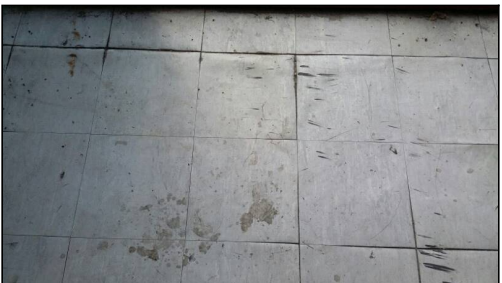
Survey Date:	Lead Surveyor	Survey Type	Floor	Analysis
	15 Feb 2021 to 18 Feb 2021	Adam Yates	Demolition Survey	Ground Floor	No Asbestos Detected
	Building	Room	Item	Quantity	
	Zone 1 - Workshop, Stores & Warehouse	Entrance/Stairwell lobby G/01	vinyl tile floor covering	15m ²	
	Sample No (S,SP,P,As)	Product Type	Surface Treatment	Condition	Accessibility
	JW004047 (S)	N/A	N/A	N/A	N/A
	Material Risk Score				
Recommended action		No further action required			
Surveyor comments		N/A

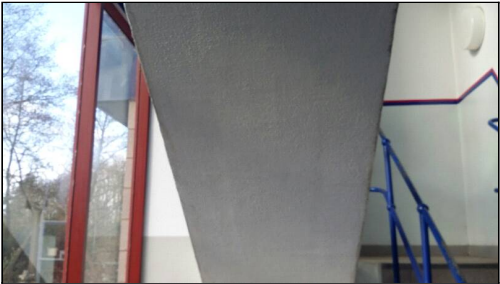
Survey Date:	Lead Surveyor	Survey Type	Floor	Analysis
	15 Feb 2021 to 18 Feb 2021	Adam Yates	Demolition Survey	Ground Floor	No Asbestos Detected
	Building	Room	Item	Quantity	
	Zone 1 - Workshop, Stores & Warehouse	Entrance/Stairwell lobby G/01	textured coating to underside of staircase	4m ²	
	Sample No (S,SP,P,As)	Product Type	Surface Treatment	Condition	Accessibility
	JW004048 (S)	N/A	N/A	N/A	N/A
	Material Risk Score				
Recommended action		No further action required			
Surveyor comments		N/A

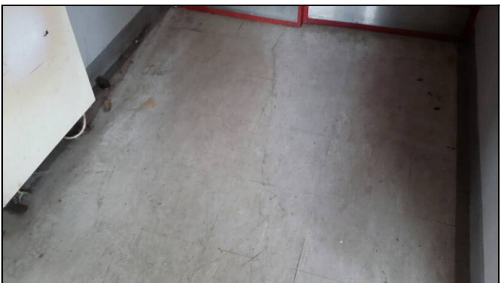
Survey Date:	Lead Surveyor	Survey Type	Floor	Analysis
	15 Feb 2021 to 18 Feb 2021	Adam Yates	Demolition Survey	Ground Floor	No Asbestos Detected
	Building	Room	Item	Quantity	
	Zone 1 - Workshop, Stores & Warehouse	Circulation G/02	vinyl tile floor covering	10m ²	
	Sample No (S,SP,P,As)	Product Type	Surface Treatment	Condition	Accessibility
	As JW004047 (SP)	N/A	N/A	N/A	N/A
	Material Risk Score				
Recommended action		No further action required			
Surveyor comments		N/A

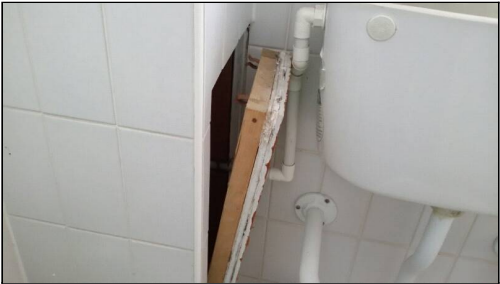
Survey Date:	Lead Surveyor	Survey Type	Floor	Analysis
	15 Feb 2021 to 18 Feb 2021	Adam Yates	Demolition Survey	Ground Floor	No Asbestos Detected
	Building	Room	Item	Quantity	
	Zone 1 - Workshop, Stores & Warehouse	Disabled WC G/03	insulating board panel to boxing inspection hatch	0.75m ²	
	Sample No (S,SP,P,As)	Product Type	Surface Treatment	Condition	Accessibility
	JW004049 (S)	N/A	N/A	N/A	N/A
	Material Risk Score				
Recommended action		No further action required			
Surveyor comments		N/A

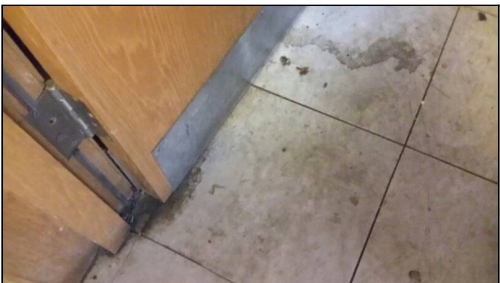
Survey Date:	Lead Surveyor	Survey Type	Floor	Analysis
	15 Feb 2021 to 18 Feb 2021	Adam Yates	Demolition Survey	Ground Floor	No Asbestos Detected
	Building	Room	Item	Quantity	
	Zone 1 - Workshop, Stores & Warehouse	Cleaners cupboard G/05	vinyl tile floor covering	4m ²	
	Sample No (S,SP,P,As)	Product Type	Surface Treatment	Condition	Accessibility
	As JW004047 (SP)	N/A	N/A	N/A	N/A
	Material Risk Score				
Recommended action		No further action required			
Surveyor comments		N/A

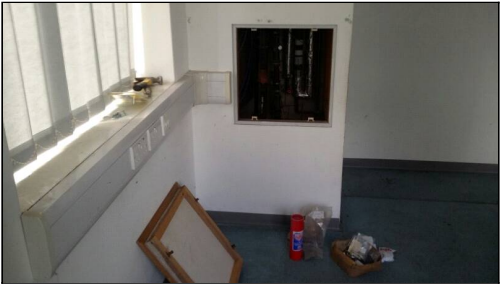
Survey Date:	Lead Surveyor	Survey Type	Floor	Analysis
	15 Feb 2021 to 18 Feb 2021	Adam Yates	Demolition Survey	Ground Floor	No Asbestos Detected
	Building	Room	Item	Quantity	
	Zone 1 - Workshop, Stores & Warehouse	Office G/06	insulating board panel to boxing inspection hatch	0.75m ²	Accessibility
	Sample No (S,SP,P,As)	Product Type	Surface Treatment	Condition	
	As JW004049 (SP)	N/A	N/A	N/A	N/A
	Material Risk Score				
Recommended action		No further action required			
Surveyor comments		N/A

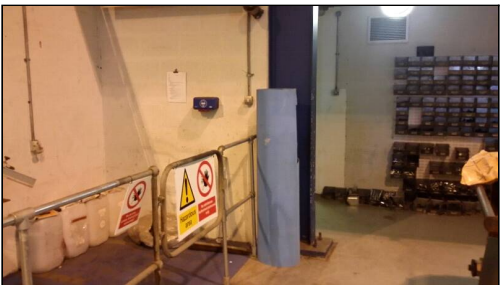
Survey Date:	Lead Surveyor	Survey Type	Floor	Analysis
	15 Feb 2021 to 18 Feb 2021	Adam Yates	Demolition Survey	Ground Floor	No Asbestos Detected
	Building	Room	Item	Quantity	
	Zone 1 - Workshop, Stores & Warehouse	Workshop/Circulation G/08	redundant gasket roll	2m ²	Accessibility
	Sample No (S,SP,P,As)	Product Type	Surface Treatment	Condition	
	JW004050 (S)	N/A	N/A	N/A	N/A
	Material Risk Score				
Recommended action		No further action required			
Surveyor comments		N/A

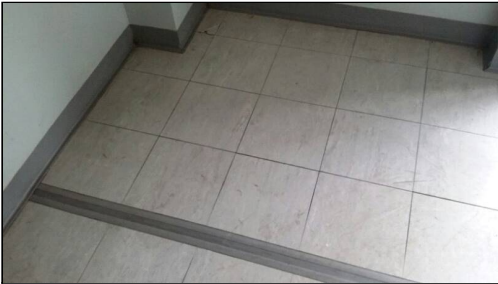
Survey Date:	Lead Surveyor	Survey Type	Floor	Analysis
	15 Feb 2021 to 18 Feb 2021	Adam Yates	Demolition Survey	1st Floor	No Asbestos Detected
	Building	Room	Item	Quantity	
	Zone 1 - Workshop, Stores & Warehouse	Stairwell lobby 1/01	vinyl tile floor covering	5m ²	
	Sample No (S,SP,P,As)	Product Type	Surface Treatment	Condition	Accessibility
	JW004051 (S)	N/A	N/A	N/A	N/A
	Material Risk Score				
Recommended action		No further action required			
Surveyor comments		N/A

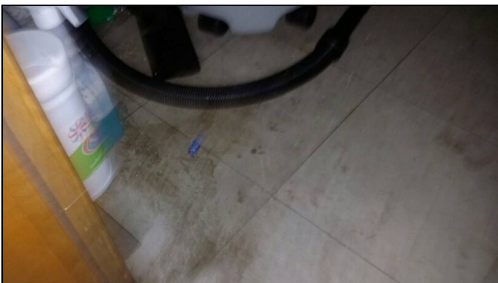
Survey Date:	Lead Surveyor	Survey Type	Floor	Analysis
	15 Feb 2021 to 18 Feb 2021	Adam Yates	Demolition Survey	1st Floor	No Asbestos Detected
	Building	Room	Item	Quantity	
	Zone 1 - Workshop, Stores & Warehouse	Cleaners cupboard 1/02	vinyl tile floor covering	4m ²	
	Sample No (S,SP,P,As)	Product Type	Surface Treatment	Condition	Accessibility
	As JW004051 (SP)	N/A	N/A	N/A	N/A
	Material Risk Score				
Recommended action		No further action required			
Surveyor comments		N/A

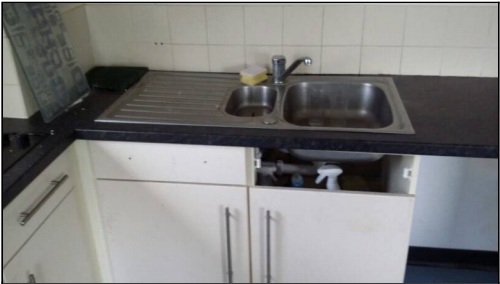
Survey Date:	Lead Surveyor	Survey Type	Floor	Analysis
	15 Feb 2021 to 18 Feb 2021	Adam Yates	Demolition Survey	1st Floor	No Asbestos Detected
	Building	Room	Item	Quantity	
	Zone 1 - Workshop, Stores & Warehouse	Kitchen 1/03	bituminous pad to sink & drainer	1no.	
	Sample No (S,SP,P,As)	Product Type	Surface Treatment	Condition	Accessibility
	JW004052 (S)	N/A	N/A	N/A	N/A
	Material Risk Score				
Recommended action		No further action required			
Surveyor comments		N/A

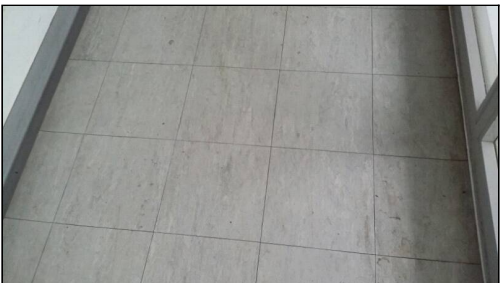
Survey Date:	Lead Surveyor	Survey Type	Floor	Analysis
	15 Feb 2021 to 18 Feb 2021	Adam Yates	Demolition Survey	1st Floor	No Asbestos Detected
	Building	Room	Item	Quantity	
	Zone 1 - Workshop, Stores & Warehouse	Circulation 1/07	vinyl tile floor covering	19m ²	
	Sample No (S,SP,P,As)	Product Type	Surface Treatment	Condition	Accessibility
	As JW004051 (SP)	N/A	N/A	N/A	N/A
	Material Risk Score				
Recommended action		No further action required			
Surveyor comments		N/A

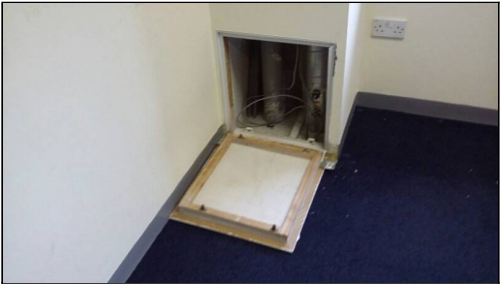
Survey Date:	Lead Surveyor	Survey Type	Floor	Analysis
	15 Feb 2021 to 18 Feb 2021	Adam Yates	Demolition Survey	1st Floor	No Asbestos Detected
	Building	Room	Item	Quantity	
	Zone 1 - Workshop, Stores & Warehouse	Office 1/08	insulating board panel to boxing inspection hatch	0.75m ²	
	Sample No (S,SP,P,As)	Product Type	Surface Treatment	Condition	Accessibility
	JW004053 (S)	N/A	N/A	N/A	N/A
	Material Risk Score				
Recommended action		No further action required			
Surveyor comments		N/A

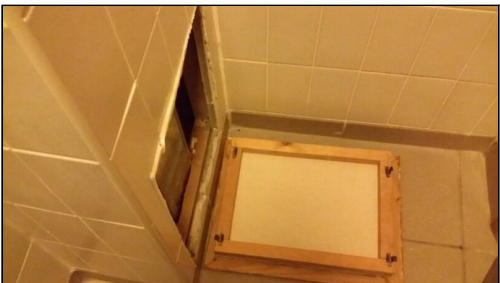
Survey Date:	Lead Surveyor	Survey Type	Floor	Analysis
	15 Feb 2021 to 18 Feb 2021	Adam Yates	Demolition Survey	1st Floor	No Asbestos Detected
	Building	Room	Item	Quantity	
	Zone 1 - Workshop, Stores & Warehouse	Female WC 1/09	insulating board panel to boxing inspection hatch	0.75m ²	
	Sample No (S,SP,P,As)	Product Type	Surface Treatment	Condition	Accessibility
	As JW004053 (SP)	N/A	N/A	N/A	N/A
	Material Risk Score				
Recommended action		No further action required			
Surveyor comments		N/A

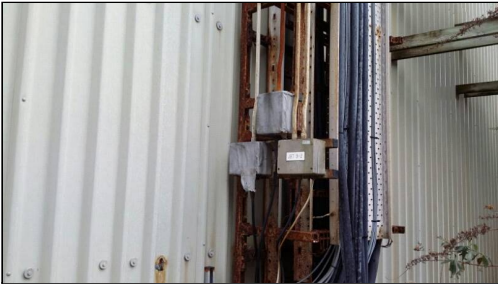
Survey Date:	Lead Surveyor	Survey Type	Floor	Analysis
	16 Feb 2021 to 18 Feb 2021	Adam Yates	Demolition Survey	External	No Asbestos Detected
	Building	Room	Item	Quantity	
	Zone 2 - Cooling Tower 1	Externals E/01	woven wrap to electrical boxes	2no.	
	Sample No (S,SP,P,As)	Product Type	Surface Treatment	Condition	Accessibility
	JW004055 (S)	N/A	N/A	N/A	N/A
	Material Risk Score				
Recommended action		No further action required			
Surveyor comments		N/A

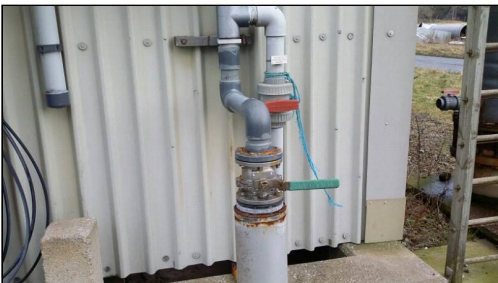
Survey Date:	Lead Surveyor	Survey Type	Floor	Analysis
	16 Feb 2021 to 18 Feb 2021	Adam Yates	Demolition Survey	External	No Asbestos Detected
	Building	Room	Item	Quantity	
	Zone 2 - Cooling Tower 1	Externals E/01	gasket to pipework flange to raw water pipework	1no.	
	Sample No (S,SP,P,As)	Product Type	Surface Treatment	Condition	Accessibility
	JW004056 (S)	N/A	N/A	N/A	N/A
	Material Risk Score				
Recommended action		No further action required			
Surveyor comments		N/A

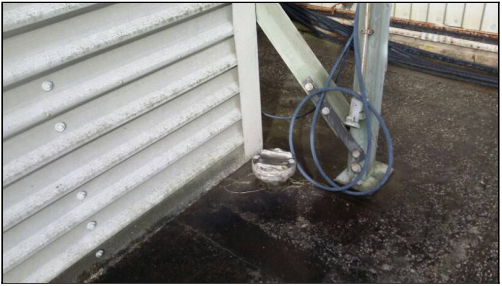
Survey Date:	Lead Surveyor	Survey Type	Floor	Analysis
	16 Feb 2021 to 18 Feb 2021	Adam Yates	Demolition Survey	External	No Asbestos Detected
	Building	Room	Item	Quantity	
	Zone 2 - Cooling Tower 2	Externals E/01	woven wrap to pipework flange adjacent shelter	1no.	
	Sample No (S,SP,P,As)	Product Type	Surface Treatment	Condition	Accessibility
	As JW004055 (SP)	N/A	N/A	N/A	N/A
	Material Risk Score				
Recommended action		No further action required			
Surveyor comments		N/A

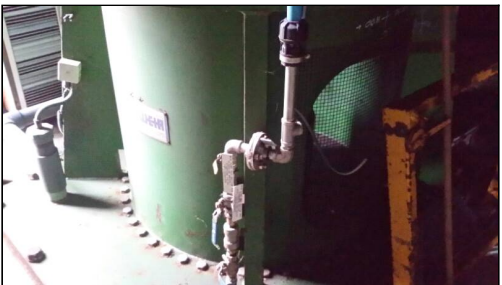
Survey Date:	Lead Surveyor	Survey Type	Floor	Analysis
	16 Feb 2021 to 18 Feb 2021	Adam Yates	Demolition Survey	Ground Floor	No Asbestos Detected
	Building	Room	Item	Quantity	
	Zone 2 - Cooling Tower Pump House, Sodium Hypochlorite & Purge Cooler Building	Loading bay G/01	gasket to pipework flange to MCW pump pipework	2no.	
	Sample No (S,SP,P,As)	Product Type	Surface Treatment	Condition	Accessibility
	JW004057 (S)	N/A	N/A	N/A	N/A
	Material Risk Score				
Recommended action		No further action required			
Surveyor comments		N/A

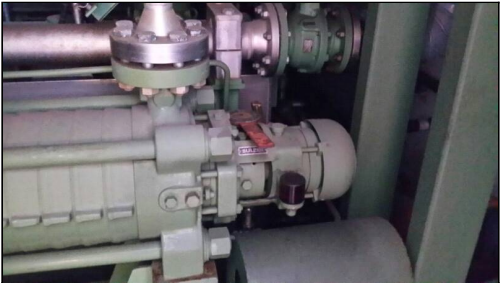
Survey Date:	Lead Surveyor	Survey Type	Floor	Analysis
	16 Feb 2021 to 18 Feb 2021	Adam Yates	Demolition Survey	Ground Floor	No Asbestos Detected
	Building	Room	Item	Quantity	
	Zone 3 - Fuel Oil Pump House	Fuel oil pump house G/01	redundant gasket to top of pump adjacent entrance	1no.	
	Sample No (S,SP,P,As)	Product Type	Surface Treatment	Condition	Accessibility
	JW004058 (S)	N/A	N/A	N/A	N/A
	Material Risk Score				
Recommended action		No further action required			
Surveyor comments		N/A

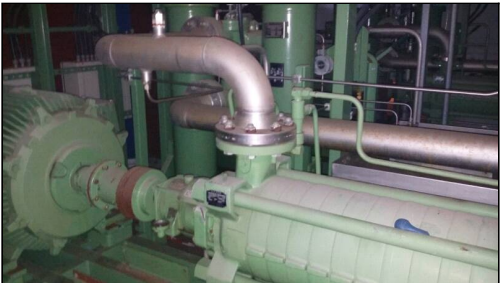
Survey Date:	Lead Surveyor	Survey Type	Floor	Analysis
	16 Feb 2021 to 18 Feb 2021	Adam Yates	Demolition Survey	Ground Floor	No Asbestos Detected
	Building	Room	Item	Quantity	
	Zone 3 - Fuel Oil Pump House	Fuel oil pump house G/01	gasket to pipework flange to pump pipework	6no.	
	Sample No (S,SP,P,As)	Product Type	Surface Treatment	Condition	Accessibility
	JW004059 (S)	N/A	N/A	N/A	N/A
	Material Risk Score				
Recommended action		No further action required			
Surveyor comments		N/A

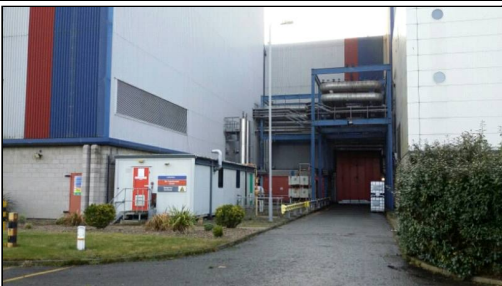
Survey Date:	Lead Surveyor	Survey Type	Floor	Analysis
	16 Feb 2021 to 18 Feb 2021	Adam Yates	Demolition Survey	Ground Floor	N/A
	Building	Room	Item	Quantity	
	Zone 3 - Laboratory	Laboratory G/01	No suspect materials found within laboratory	N/A	
	Sample No (S,SP,P,As)	Product Type	Surface Treatment	Condition	Accessibility
	Visual (P)	N/A	N/A	N/A	N/A
Material Risk Score					
N/A					
Recommended action					
No further action required					
Surveyor comments					
N/A

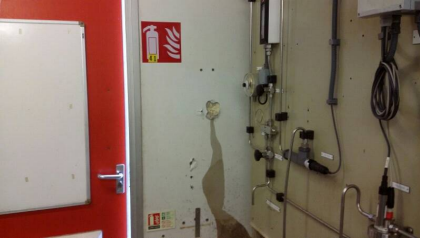
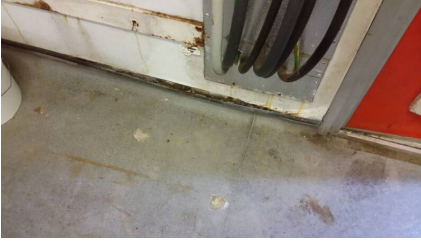
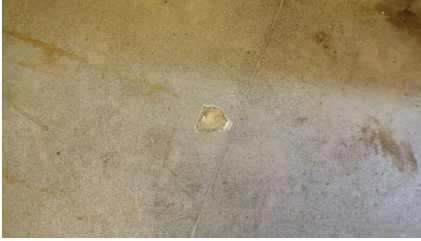
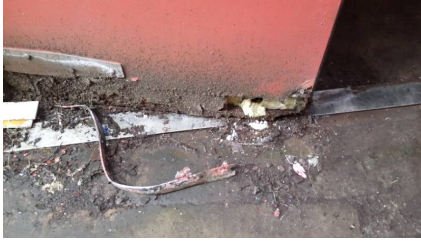
Intrusion into wall	Intrusion into skirting	Intrusion into floor	Intrusion into door

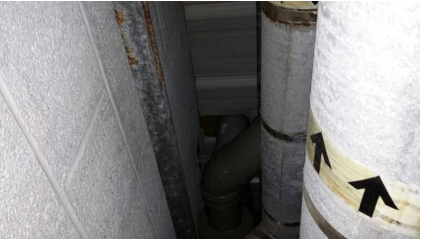
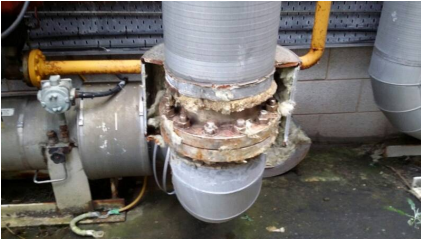
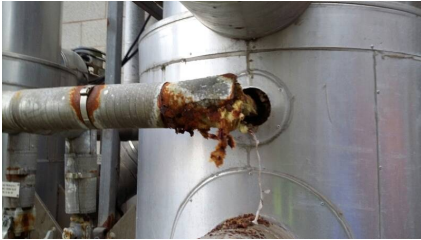
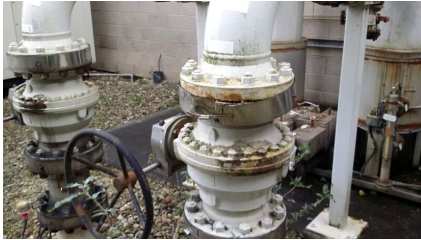
Intrusion into ceiling	Inspection to pipework flange	Intrusion into pipework insulation	Inspection to pipework flange

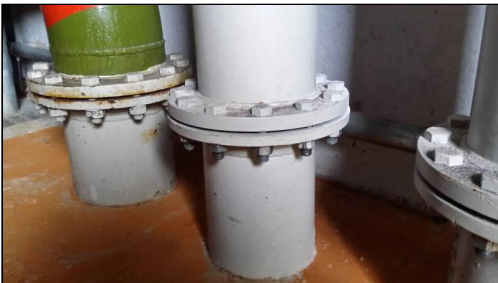
Survey Date:	Lead Surveyor	Survey Type	Floor	Analysis
	17 Feb 2021 to 18 Feb 2021	Adam Yates	Demolition Survey	Ground Floor	No Asbestos Detected
	Building	Room	Item	Quantity	
	Zone 4 - Water Treatment Plant, Waste Collection Area & Demin Tank	Diesel fire pump room G/02	gasket to pipework flange to fire protection deisel pump delivery pipework	9no.	
	Sample No (S,SP,P,As)	Product Type	Surface Treatment	Condition	Accessibility
	JW004064 (S)	N/A	N/A	N/A	N/A
Material Risk Score					
N/A					
Recommended action	No further action required				
Surveyor comments	N/A

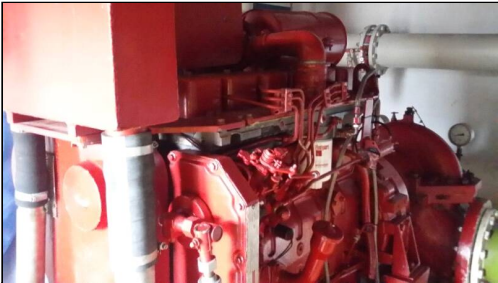
Survey Date:	Lead Surveyor	Survey Type	Floor	Analysis
	17 Feb 2021 to 18 Feb 2021	Adam Yates	Demolition Survey	Ground Floor	No Asbestos Detected
	Building	Room	Item	Quantity	
	Zone 4 - Water Treatment Plant, Waste Collection Area & Demin Tank	Diesel fire pump room G/02	head gasket to to diesel generator	1no.	
	Sample No (S,SP,P,As)	Product Type	Surface Treatment	Condition	Accessibility
	JW004065 (S)	N/A	N/A	N/A	N/A
	Material Risk Score				
Recommended action		No further action required			
Surveyor comments		N/A

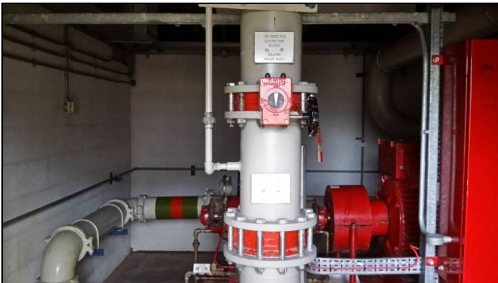
Survey Date:	Lead Surveyor	Survey Type	Floor	Analysis
	17 Feb 2021 to 18 Feb 2021	Adam Yates	Demolition Survey	Ground Floor	No Asbestos Detected
	Building	Room	Item	Quantity	
	Zone 4 - Water Treatment Plant, Waste Collection Area & Demin Tank	Electric fire pump room G/03	gasket to pipework flange to fire protection electric pump delivery pipework	6no.	
	Sample No (S,SP,P,As)	Product Type	Surface Treatment	Condition	Accessibility
	As JW004064 (SP)	N/A	N/A	N/A	N/A
	Material Risk Score				
Recommended action		No further action required			
Surveyor comments		N/A

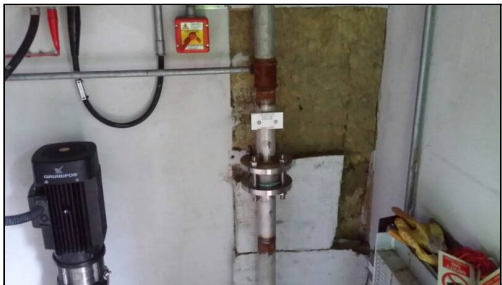
Survey Date:	Lead Surveyor	Survey Type	Floor	Analysis
	17 Feb 2021 to 18 Feb 2021	Adam Yates	Demolition Survey	Ground Floor	No Asbestos Detected
	Building	Room	Item	Quantity	
	Zone 4 - Water Treatment Plant, Waste Collection Area & Demin Tank	Electric fire pump room G/03	gasket to pipework flange to fire protection jockey pump pipework	4no.	
	Sample No (S,SP,P,As)	Product Type	Surface Treatment	Condition	Accessibility
	JW004066 (S)	N/A	N/A	N/A	N/A
	Material Risk Score				
	N/A				
Recommended action	No further action required				
Surveyor comments	N/A

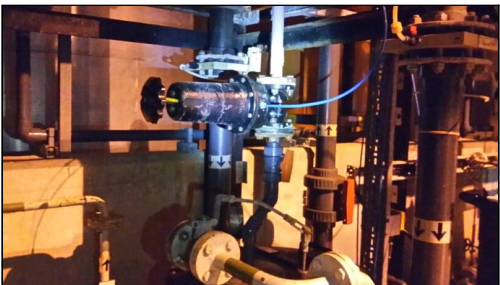
Survey Date:	Lead Surveyor	Survey Type	Floor	Analysis
	17 Feb 2021 to 18 Feb 2021	Adam Yates	Demolition Survey	Ground Floor	No Asbestos Detected
	Building	Room	Item	Quantity	
	Zone 4 - Water Treatment Plant, Waste Collection Area & Demin Tank	Water treatment room G/05	gasket to pipework flange to caustic measuring tank outlet pipework	2no.	
	Sample No (S,SP,P,As)	Product Type	Surface Treatment	Condition	Accessibility
	JW004067 (S)	N/A	N/A	N/A	N/A
	Material Risk Score				
	N/A				
Recommended action	No further action required				
Surveyor comments	N/A

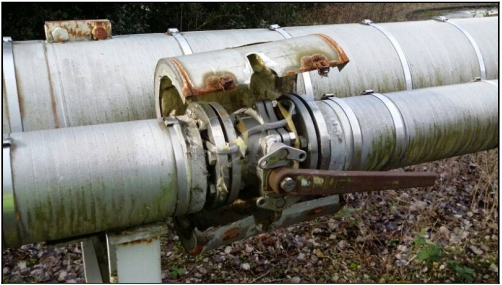
Survey Date:	Lead Surveyor	Survey Type	Floor	Analysis
	17 Feb 2021 to 18 Feb 2021	Adam Yates	Demolition Survey	External	No Asbestos Detected
	Building	Room	Item	Quantity	
	Zone 4 - Water Treatment Plant, Waste Collection Area & Demin Tank	Externals E/01	gasket to pipework flange to make up water flow pipework	2no.	
	Sample No (S,SP,P,As)	Product Type	Surface Treatment	Condition	Accessibility
	JW004068 (S)	N/A	N/A	N/A	N/A
Material Risk Score					
N/A					
Recommended action	No further action required				
Surveyor comments	N/A

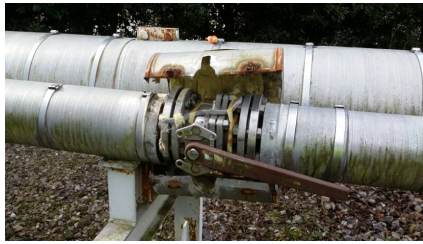
Inspection of pipework flange

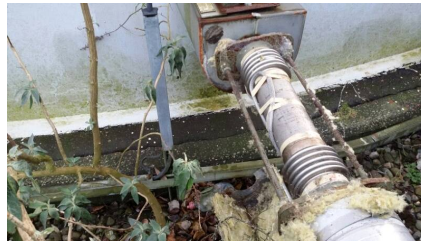
Intrusion into pipework casing

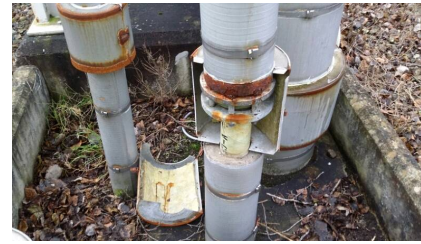
Inspection of pipework flange

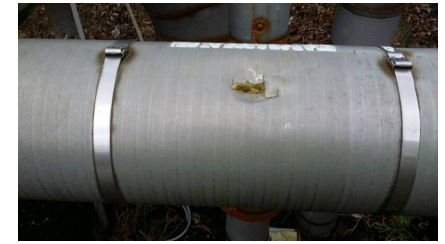
Intrusion into pipework casing

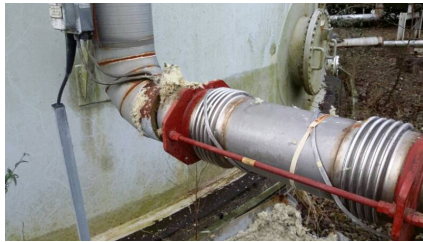
Intrusion into pipework casing

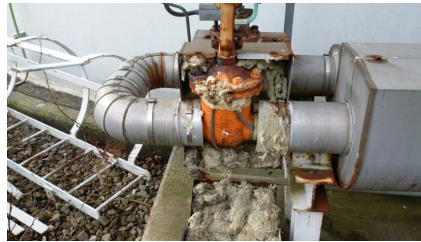
Inspection of pipework flange

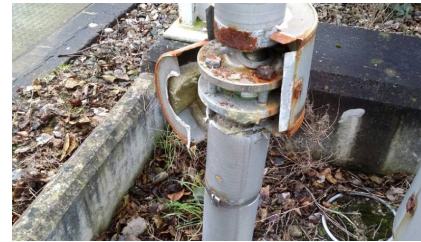
Inspection of pipework flange

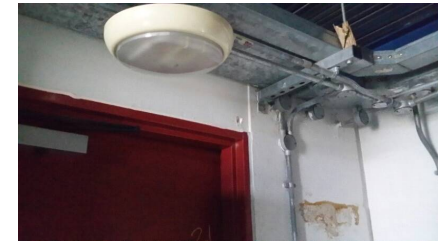
Intrusion into panel above door

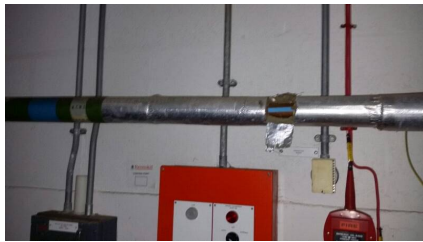
Intrusion into pipework insulation
